#### FLOODS ON MAHONING RIVER AT WARREN, OHIO, IN 1959

## FLOODS AT WARREN, OHIO

G. W. Edelen, Jr., F. H. Ruggles, Jr., and W. P. Cross  
1963

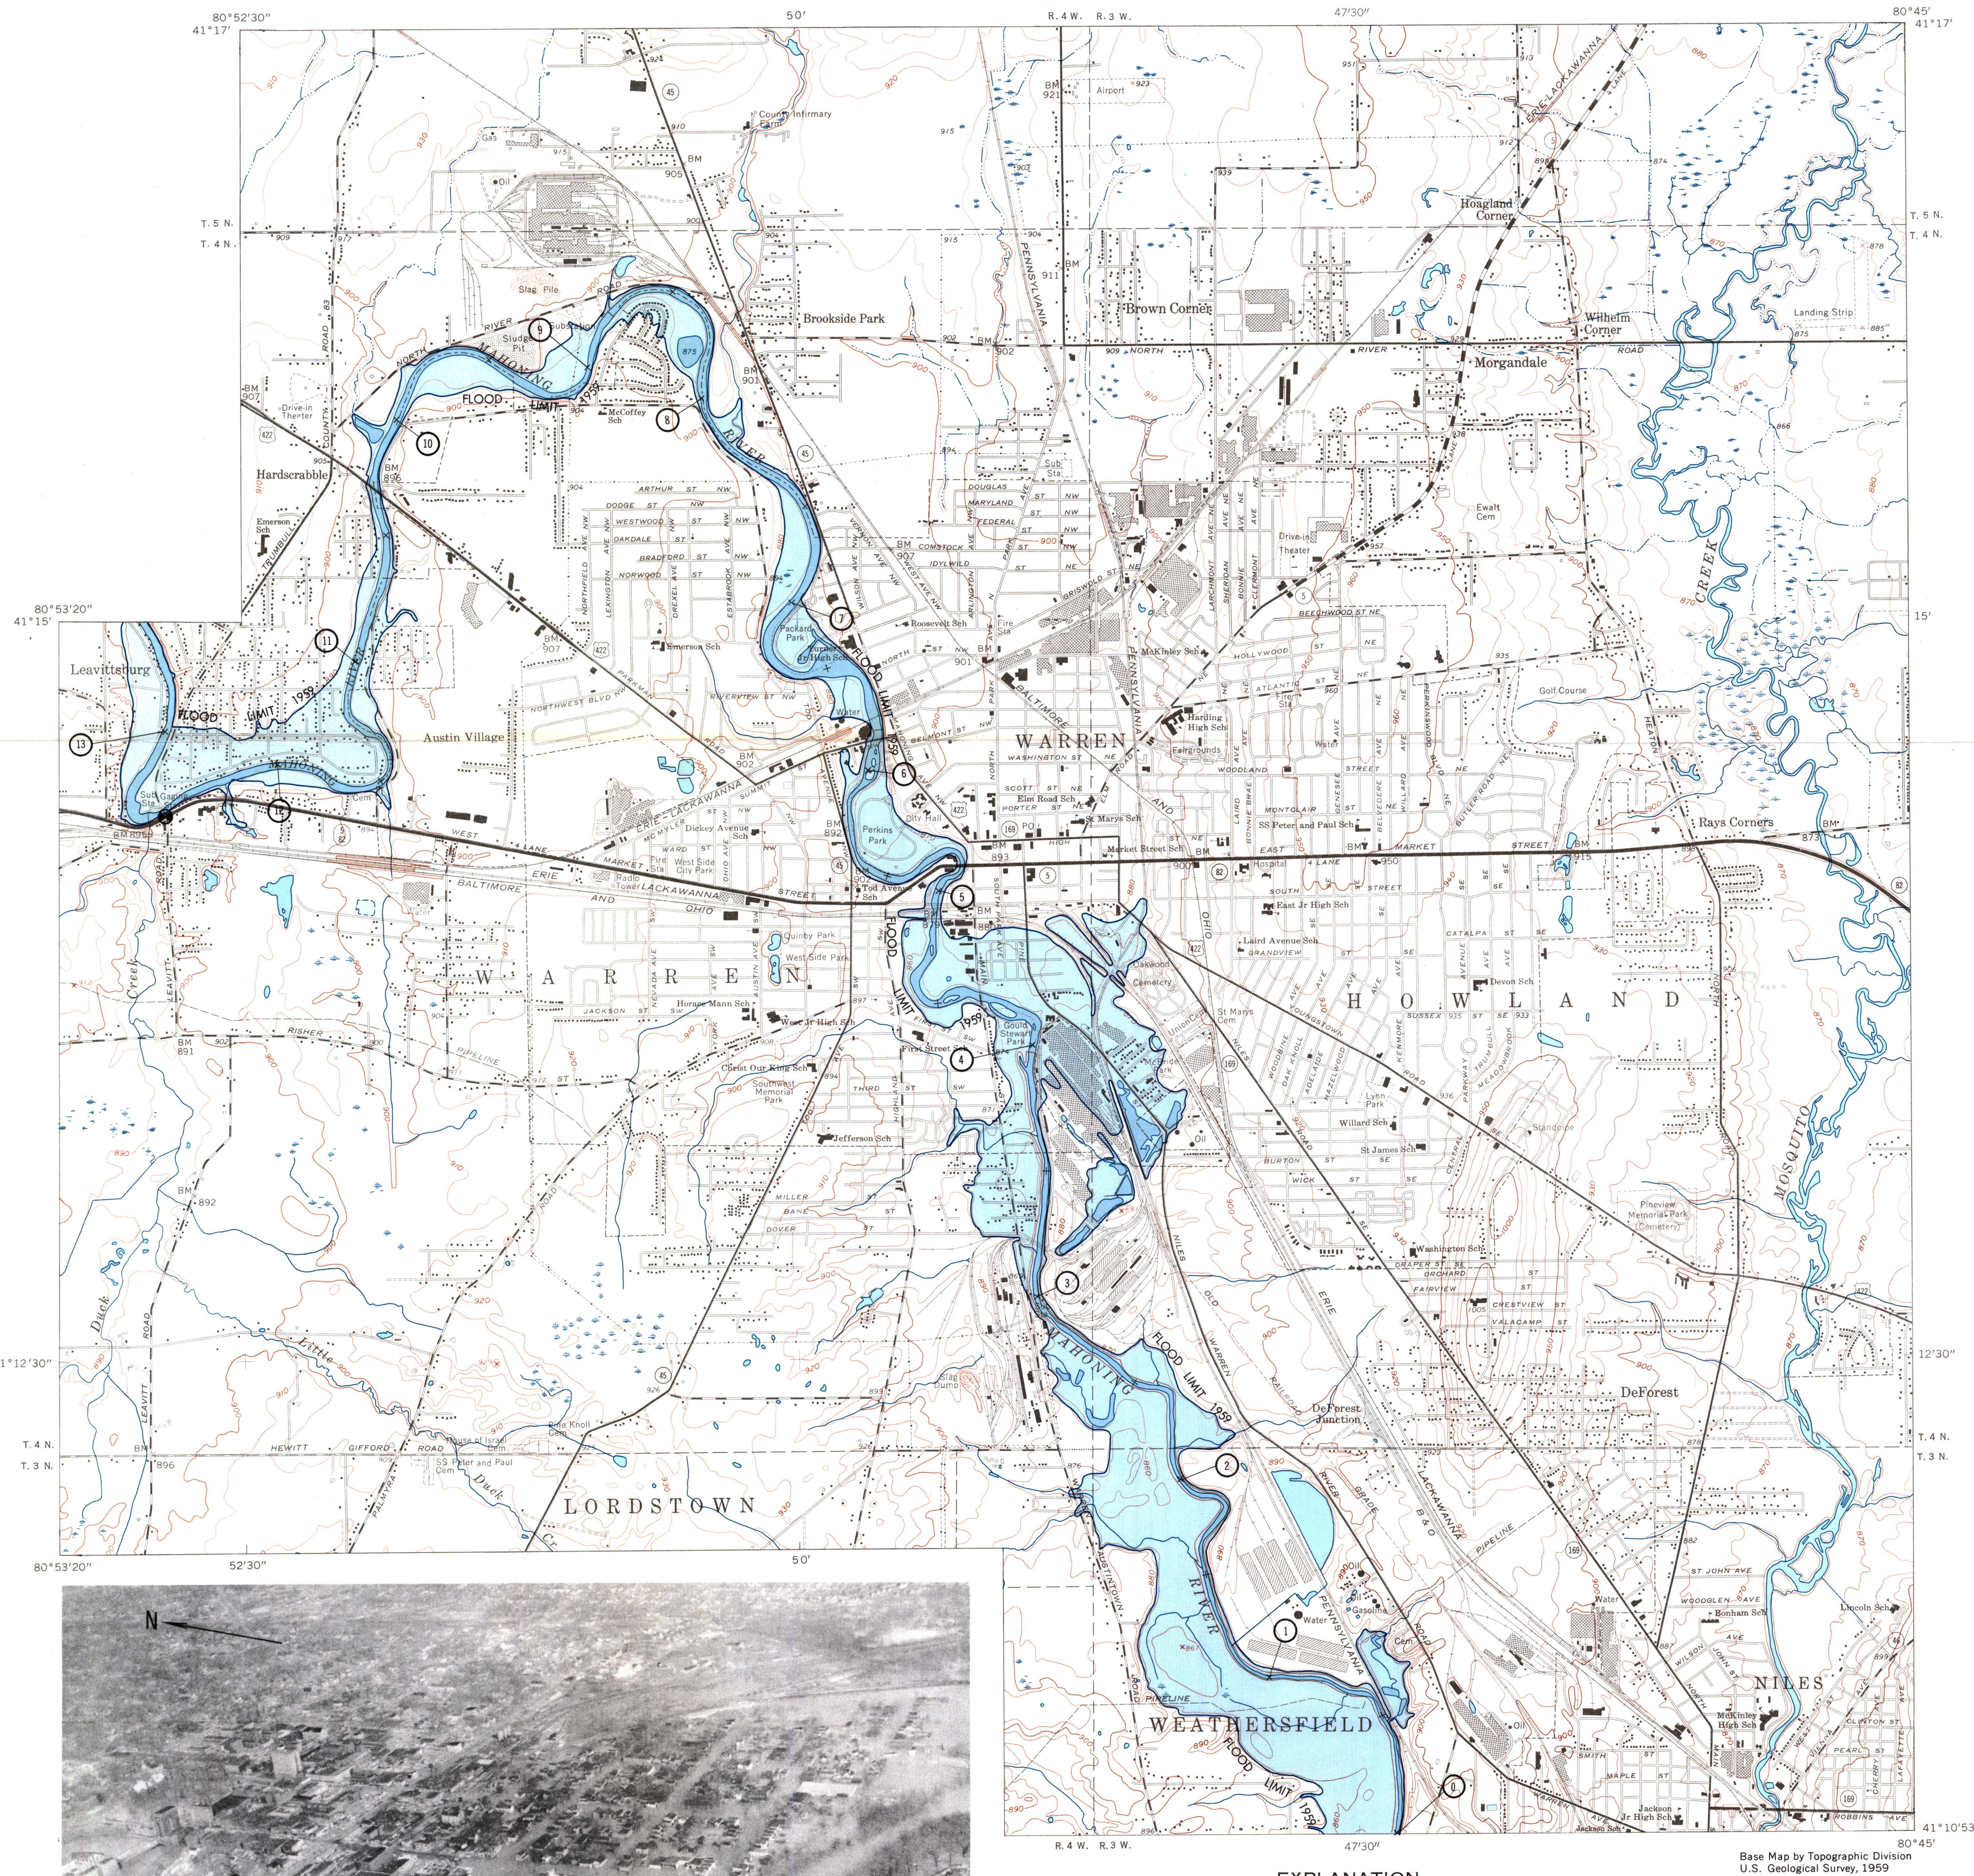
FLOOD LIMIT 1959

River miles measured upstream from  
West Park Street in Niles, Ohio

The approximate areas inundated in the vicinity of Warren, Ohio, by the Mahoning River during the flood of January 22, 1959, is shown on a topographic map base to record the flood hazard in graphical form. Greater floods are possible but no attempt has been made to show their probable overflow limits. The flood of January 1959, although reduced somewhat by storage in reservoirs upstream, was the highest on the Mahoning River since the flood of March 26, 1913. The 1913 flood was the greatest after 1800. Protective works built after the flood of January 1959 may reduce the frequency of flooding in the area but will not necessarily eliminate future flooding. New highways and other cultural changes may influence the inundation pattern of future floods.

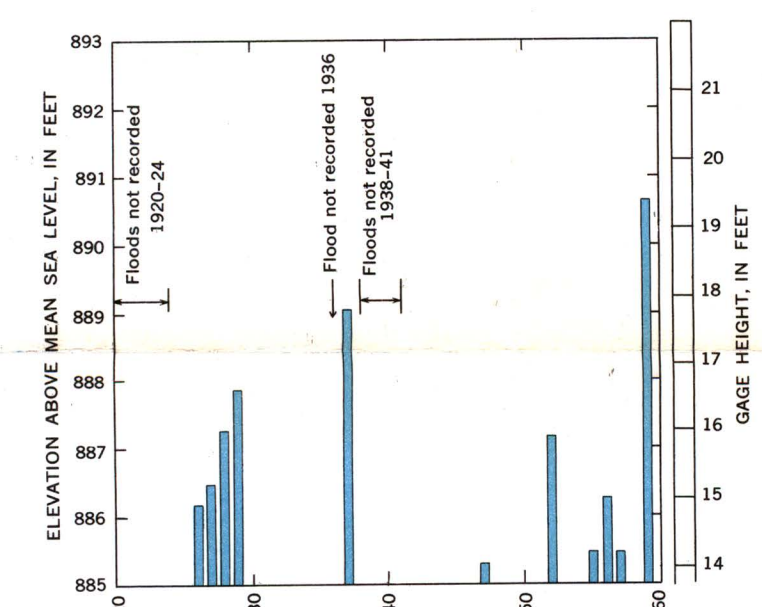
FIGURE 1.—Annual floods above 885-foot elevation, 1925-35, 1937, 1942-59, on Mahoning River at Leavittsburg, Ohio.

**Gage height and year of occurrence of each annual flood (greatest flood each year)** which exceeded elevation 885 feet at the gaging station on Mahoning River at Leavittsburg, Ohio, are shown in figure 1. The irregular occurrence of floods is evident. The annual flood exceeded elevation 885 feet 11 times in 30 years of record (fig. 1). Although floods above elevation 885 feet occurred on the average of about 4 times per decade, 1 was experienced in some decades, whereas 5 occurred during the period 1950-59.
