FLOODS ON DES MOINES RIVER, RACCOON RIVER, WALNUT CREEK,
AND FOURMILE CREEK AT DES MOINES, IOWA, IN 1947, 1954, AND 1960

FLOODS AT DES MOINES, IOWA

By
R. E. Myers
1963

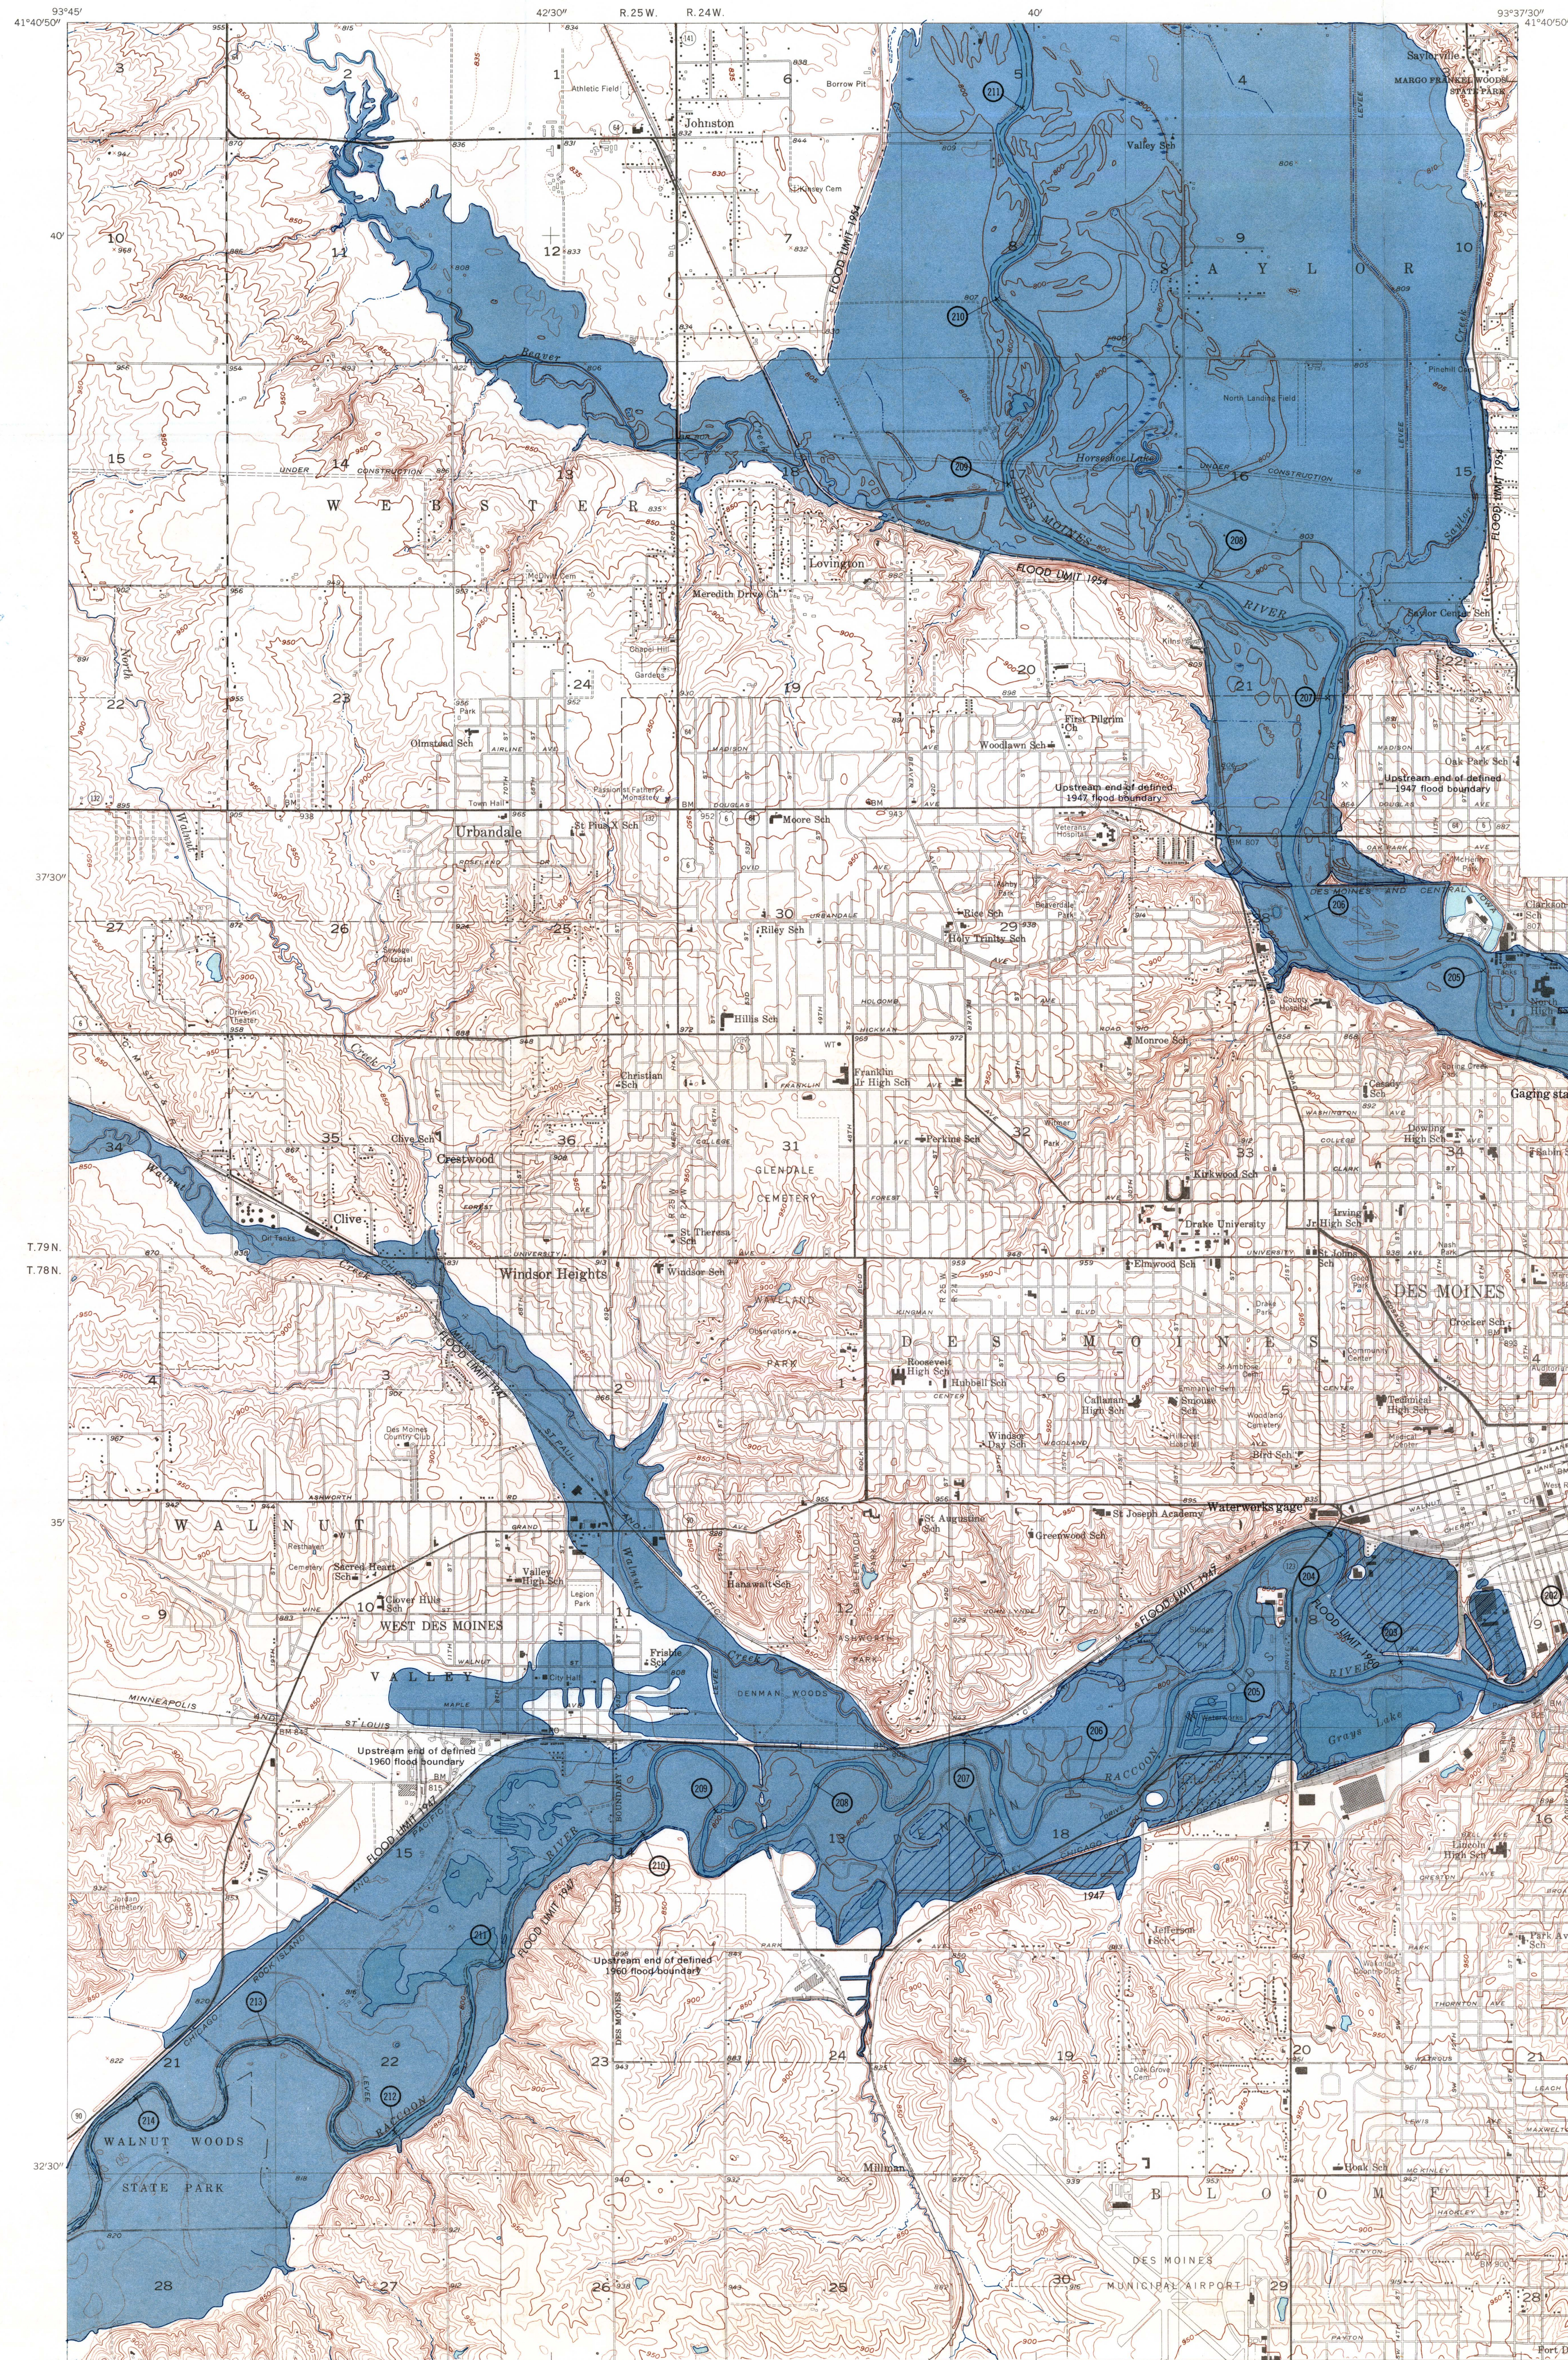
PHOTOGRAPH BY DES MOINES REGISTER AND TRIBUNE
AERIAL VIEW OF DES MOINES IOWA
JUNE 26, 1947

The approximate areas inundated in the vicinity of Des Moines, Iowa, by the Des Moines River during the floods of June 26, 1947, and June 24, 1954; by the Raccoon River during the floods of June 13, 1947, and April 2, 1960; by Walnut Creek during the flood of June 13, 1947; and by Fourmile Creek during the floods of June 13, 1947, and by Fourmile Creek during the floods of June 13, 1947, and June 24, 1954, are delineated on a topographic map base.

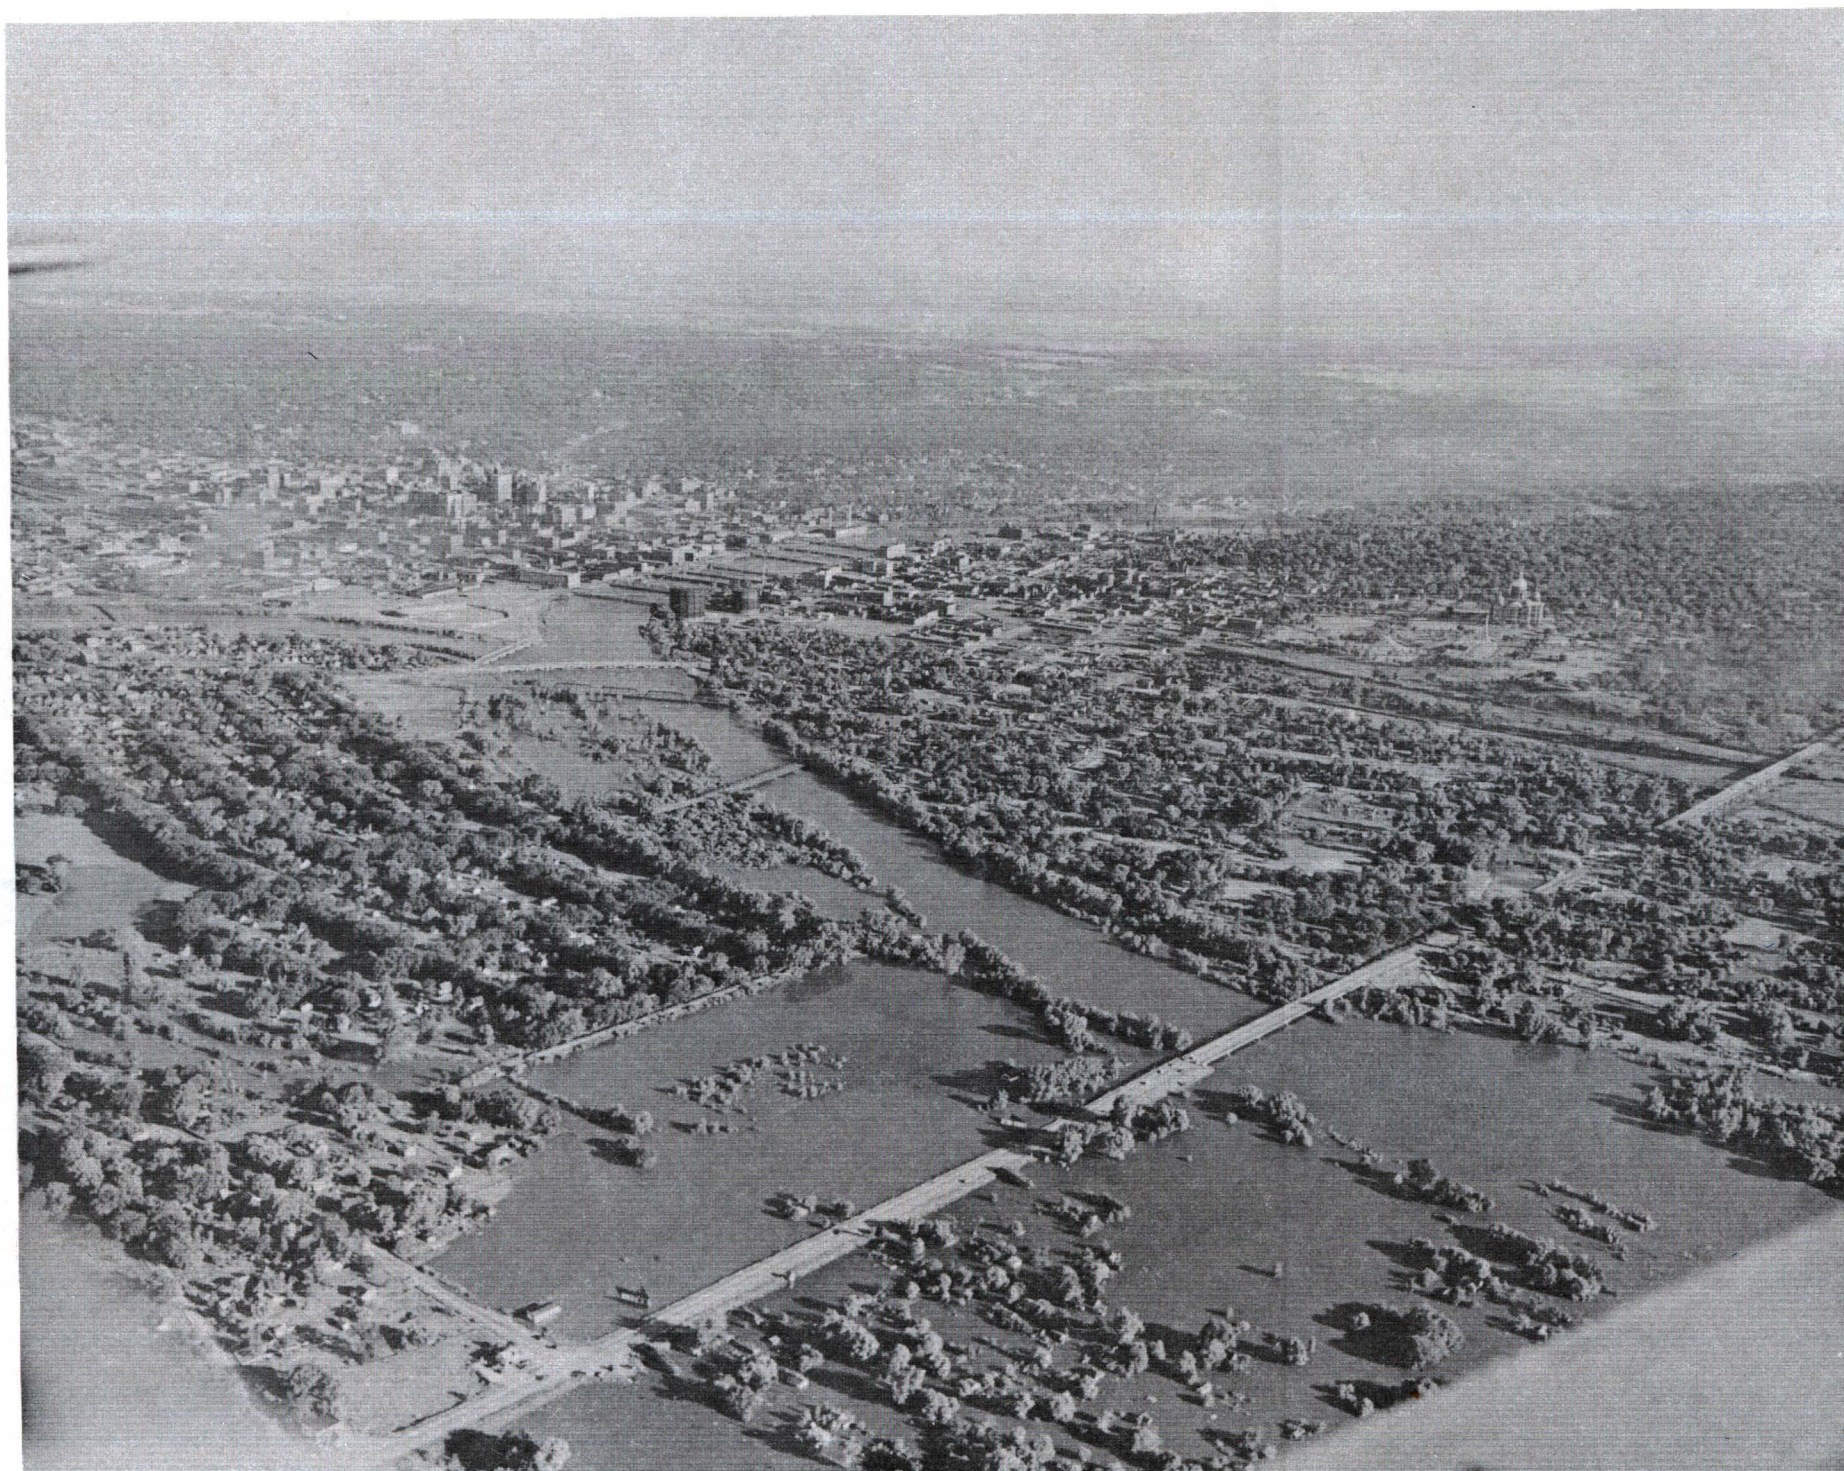
FIGURE 1.—ANNUAL FLOODS ABOVE ELEVATION 792 FEET, 1903-1950, WATERWORKS GAGE AT SOUTHWEST EIGHTEENTH STREET BRIDGE ON RACCOON RIVER AT DES MOINES

Gage height and year of each annual flood (greatest flood each year) that exceeded elevation 792 feet at the Waterworks gage at the Southwest Eighteenth Street bridge on Raccoon River at Des Moines, are shown in figure 1. The 792-foot elevation, which corresponds to a gage height of 111.4 feet, was exceeded 13 times in 47 years of record (fig. 1). Although floods above elevation 792 feet occurred on the average of about 3 times per decade, none were experienced in some decades, whereas 10 occurred during the period 1944-53. The erratic frequency of floods is evident.

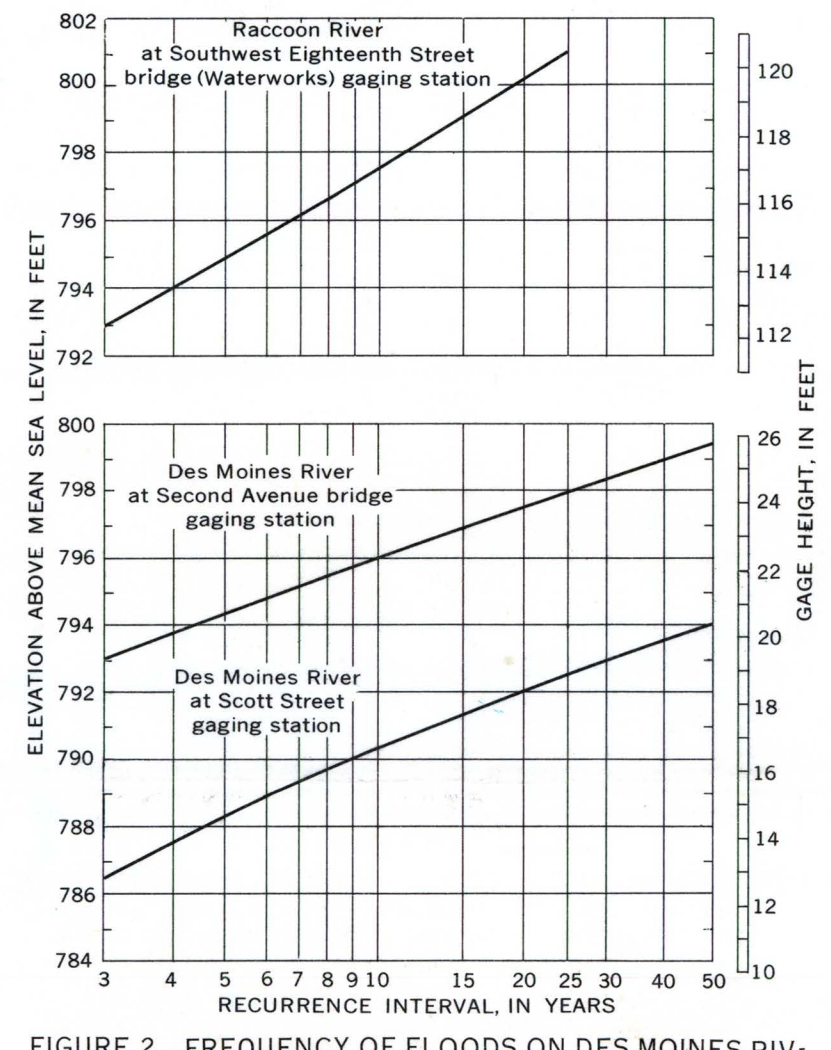
FIGURE 2.—FREQUENCY OF FLOODS ON DES MOINES RIVER AND RACCOON RIVER AT DES MOINES

The general relationship between recurrence interval and flood height at three gaging stations in Des Moines is shown graphically in figure 2 and is tabulated below:

Recurrence interval (years)	Des Moines River at Des Moines (Second Avenue bridge)	Des Moines River below Raccoon River at Des Moines (Scott Street bridge, above dam)	Raccoon River at Des Moines (Waterworks gage, Southwest Eighteenth Street bridge)
50	799.4	794.9	—
25	797.9	792.5	801.0
10	796.0	790.3	797.5
5	795.0	789.4	795.9

Flood-frequency relationships for Walnut Creek and Fourmile Creek are not shown.

It is emphasized that recurrence intervals are average figures—the average number of years that will elapse between occurrences of floods that equal or exceed a certain flood height. Thus on Des Moines River, a flood that reaches 797.9-foot elevation at Second Avenue is said to have a 25-year recurrence interval. However, because of the erratic nature of flood occurrences, the 797.9-foot elevation may not be reached in any one 25-year period, or it may be reached more than once.
