**FLOODS ON DELAWARE AND LEHIGH RIVERS AT EASTON, PENNSYLVANIA—PHILLIPSBURG, NEW JERSEY**

**FLOODS AT EASTON, PENNSYLVANIA—PHILLIPSBURG, NEW JERSEY**

By  
George M. Farlekas  
1967

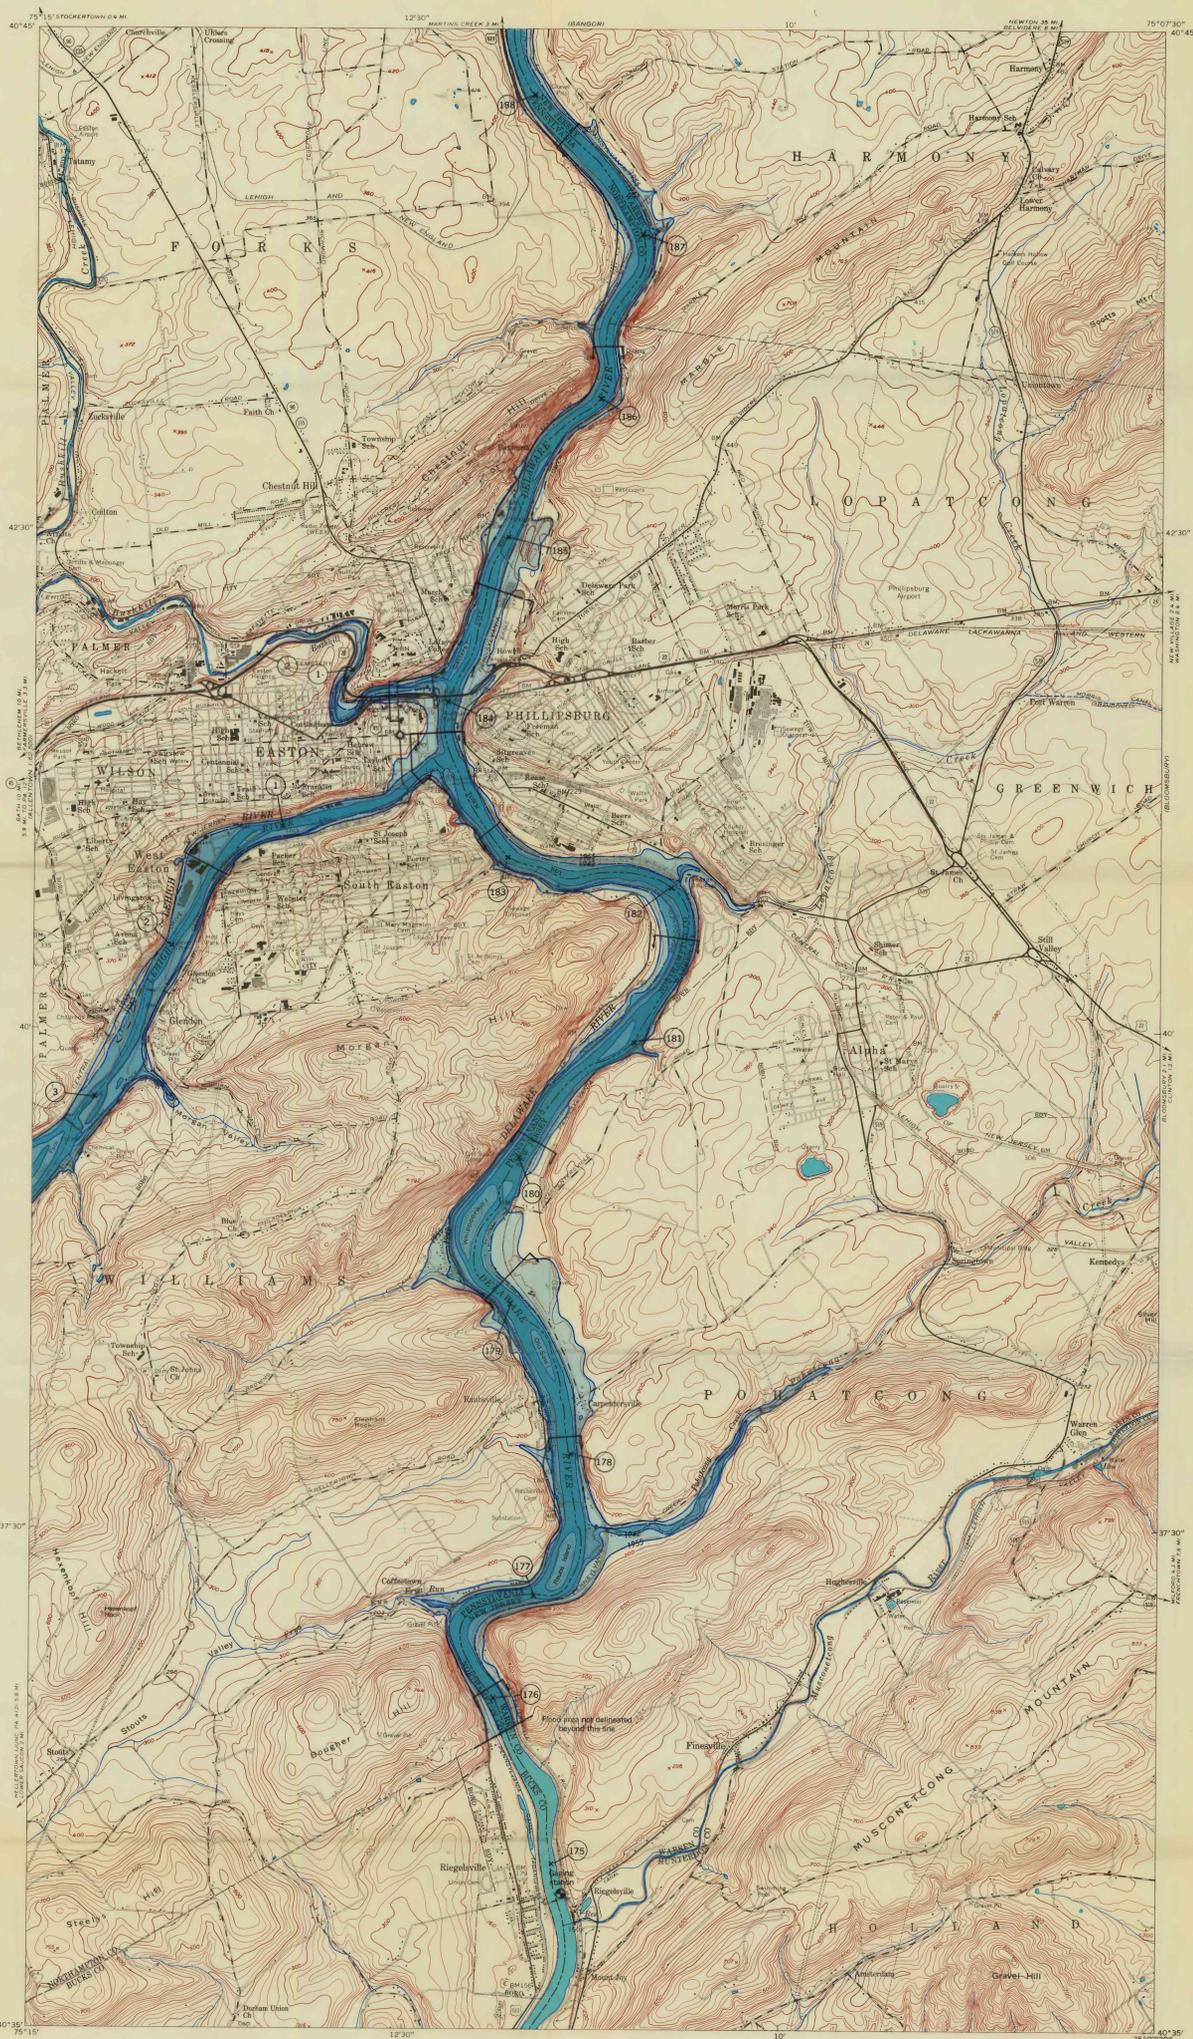
Areas inundated by the floods of August 19, 1955, and May 24, 1942, are shown on the map. The areal extent of flooding was delineated on the basis of floodmarks identified in the field and flood profiles were developed from these data. Depths of inundation and limits of overflow of floods of various sizes can be estimated by using the relations presented.

The flood of August 19, 1955, delineated on the map, has an estimated recurrence interval of more than 150 years. The smaller flood of May 24, 1942, also delineated, has an estimated recurrence interval of 11 years.

EXPLANATION  
Boundary of 1942 flood 1942  
Boundary of 1955 flood 1955  
Flood of May 24, 1942  
Flood of August 19, 1955  
Cross section location  
River miles measured along stream channel

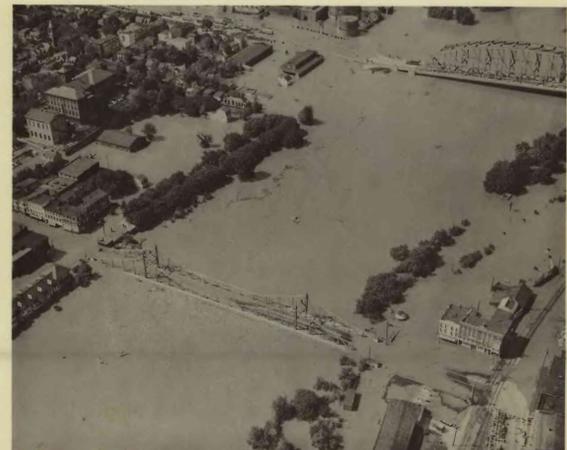
AERIAL VIEW OF FLOODED AREAS IN EASTON, PA. (ON LEFT) AND PHILLIPSBURG, N.J. (ON RIGHT), AUGUST 19, 1955. PRIOR TO PEAK STAGE. VIEW LOOKING NORTHWARD.
