The rains limited by floods along streams in the Pecos 70-minute quadrant are delineated on a topographic map. The quadrant's location is shown in figure 1. Inundated areas for the Flood of July 1957 are shown along South Branch, Fortified Creek, Rock Creek, Black Water Creek, and the Pecos River. The map also shows the Edna Slough, and several unnamed creeks.

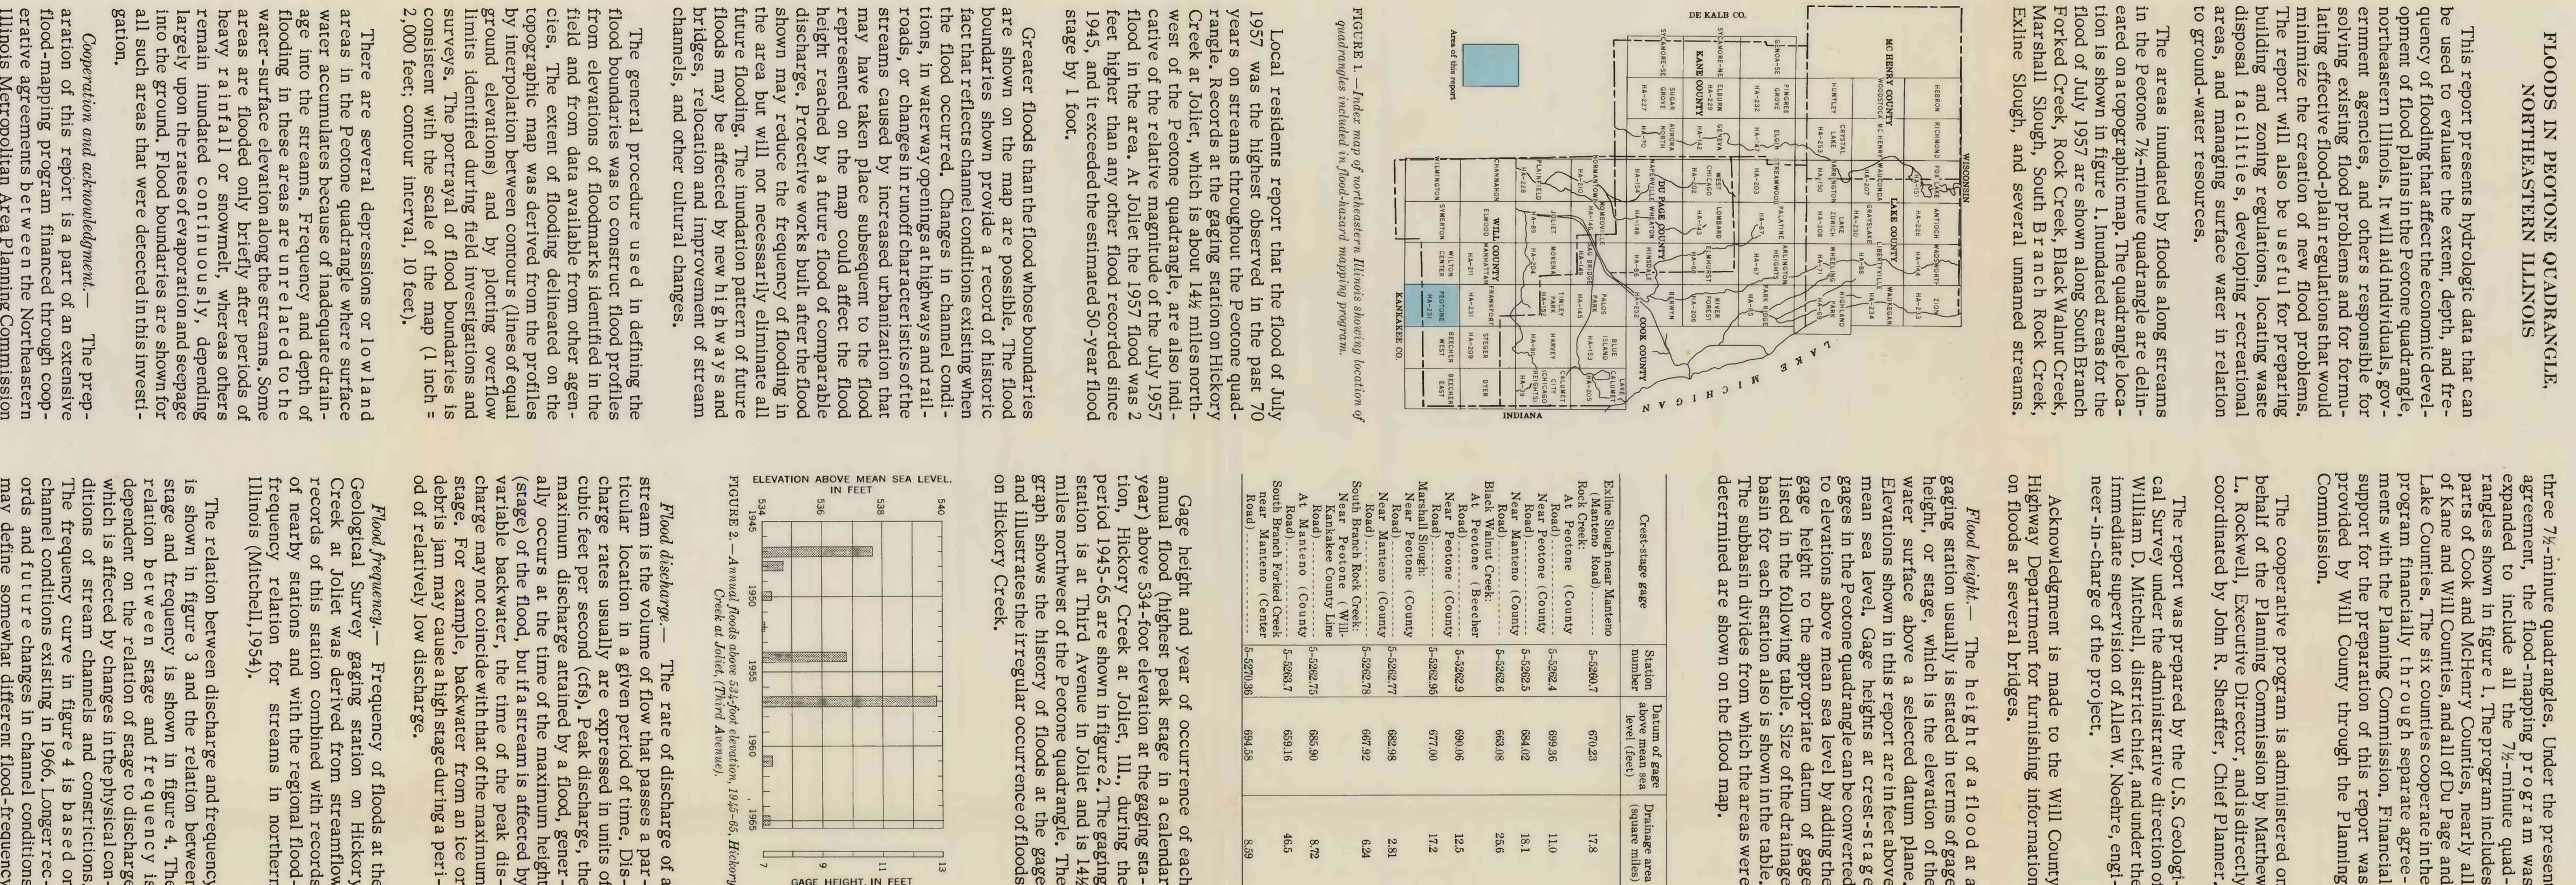
Flood profiles.—Profiles of the water surface, based on profiles of the stream bed, for the floods of July 1957, December 1965, and May 1966 are shown in figures 5-9. Where flood-marks could not be identified, the profiles were constructed on the basis of flood crests determined from a series of cross sections at elevations of streambeds and lower flood stages. River miles used for the profiles correspond to those marked along the stream on the flood map.

Flood depths.—Depth of flooding at any point can be estimated by subtracting the ground elevation from the water-surface elevation at the same point. The approximate ground elevation can be obtained from the profiles in figures 5-9. More accurate elevations can be obtained by leveling from nearby bench marks.

FIGURE 5.—Profile of flood on Black Walnut Creek.

FIGURE 6.—Profile of flood on Blue Prairie Creek.

FIGURE 7.—Profile of flood on Hickory Creek at Joliet.

FIGURE 8.—Profile of flood on Marshall Slough and Entire Slough.

FIGURE 9.—Profile of flood on South Branch Peoria Creek.
