FLOODS ON LICKING RIVER IN VICINITY OF SALTERSVILLE, KENTUCKY

By
Curtis H. Hannum
1969

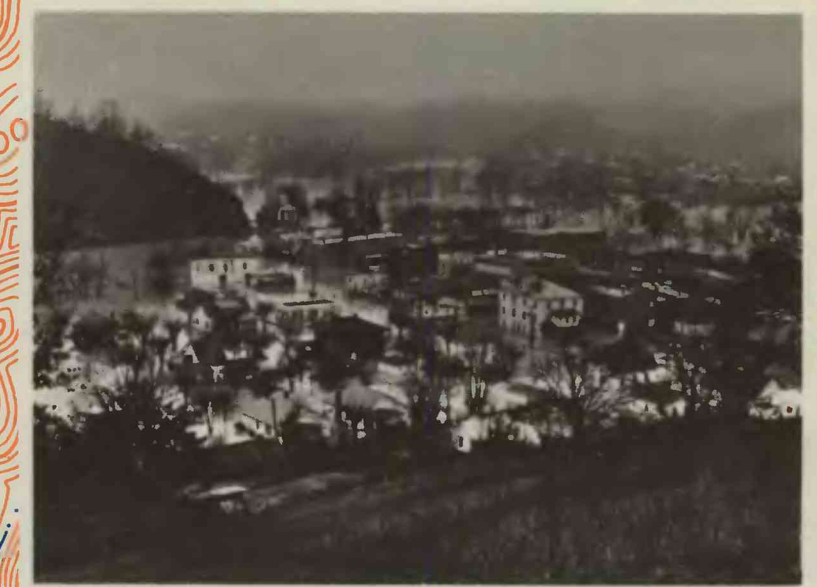
SALTERSVILLE FLOODED BY LICKING RIVER, FEBRUARY 27, 1962. SALTERSVILLE LOOKING SOUTHWEST. PHOTOGRAPH BY WILLIAM J. CANTRELL, U.S. SOIL CONSERVATION SERVICE, SALTERSVILLE, KY.

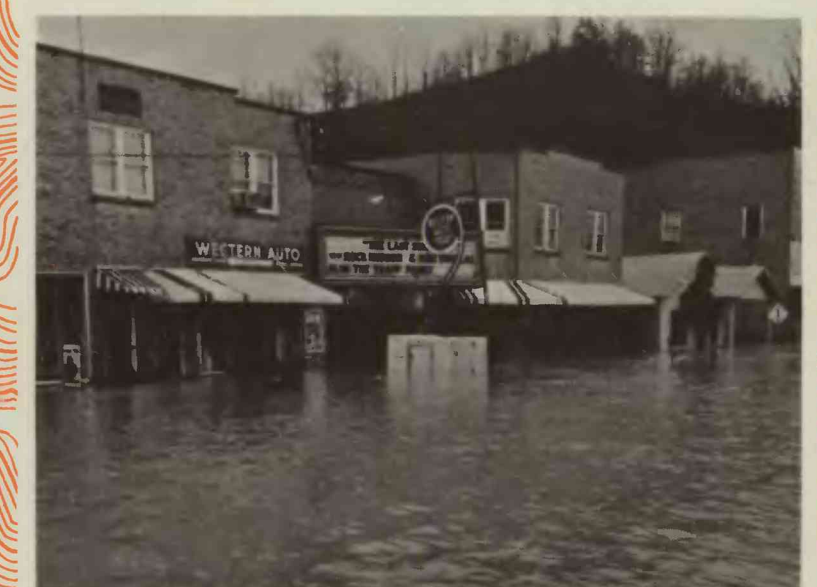
BUSINESS ESTABLISHMENTS AT SALTERSVILLE DURING LICKING RIVER FLOOD OF FEBRUARY 27, 1962. VIEW LOOKING SOUTH ALONG STATE HIGHWAY 7 FROM INTERSECTION WITH U.S. HIGHWAY 460. PHOTOGRAPH BY WILLIAM J. CANTRELL, U.S. SOIL CONSERVATION SERVICE, SALTERSVILLE, KY.

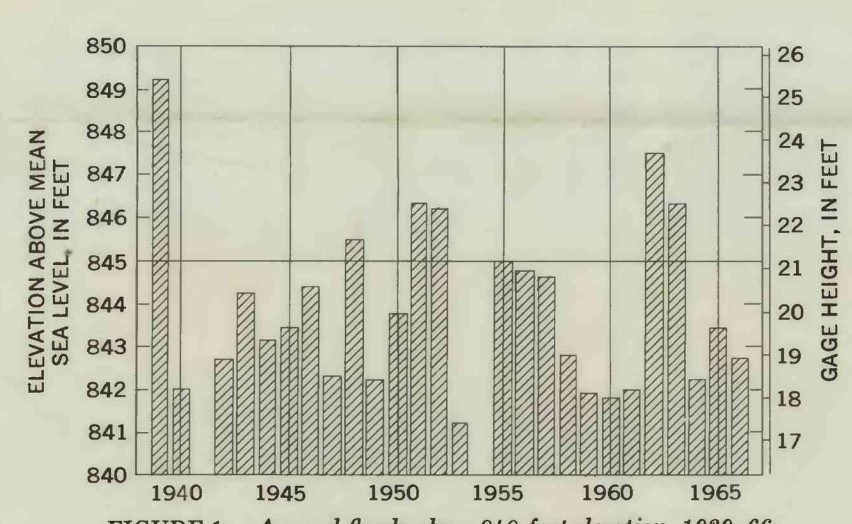
FIGURE 1.—Annual floods above 840-foot elevation, 1939-66, Licking River near Salyersville (at bridge on Kentucky Highway 30).

Elevation and year of occurrence of each annual flood (highest peak in each water year) above 840-foot elevation at the gaging station during the period 1939-66 are shown in figure 1. This graph illustrates the irregular occurrence of floods on Licking River and typifies the probable magnitude of floods in the Salyersville area.

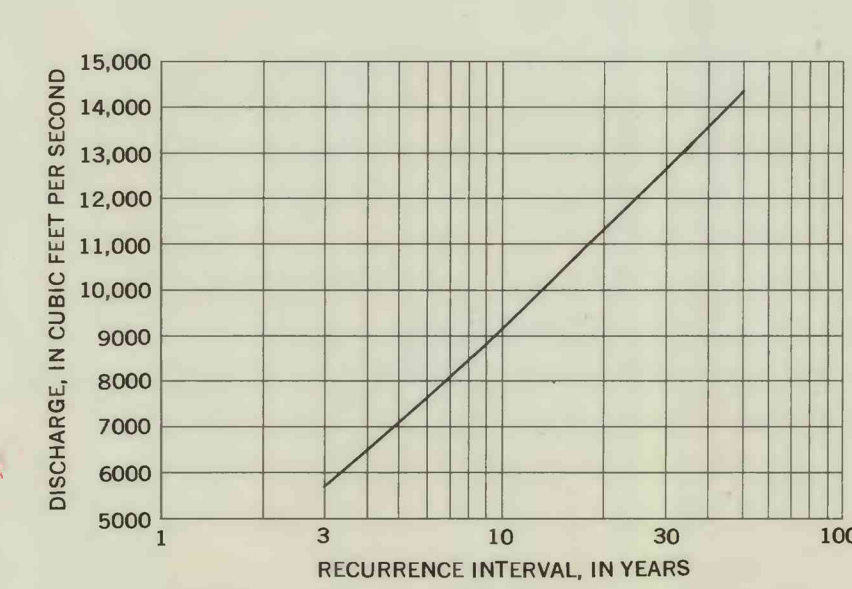
FIGURE 2.—Frequency of flood discharge on Licking River near Salyersville (at bridge on Kentucky Highway 30).

Flood frequency.—Frequency of floods at the gaging station on Licking River near Salyersville is based on the partial-duration series for this report. The partial-duration series is computed on the basis of all momentary peak discharges above a selected base discharge. The general relation between frequency and discharge is shown in figure 2, and the general relation between frequency and stage is shown in figure 3. The frequency curves shown are based on channel conditions existing in 1966. Future changes in channel conditions would likely change the frequency relations. The relation between frequency and stage is dependent on the relation of stage to discharge. Any changes in the stage-discharge relation, caused by channel filling or dredging, straightening stream channel, and building of floodwalls in the immediate vicinity of the gage could alter stage-discharge relations and hence frequency-stage relations.

Changes upstream such as construction of reservoirs or floodwalls and filling or dredging the stream channel will alter the frequency-discharge relations. Extrapolation of the curves beyond the limits shown is not recommended because of the possible large errors.
