FLOODS ON THE GUYANDOTTE RIVER IN THE VICINITY OF LOGAN,
LOGAN COUNTY, WEST VIRGINIA

By
E. A. Friel and G. S. Runner
1972

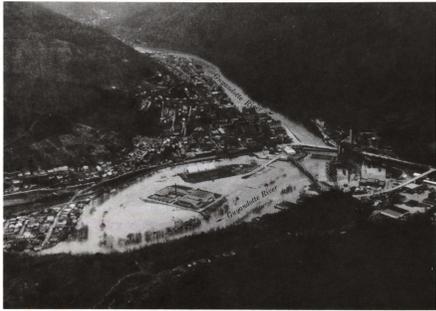
FIGURE 9.—Aerial view of Guyandotte River at mouth of Ohio Creek during flood of March 1963. Courtesy of The Charleston Gazette.

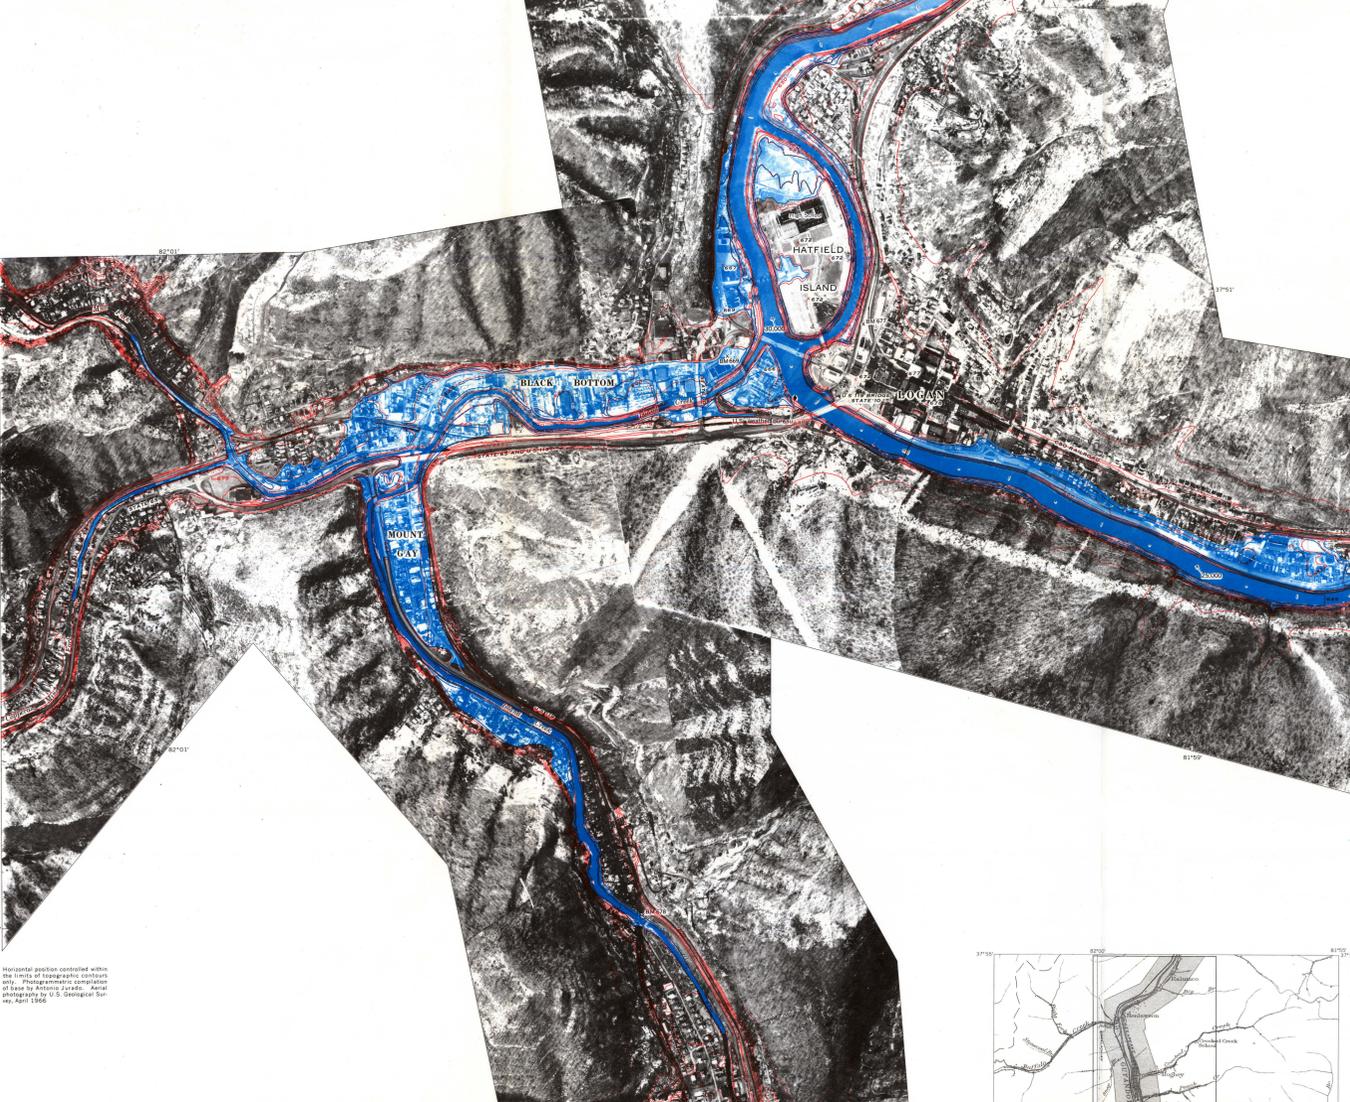
Horizontal position controlled within the limits of topographic conditions only. Photogrammetric comparison of base by Antonio Jarama. Aerial photographs by U.S. Geological Survey, April 1968.

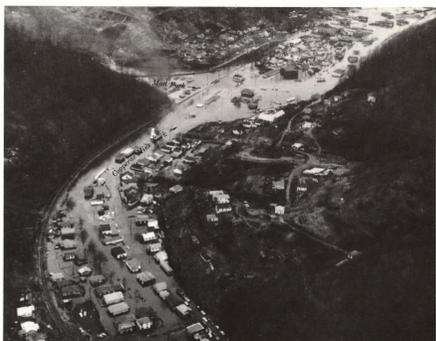
FIGURE 10.—Aerial view of the Copper Mine Fork on-half mile upstream from mouth during flood of March 1963. Courtesy of The Charleston Gazette.
