**FLOODS IN THE YABUCOA AREA, PUERTO RICO**

By  
Fred K. Fields

1971

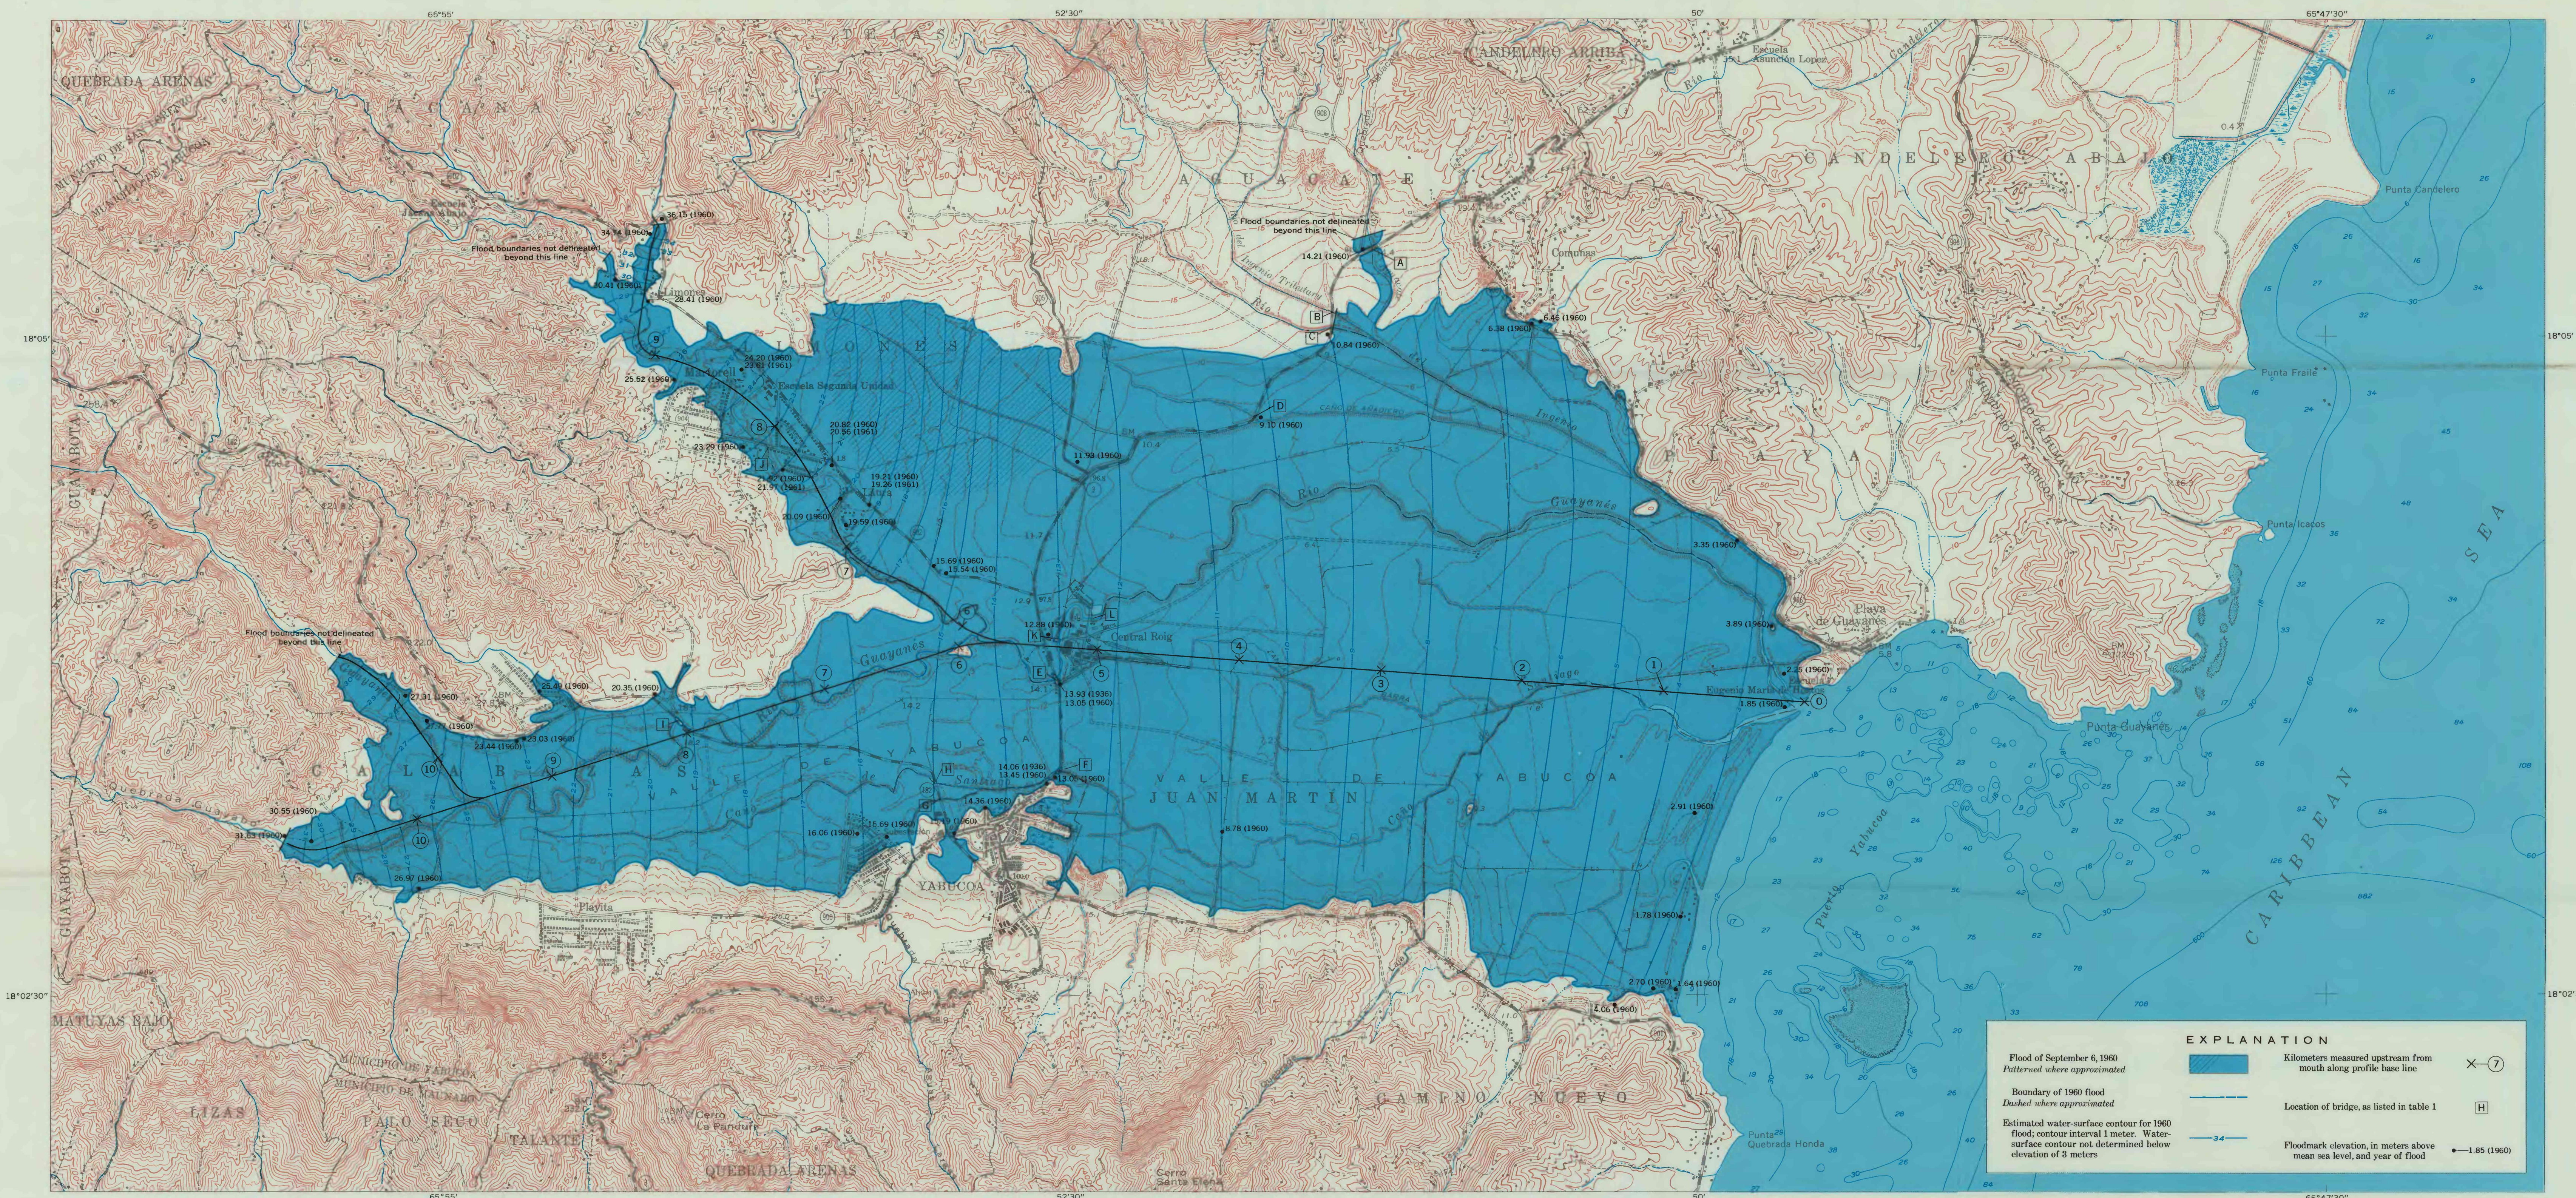
- Flood of September 6, 1960
- Pattered where approximated
- Boundary of 1960 flood
- Dashed where approximated
- Estimated water-surface contour for 1960 flood, contour interval 1 meter. Water-surface contour not determined below elevation of 3 meters
- Kilometers measured upstream from mouth along profile base line
- Location of bridge, as listed in table 1
- Floodmark elevation, in meters above mean sea level, and year of flood

**Inundated area.**—The area of inundation that resulted from floodflow in the lower Río Guayanés basin is delineated on the topographic map. The delineation is a reasonably accurate portrayal with two exceptions: the area from Martorell east to Highway PR-905, which lies north of Highway PR-902, is undefined and is estimated; and the crests of the levees have not been removed from the blue-tinted inundated area. Several of the levees were breached by floodwaters, but locations of the breaks are not known. High-water elevations along the edge of the flood plain are uniform, however, indicating the levees did not effectively shield the flood plain from crossflow.

**Floodmark information.**—The inundated area was delineated on the basis of flood-stage information furnished by residents. Field surveys were conducted to determine the elevation of flood stages provided by personal interviews. Selected floodmark elevations are shown on the topographic map.

**Water-surface elevation.**—The estimated water-surface contours for the flood of September 6, 1960, are shown on the map.

**Depth of flooding.**—Depth of flooding can be estimated by subtracting the ground elevation from the water-surface elevation. Each is shown by contours on the map. Intermediate estimates of depth can be determined by interpolation.

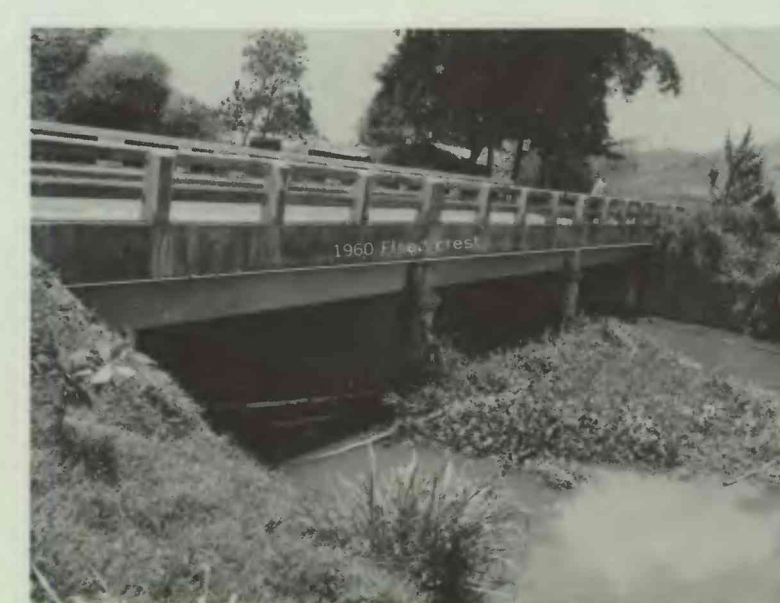
FIGURE 2.—Highway PR-3 bridge spanning Río Guayanés. The 1960 flood (shown by white line) reached a crest 0.5 meter below the roadway level.

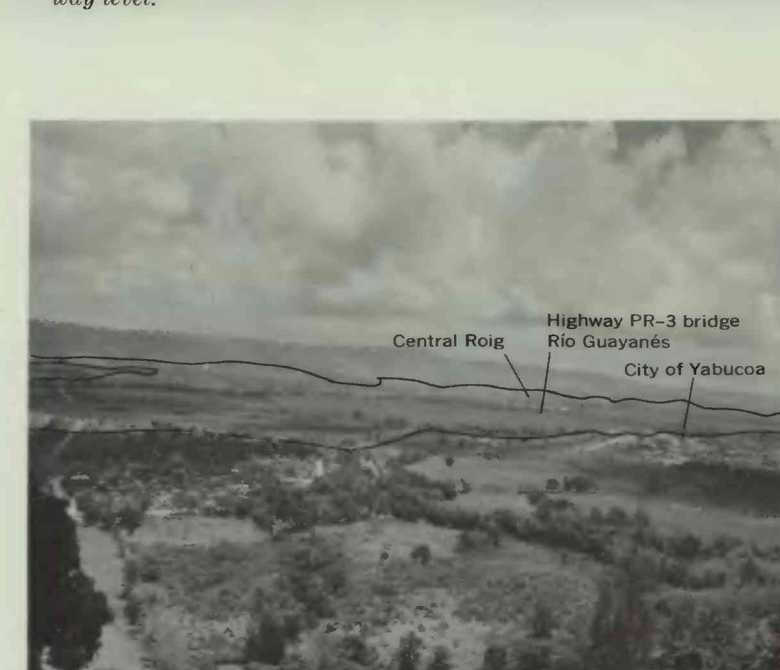
FIGURE 3.—City of Yabucoa and Central Roig. The 1960 flood inundated the entire flat area from the edge of Yabucoa to the edge of the distant hills and to the sea.

**The basin.**—The water in Río Guayanés is derived largely from the drainage of Sierra de Cayey, about 14 kilometers west of Yabucoa, and from Cuchillo de Panduras. The flow travels eastward into the study area or lower Río Guayanés basin, which is the complex composite flood plain of several streams. The basin is 22 kilometers in length, has a total drainage area of 49.3 square miles, and is shown on the location sketch, figure 1. Río Guayanés, the principal stream, empties into Pasaje de Vieques at Puerto Yabucoa. Other significant streams in the basin are Río del Ingenio and Caño de Santiago. Río Guayanés drains an area of 26.5 square miles upstream from the Highway PR-3 bridge, which is shown in figure 2. The area of inundation during the September 6, 1960, flood as delineated on the topographic map was about 12 square miles. The city of Yabucoa is situated on the south edge of the flood plain. A view of Yabucoa and Central Roig, looking north from Highway PR-3, is shown in figure 3.

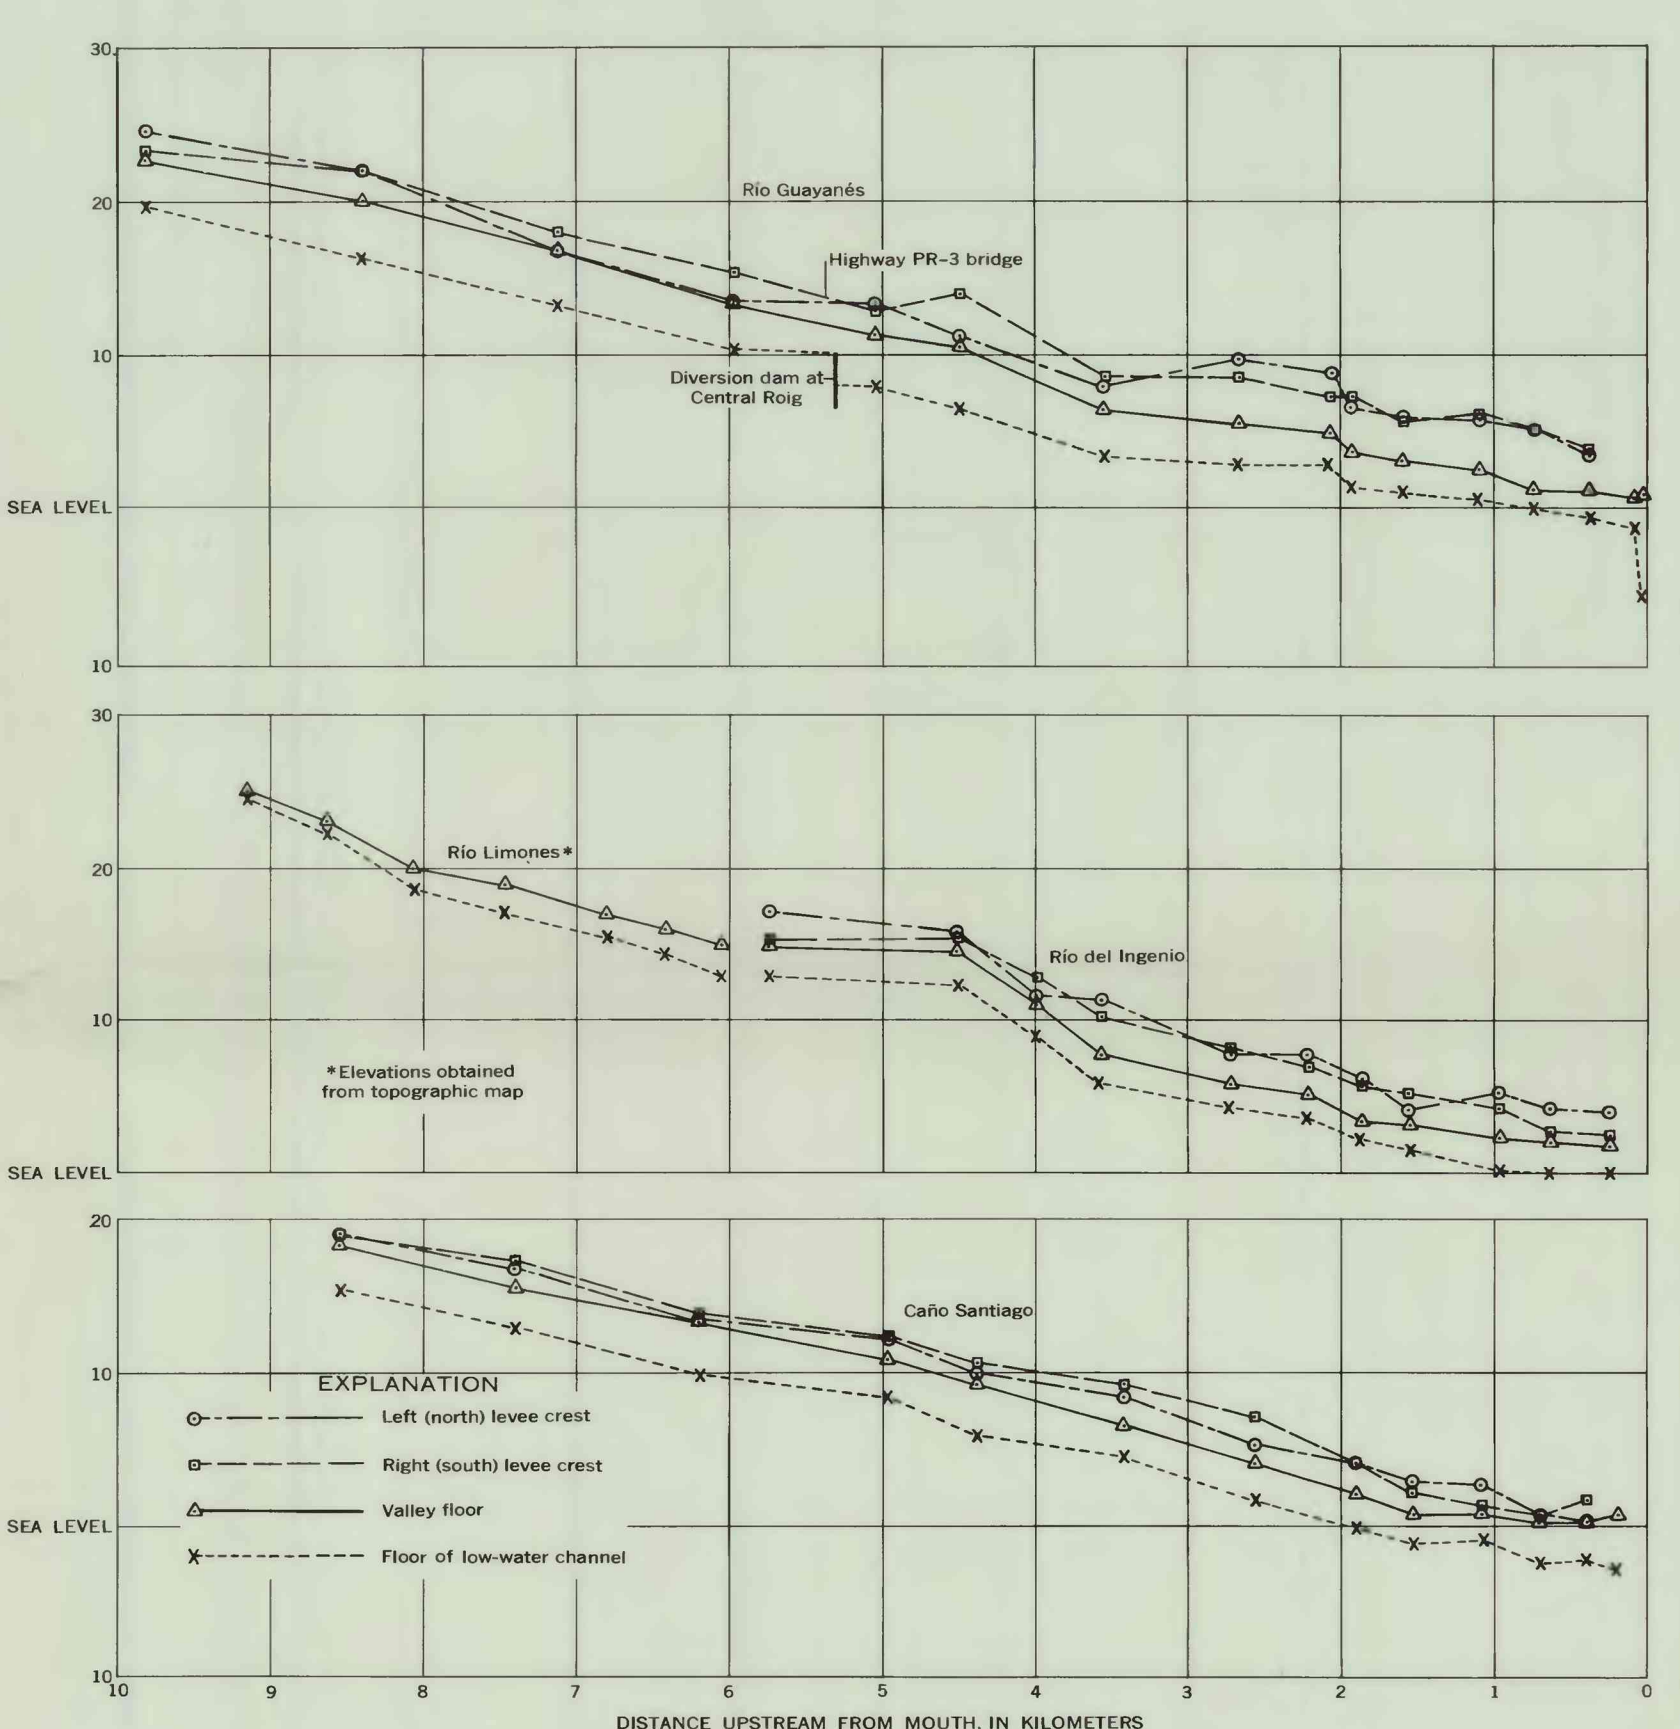
FIGURE 4.—Profiles of the levees and channels in lower Río Guayanés basin.

Current-meter measurements of Río Guayanés made at Highway PR-3 define the stage-discharge relation from 30 to 1,200 cfs (cubic feet per second). The U.S. Soil Conservation Service has estimated the discharge of the 1960 flood at the valley cross section along Highway PR-3 to be 40,000 cfs. The total drainage area upstream from the highway is 36.6 square miles. The stage-discharge relation is shown in figure 5, from which the discharge of the 1936 flood is estimated to be 44,000 cfs in the range of moderate flow, the stage-discharge relation is controlled by the diversion dam at Central Roig, as shown in figure 4 and in table 1. The dam

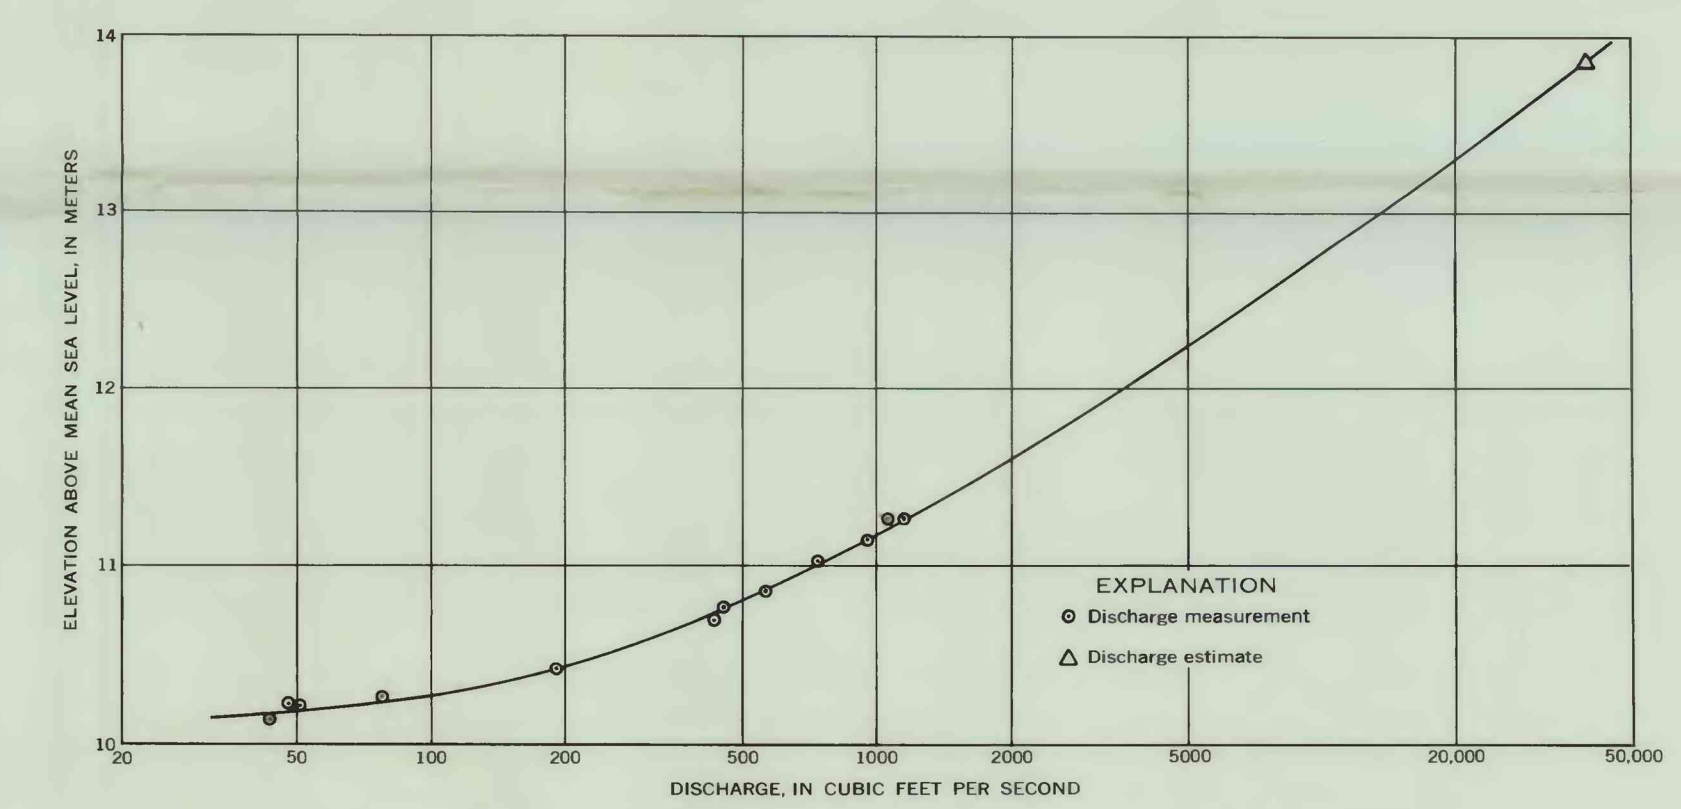
FIGURE 5.—Stage-discharge relation for Río Guayanés at Highway PR-3 bridge at Yabucoa.

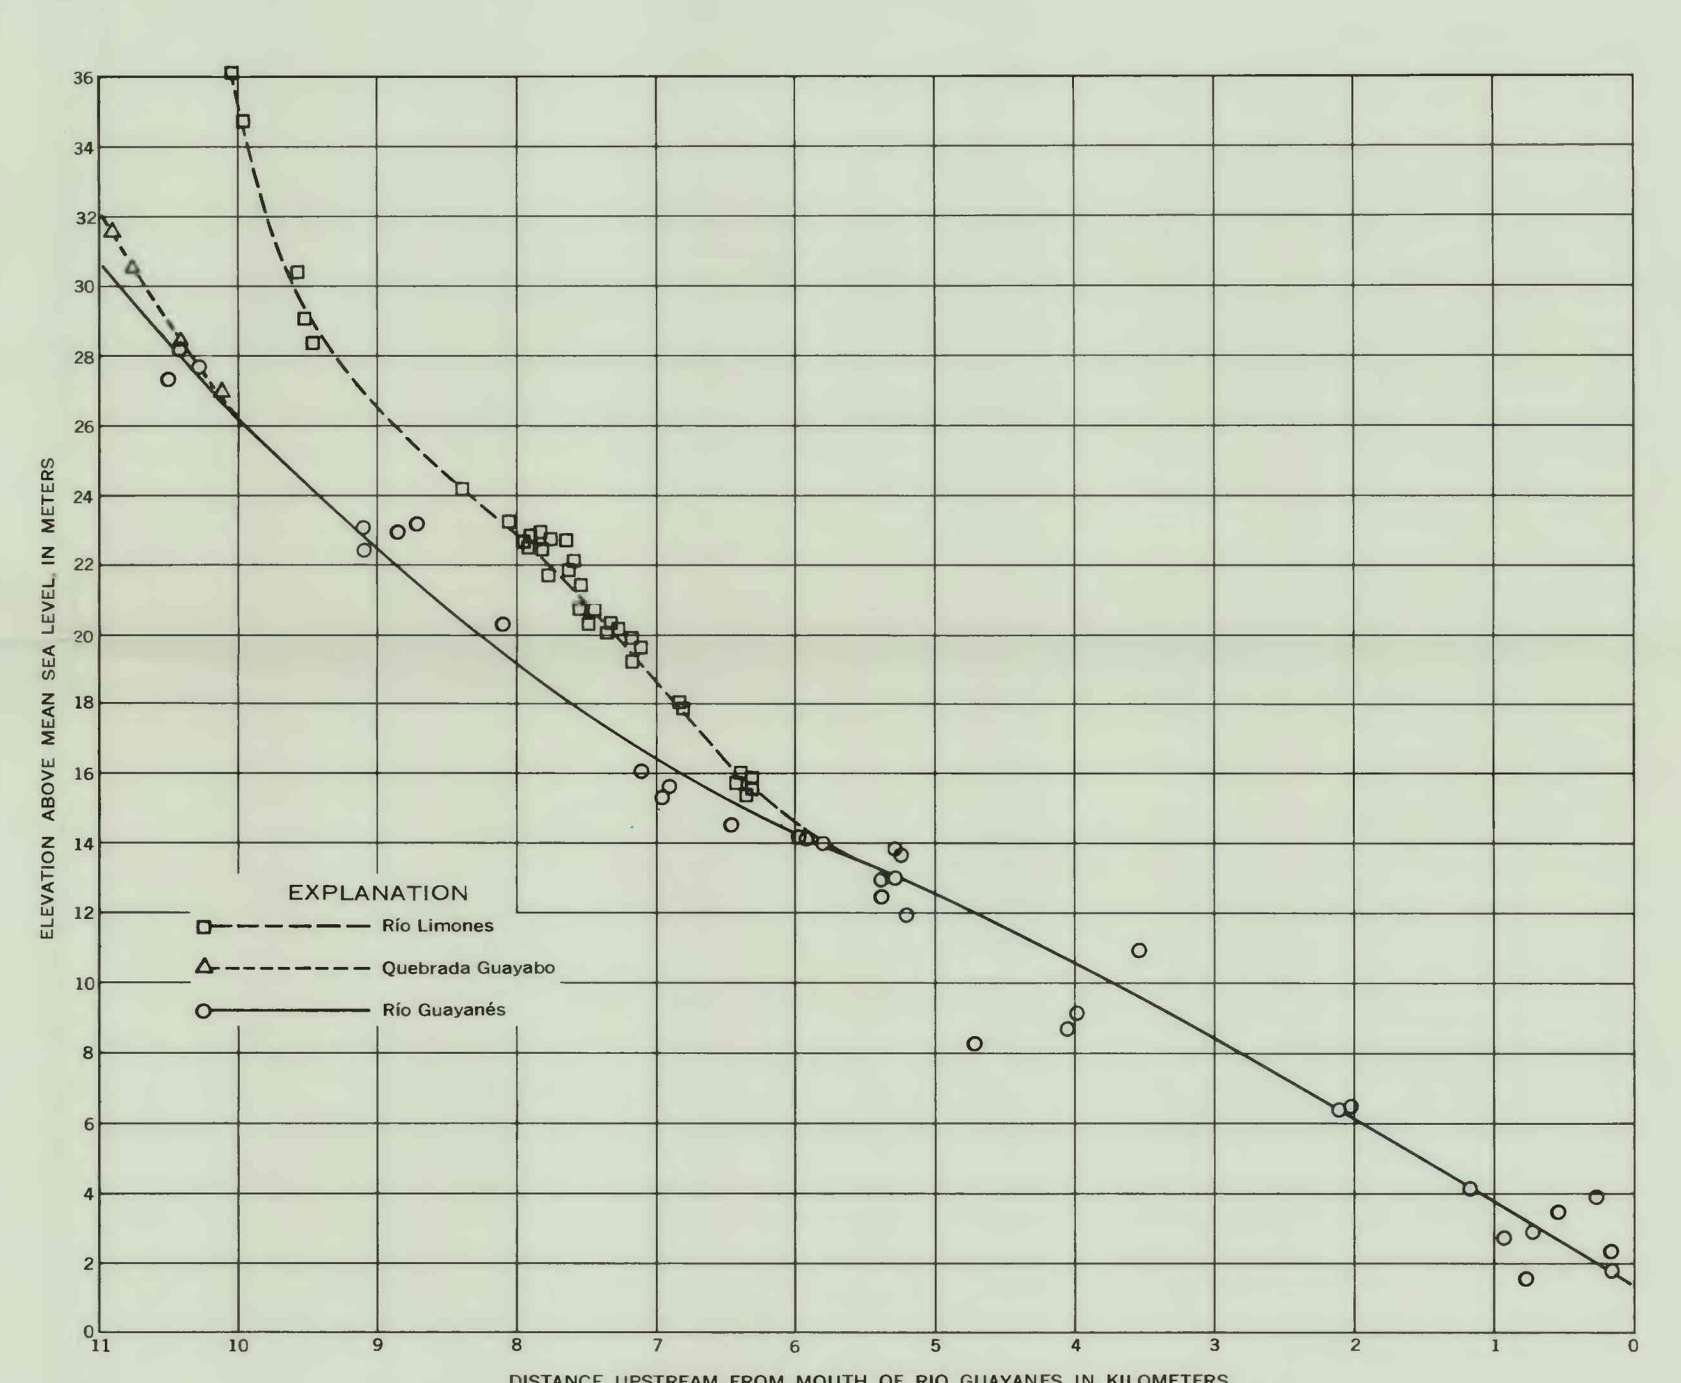
FIGURE 6.—Water-surface profiles, flood of September 6, 1960.

**Flood profiles.**—Flood elevations, referenced to the arbitrary base line shown on the topographic map, are shown in figure 6. The curves are a graphical portrayal of the average water-level profile. The profiles are well defined except for the interval between 2 and 5 kilometers above the mouth of Río Guayanés.
