**Introduction.**—The approximate areas inundated in and near Richmond, Va., by the flood of August 22, 1969, on the James River are shown on the topographic map. The flood was caused by torrential rains brought by the remnants of Hurricane Camille.

**FLOOD OF AUGUST 1969, BON AIR QUADRANGLE, RICHMOND, VIRGINIA**  
By  
**E. M. Miller**  
1969

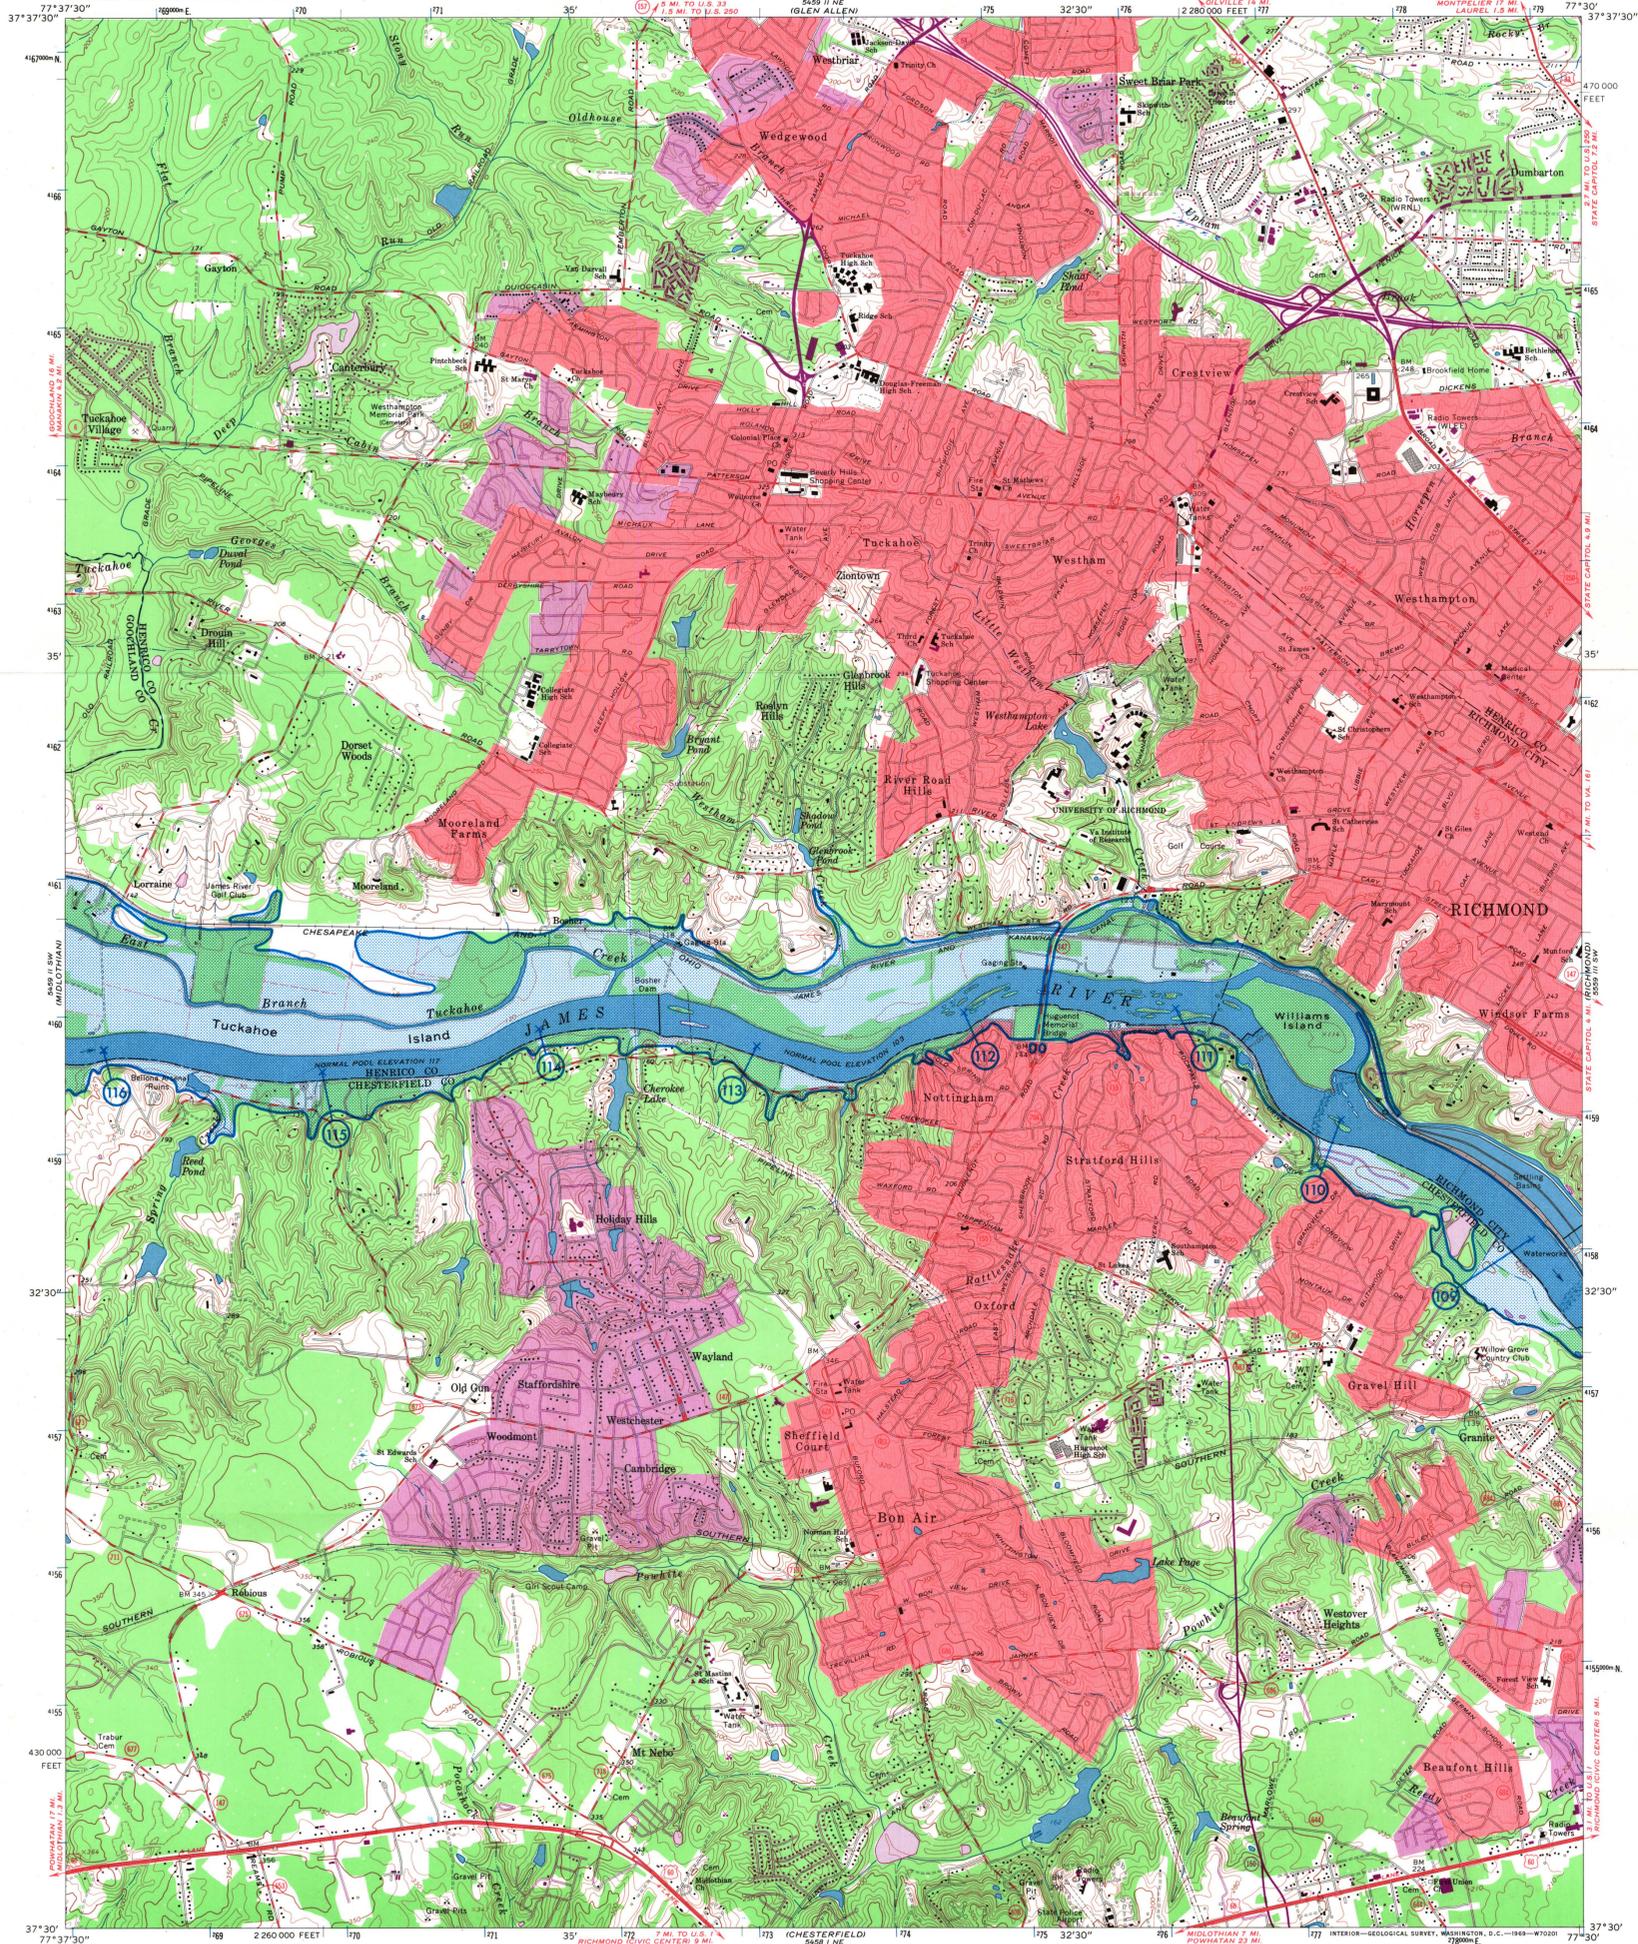
Area flooded August 1969

Boundary of flooded area

River mile measured along stream channel upstream from mouth

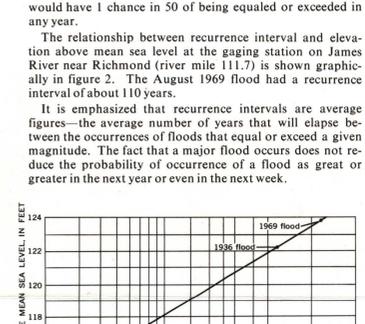
FIGURE 2.—Frequency of floods on James River near Richmond, river mile 111.7.

The relationship between recurrence interval and elevation above mean sea level at the gaging station on James River near Richmond (river mile 111.7) is shown graphically in figure 2. The August 1969 flood had a recurrence interval of about 110 years.

**Recurrence intervals.**—As applied to flood events, the recurrence interval is the average interval of time within which a given flood will be equaled or exceeded once. Recurrence interval is inversely related to the chance of a flood of a specific height being equaled or exceeded in any one year. Thus, a 20-year flood would have 1 chance in 20 of being equaled or exceeded in any year, or a 50-year flood would have 1 chance in 50 of being equaled or exceeded in any year.

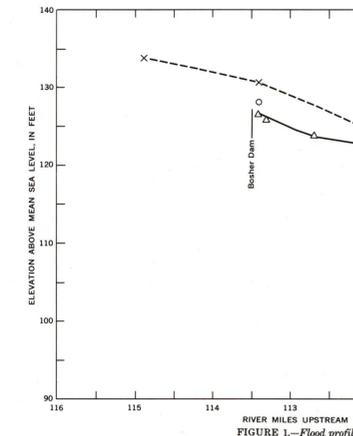
FIGURE 1.—Flood profile, James River near Richmond.

Depth of flooding at any point can be estimated by subtracting the ground elevation from the water-surface elevation indicated by the profile in figure 1. Approximate ground elevations can be estimated from contours on the map; however, more accurate elevations can be obtained by leveling to bench marks.

**Flood profiles.**—Profiles of the water surface along the James River between mile 108.6 and mile 114.9 for the floods of April 1937 (floodmarks from U.S. Army Corps of Engineers) and August 1969 are shown in figure 1. High-

water marks for the flood of March 1936 are also shown at several points along the river. River miles used in figure 1 were measured upstream from the mouth of James River and are marked on the map along the thalweg of the stream.

water marks for the flood of March 1936 are also shown at several points along the river. River miles used in figure 1 were measured upstream from the mouth of James River and are marked on the map along the thalweg of the stream.
