FLOOD OF AUGUST 1969 ON MAURY RIVER AT BUENA VISTA, VIRGINIA

By
Gerald S. Runner
1969

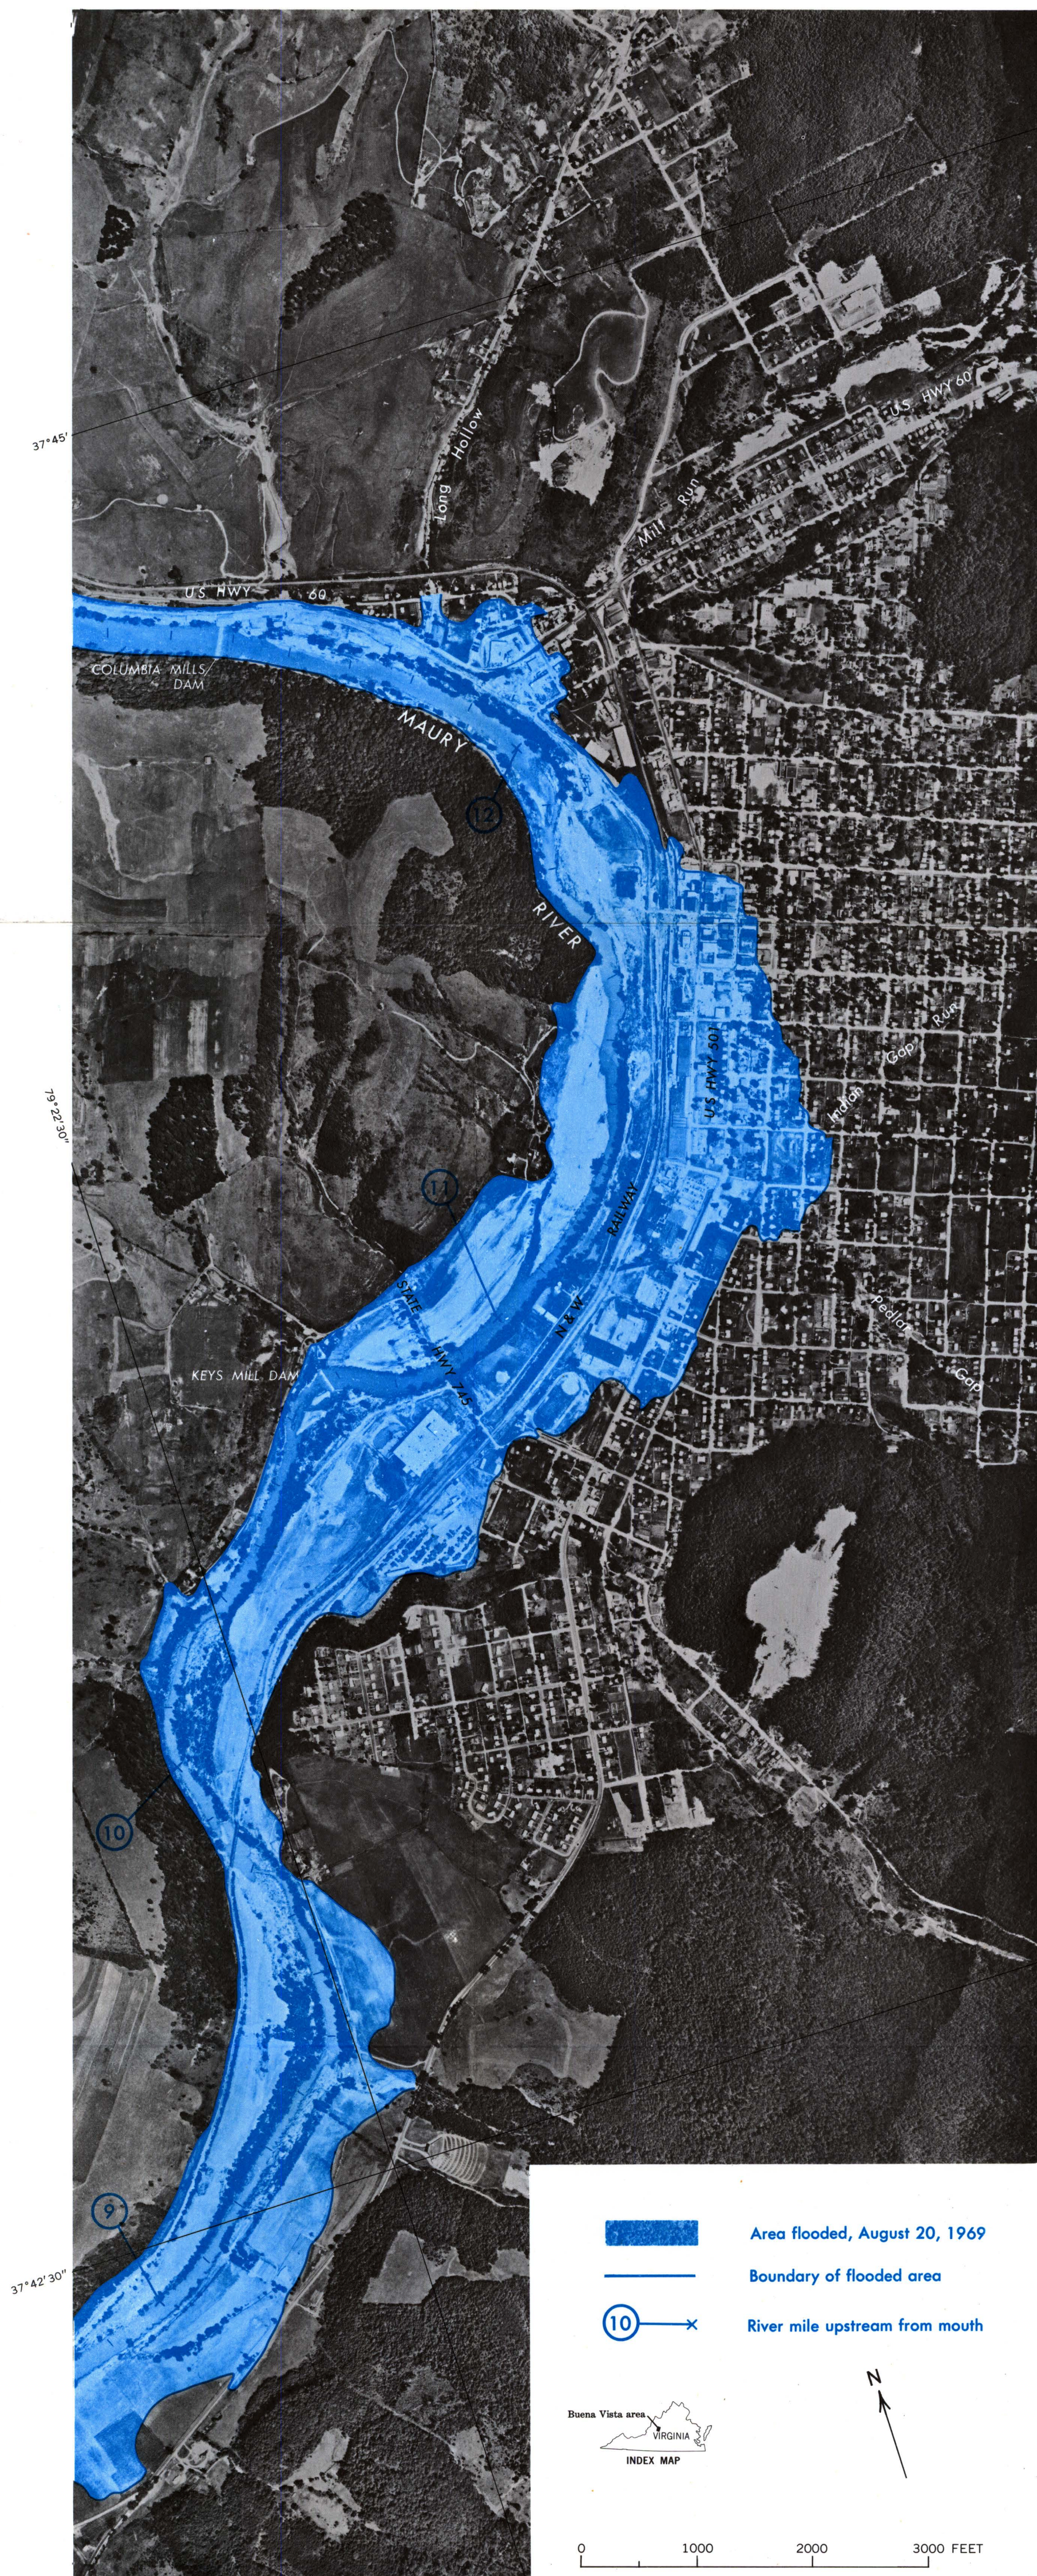
Introduction.—The approximate area inundated by the Maury River at Buena Vista, Va., during the flood of August 20, 1969, is shown on a photomosaic base map. The flood, the highest known on the river, was caused by the torrential rains brought by the remnants of Hurricane Camille. Floodmarks were identified in a 4-mile reach of the river near Buena Vista, and their elevations were determined by leveling to bench marks. Flood boundaries were delineated on aerial photographs taken after the crest and were verified by field inspection.

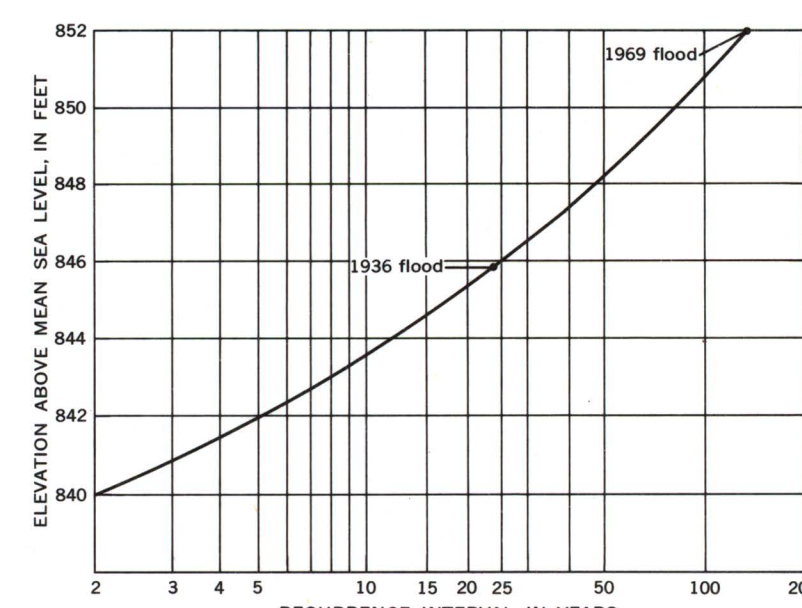
FIGURE 1.—Stage frequency curve for Maury River at U.S. Highway 60 at Buena Vista.

Flood frequency.—Stage-frequency relations were derived from stage records for the U.S. Weather Bureau gage at U.S. Highway 60 at Buena Vista for the period 1936–69. The general relationship between recurrence interval and flood height for the Maury River at Buena Vista is shown in figure 1. The March 1936 flood had a recurrence interval of about 25 years (fig. 1), whereas the August 1969 flood had a recurrence interval of about 130 years.

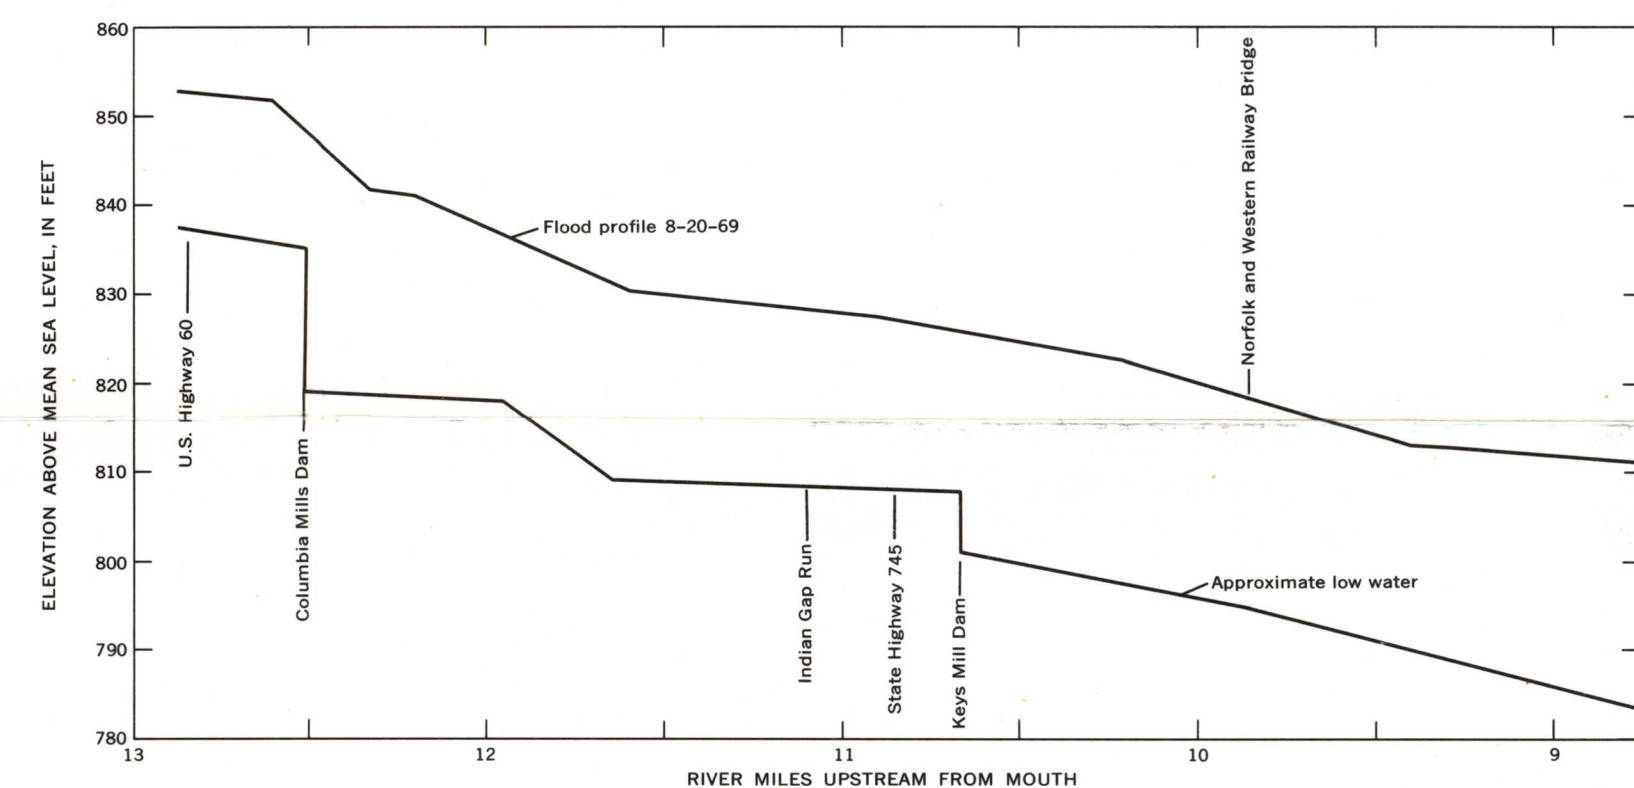
FIGURE 2.—Profile of flood of August 20, 1969, Maury River at Buena Vista.

Flood profiles.—Profiles of the water surface constructed from high-water marks left by the flood of August 20, 1969, are shown in figure 2. Distances in miles (upstream from mouth) used for the profiles correspond to those marked at one-tenth mile intervals along the channel on the flood map.

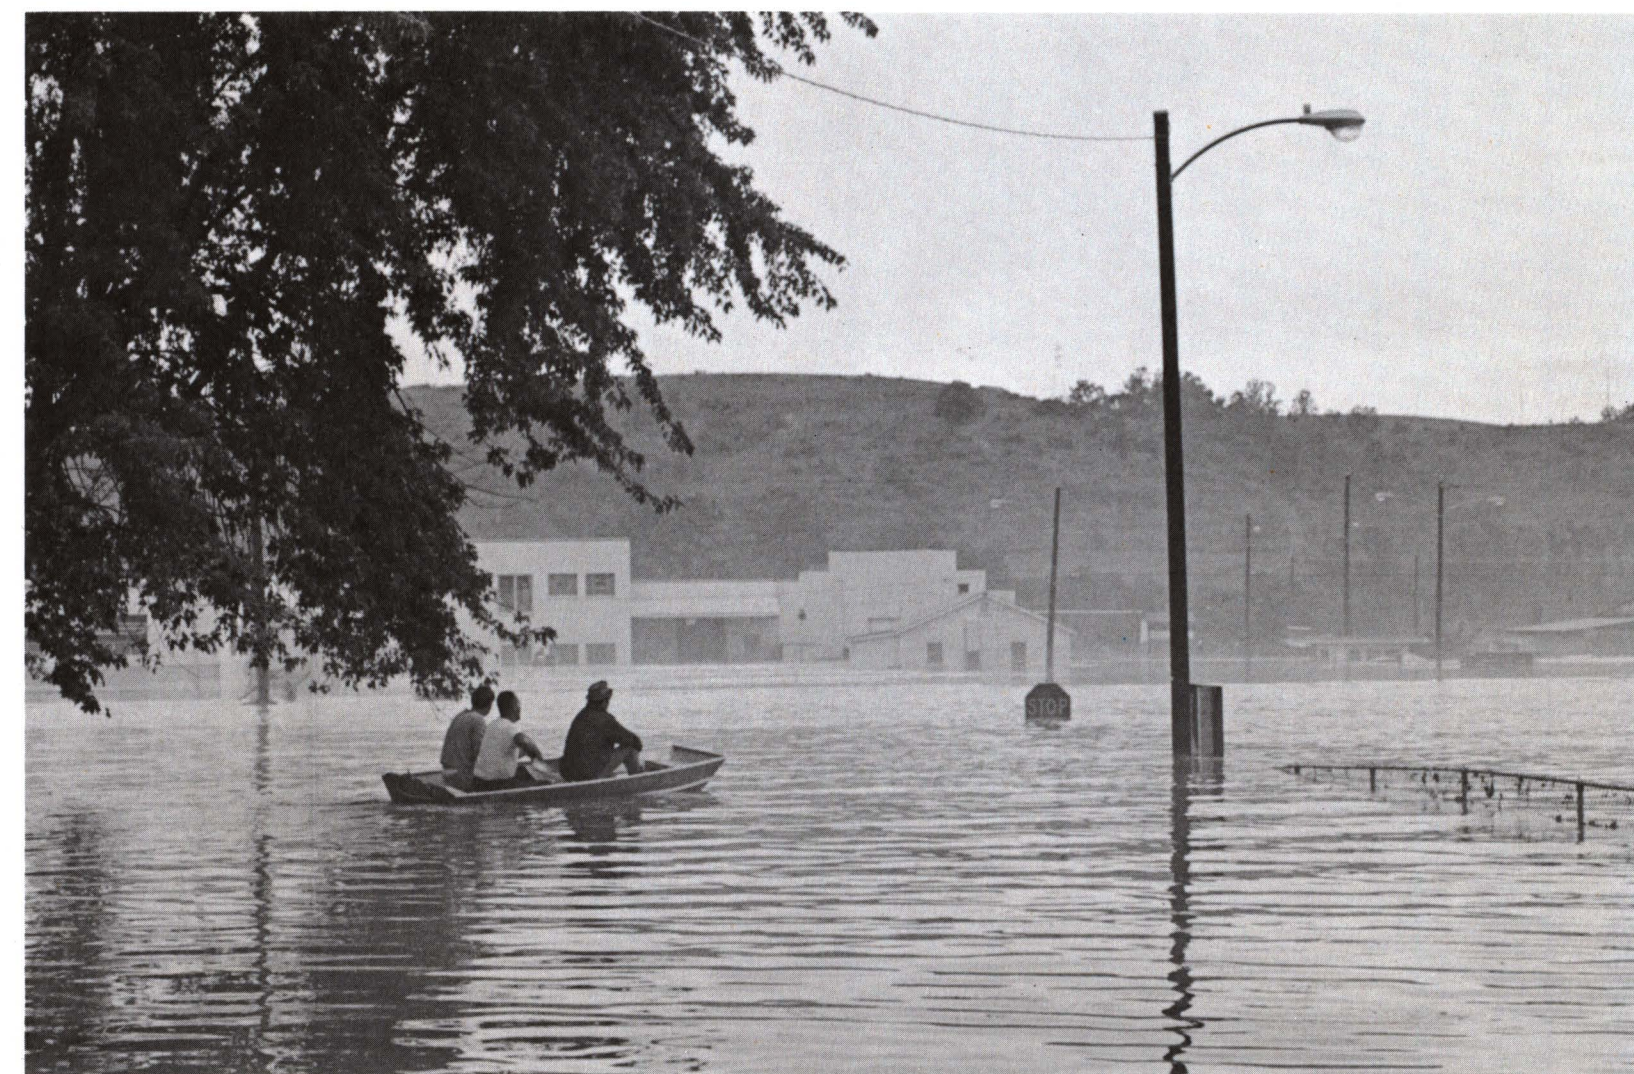
Photograph from Fitzgerald Photos, Buena Vista
Floodwaters of Maury River surrounding Reeves Bros. plant in Buena Vista, August 1969.

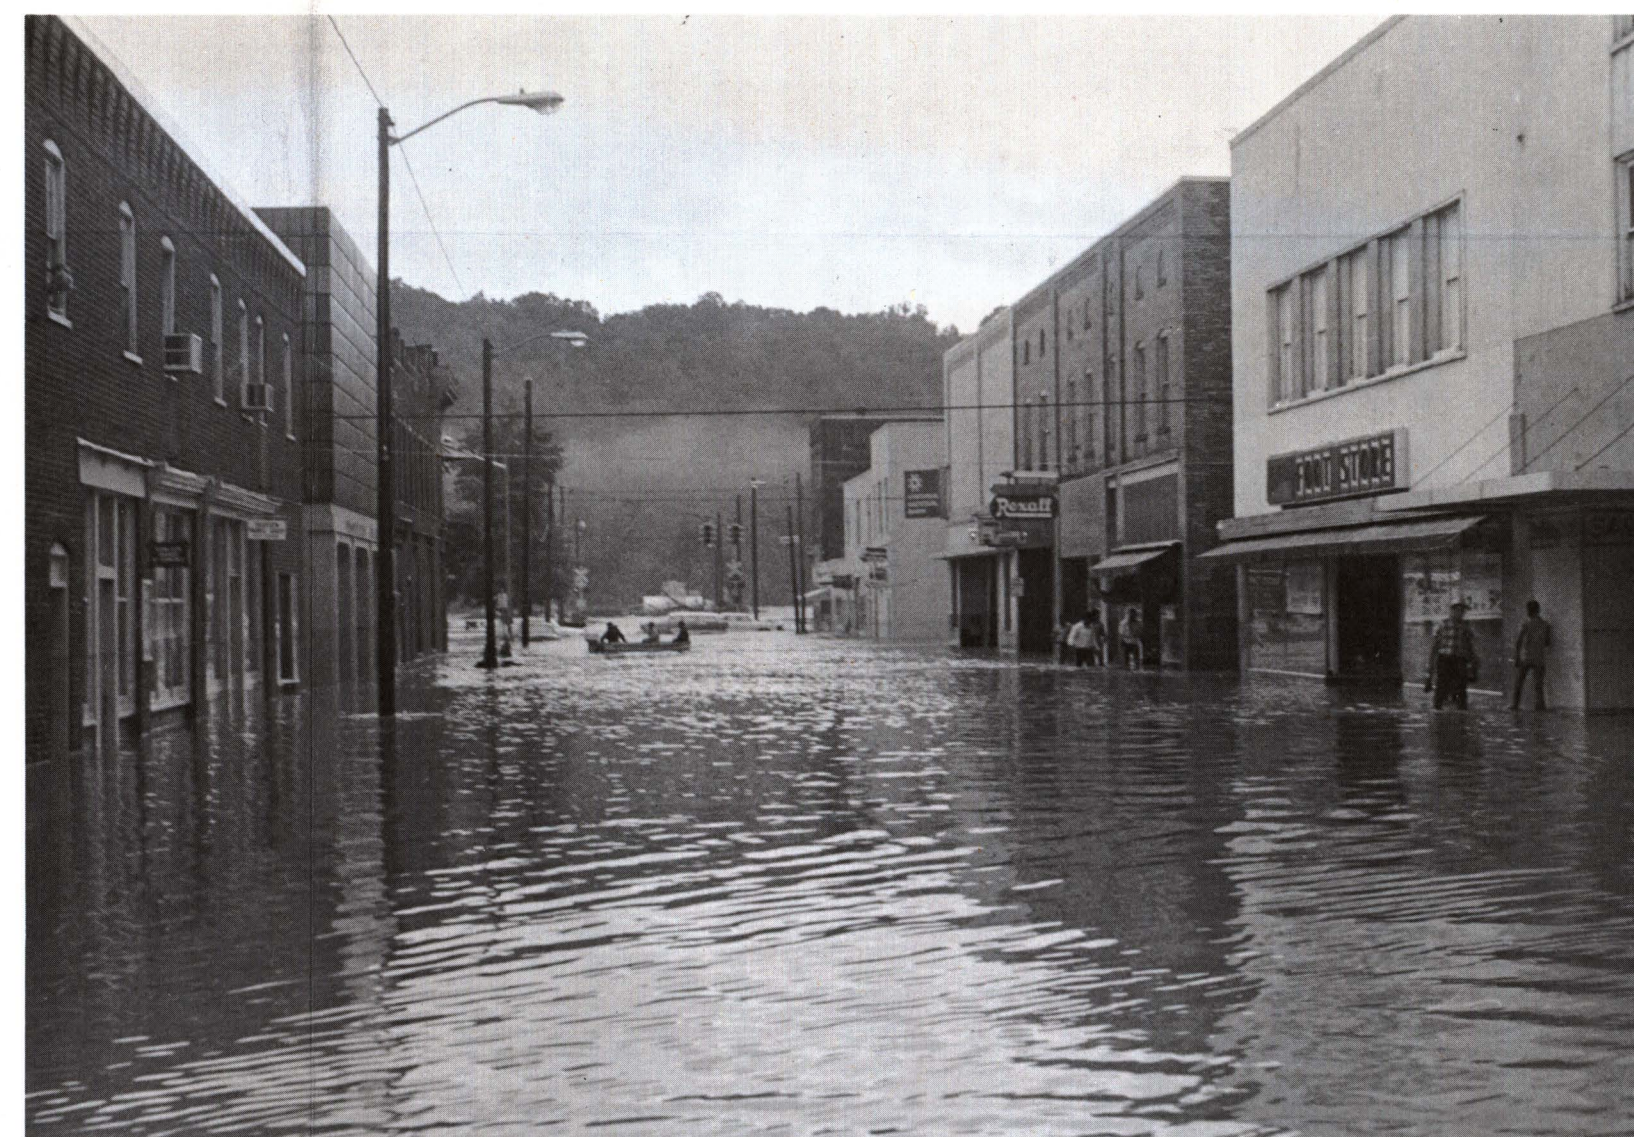
Photograph from Fitzgerald Photos, Buena Vista
Downtown Buena Vista about 10 a.m., August 20, 1969. Floodwater had receded.
