FLOOD OF JANUARY 1969 NEAR AZUSA AND GLENDORA, CALIFORNIA

By
Frank W. Giessner and McGlone Price

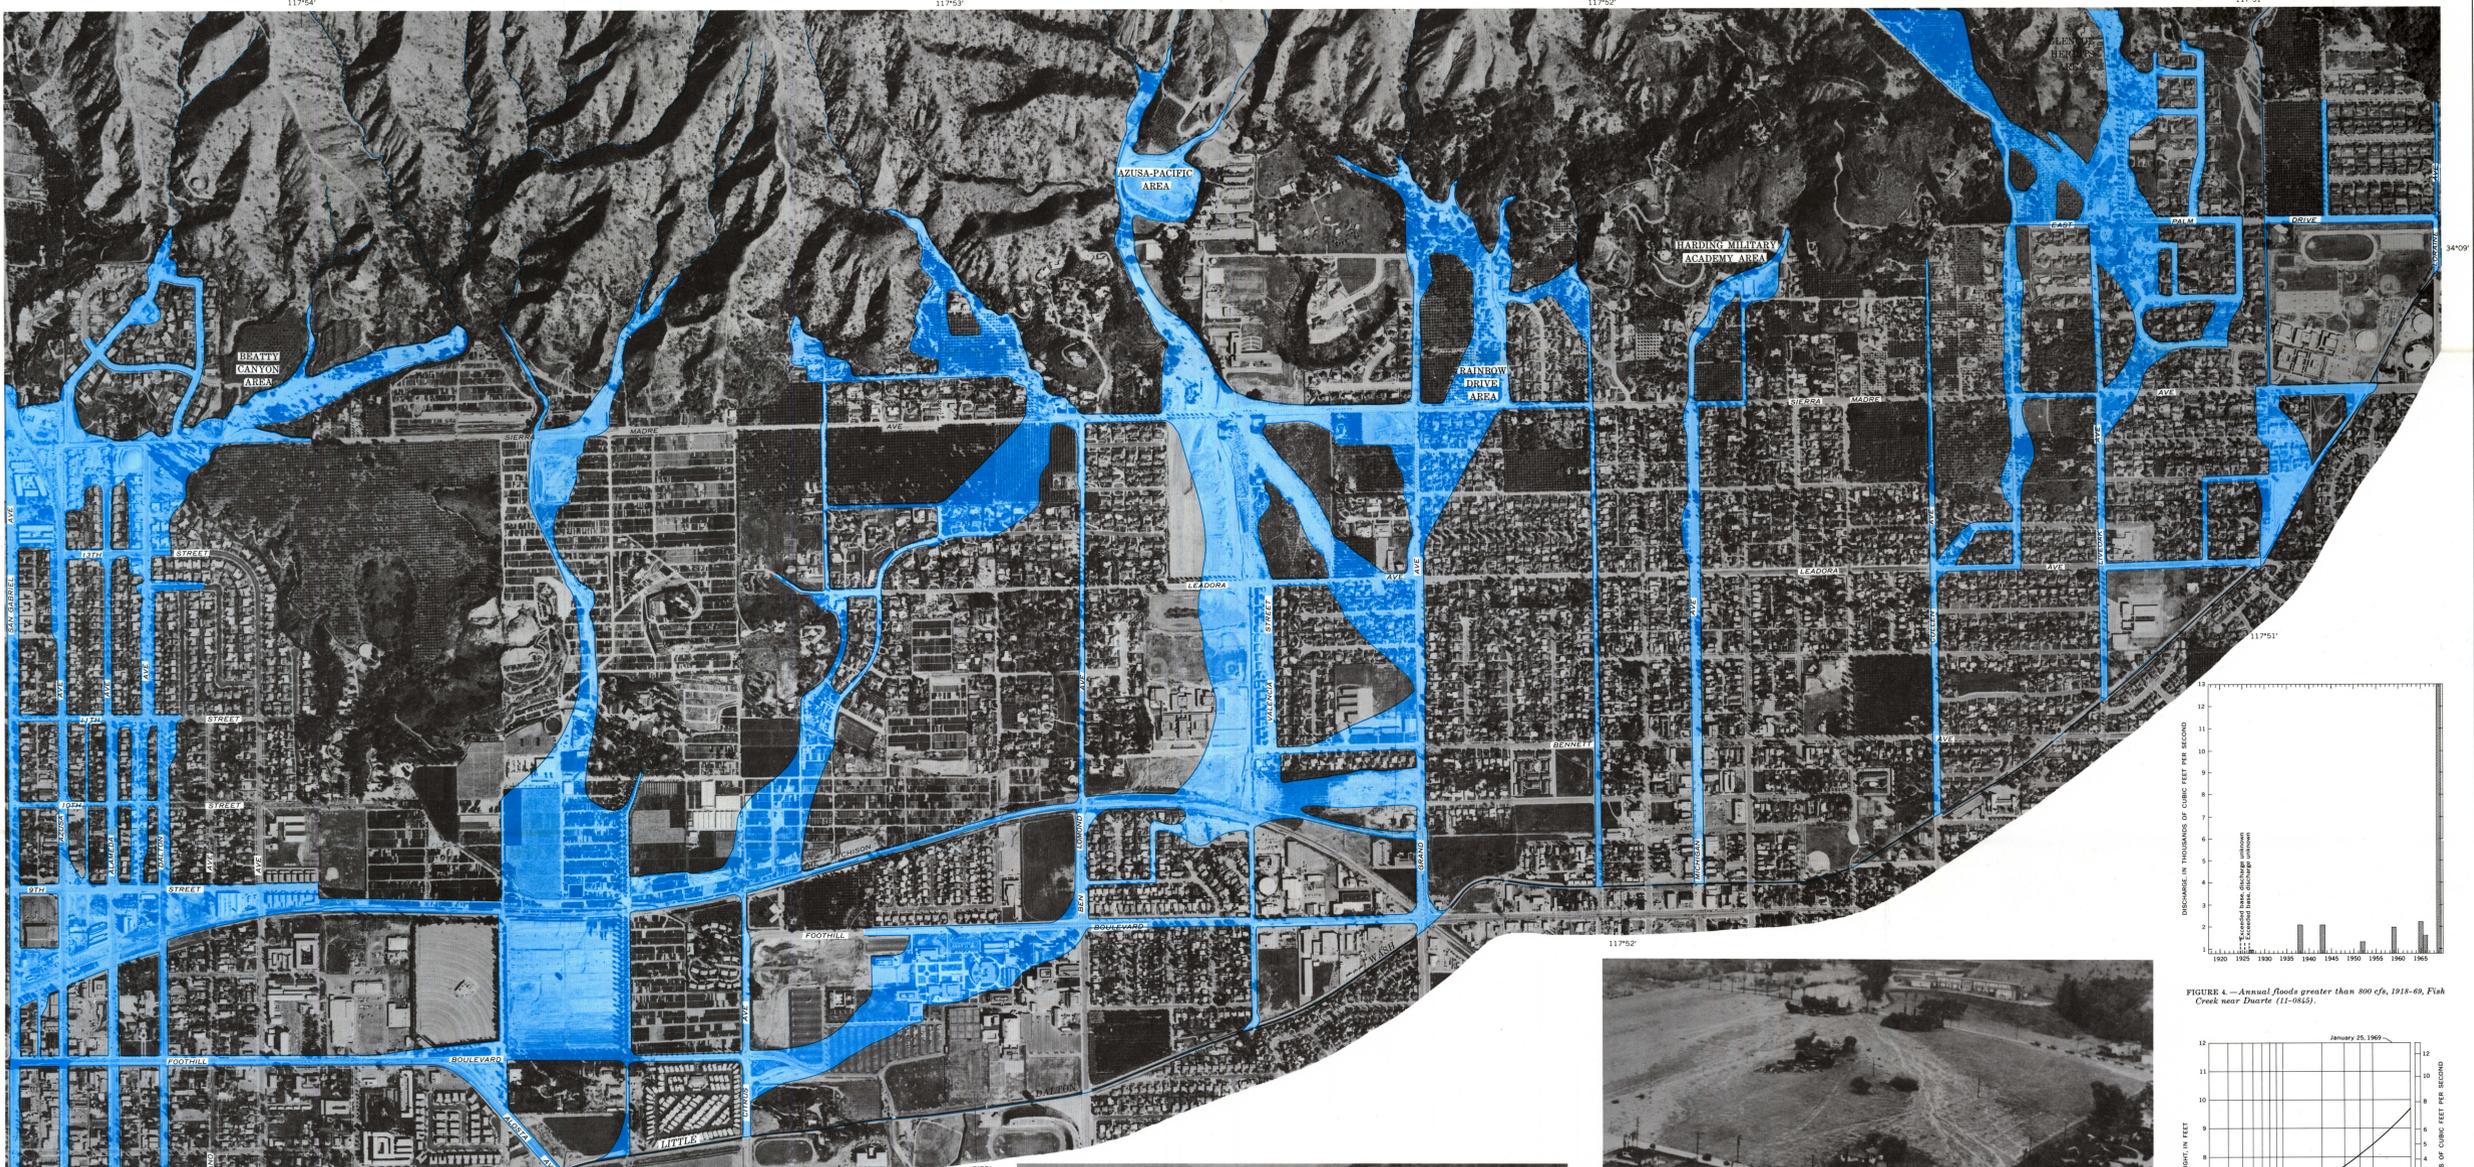
The extent of inundation in the Azusa and Glendora area is shown on an aerial photomosaic base that represents a land area of about 5 square miles extending 3½ miles east from Azusa Avenue in Azusa. The limits of flooding were identified on aerial photographs taken immediately after the flood and from field inspections. The inundation delineated reflects conditions existing at the time of the 1969 flood. Changes in waterway openings at bridges and culverts, channel conditions, extent and condition of vegetative cover in the upland areas, and urbanization may significantly affect the extent of areas inundated by overflows from future floods.

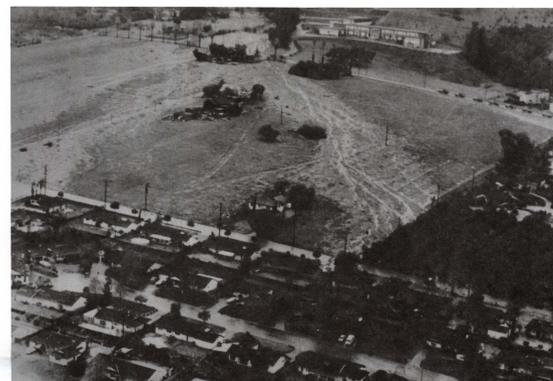
FIGURE 2.—View of overflows in Leadora Avenue-Valencia Street area in Glendora, January 21, 1969. Site is south of Azusa-Pacific College. Sierra Madre Avenue in upper part of view. Photograph, courtesy of Los Angeles County Fire Department.

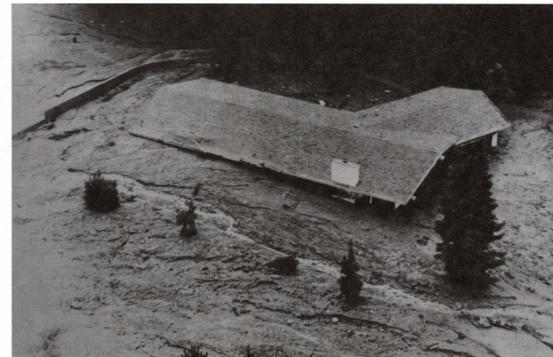
FIGURE 3.—Residence engulfed by mudflow in Glendora Heights area, January 21, 1969. Photograph, courtesy of Los Angeles County Fire Department.
