FLOODS IN PATILLAS-MAUNABO AREA, PUERTO RICO

By
William J. Haire

1971

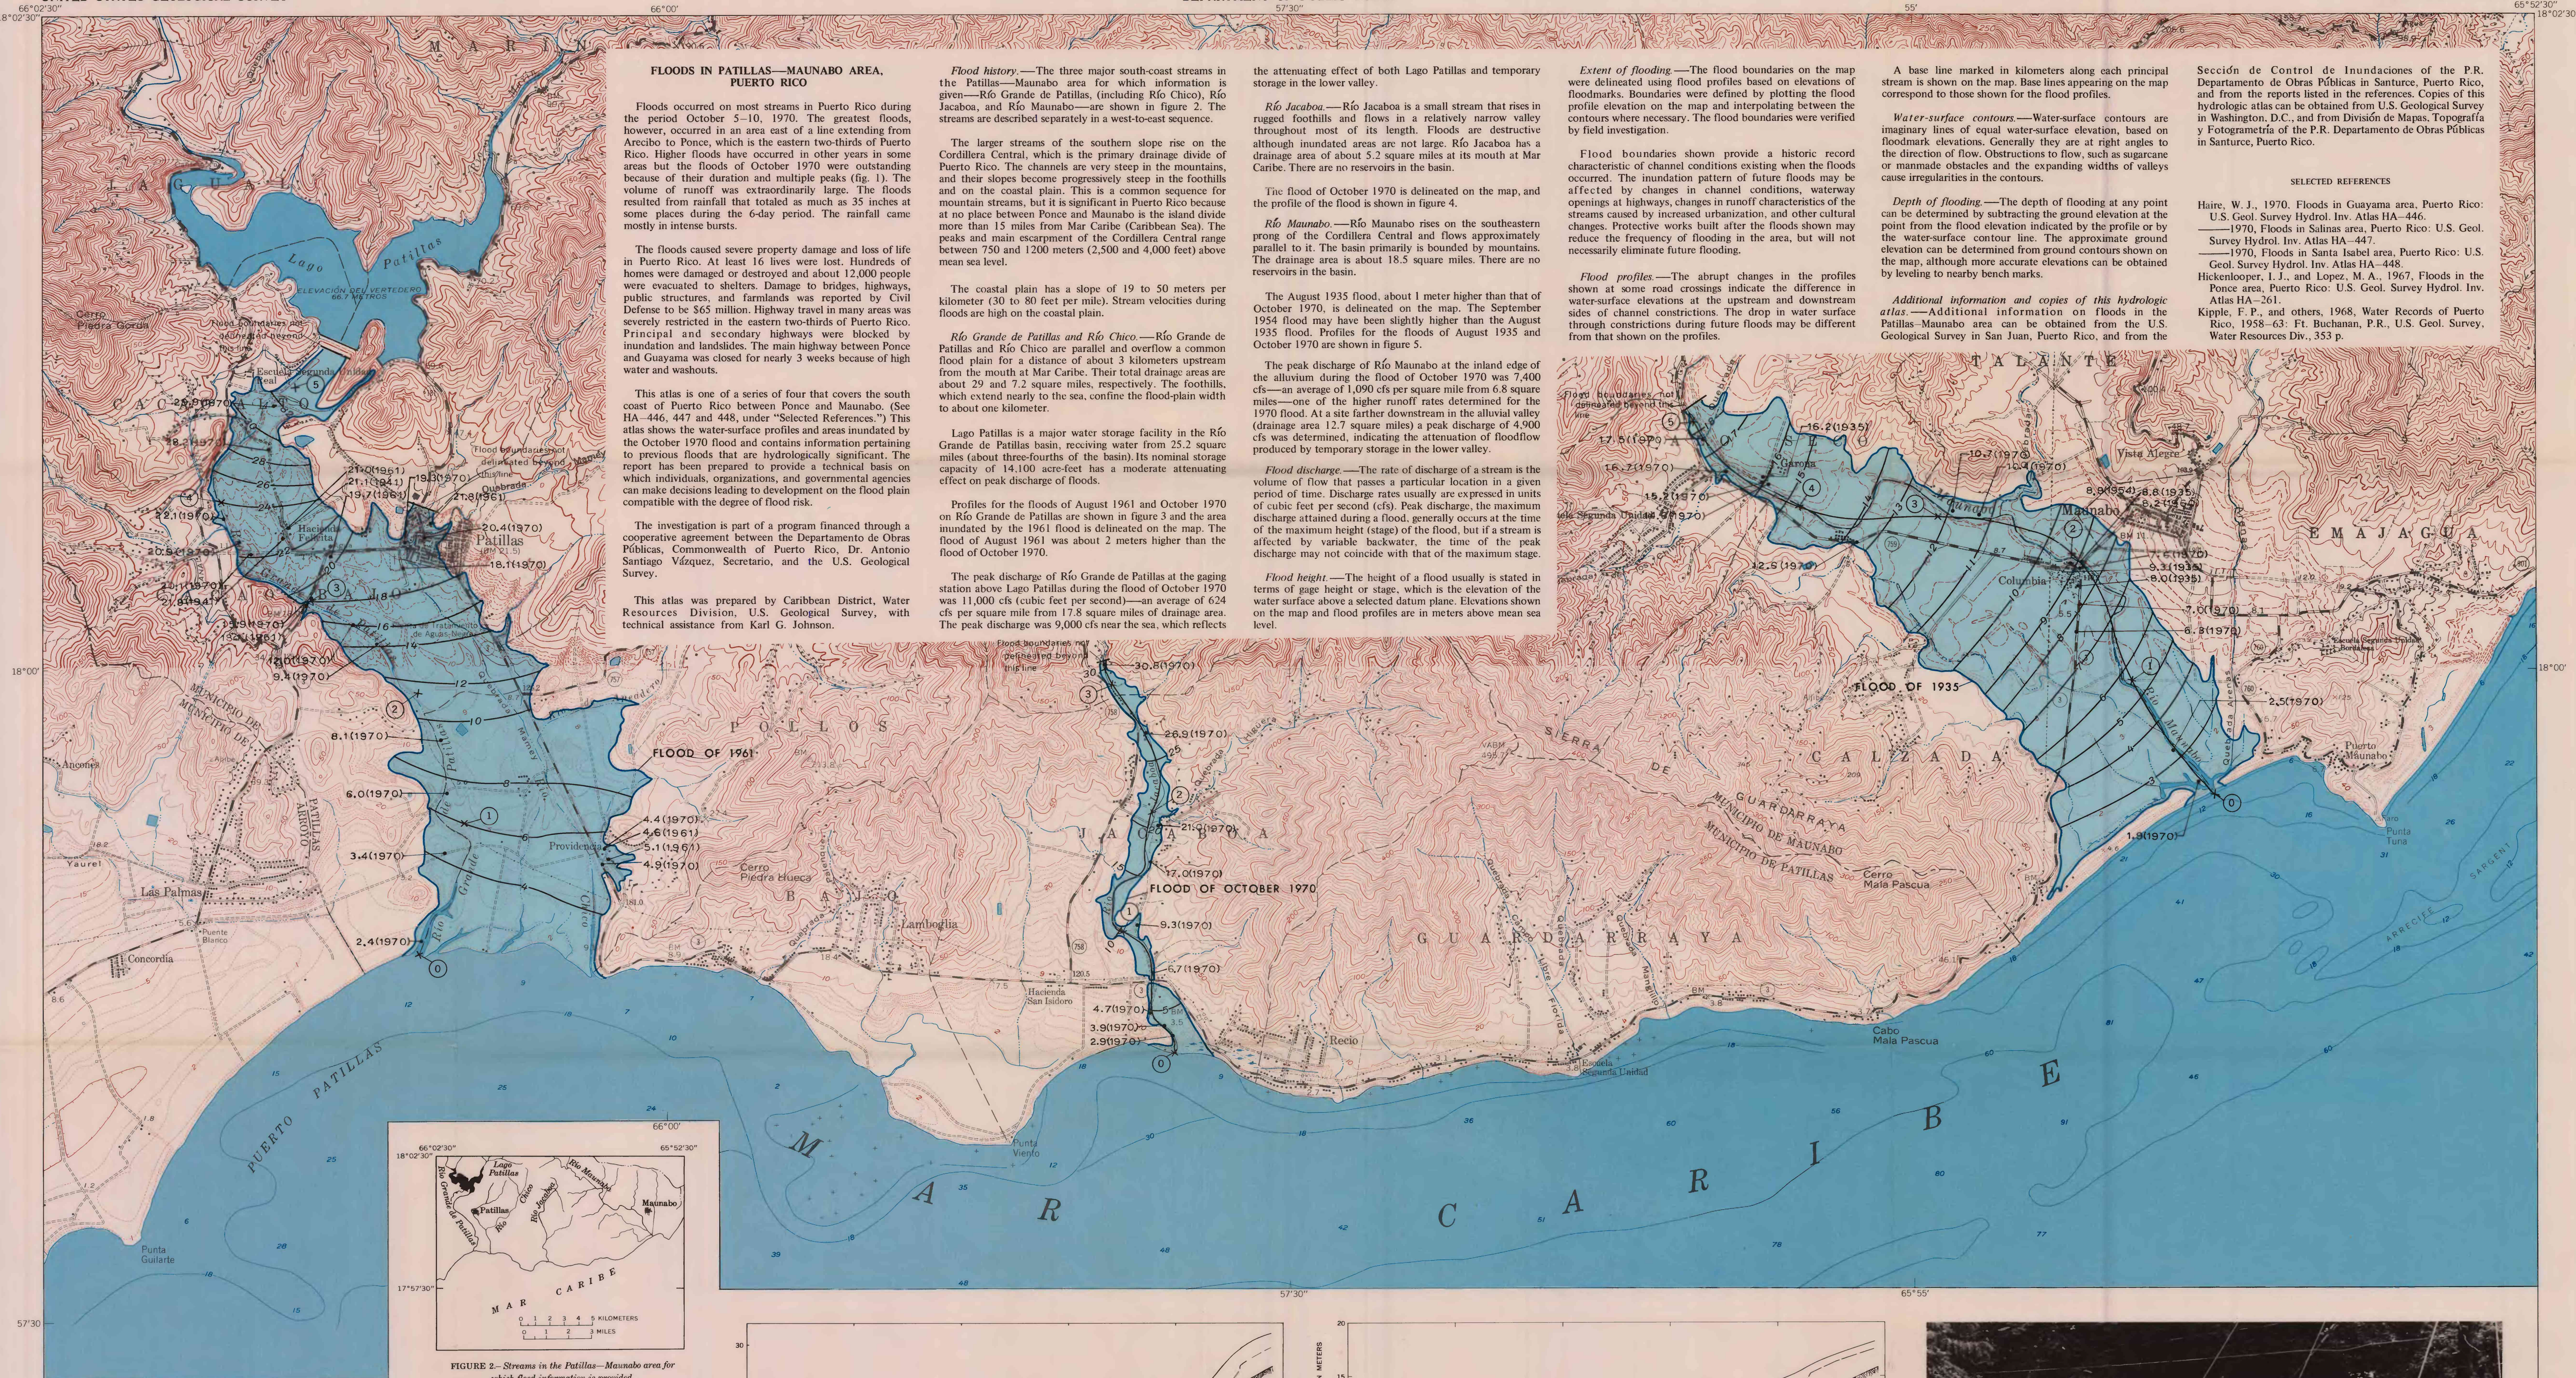
FIGURE 2.—Streams in the Patillas—Maunabo area for which flood information is provided.

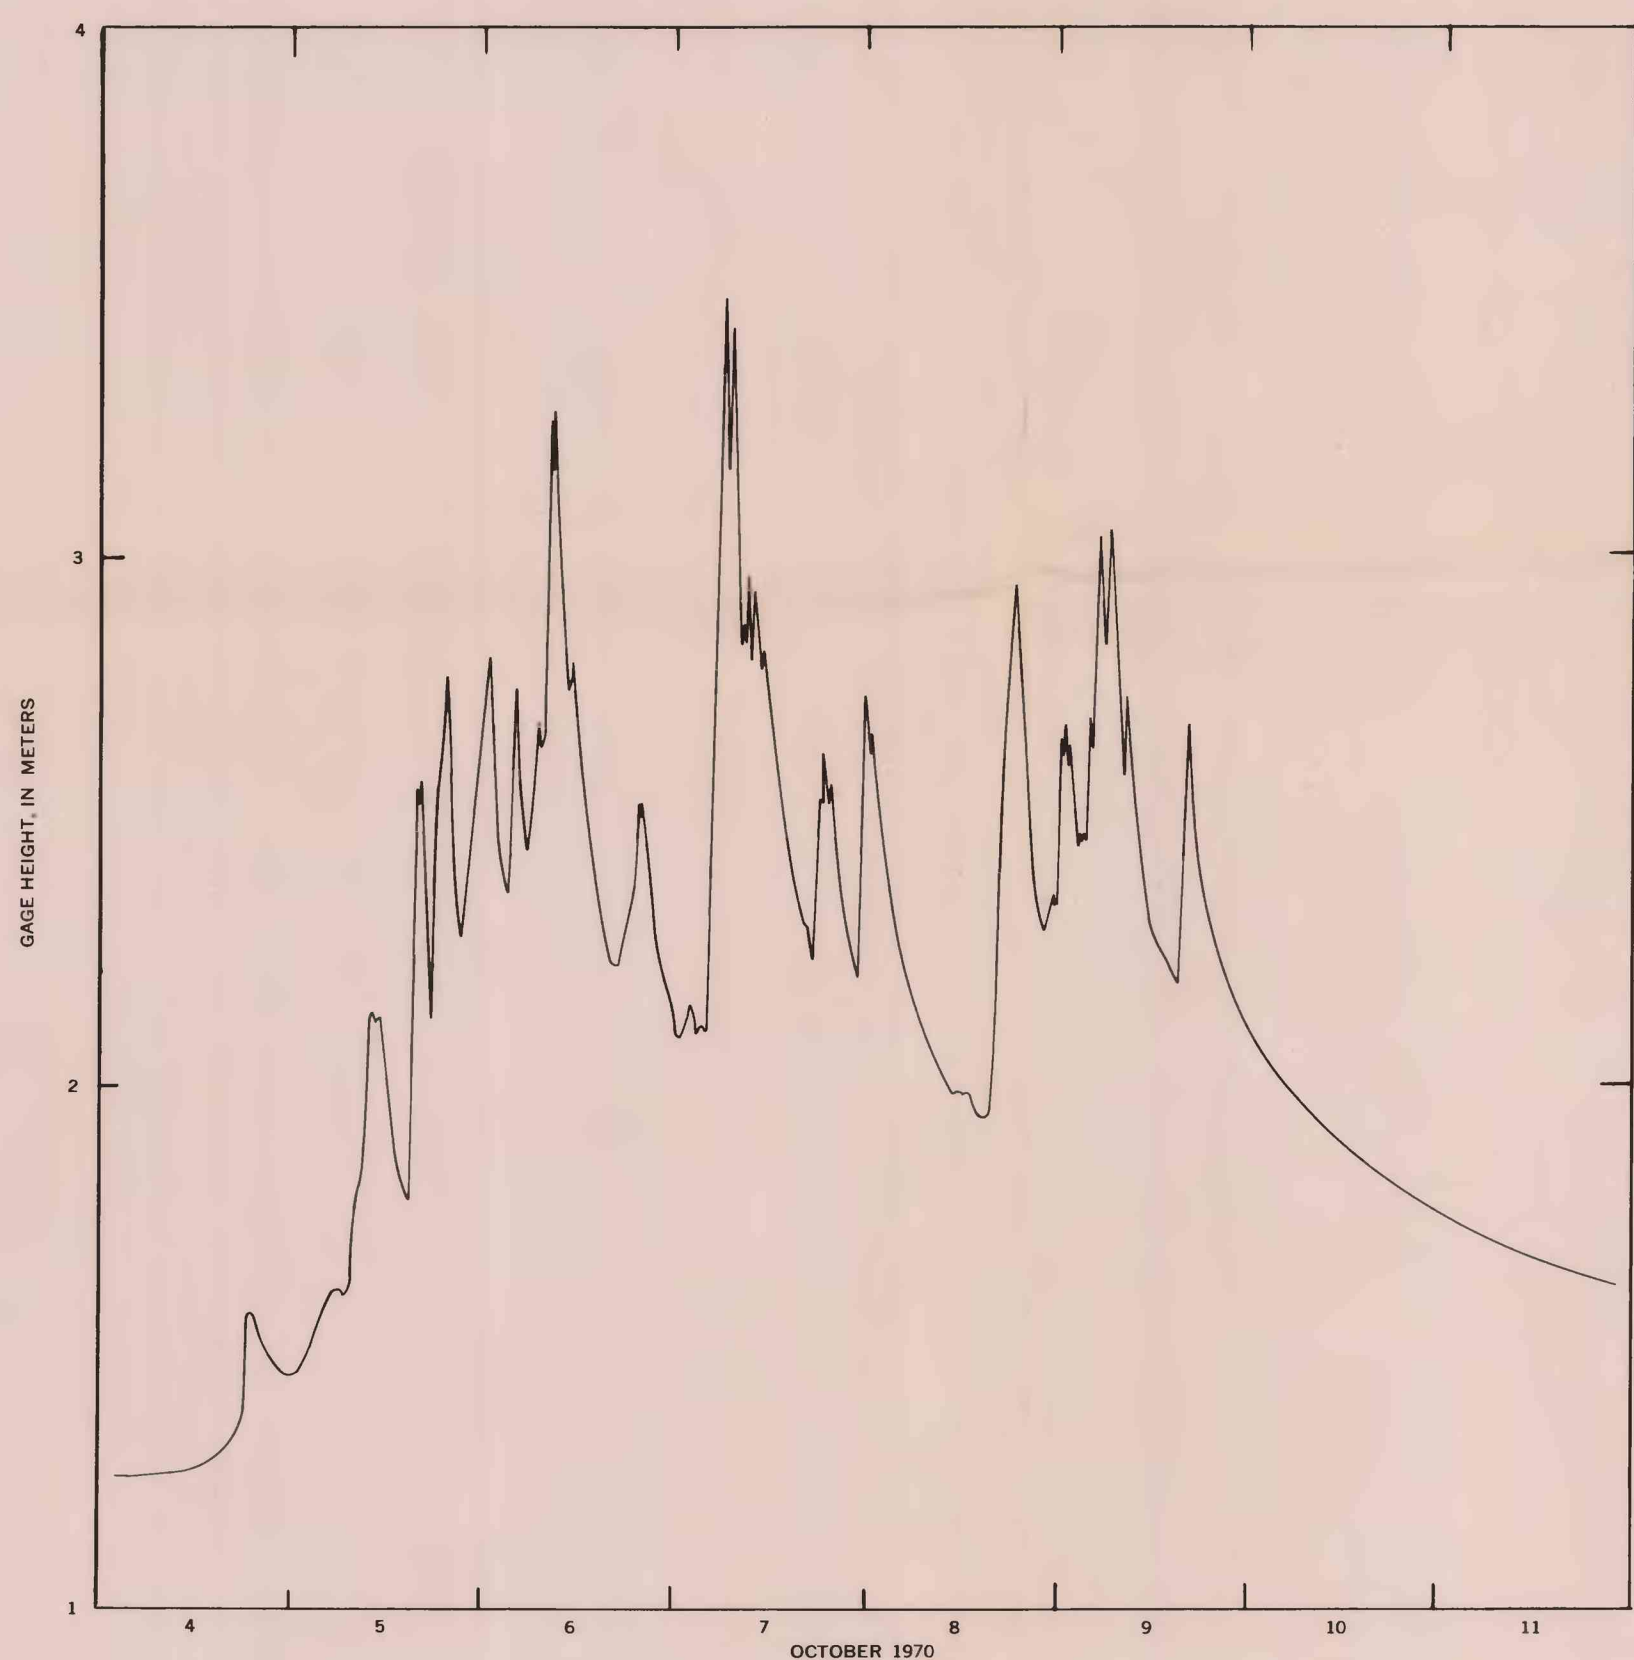
FIGURE 1.—Stage hydrograph of Río Grande de Patillas October 4-11, 1970, showing multiple peaks, typical of the 1970 flood on streams in the eastern two-thirds of Puerto Rico.

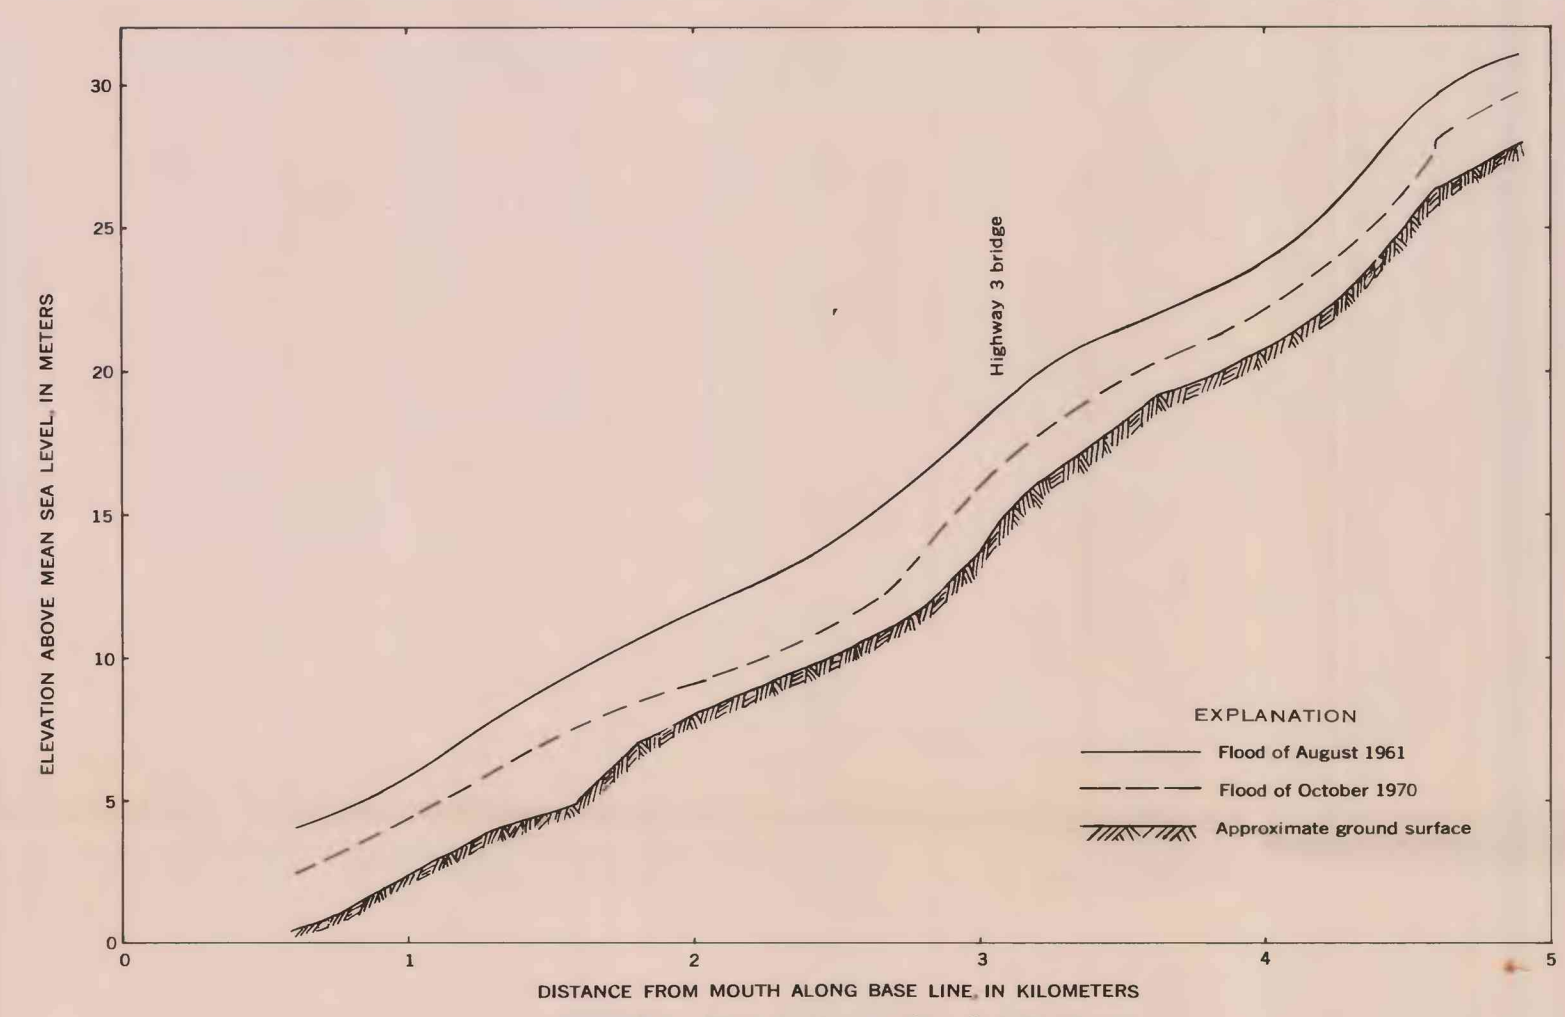
FIGURE 3.—Flood profiles, Río Grande de Patillas.

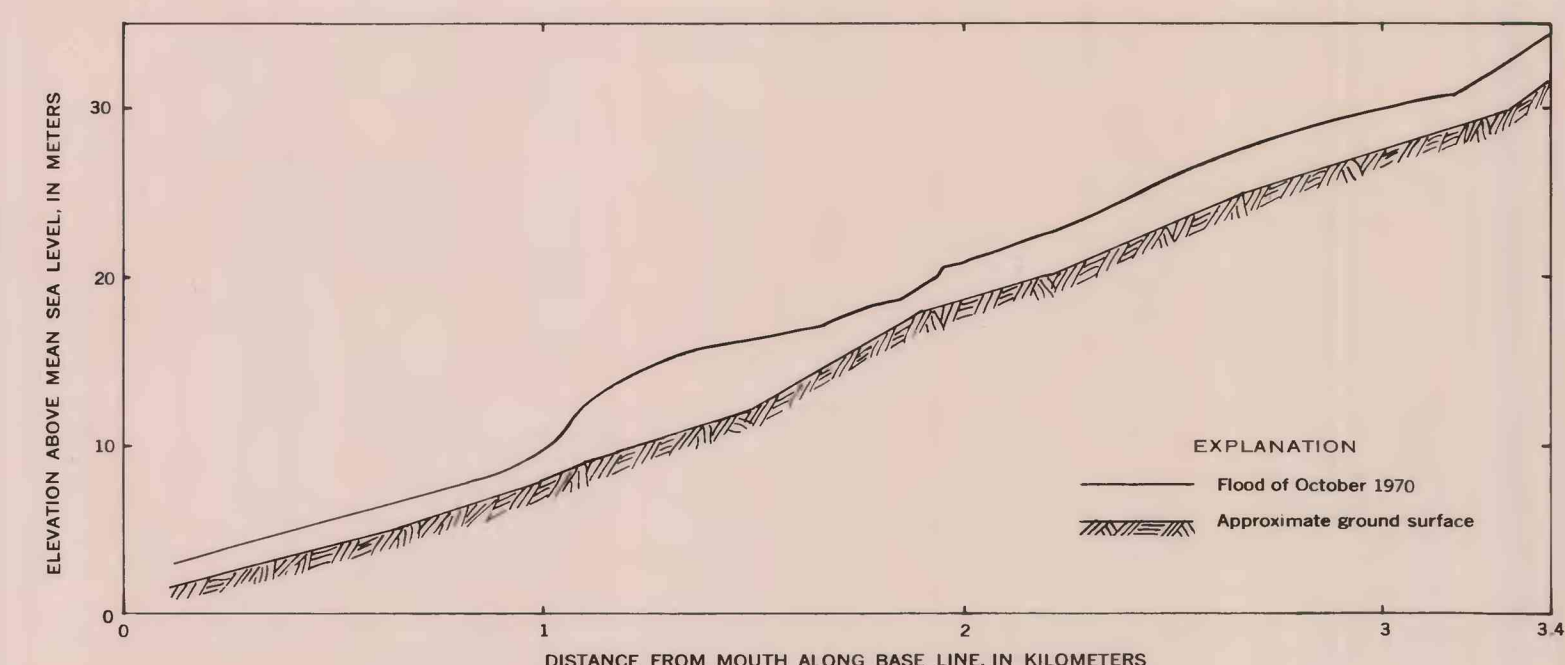
FIGURE 4.—Flood profile, Río Jacoboa.

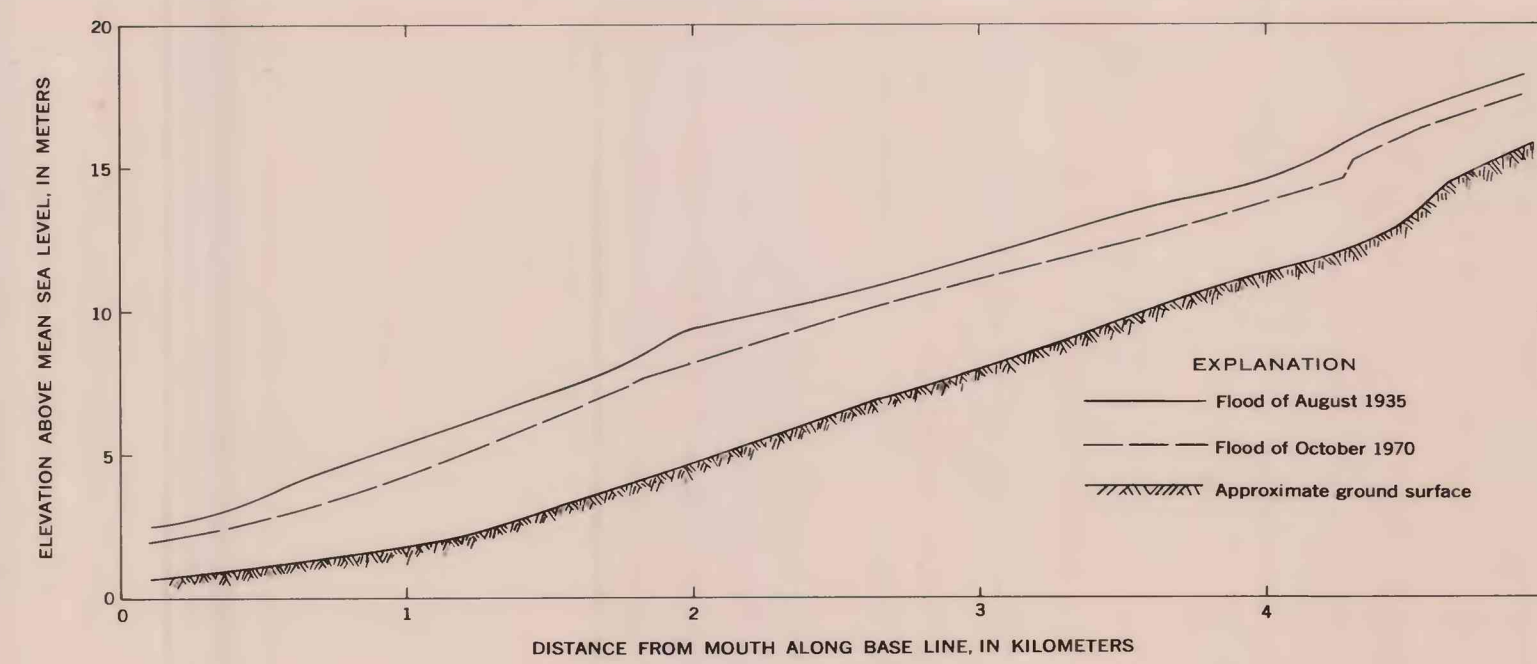
FIGURE 5.—Flood profiles, Río Maunabo.
