FLOODS IN SANTA ISABEL AREA, PUERTO RICO

By
William J. Haite

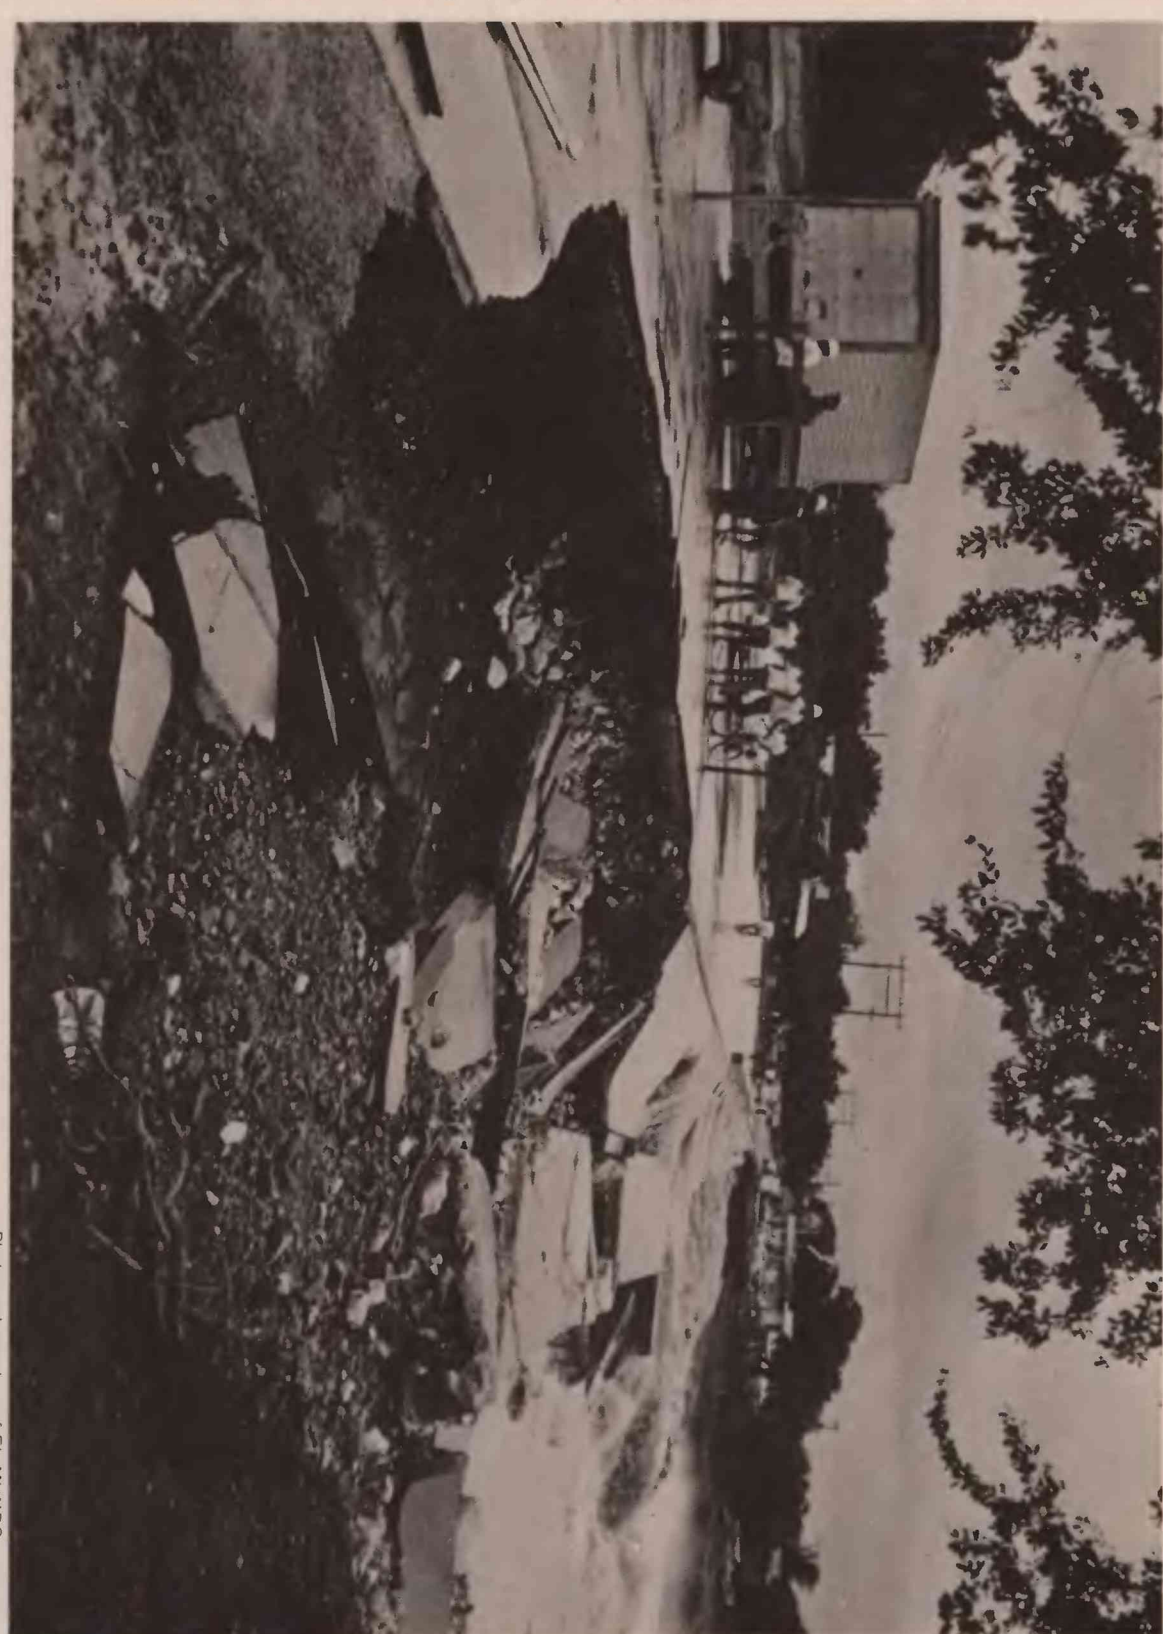
Highway 2 of Rio Camero between flood plain in October 1970. Bridge and center strip structure was completely damaged later in the flood.

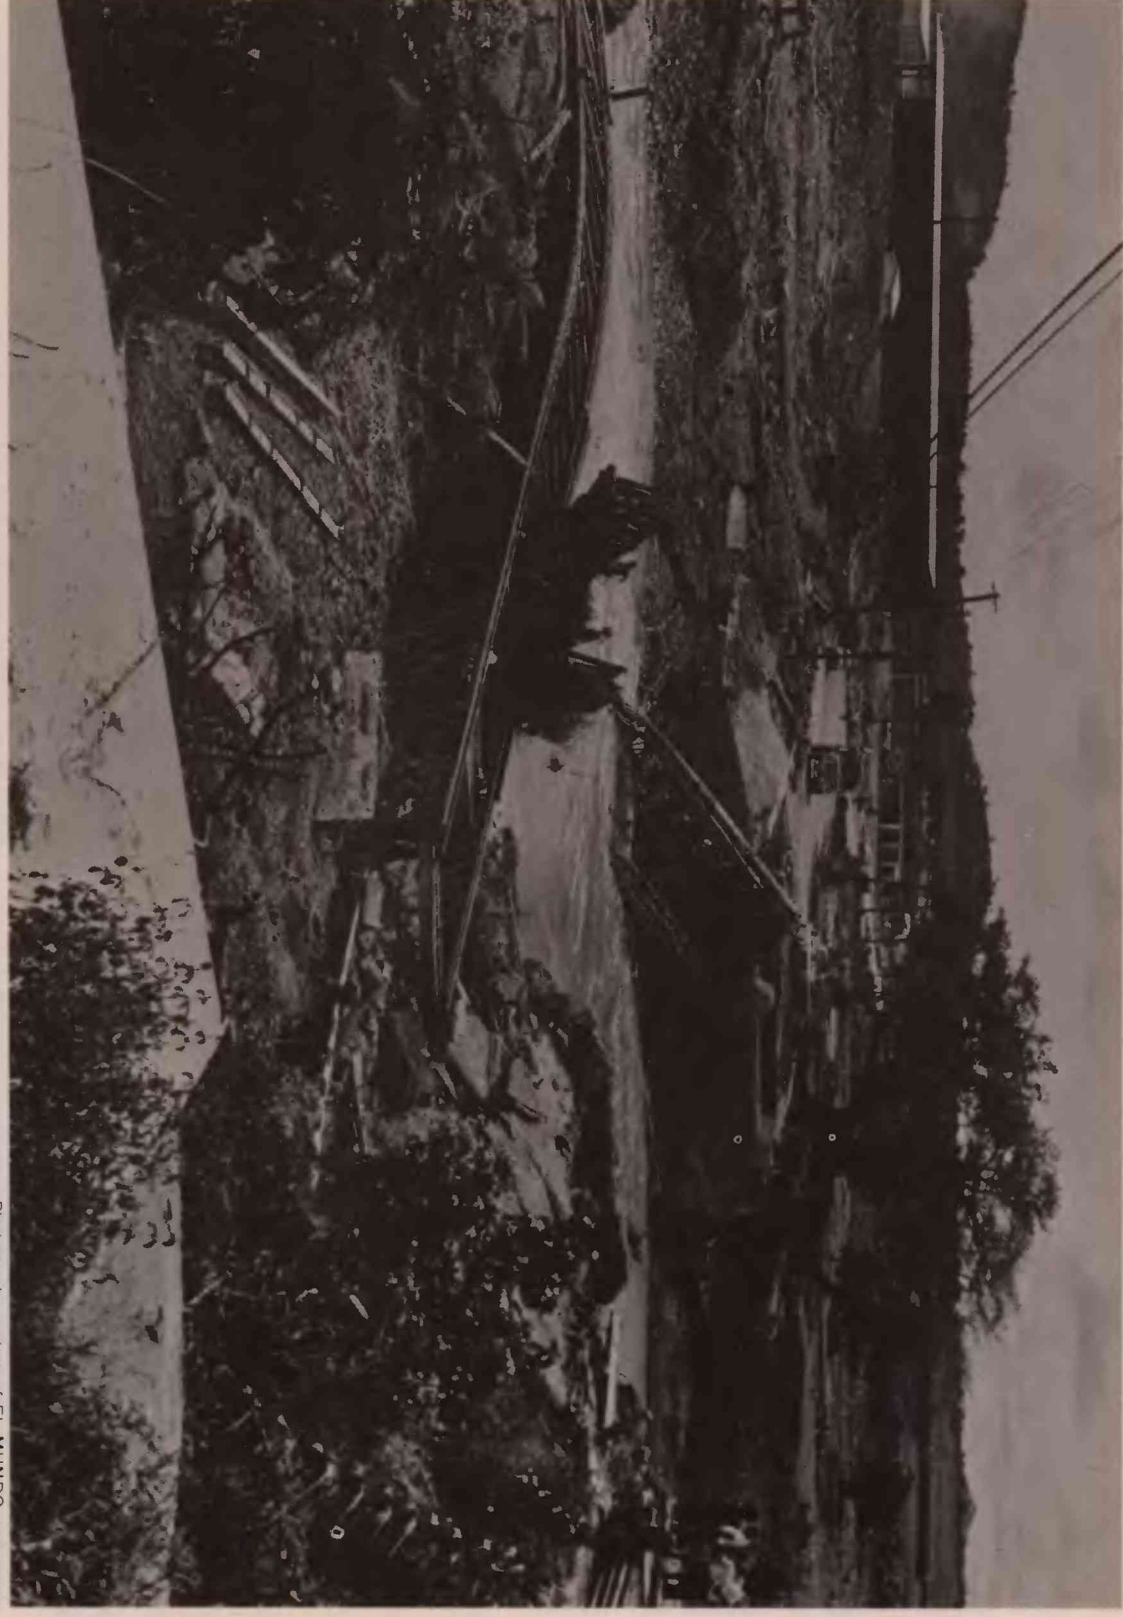
7 mi. Santa Isabela - Highway 1 of Rio Camero during the flood of October 1970.
