FLOODS IN THE RÍO GUANAJIBO VALLEY, SOUTHWESTERN PUERTO RICO
By
William J. Haire
1972

This report provides factual and interpretive information that will aid administrators, planners, engineers, and other interested persons concerned with future development in areas subject to flooding in the Río Guanajibo basin. More specifically, the information given here is useful to those responsible for formulating effective floodplain regulations that would minimize flood damage.

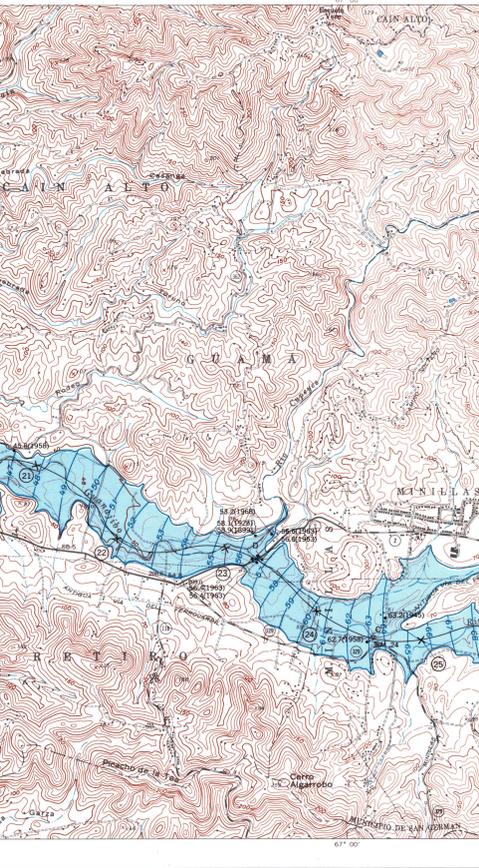
FIGURE 4.—Profile of Río Guanajibo, base-line stations 7 to 25, flood of July 30, 1963. Letters on bridges refer to table 2.

FLOOD PROFILE
The maximum elevation of the water surface for the flood of July 30, 1963, on Río Guanajibo referred to the arbitrary valley base line on the topographic map is shown in figure 3 to 7. The base line is not the highway but follows a smoother path along the valley and conforms to the general direction of flow. Fourteen highway bridges are in the valley, 11 of which cross Río Guanajibo (see table 2). The water surface during this flood was above low water at 5 of these bridges and 2 of the 5 bridges were completely inundated. Not enough data are available to define accurate profiles for other floods.
