The flood along Rapid Creek gained national attention because of damage to property and the loss of life in Rapid City. It has been called the greatest disaster in the history of South Dakota. The flood map and stage graphs show the results of analysis of data on the extent and frequency of the flood. These data provide a basis for making decisions concerning future development of the flood-prone area.

FLOOD OF JUNE 9-10, 1972, AT RAPID CITY, SOUTH DAKOTA
By
Owen J. Larimer
1973

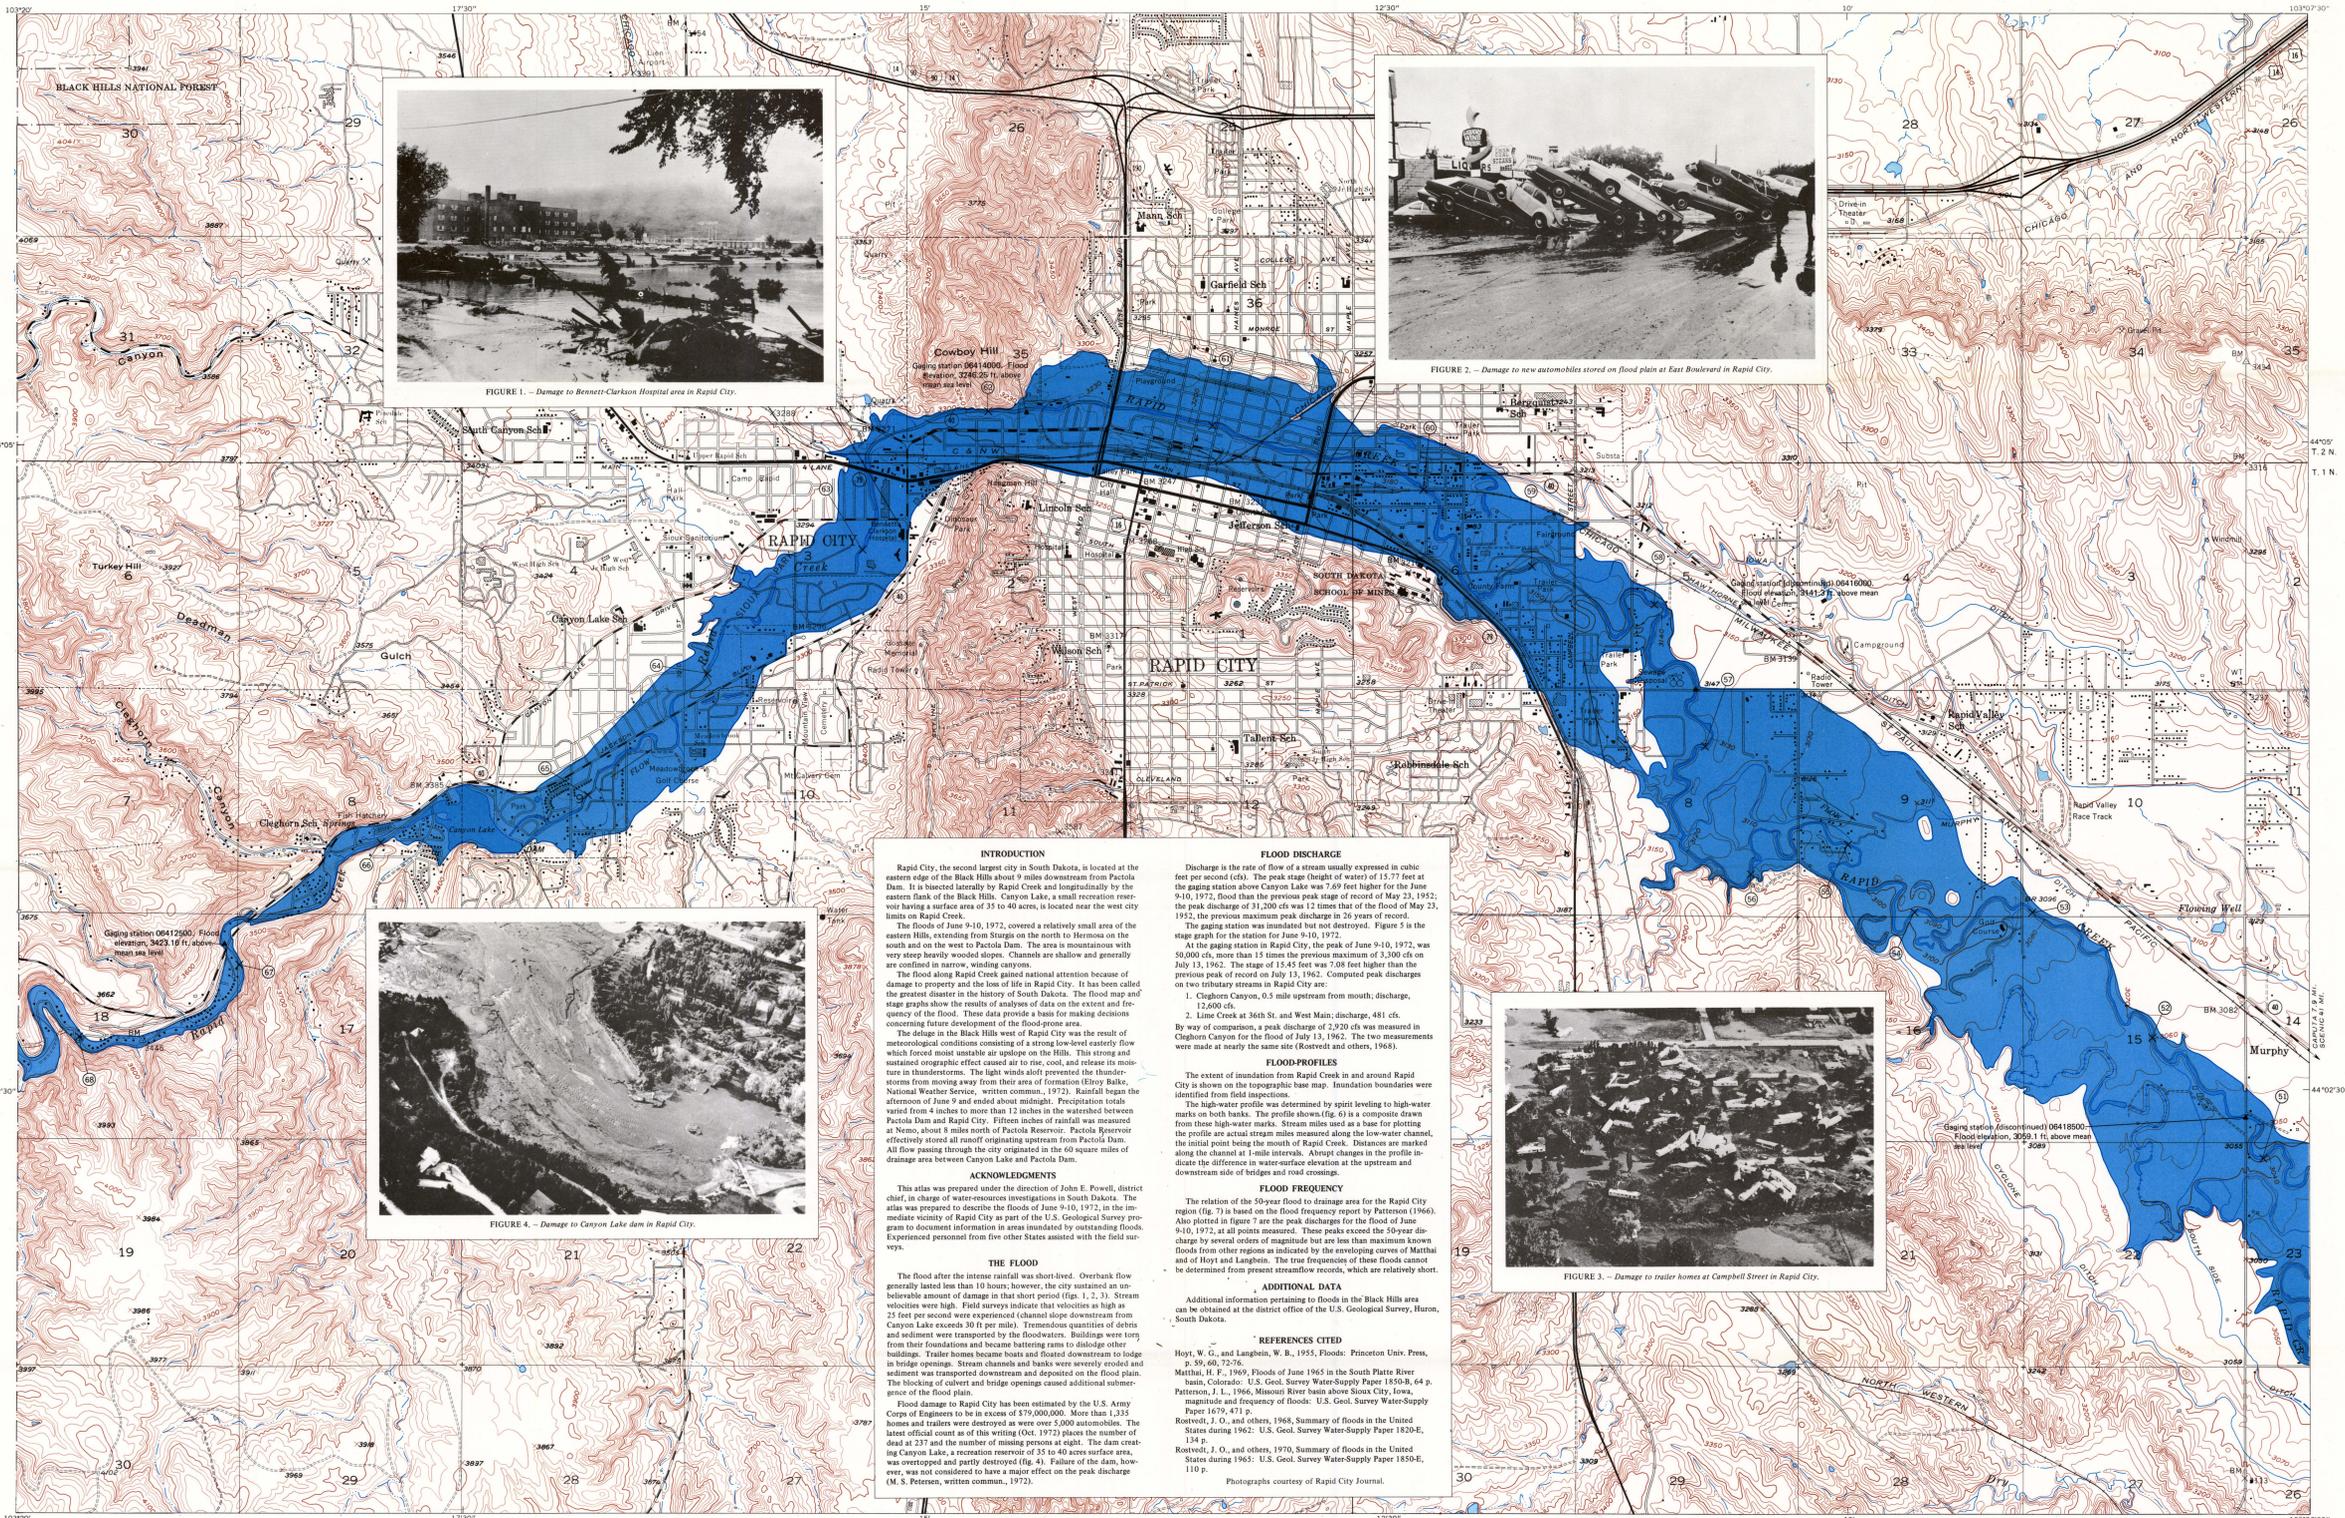
FLOOD PROFILES
The extent of inundation from Rapid Creek in and around Rapid City is shown on the topographic base map. Inundation boundaries were identified from field inspection.

EXPLANATION
 Area flooded, June 9-10, 1972
 Boundary of flooded area
 River miles measured along stream channel upstream from mouth
 U.S. Geological Survey gaging station

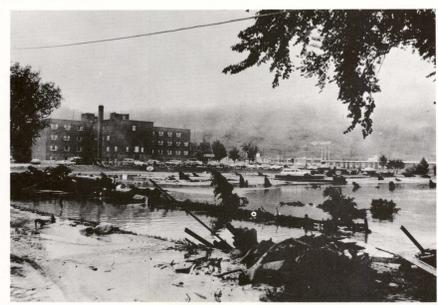
FIGURE 1. — Damage to Bennett-Clarkson Hospital area in Rapid City.

THE FLOOD
The flood after the intense rainfall was short-lived. Overbank flow generally lasted less than 10 hours; however, the city sustained an unbelievable amount of damage in that short period (figs. 1, 2, 3). Stream velocities were high. Field surveys indicate that velocities as high as 25 feet per second were experienced (channel slope downstream from Canyon Lake exceeds 30 ft per mile). Tremendous quantities of debris and sediment were transported by the floodwaters. Buildings were torn from their foundations and became battering rams to dislodge other buildings. Trailer homes became boats and floated downstream to lodge in bridge openings. Stream channels and banks were severely eroded and sediment was transported downstream and deposited on the flood plain. The blocking of culvert and bridge openings caused additional submergence of the flood plain.

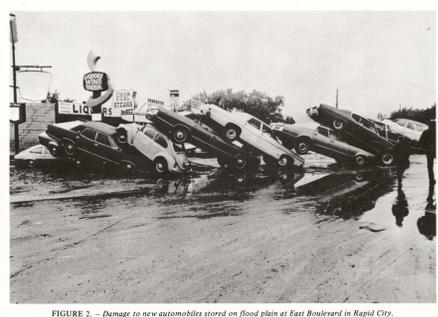
FIGURE 2. — Damage to new automobiles stored on flood plain at East Boulevard in Rapid City.

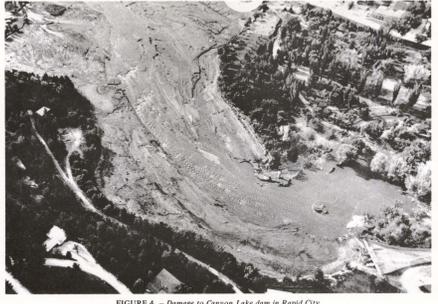
FIGURE 4. — Damage to Canyon Lake dam in Rapid City.

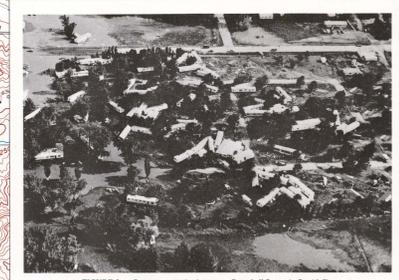
FIGURE 3. — Damage to trailer homes at Campbell Street in Rapid City.

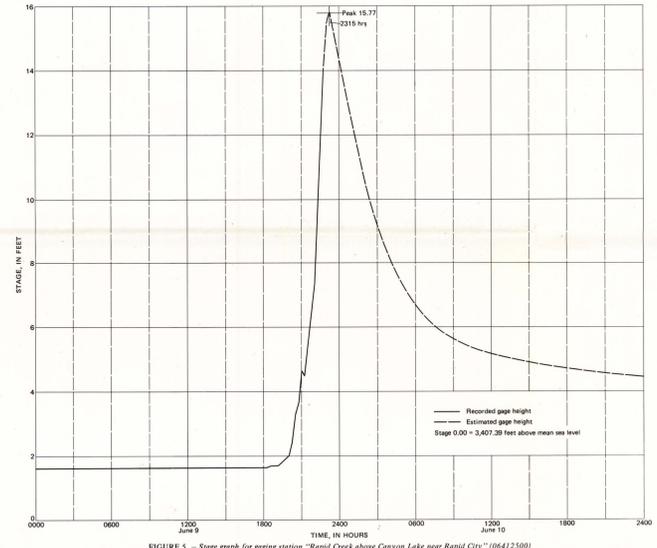
FIGURE 5. — Stage graph for gaging station "Rapid Creek above Canyon Lake near Rapid City" (06412500) for June 9-10, 1972.

FLOOD DISCHARGE
Discharge is the rate of flow of a stream usually expressed in cubic feet per second (cfs). The peak stage (height of water) of 15.77 feet at the gaging station above Canyon Lake was 7.89 feet higher for the June 9-10, 1972, flood than the previous peak stage of record of May 23, 1952; the peak discharge of 31,200 cfs was 12 times that of the flood of May 23, 1952, the previous maximum peak discharge in 26 years of record.

The gaging station was inundated but not destroyed. Figure 5 is the stage graph for the station for June 9-10, 1972.

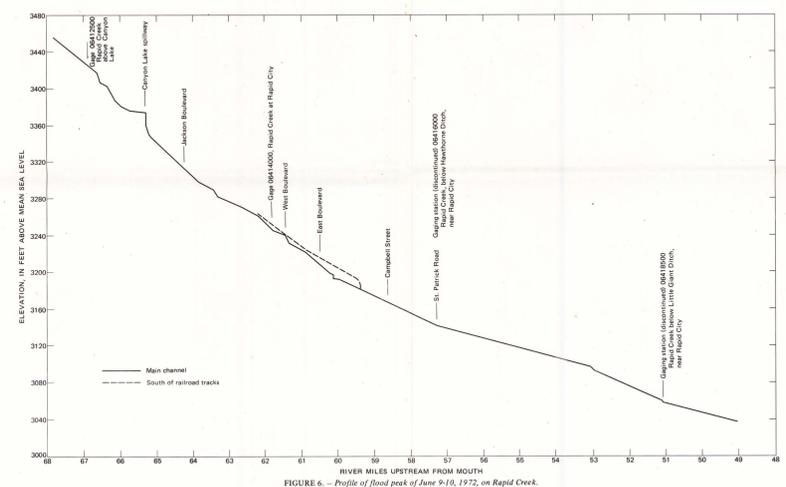
FIGURE 6. — Profile of flood peak of June 9-10, 1972, on Rapid Creek.

The high-water profile was determined by spirit leveling to high-water marks on both banks. The profile shown (fig. 6) is a composite drawn from three high-water marks. Stream miles used as a base for plotting the profile are actual stream miles measured along the low-water channel, the initial point being the mouth of Rapid Creek. Distances are marked along the channel at 1-mile intervals. Abrupt changes in the profile indicate the difference in water-surface elevation at the upstream and downstream side of bridges and road crossings.

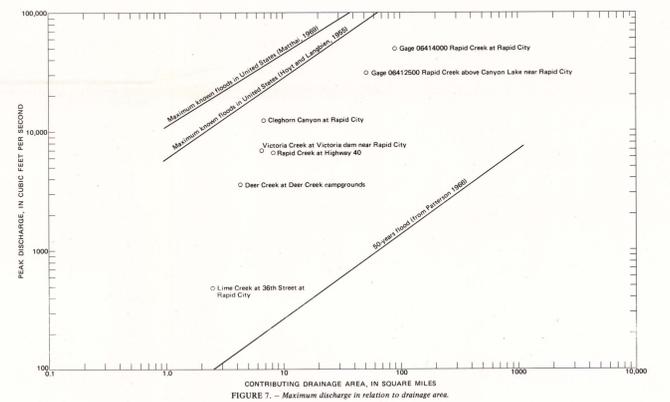
FIGURE 7. — Maximum discharge in relation to drainage area.

FLOOD FREQUENCY
The relation of the 50-year flood to drainage area for the Rapid City region (fig. 7) is based on the flood frequency report by Patterson (1966). Also plotted in figure 7 are the peak discharges for the flood of June 9-10, 1972, at all points measured. These peaks exceed the 50-year discharge by several orders of magnitude but are less than maximum known floods from other regions as indicated by the enveloping curves of Matthai and Hoyt and Langbein. The true frequencies of these floods cannot be determined from present streamflow records, which are relatively short.
