**FLOOD OF JUNE 1972 AT ELMIRA, NEW YORK**

**Introduction.**—The greatest flood disaster in the history of New York occurred during late June 1972 as a result of torrential rains brought by the remnants of Tropical Storm Agnes. The city of Elmira, in southwest-central New York, sustained the most extensive flooding of any populated area in the flood zone of New York. Flooding was primarily due to Chemung River, but Newtown Creek and Seelye Creek also experienced high flows.

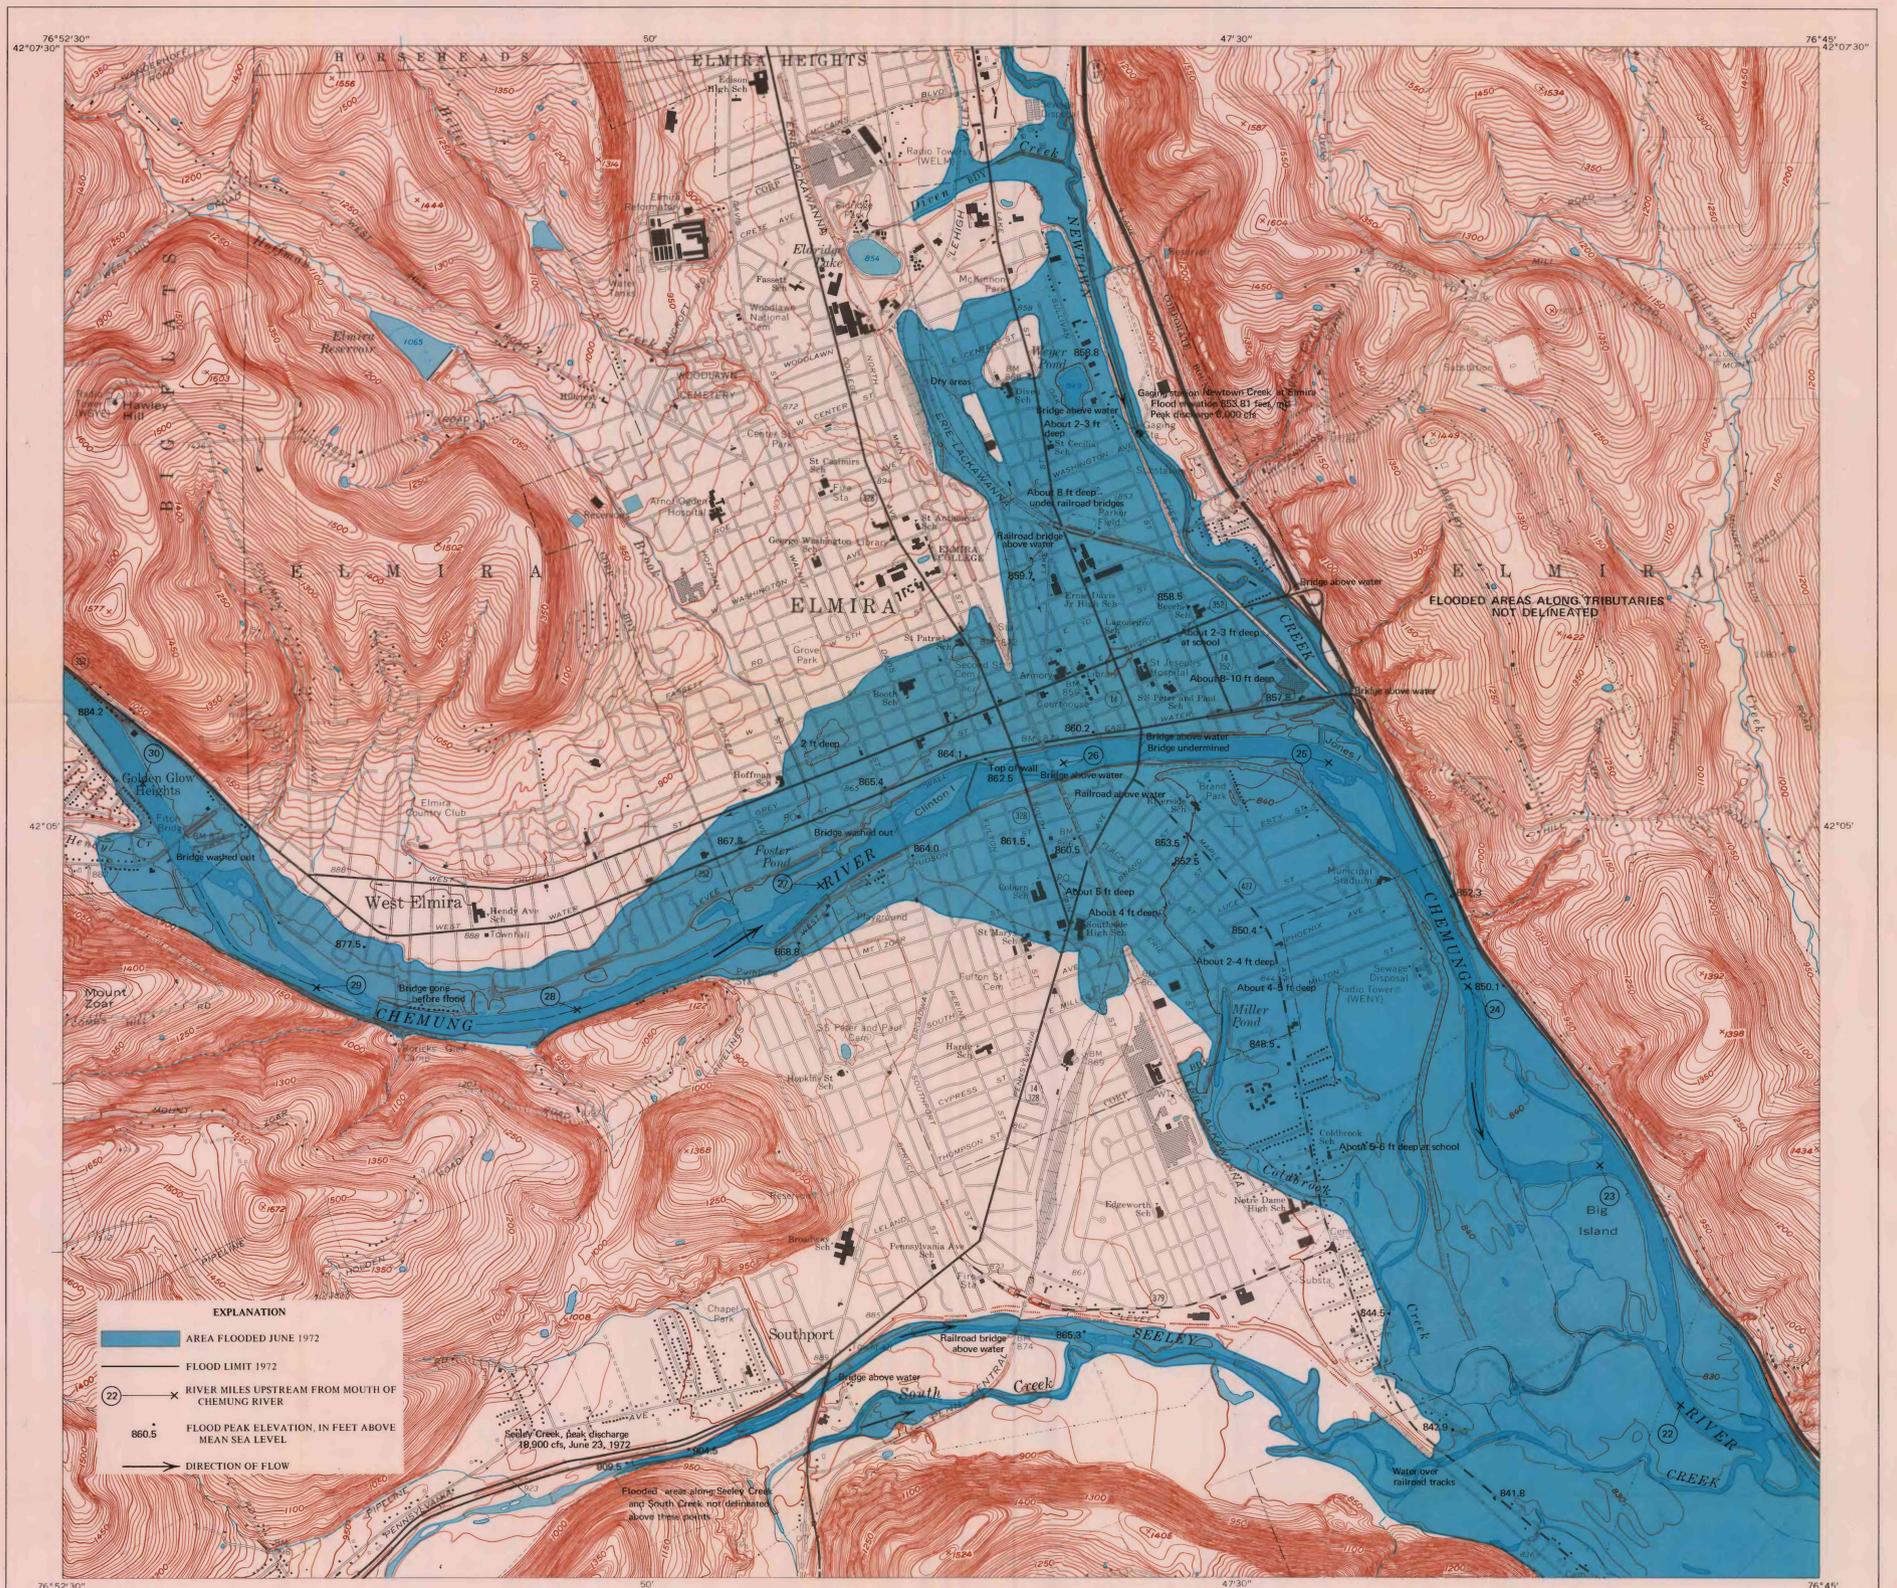
Base from U.S. Geological Survey, 1:24,000, Elmira, 1962  
SCALE 1:18,000  
CONTOUR INTERVAL 10 FEET  
DATUM IS MEAN SEA LEVEL

**Floodmarks** were identified at more than 150 locations in Elmira and along the 9.1-mile reach of the Chemung River shown on the flood map. Elevations of the floodmarks were determined by leveling to bench marks. Flood boundaries were delineated from field surveys made soon after the flood. Elevations of representative floodmarks are shown on the map.
