**FLOOD OF JUNE 1972 AT CORNING, NEW YORK**

By  
**Kenneth I. Darmer and Lloyd A. Wagner**

1973

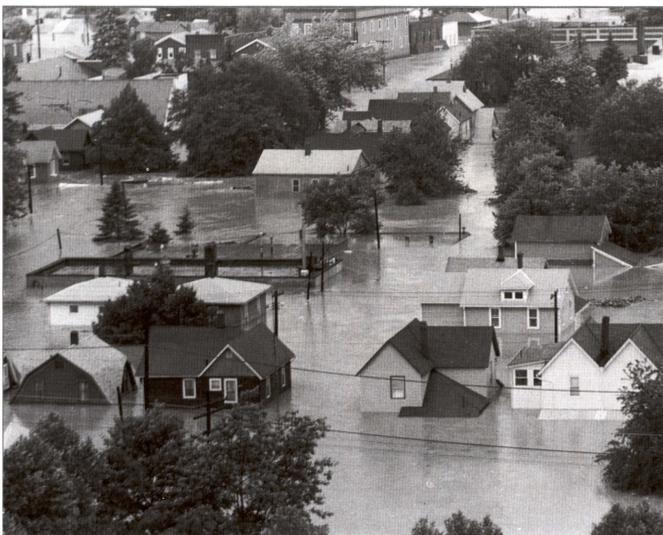
Photograph—Flooding in vicinity of Warren and East William Streets in Corning, flood of June 1972.

**The flood at Corning.**—Floods of the Chemung River at Corning are produced by three major streams that converge west-southwest of the city. The relative time of occurrence of the peak in each of these streams as well as the manmade controls of the floodflow and the vast amount of water temporarily stored on the flood plain result in a complex flood pattern at Corning. Figure 3 is a schematic illustration of the peak flows and the approximate time of occurrence of the June 1972 flood near Corning. The Tioga River contributed the greatest amount of the floodflow at Corning. The accompanying photograph illustrates the severity of the flooding in Corning.
