FLOODS IN EASTERN LAJAS VALLEY AND THE LOWER RIO LOCO BASIN, SOUTHWESTERN PUERTO RICO

This report provides a detailed hydrologic study of the eastern Lajas Valley and the lower Rio Loco basin. It includes a topographic map showing flood boundaries for the years 1928, 1959, 1961, and 1972. The map also displays drainage basins and contour lines. A scale of 1:20,000 is provided. The study area is located in the southwestern part of Puerto Rico, near the town of Lajas. The report is based on data collected from people who live in the area and from field investigations by the U.S. Geological Survey and the Puerto Rico Water Resources Authority. All elevations given are in meters above mean sea level.

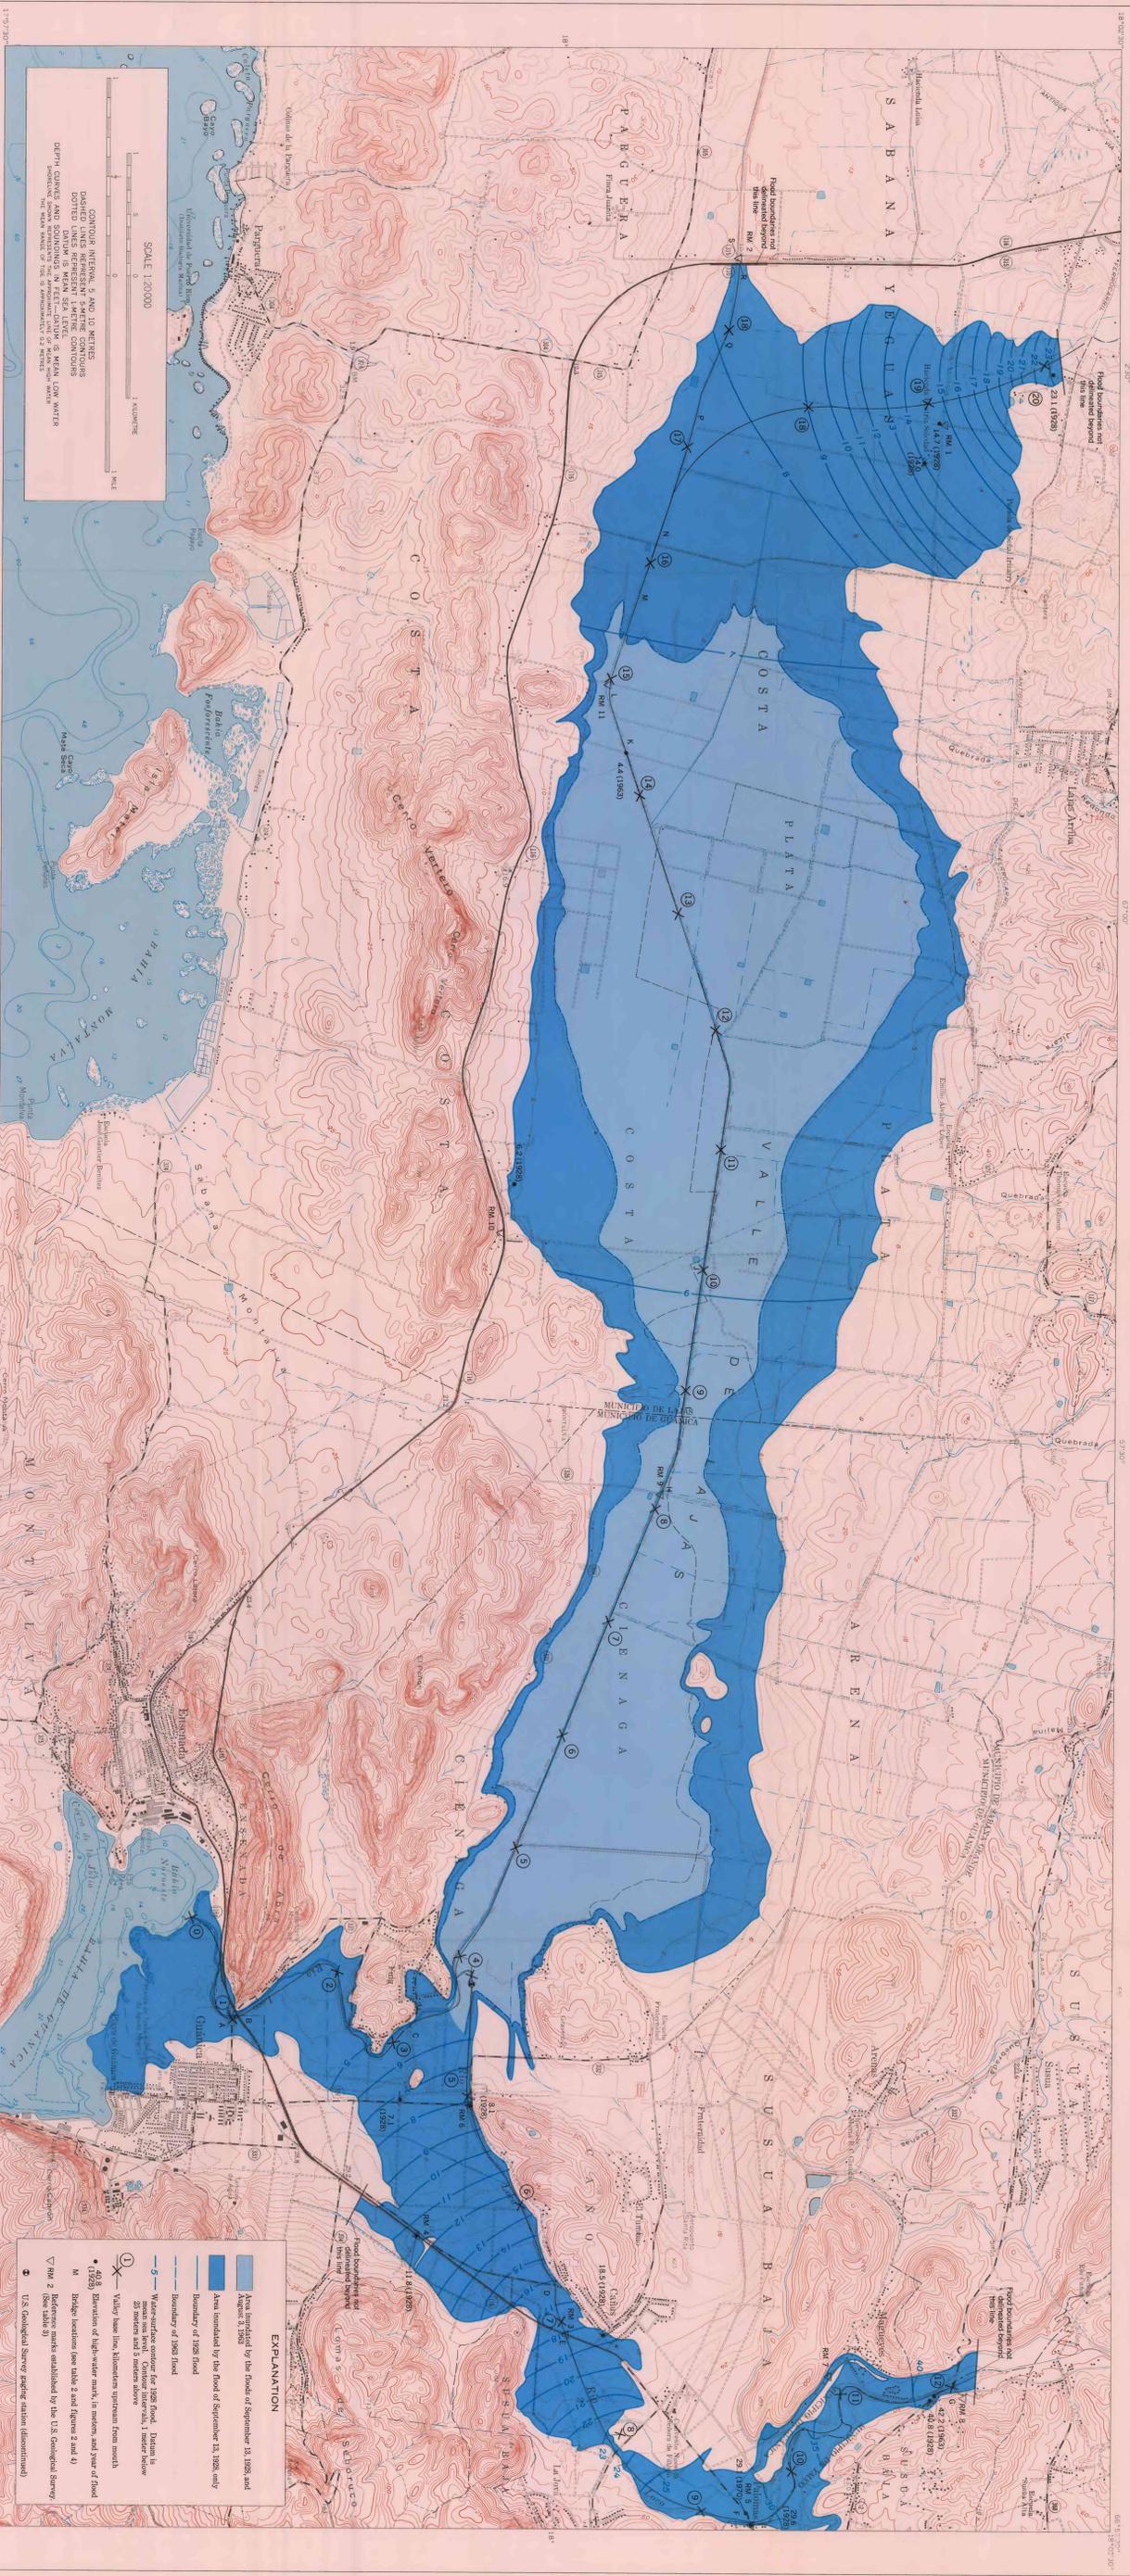
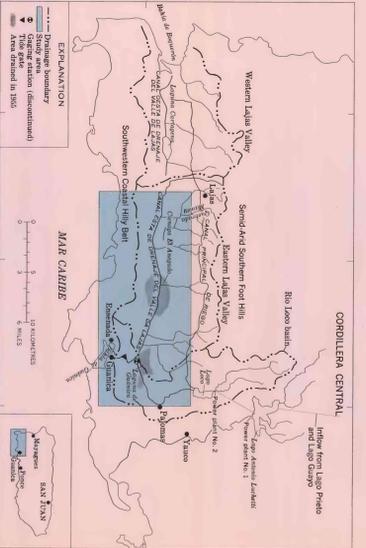
The hydrologic study was conducted in the eastern Lajas Valley, which is a sub-basin of the Rio Loco. The study area is bounded by the Rio Loco to the north and the Rio Lajas to the south. The topographic map shows the flood boundaries for the years 1928, 1959, 1961, and 1972. The map also displays drainage basins and contour lines. A scale of 1:20,000 is provided. The study area is located in the southwestern part of Puerto Rico, near the town of Lajas. The report is based on data collected from people who live in the area and from field investigations by the U.S. Geological Survey and the Puerto Rico Water Resources Authority. All elevations given are in meters above mean sea level.

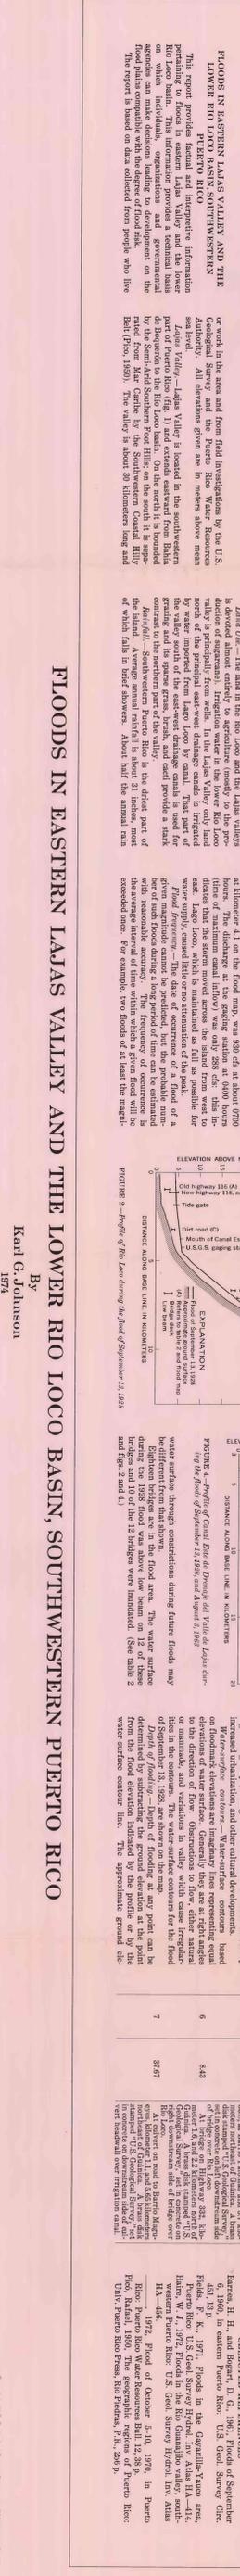
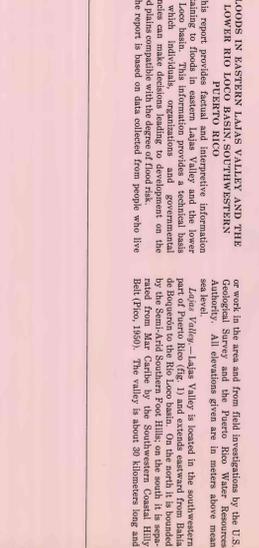
This report provides a detailed hydrologic study of the eastern Lajas Valley and the lower Rio Loco basin. It includes a topographic map showing flood boundaries for the years 1928, 1959, 1961, and 1972. The map also displays drainage basins and contour lines. A scale of 1:20,000 is provided. The study area is located in the southwestern part of Puerto Rico, near the town of Lajas. The report is based on data collected from people who live in the area and from field investigations by the U.S. Geological Survey and the Puerto Rico Water Resources Authority. All elevations given are in meters above mean sea level.

The hydrologic study was conducted in the eastern Lajas Valley, which is a sub-basin of the Rio Loco. The study area is bounded by the Rio Loco to the north and the Rio Lajas to the south. The topographic map shows the flood boundaries for the years 1928, 1959, 1961, and 1972. The map also displays drainage basins and contour lines. A scale of 1:20,000 is provided. The study area is located in the southwestern part of Puerto Rico, near the town of Lajas. The report is based on data collected from people who live in the area and from field investigations by the U.S. Geological Survey and the Puerto Rico Water Resources Authority. All elevations given are in meters above mean sea level.
