**FLOOD ON BUFFALO CREEK FROM SAUNDERS TO MAN,
WEST VIRGINIA**

By
G. S. Runner
1974

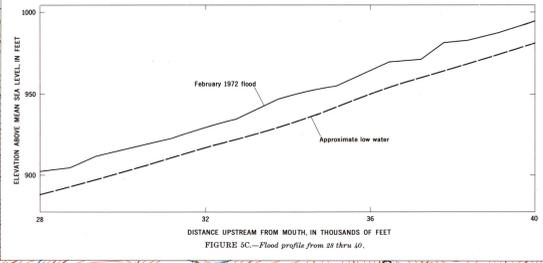
FIGURE 5C.—Flood profile from 28 thru 40.

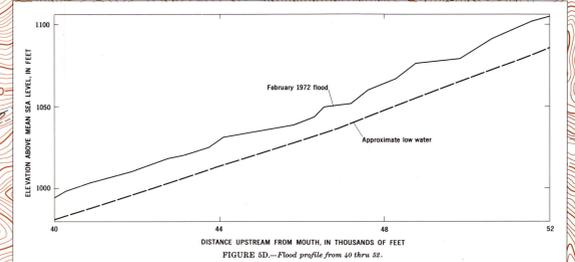
FIGURE 5D.—Flood profile from 40 thru 52.

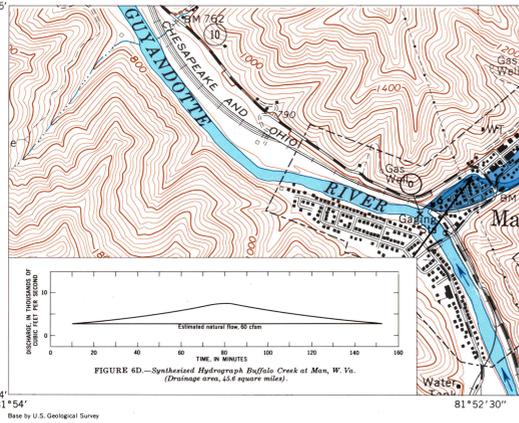
FIGURE 6D.—Synthesized Hydrograph Buffalo Creek at Man, W. Va. (Drainage area, 14.6 square miles).

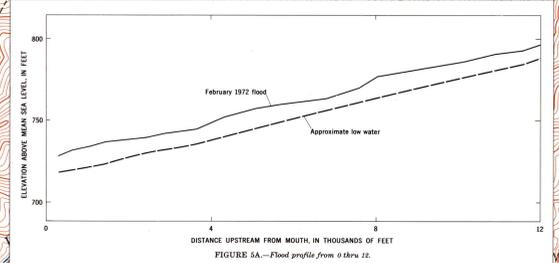
FIGURE 5A.—Flood profile from 0 thru 12.
