TETON DAM FLOOD, SOUTHEASTERN IDAHO, JUNE 1976

The failure of the Teton Dam caused extreme flooding along the Teton River, Henrys Fork, and Snake River in southeastern Idaho on June 5-8, 1976. No flooding occurred downstream from American Falls Reservoir.

TETON DAM FLOOD OF JUNE 1976, PARKER QUADRANGLE, IDAHO
By Cecil A. Thomas and Herman A. Ray

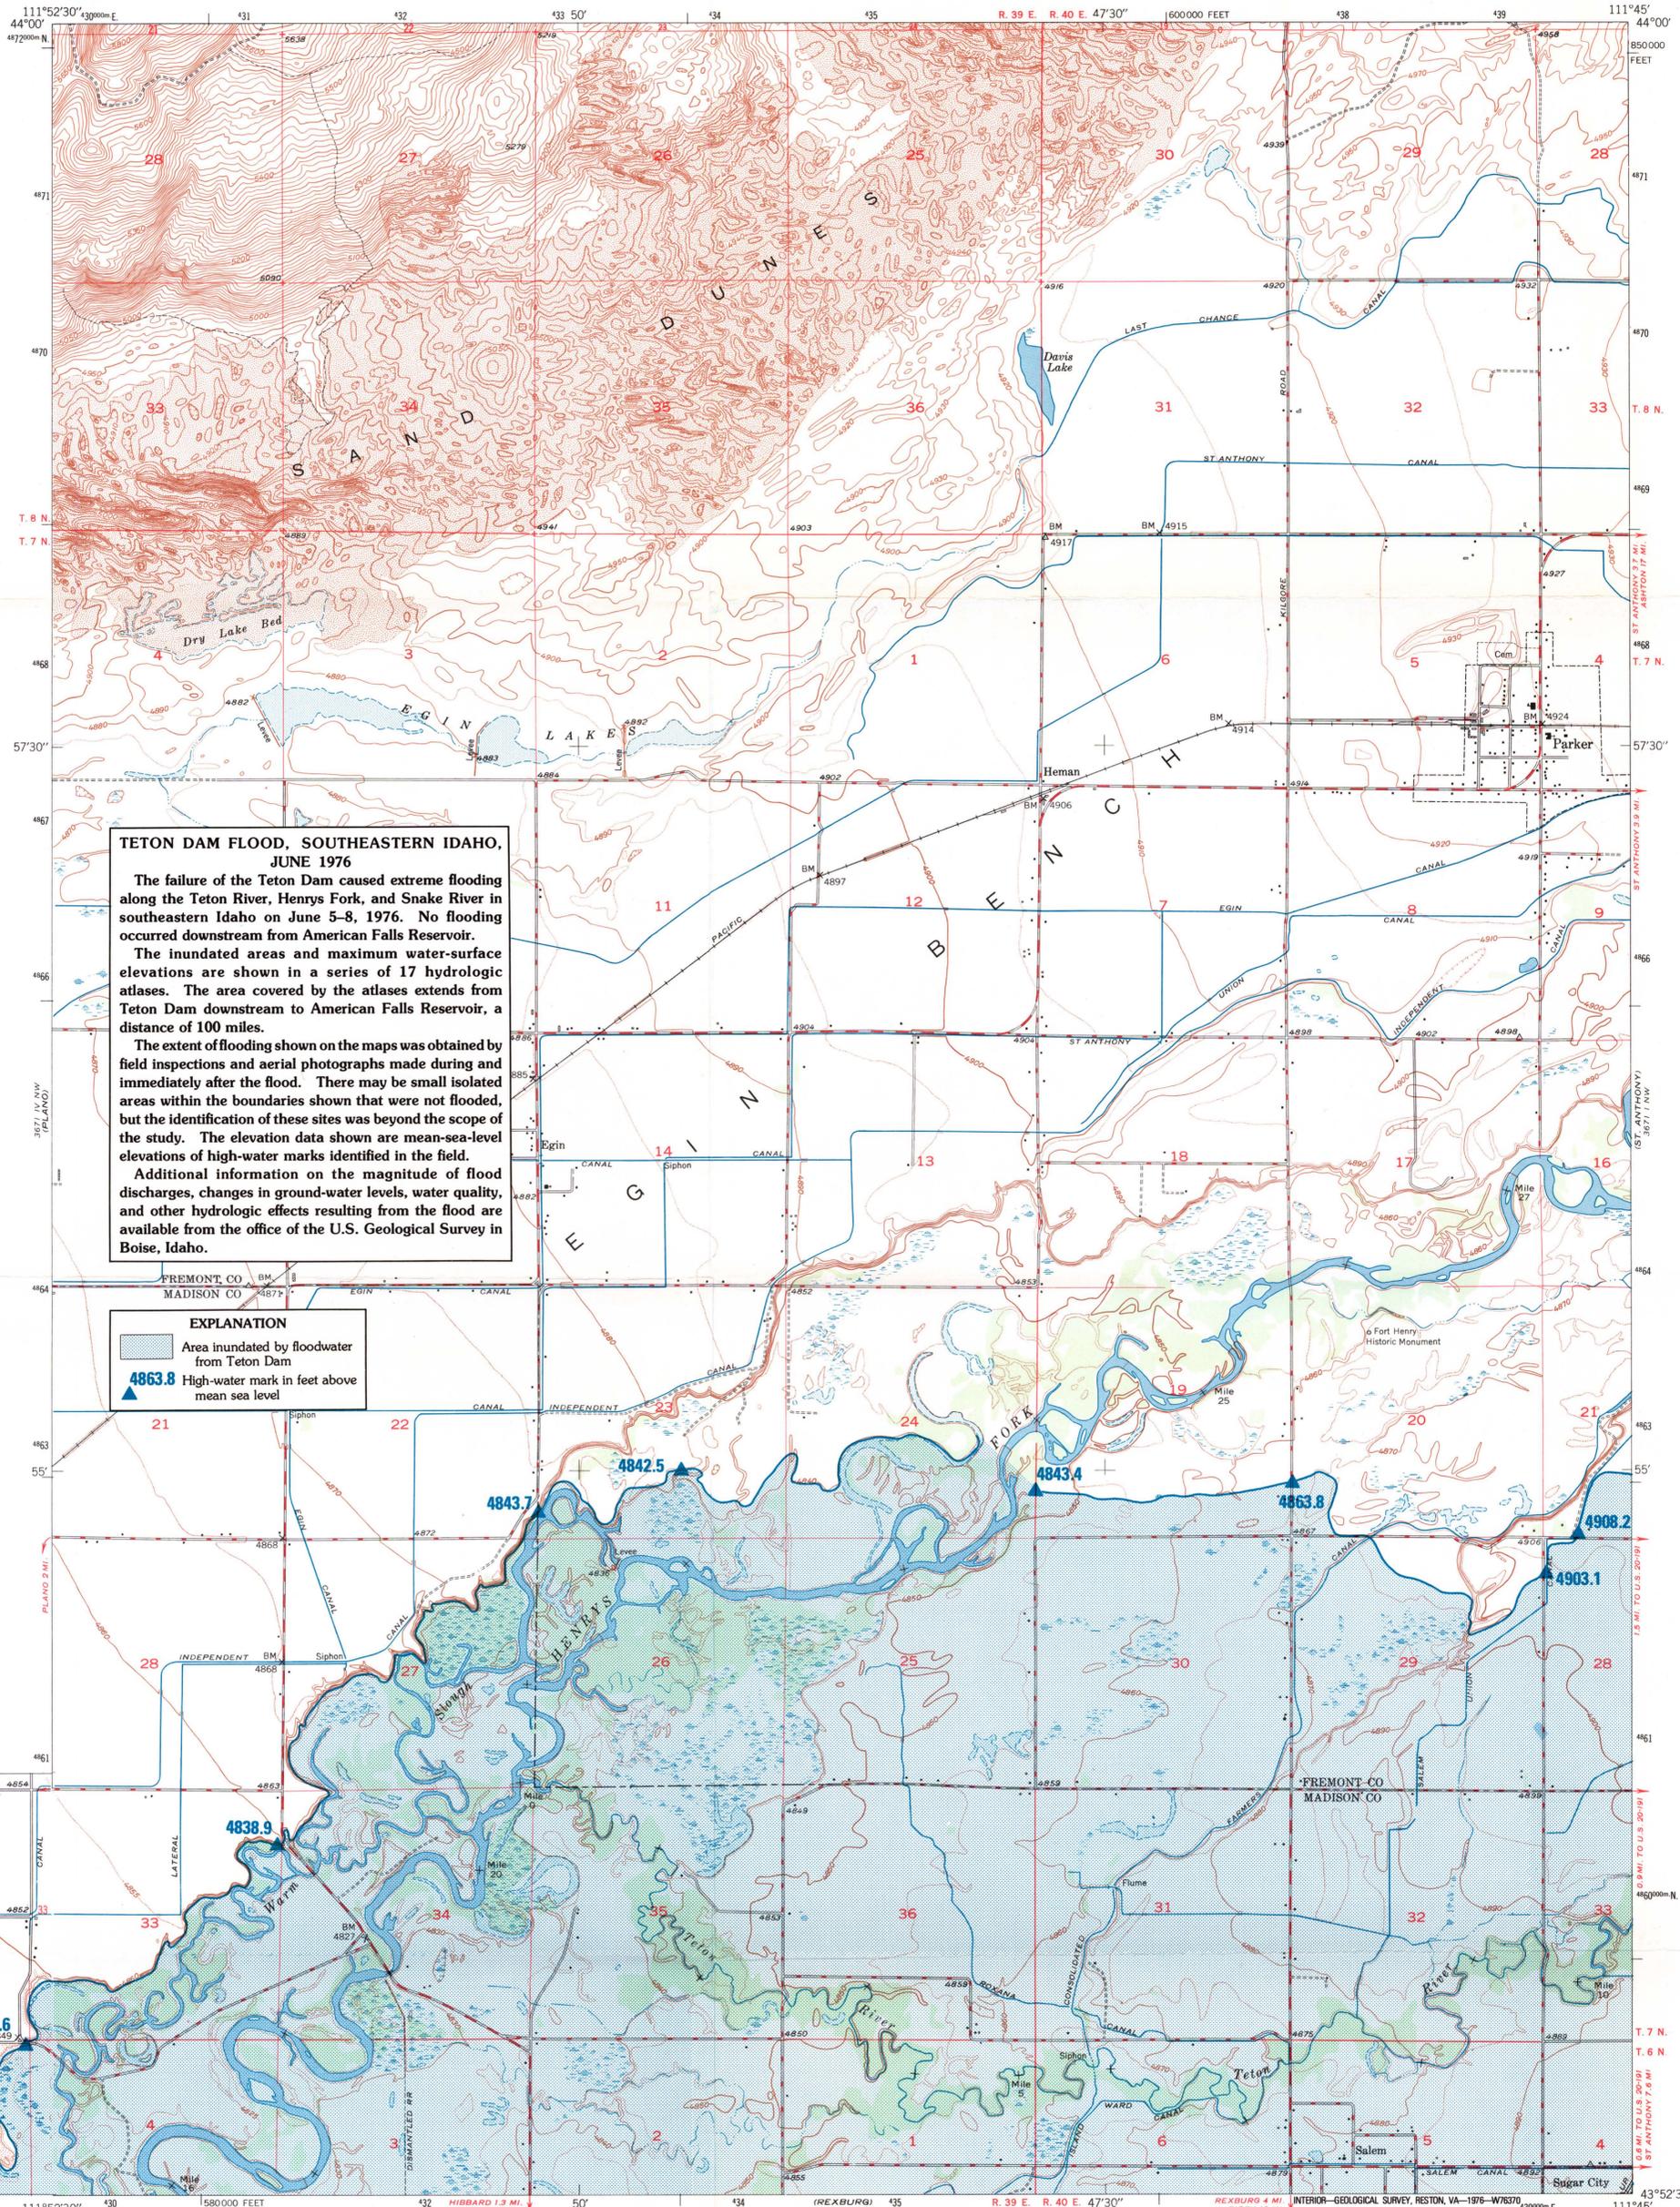
The inundated areas and maximum water-surface elevations are shown in a series of 17 hydrologic atlases. The area covered by the atlases extends from Teton Dam downstream to American Falls Reservoir, a distance of 100 miles.

The extent of flooding shown on the maps was obtained by field inspections and aerial photographs made during and immediately after the flood. There may be small isolated areas within the boundaries shown that were not flooded, but the identification of these sites was beyond the scope of the study. The elevation data shown are mean-sea-level elevations of high-water marks identified in the field.

Area inundated by floodwater from Teton Dam

▲ 4863.8 High-water mark in feet above mean sea level
