**TETON DAM FLOOD, SOUTHEASTERN IDAHO, JUNE 1976**

**TETON DAM FLOOD OF JUNE 1976, REXBURG QUADRANGLE, IDAHO**

By William A. Harenberg and Bruce B. Bigelow

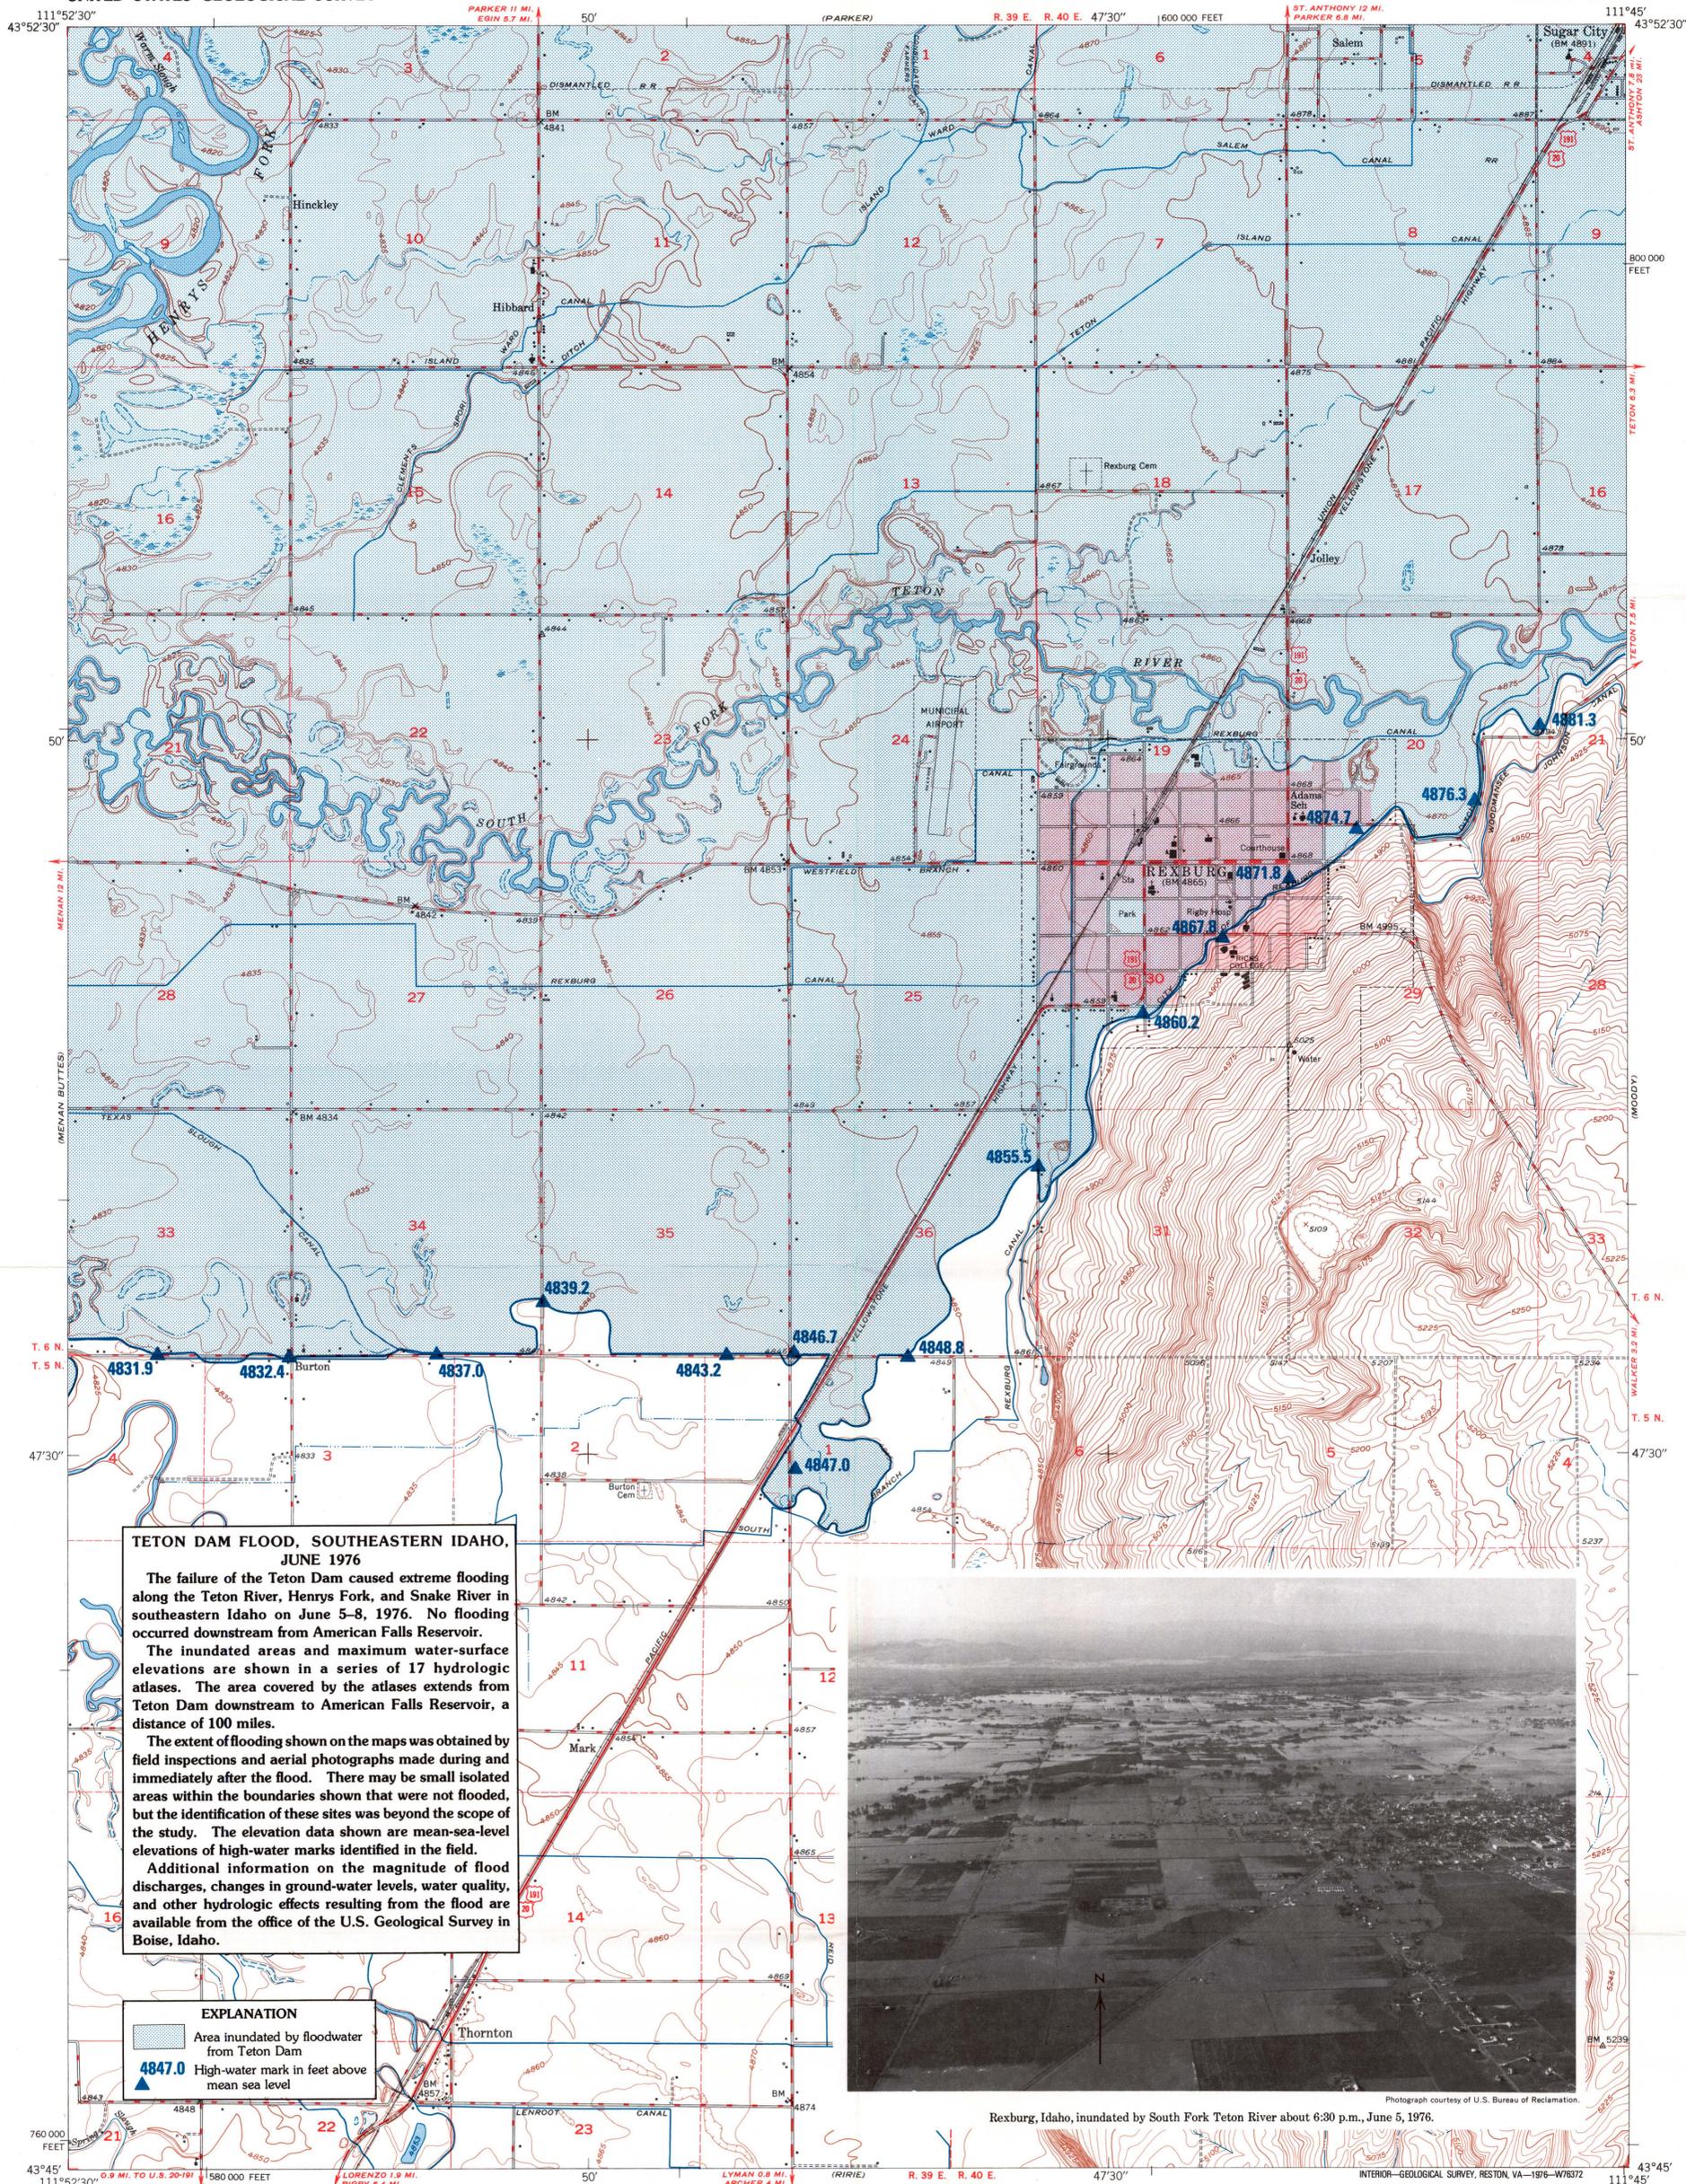
The inundated areas and maximum water-surface elevations are shown in a series of 17 hydrologic atlases. The area covered by the atlases extends from Teton Dam downstream to American Falls Reservoir, a distance of 100 miles.

The extent of flooding shown on the maps was obtained by field inspections and aerial photographs made during and immediately after the flood. There may be small isolated areas within the boundaries shown that were not flooded, but the identification of these sites was beyond the scope of the study. The elevation data shown are mean-sea-level elevations of high-water marks identified in the field.

- Area inundated by floodwater from Teton Dam
- 4847.0 High-water mark in feet above mean sea level
