TETON DAM FLOOD, SOUTHEASTERN IDAHO, JUNE 1976

TETON DAM FLOOD OF JUNE 1976, DEER PARKS QUADRANGLE, IDAHO
By Herman A. Ray, C. Michael Bennett, and Andrew W. Records

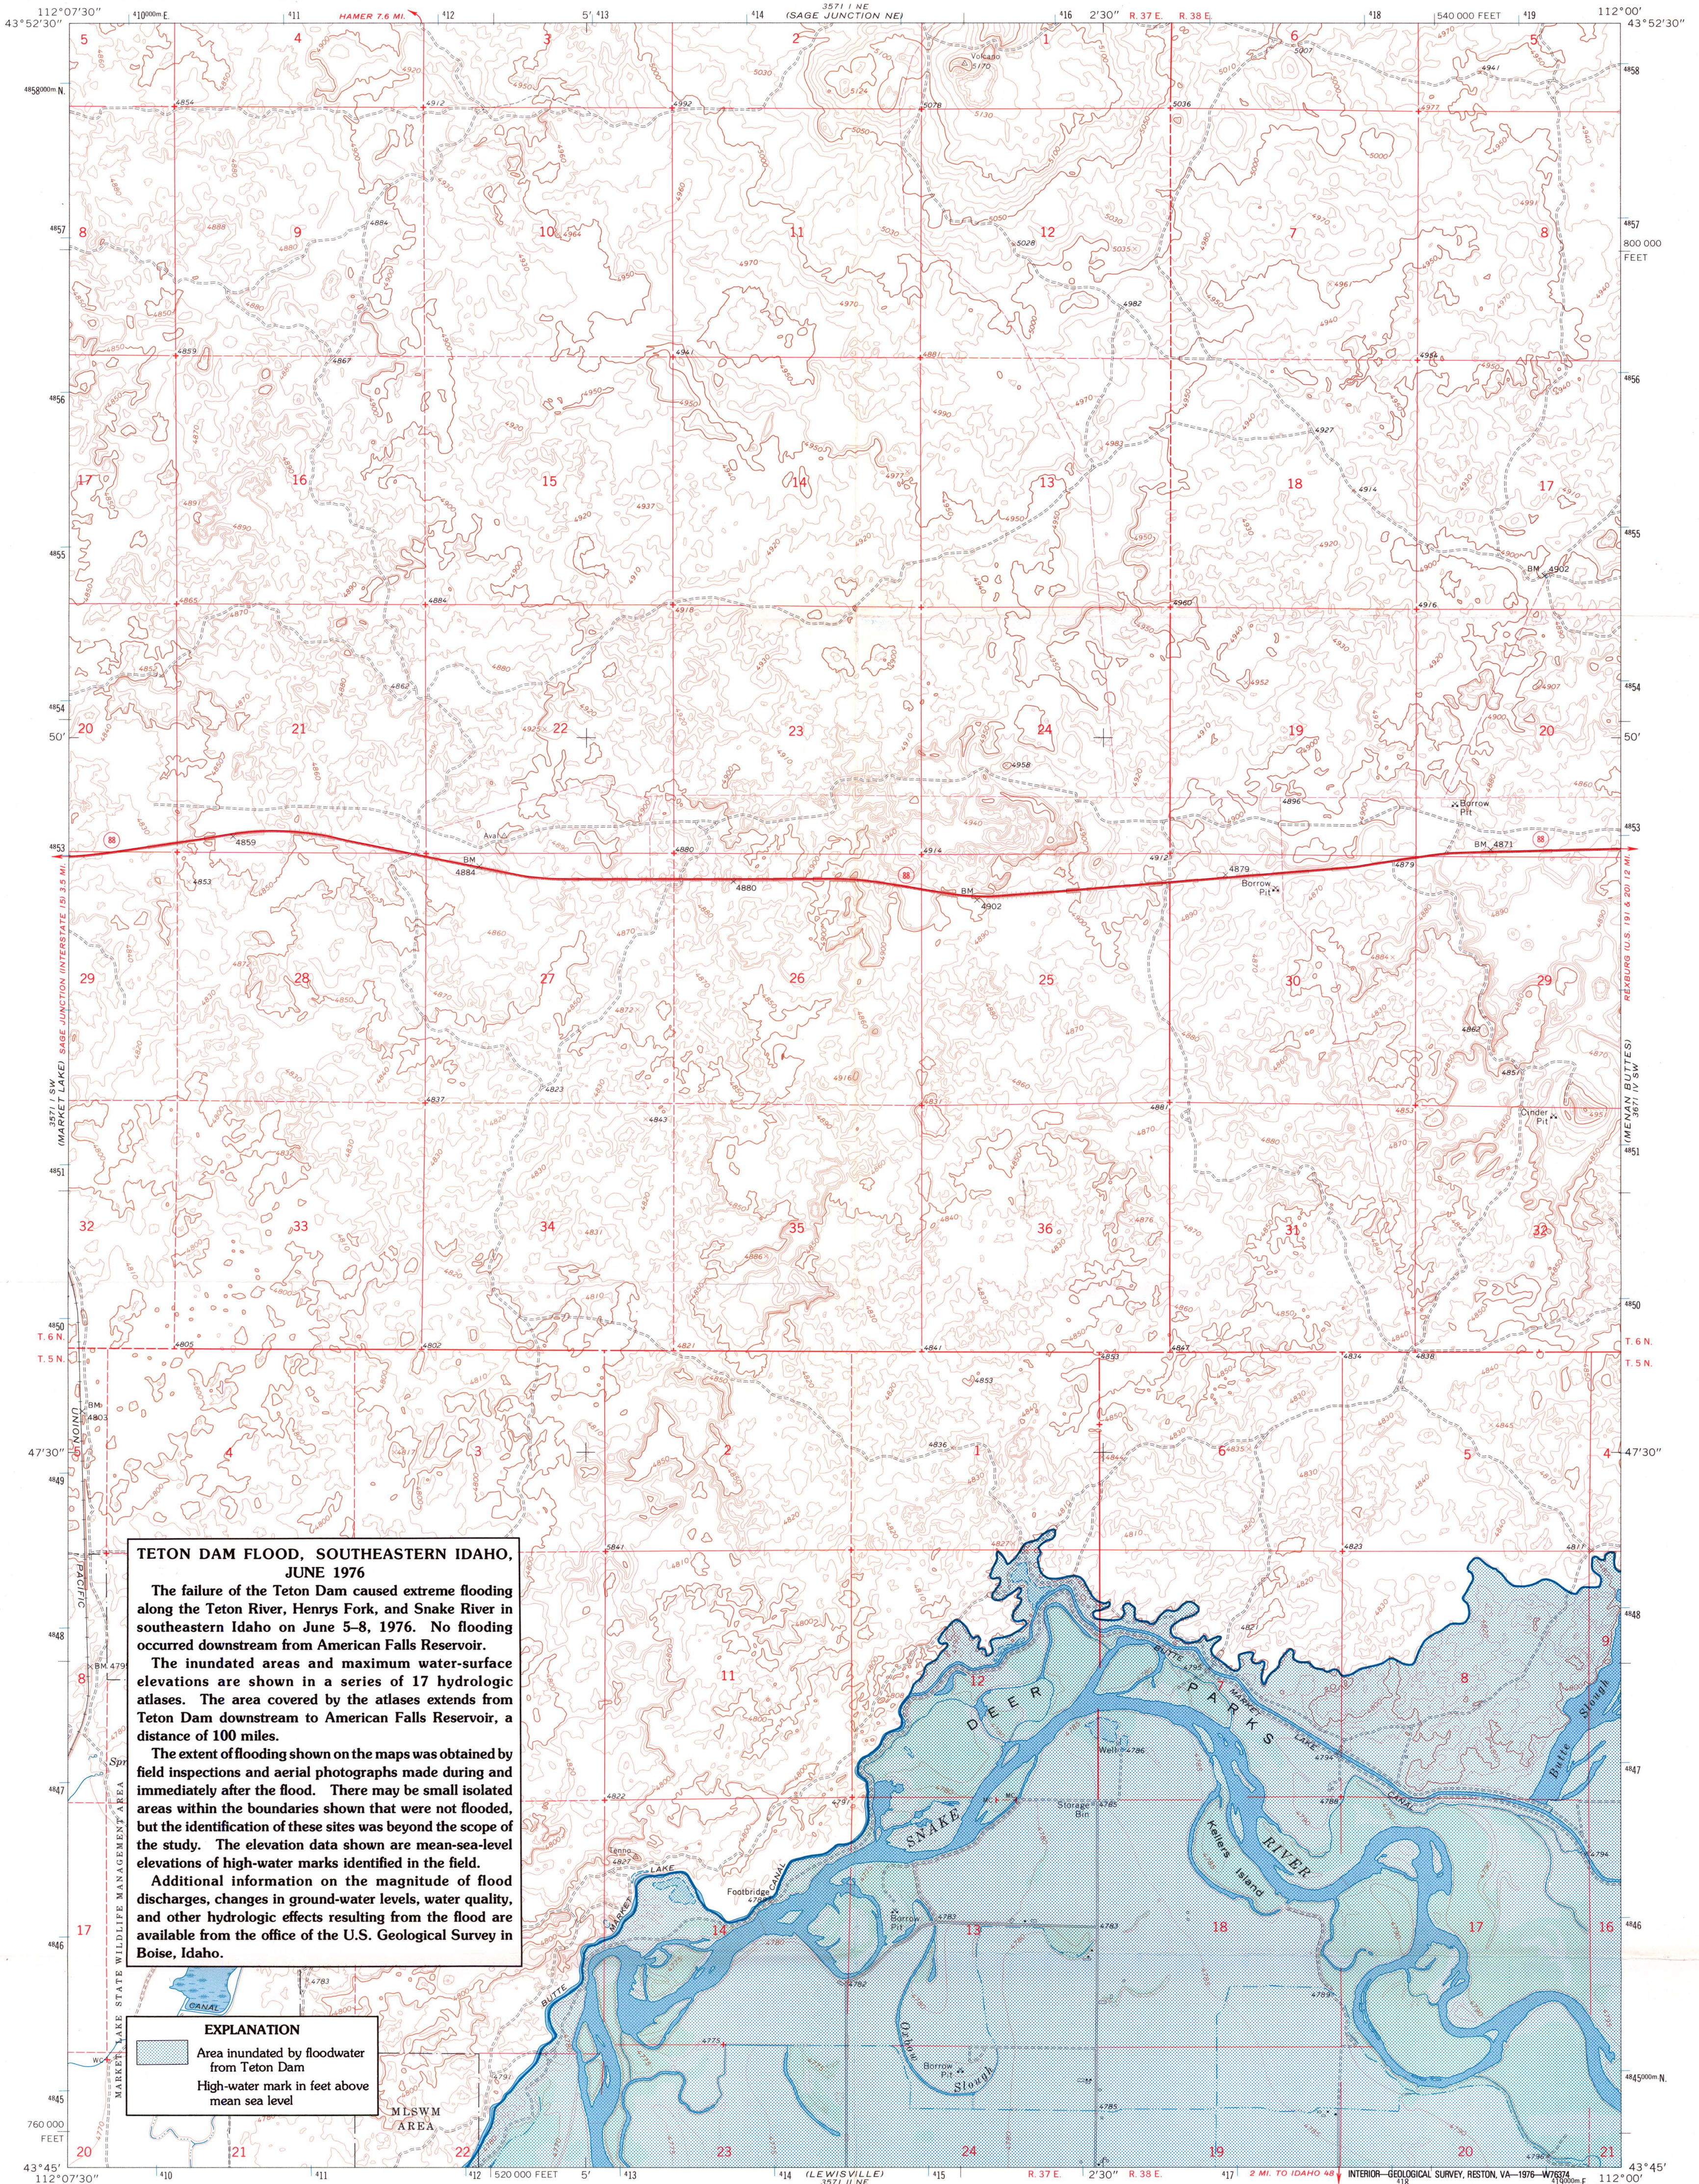
The inundated areas and maximum water-surface elevations are shown in a series of 17 hydrologic atlases. The area covered by the atlases extends from Teton Dam downstream to American Falls Reservoir, a distance of 100 miles.

The extent of flooding shown on the maps was obtained by field inspections and aerial photographs made during and immediately after the flood. There may be small isolated areas within the boundaries shown that were not flooded, but the identification of these sites was beyond the scope of the study. The elevation data shown are mean-sea-level elevations of high-water marks identified in the field.
