TETON DAM FLOOD, SOUTHEASTERN IDAHO, JUNE 1976

TETON DAM FLOOD OF JUNE 1976, IDAHO FALLS SOUTH QUADRANGLE, IDAHO

By Herman A. Ray and Howard F. Matthai

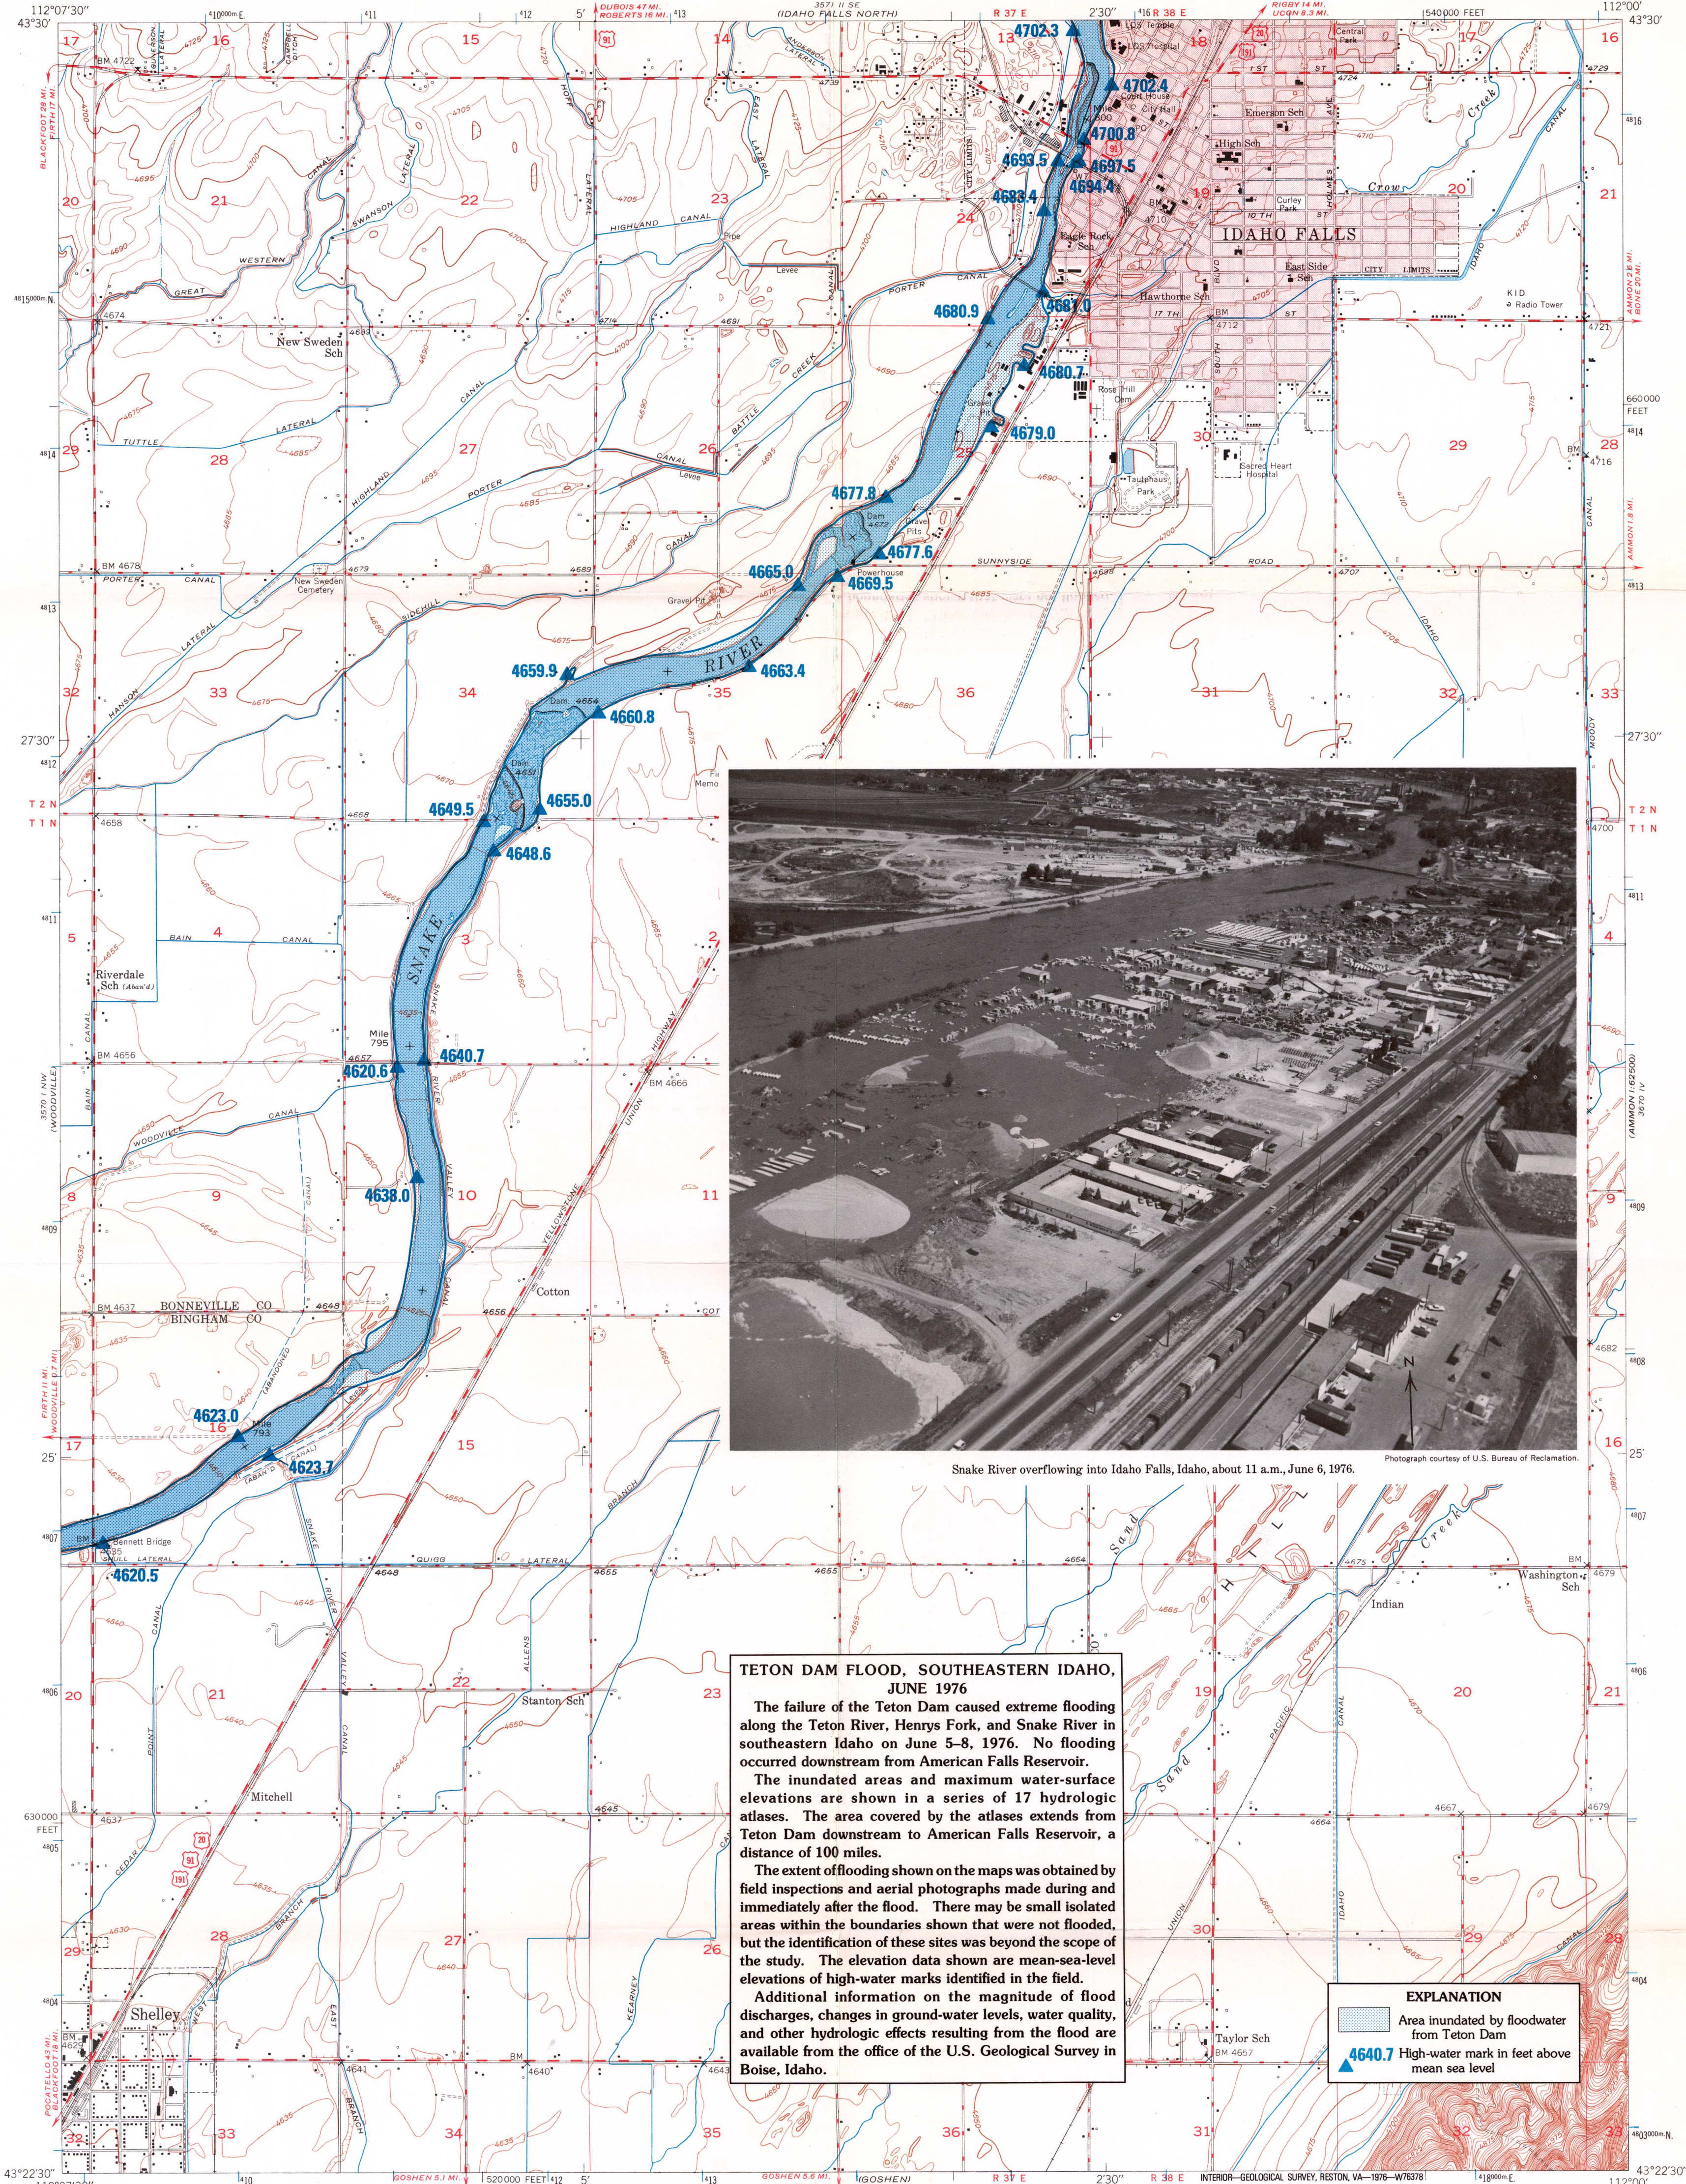
The failure of the Teton Dam caused extreme flooding along the Teton River, Henrys Fork, and Snake River in southeastern Idaho on June 5-8, 1976. No flooding occurred downstream from American Falls Reservoir.

The inundated areas and maximum water-surface elevations are shown in a series of 17 hydrologic atlases. The area covered by the atlases extends from Teton Dam downstream to American Falls Reservoir, a distance of 100 miles.

The extent of flooding shown on the maps was obtained by field inspections and aerial photographs made during and immediately after the flood. There may be small isolated areas within the boundaries shown that were not flooded, but the identification of these sites was beyond the scope of the study. The elevation data shown are mean-sea-level elevations of high-water marks identified in the field.

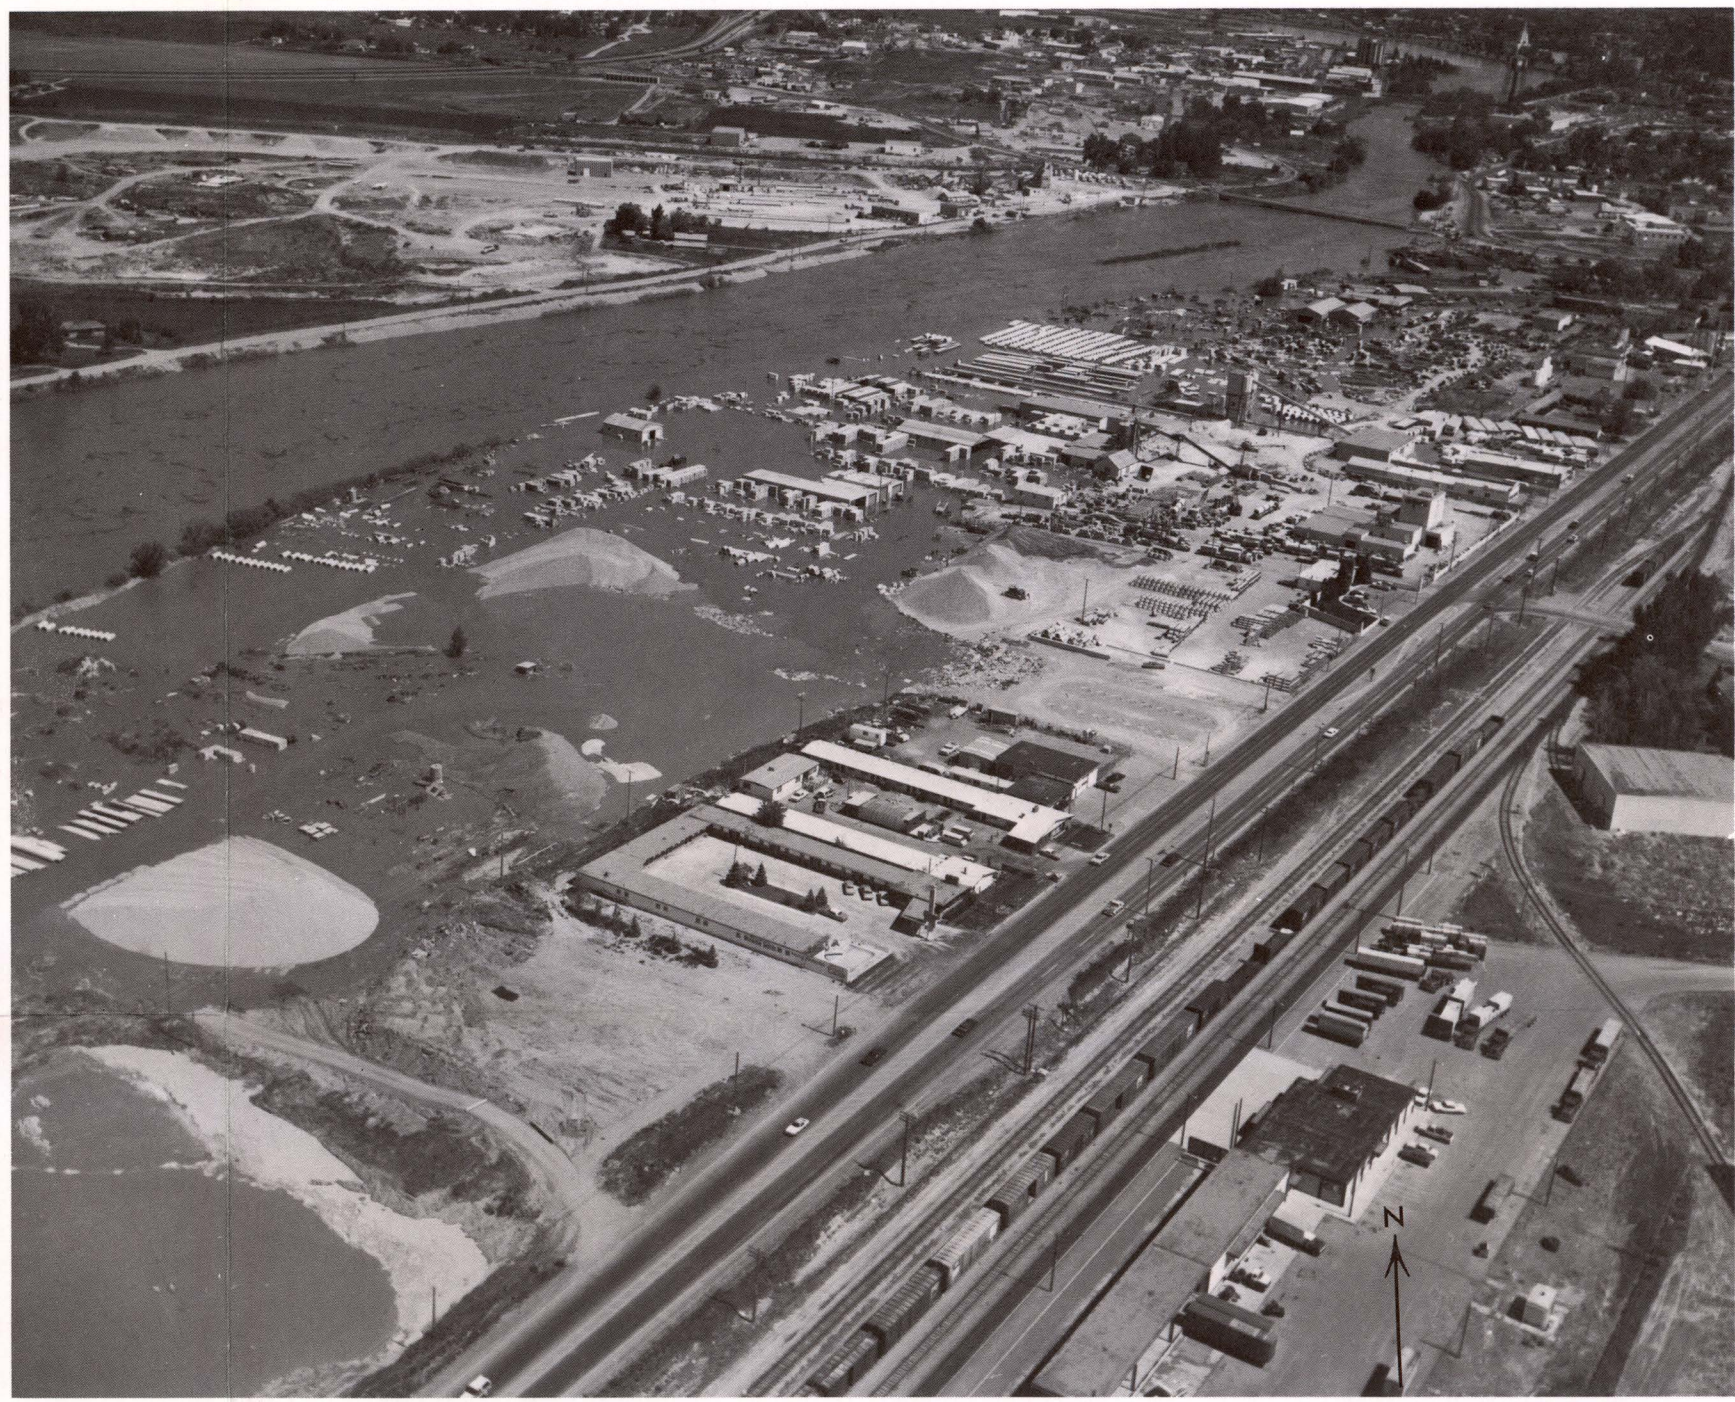
Snake River overflowing into Idaho Falls, Idaho, about 11 a.m., June 6, 1976. Photograph courtesy of U.S. Bureau of Reclamation.
