**TETON DAM FLOOD, SOUTHEASTERN IDAHO, JUNE 1976**

**TETON DAM FLOOD OF JUNE 1976, PINGREE QUADRANGLE, IDAHO**

By Larry L. Hubbard and John H. Bartells

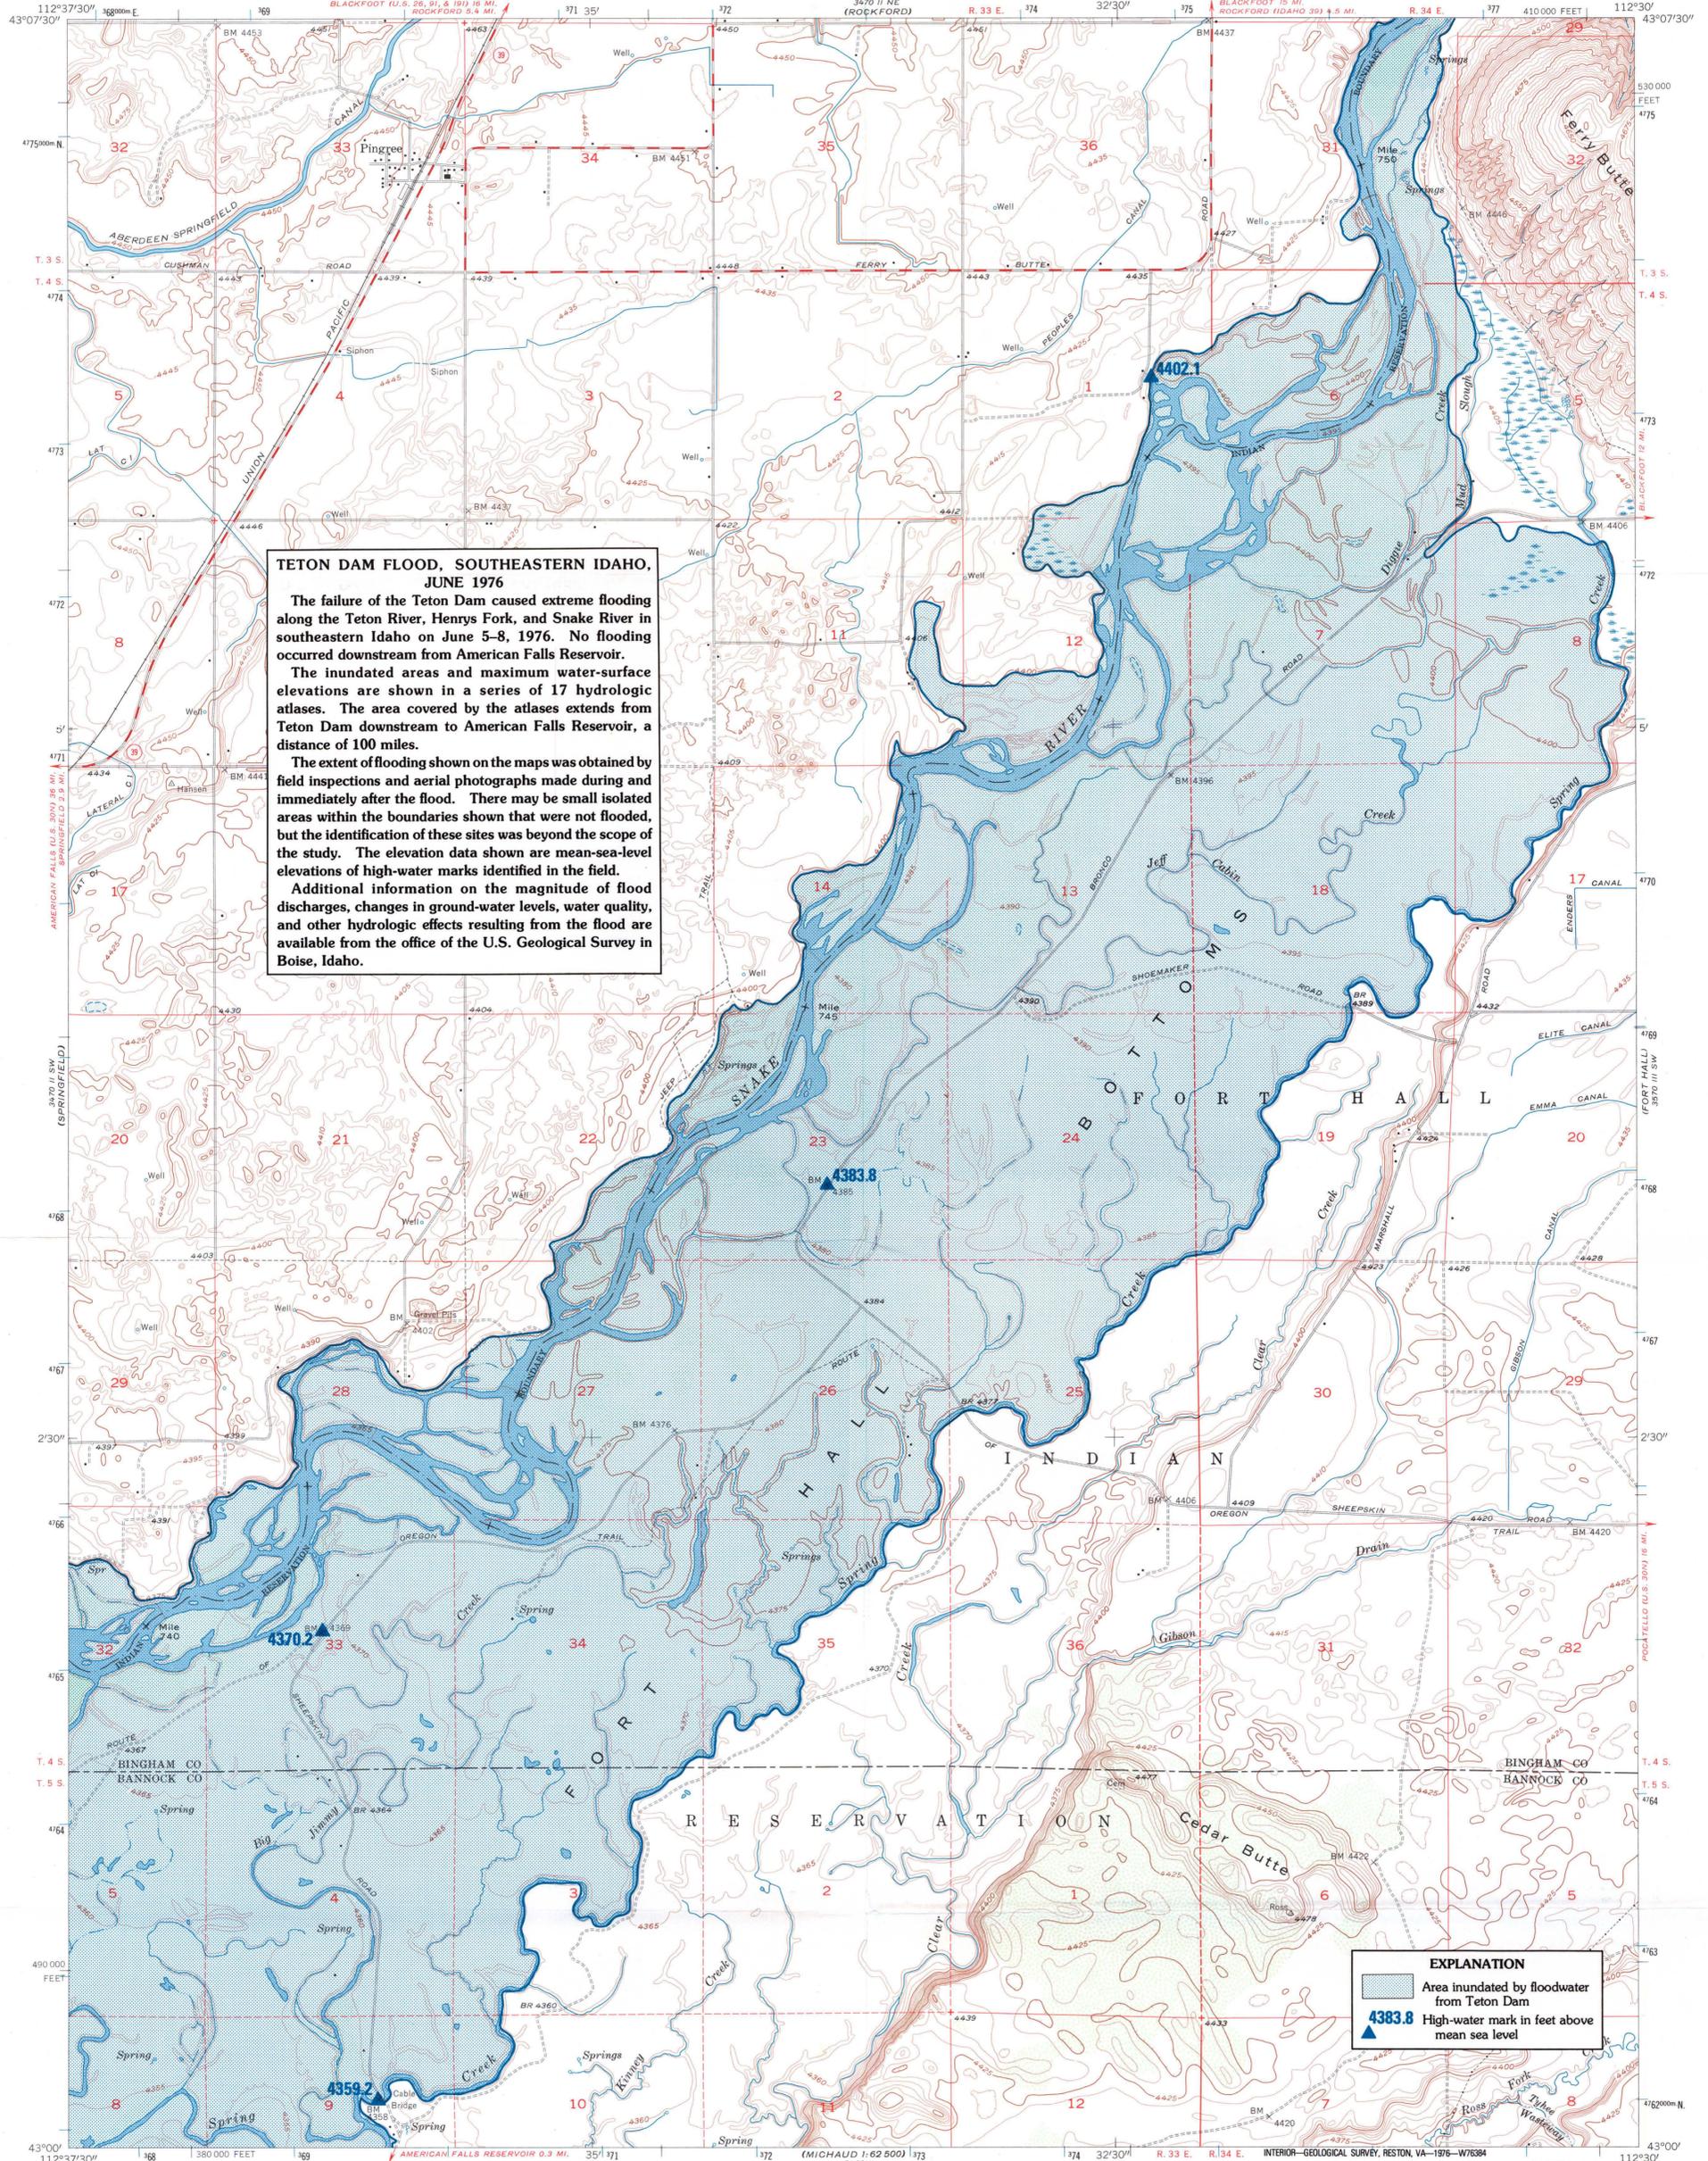
The failure of the Teton Dam caused extreme flooding along the Teton River, Henrys Fork, and Snake River in southeastern Idaho on June 5-8, 1976. No flooding occurred downstream from American Falls Reservoir.

The inundated areas and maximum water-surface elevations are shown in a series of 17 hydrologic atlases. The area covered by the atlases extends from Teton Dam downstream to American Falls Reservoir, a distance of 100 miles.

The extent of flooding shown on the maps was obtained by field inspections and aerial photographs made during and immediately after the flood. There may be small isolated areas within the boundaries shown that were not flooded, but the identification of these sites was beyond the scope of the study. The elevation data shown are mean-sea-level elevations of high-water marks identified in the field.
