**FLOOD OF JULY 1-5, 1978 ON THE KICKAPOO RIVER,  
SOUTHWESTERN WISCONSIN**

BY  
P. E. HUGHES, J. S. HANNUKSELA, AND W. J. DANCHUK  
1981

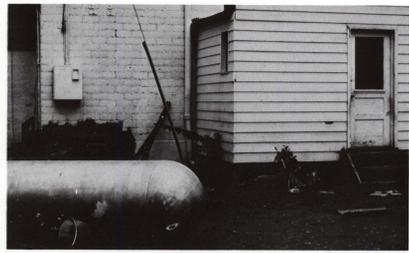
SOLDIERS GROVE—Flood debris

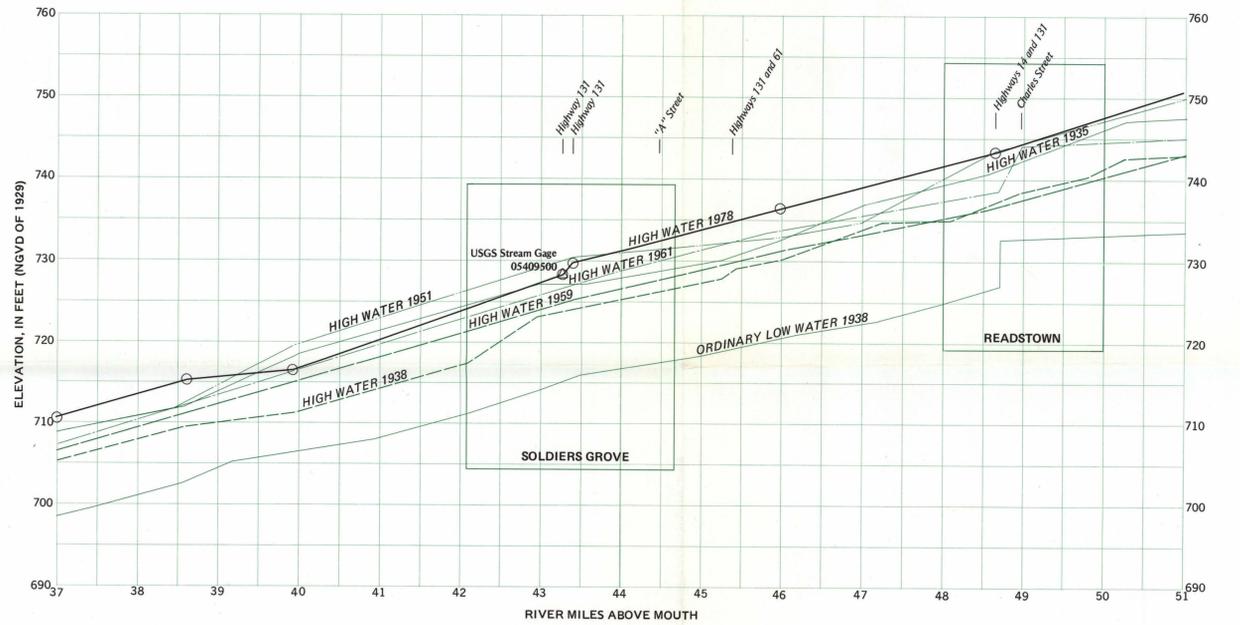
UNRECTIFIED AERIAL PHOTOS  
TAKEN JULY 5, 1978  
SCALE APPROXIMATELY  
1:18,000 (1" = 1500')  
FLOOD DELINEATIONS BASED ON  
FIELD SURVEY AND  
LARGE SCALE TOPOGRAPHIC MAPS

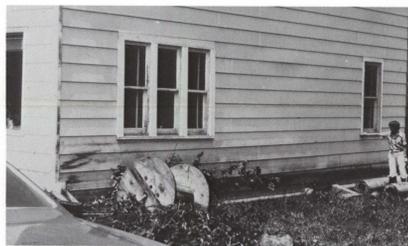
SOLDIERS GROVE—Depth of floodwater on building

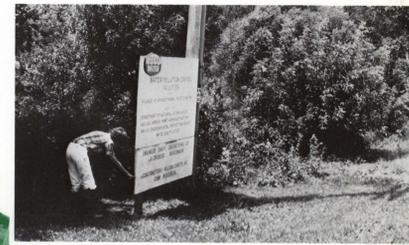
READSTOWN—Depth of floodwater at sewage treatment plant sign

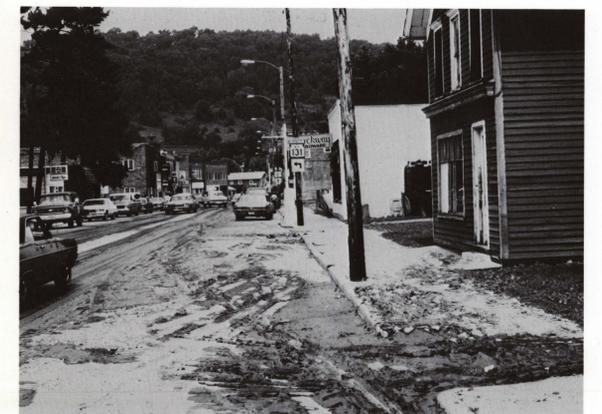
SOLDIERS GROVE—Wis Highway 131 looking northwest

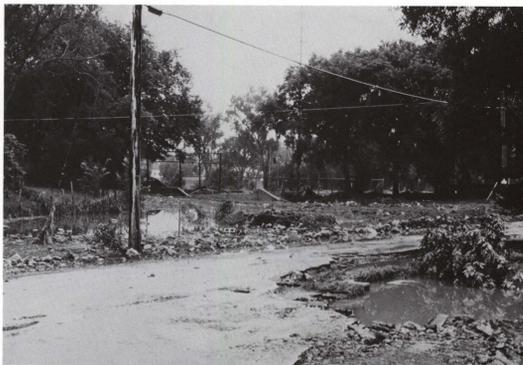
SOLDIERS GROVE—Right bank area of overflow from levee breach

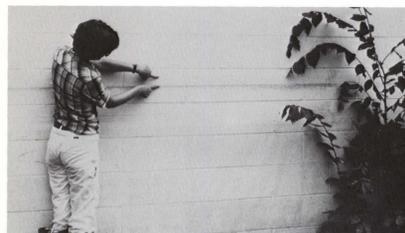
SOLDIERS GROVE—Depth of floodwater on rear of Farmers' Cooperative building
