STRIP MAPS SHOWING AREAS FLOODED ALONG DRY CREEK

**FLOOD OF AUGUST 1, 1985, IN CHEYENNE, WYOMING**  
 By  
 Stanley A. Druze, M. E. Cooley, Sharon L. Green, and H. W. Lowham  
 1986

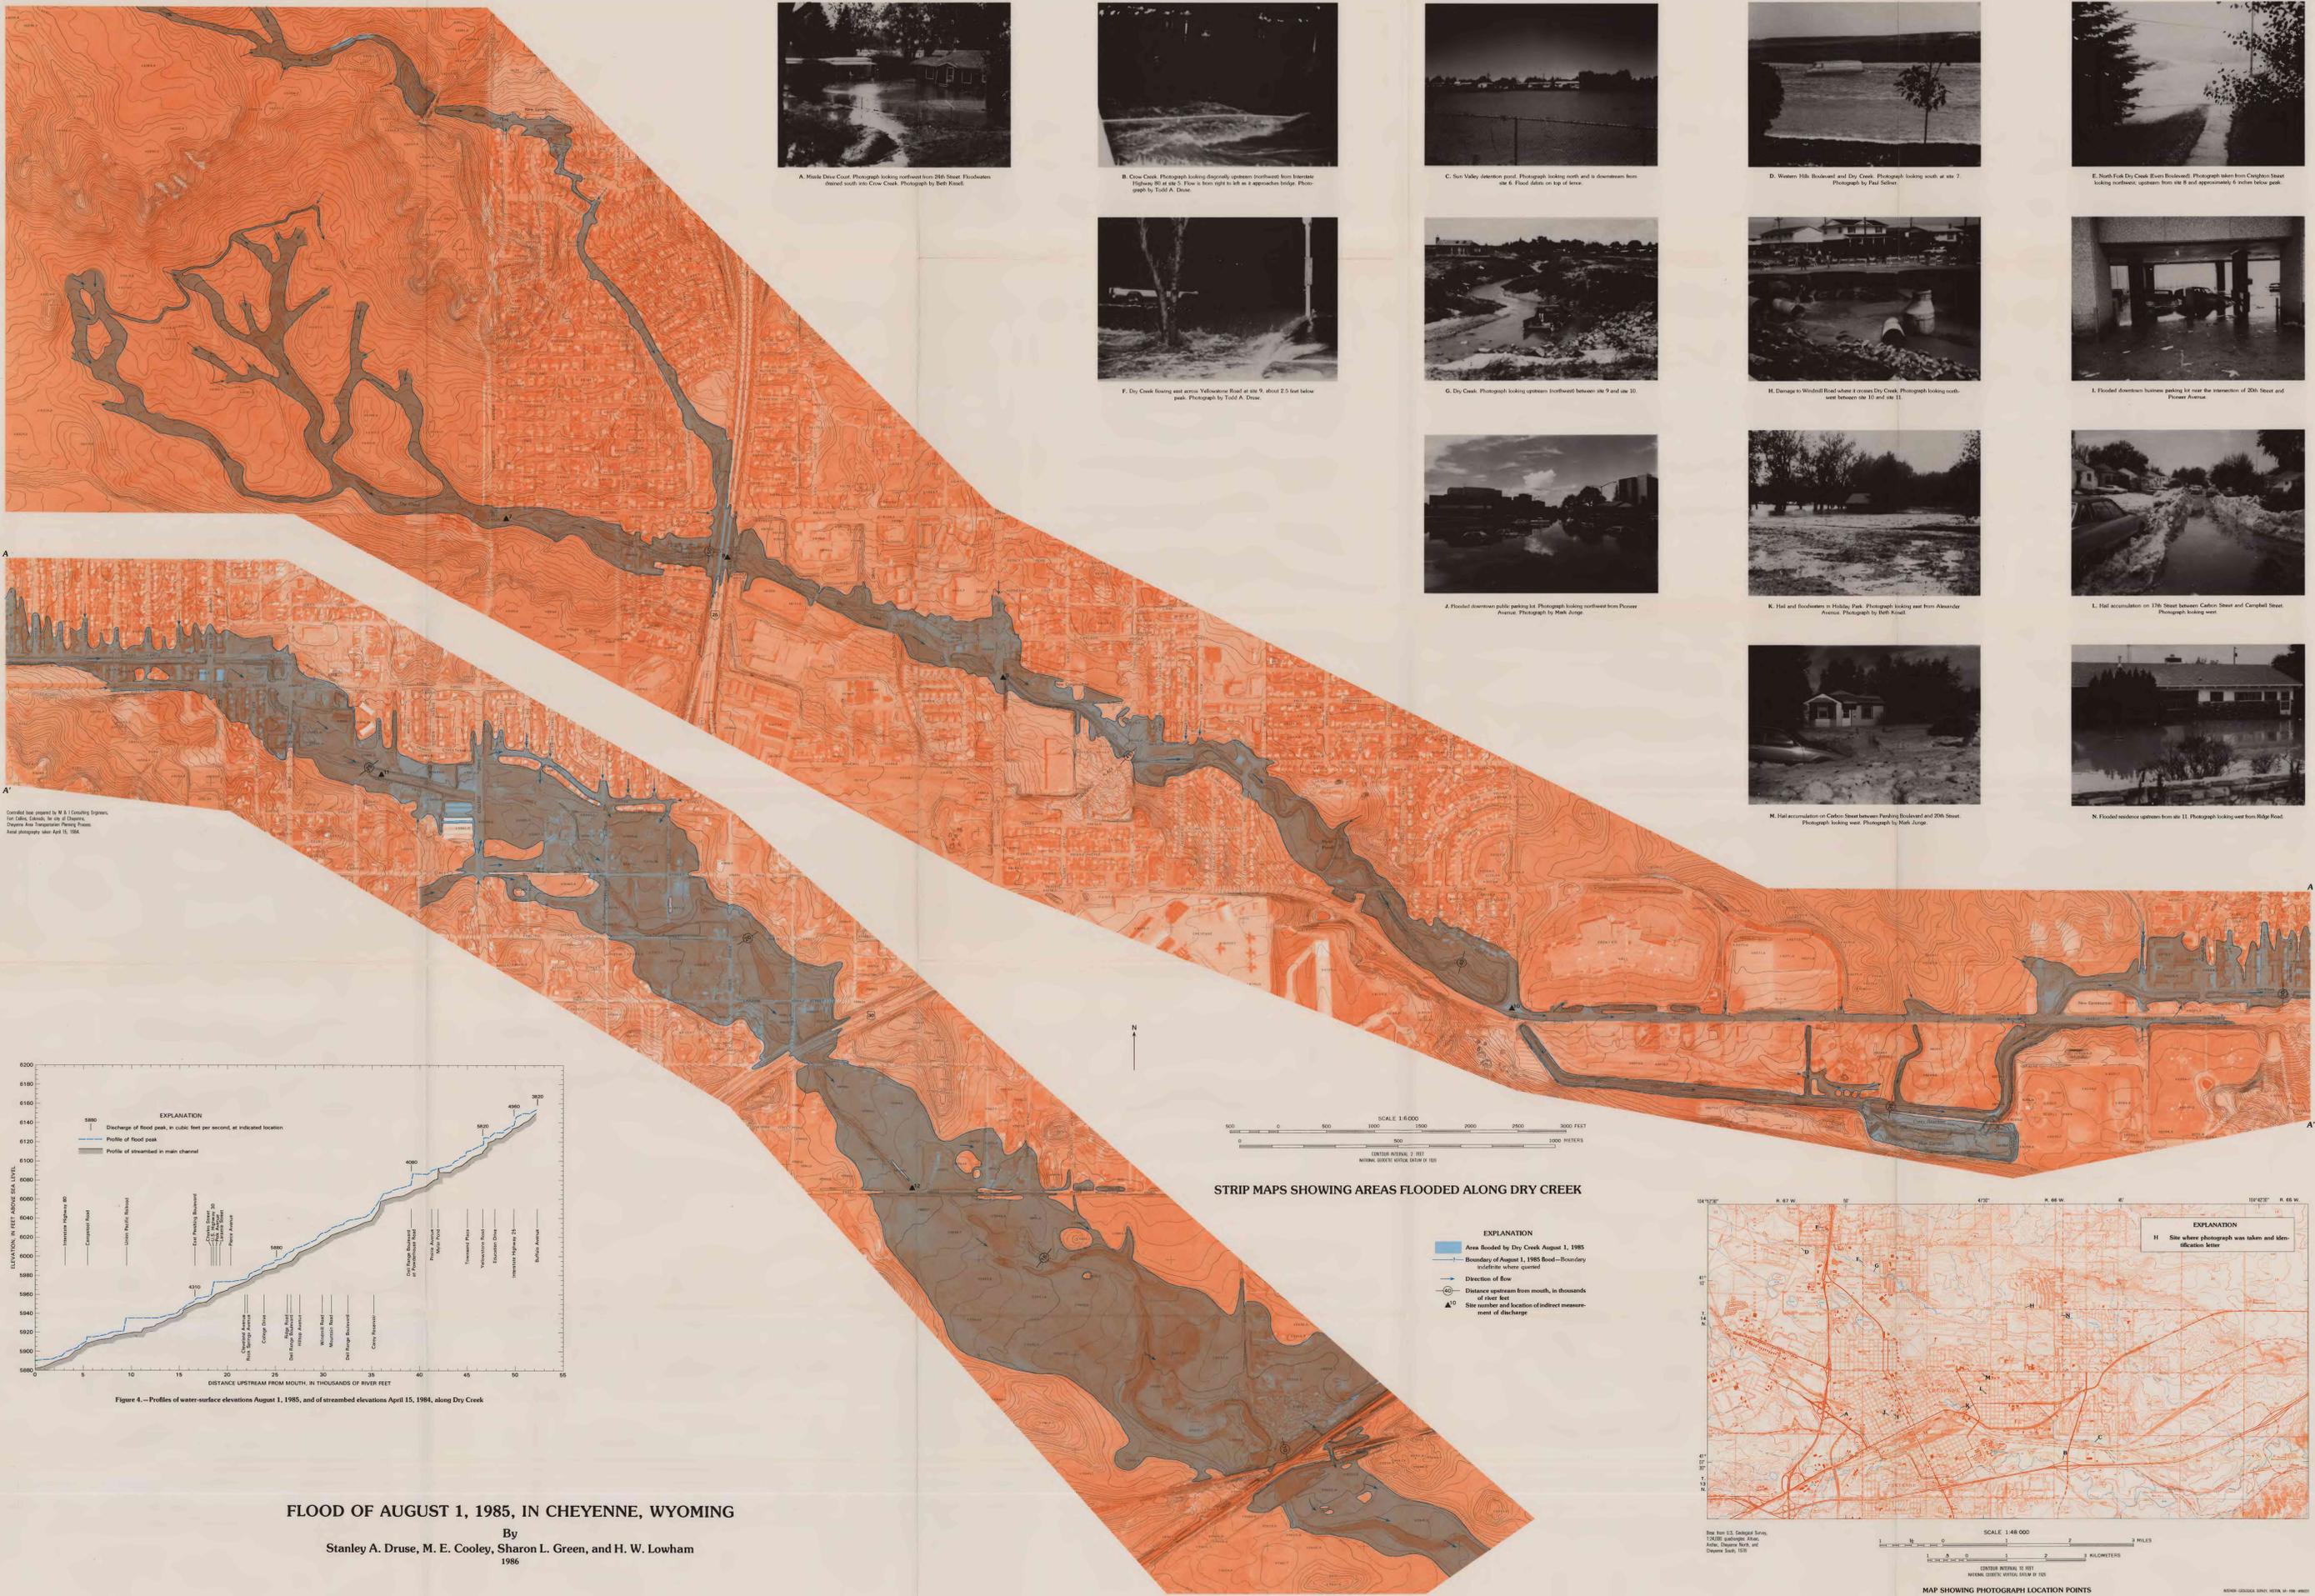
A. Mink Ditch Court. Photograph looking northeast from 26th Street. Floodwaters covered south side of Dry Creek. Photograph by Beth Reed.

B. Dry Creek. Photograph looking downstream from Interstate Highway 80 at site 9. Flow is from right to left as it approaches bridge. Photograph by Todd A. Duse.

C. Sun Valley detention pond. Photograph looking north and is downstream from site 6. Flood debris on top of fence.

D. Western 18th Boulevard and Dry Creek. Photograph looking south at site 7. Photograph by Paul Seiber.

E. North Fork Dry Creek (East Boulevard). Photograph taken from Crighen Street looking northeast, upstream from site 8 and approximately 6 miles below peak.

F. Dry Creek flowing east across Yellowstone Road at site 9, about 2.5 feet below peak. Photograph by Todd A. Duse.

G. Dry Creek. Photograph looking upstream from site 9 and site 10.

H. Damage to Windsor Road where it crosses Dry Creek. Photograph looking northwest between site 10 and site 11.

I. Flooded downtown business parking lot near the intersection of 20th Street and Pioneer Avenue.

J. Flooded downtown parking lot. Photograph looking northwest from Pioneer Avenue. Photograph by Mark Jurge.

K. Hill and floodwaters in Hickory Park. Photograph looking east from Alexander Avenue. Photograph by Beth Reed.

L. Hill accumulation on 17th Street between Carbon Street and Campbell Street. Photograph looking west.

M. Hill accumulation on Carbon Street between Franklin Boulevard and 20th Street. Photograph looking west. Photograph by Mark Jurge.

N. Flooded residence upstream from site 11. Photograph looking west from Ridge Road.

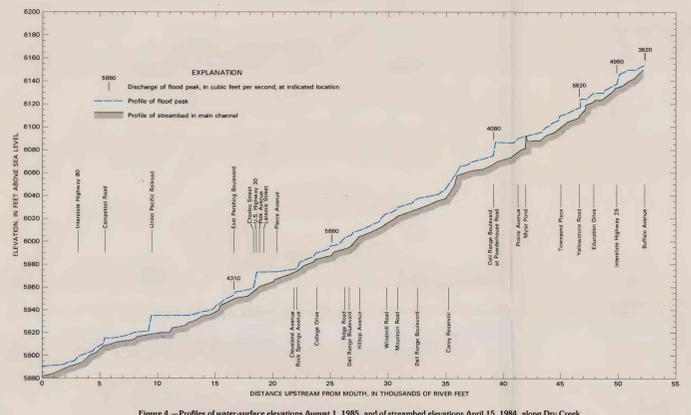
Figure 4.—Profiles of water-surface elevations August 1, 1985, and of streambed elevations April 15, 1984, along Dry Creek
