RELATIVE SLOPE STABILITY OF THE SOUTHERN HOOD CANAL AREA, WASHINGTON

By
Mackey Smith and R. J. Carson
Washington Department of Natural Resources
Division of Geology and Earth Resources

1977

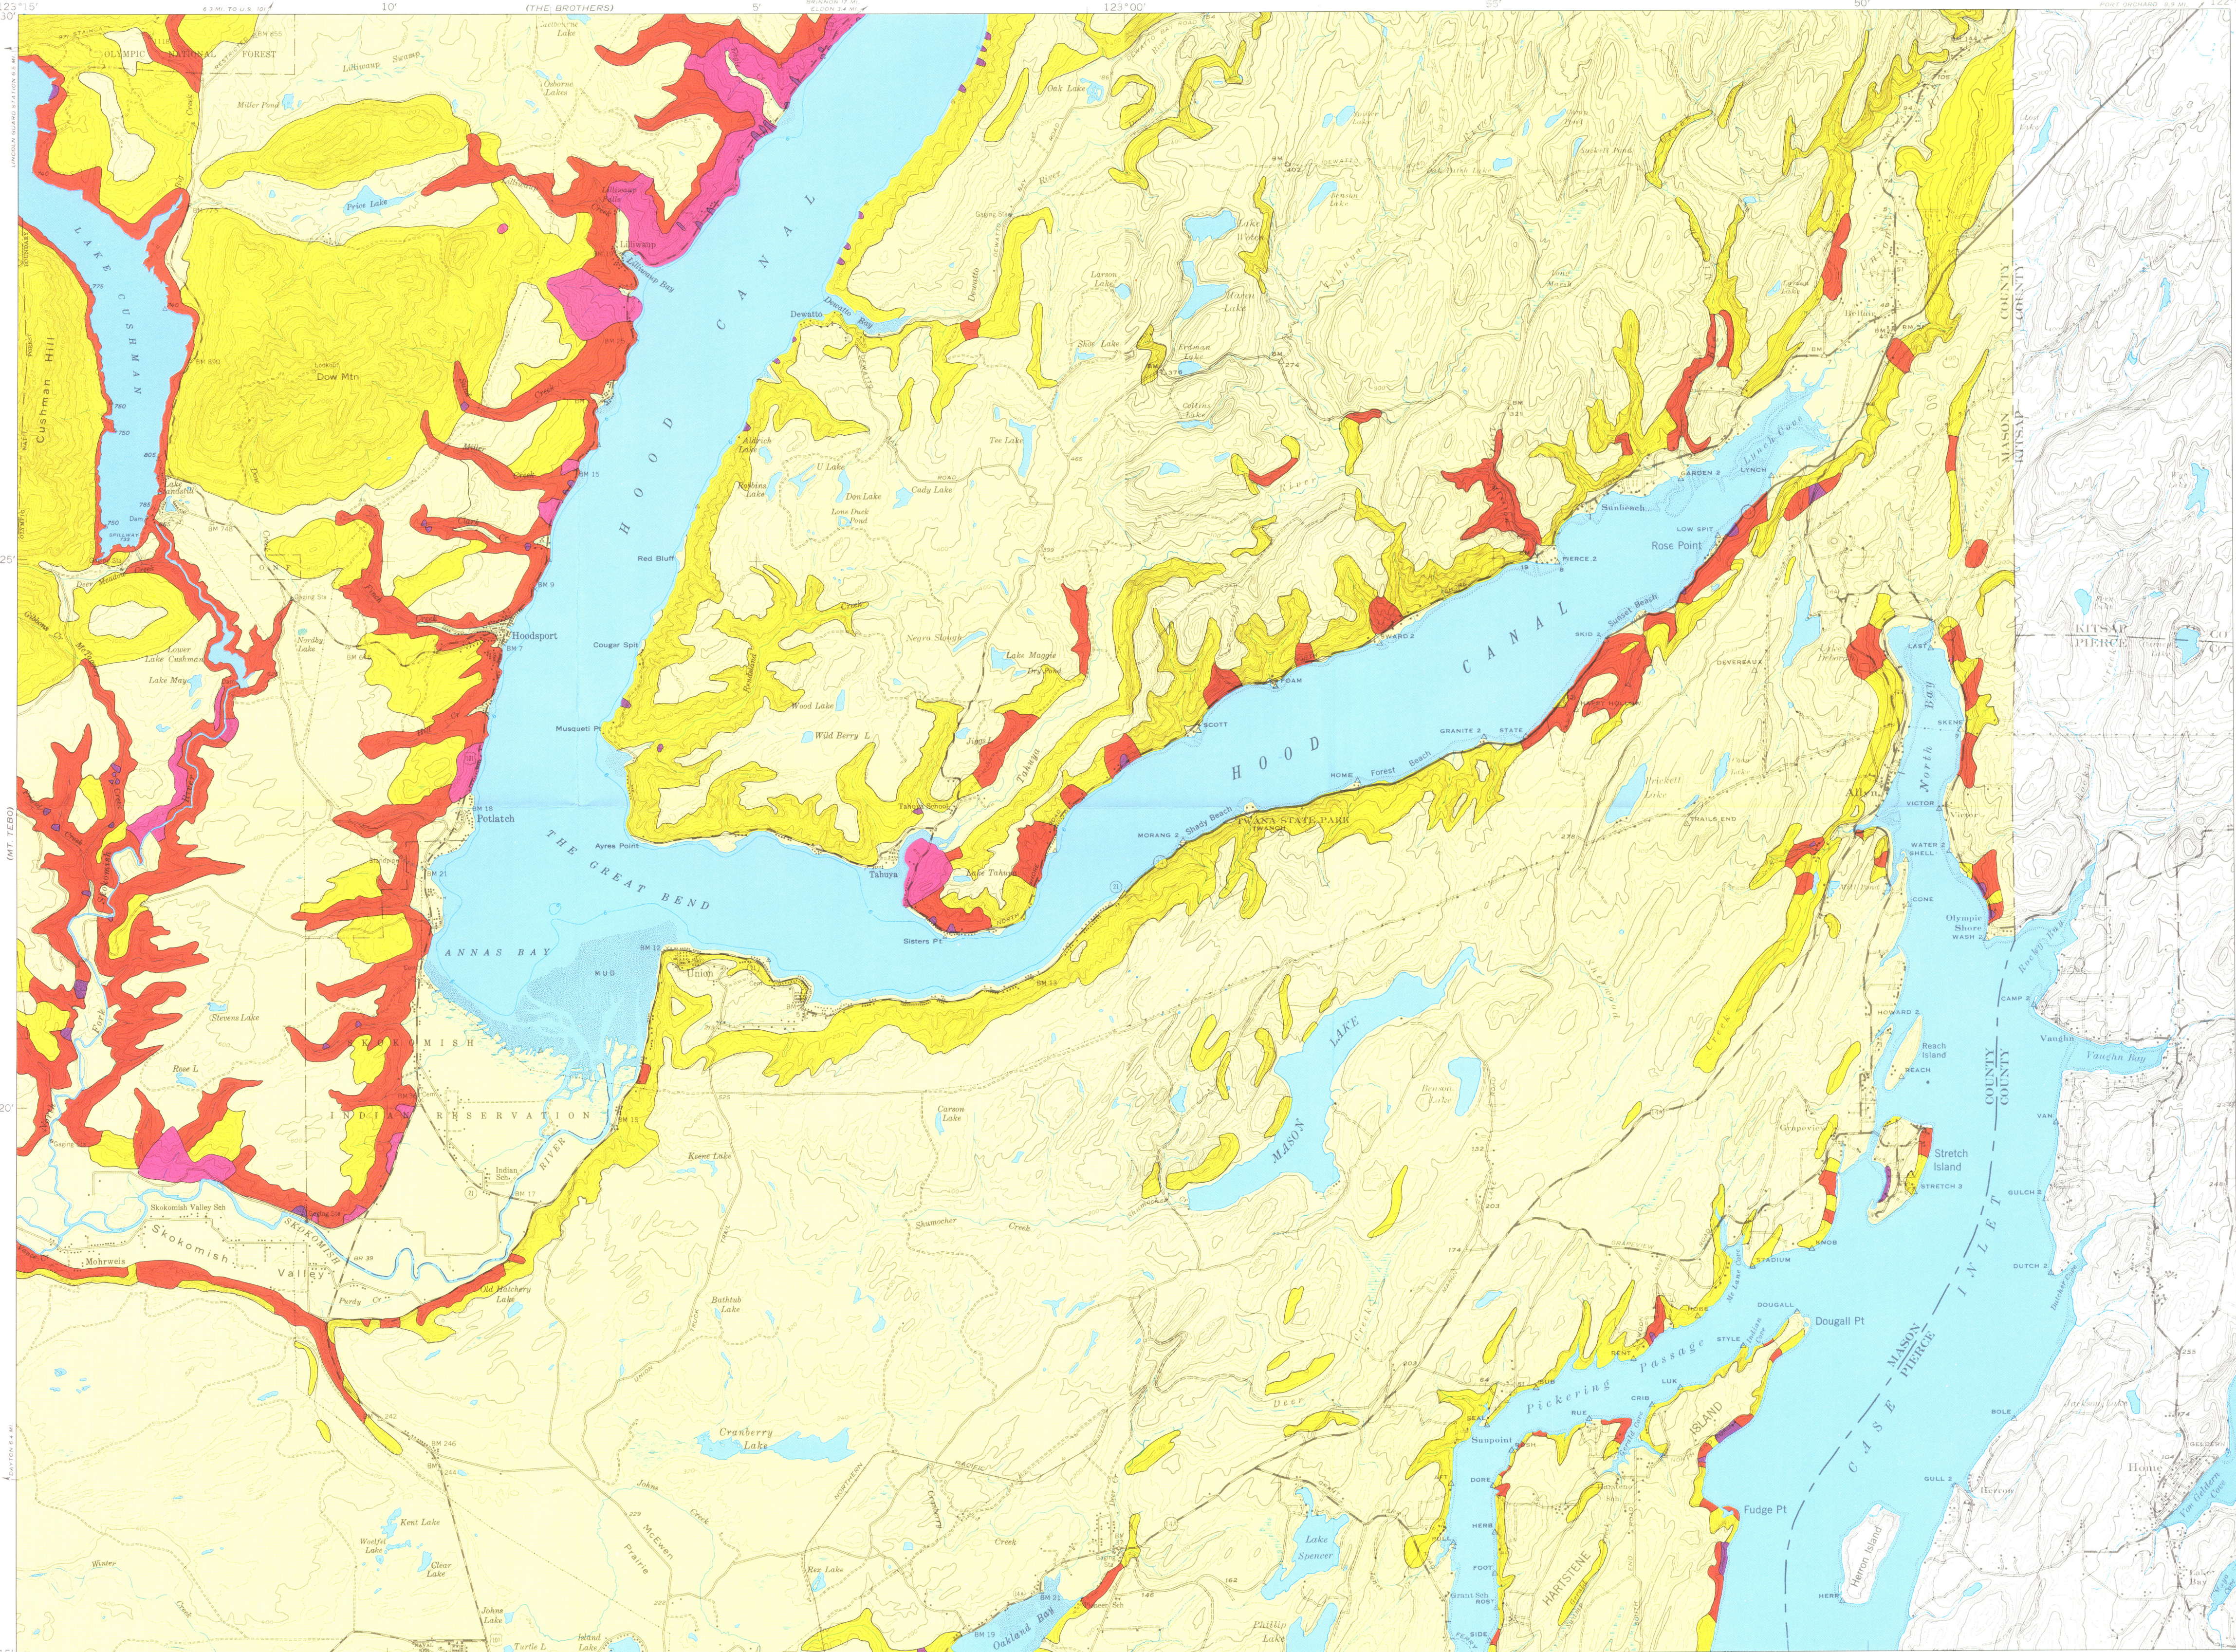
This map shows the relative stability of natural slopes in the southern Hood Canal area of Mason County, Washington. It is one of a series being prepared by the U.S. Department of the Interior in cooperation with several agencies to present basic environmental information and interpretations to assist land-use planning in the Puget Sound area. Landsliding is only one of many geologic hazards active in the southern Hood Canal area. Other hazards, some of which may be interrelated, are seismic shock, recent faulting, flooding, and differential settlement. A significant example of this interrelation is the effect of earthquakes on slope stability; seismic shock may initiate or intensify landsliding. Land in the southern Hood Canal area ranges from stable surfaces to actively moving landslides. Stability depends on the steepness of the slope, the character of underlying geologic materials, ground-water and soil-moisture conditions, stream and wave erosion, and modifications by man. Man's activities often modify natural physical processes to the extent that landslides occur in areas that have been stable over many centuries. These landslides are commonly associated with extensive road building and logging operations, and development of second homes on slopes overlooking lakes and Hood Canal. Clearing of vegetation can increase erosion and may result in a buildup of ground water—both major causes of slope instability. Construction of roads and housing sites often directly produces oversteepening or overloading of natural slopes. Earth materials that are otherwise firm may also be weakened by overwatering from septic-tank drainfields and from irrigation of lawns and fields. Knowing the location of potentially unstable areas can guide planners to places where land-use regulations are needed most to avert damage from these kinds of acts.

- The area mapped is separated into 5 classes of relative slope stability:
1. Areas that are inferred to be stable.
 2. Areas that probably are stable under normal conditions, but may become unstable if modified by man's activities.
 3. Areas inferred to have poor natural stability.
 4. Areas of former, still recognizable landslides, the present stability of which is unknown.
 5. Areas of recently active, rapid downslope movement.

The boundaries on the map between areas of stability classes 1 to 3 are imprecise in places, because data on slopes and geologic materials are locally generalized or poorly known. Also, there are places where stability characteristics differ from the pattern shown because they are too small to be indicated at the map scale. Therefore, in any areas other than class 1, thorough geologic and engineering studies should be made before changes in land uses are undertaken.

Areas believed to be stable. Slopes generally less than 15 percent, but may be greater locally in areas too small to be shown as the map scale. Largely comprises rolling uplands underlain by very stable material such as young glacial till, mantled in places by a thin layer of sandy gravel or other permeable material; also includes flood plains, deltas, alluvial fans, and some beach deposits. Class 1 areas immediately adjacent to steep slopes of class 3 areas may be threatened by potential landsliding. Normal, proper engineering practices generally are adequate to insure stability in these areas.

Areas believed to be stable under normal conditions, but may become unstable if disturbed by man's activities, if slope is oversteepened by erosion, or if subjected to strong seismic shaking. Slopes generally steeper than 15 percent, but may be less in some areas of weak geologic materials. Includes areas underlain by: well-drained sand and gravel, mostly on valley sides that lack known slope failures; glacial till with steep slopes; and bedrock.

Areas inferred to be unstable because slopes, generally greater than 15 percent, are underlain by weak, unstable materials in which old or recently active landslides have occurred. Includes areas of sand and gravel on top of impermeable silt and clay, mostly along steep valley sides.

Former landslide areas, generally within class 3 areas; include relatively large slumps, flows, and slides of soil, rock, and debris that have occurred since retreat of glaciers from the region (about 13,500 years ago). Present stability unknown, but sliding may be reactivated by excavations, slope modifications, or strong seismic shaking.

Known areas of recently active rapid downslope movement (probably within the past 50 years) generally in class 2 and 3 areas. Includes a few cases of moderate-size landslides, but most commonly only slumping, sliding, and falling of relatively small amounts of earth material, usually occurring during periods of heavy rains. Present stability considered very poor.
