DESCRIPTION OF SCENE
At the left in this view east from the lander, a field of drifts of very fine grained material dominates the scene. This material probably covered the area as a thick blanket and was subsequently stripped off by the wind; patches of the material were left behind in the form of drifts scattered among the blocks that litter the landscape. The ridge that forms the horizon above the drifts (line 80, sample 700) lies about 1.18 km from the lander. The block-strewn ridge that forms the horizon on the right is only about 80 m from the lander. The angular blocks that cover the surface range in size from a few tens of millimeters to over 1 m.

THE VIKING MISSION
Two Viking spacecraft, each consisting of an orbiter and lander, were launched from Kennedy Space Center on August 20 and September 9, 1975. The Viking 1 spacecraft arrived at Mars on June 19, 1976, and was placed in a highly elliptic orbit around the planet at a periastron altitude of nearly 1500 km. The orbiter cameras were used in conjunction with other instrumental methods to find a suitable landing site for the lander. After about 20 days in orbit, the lander was separated from the orbiter, and on July 20,

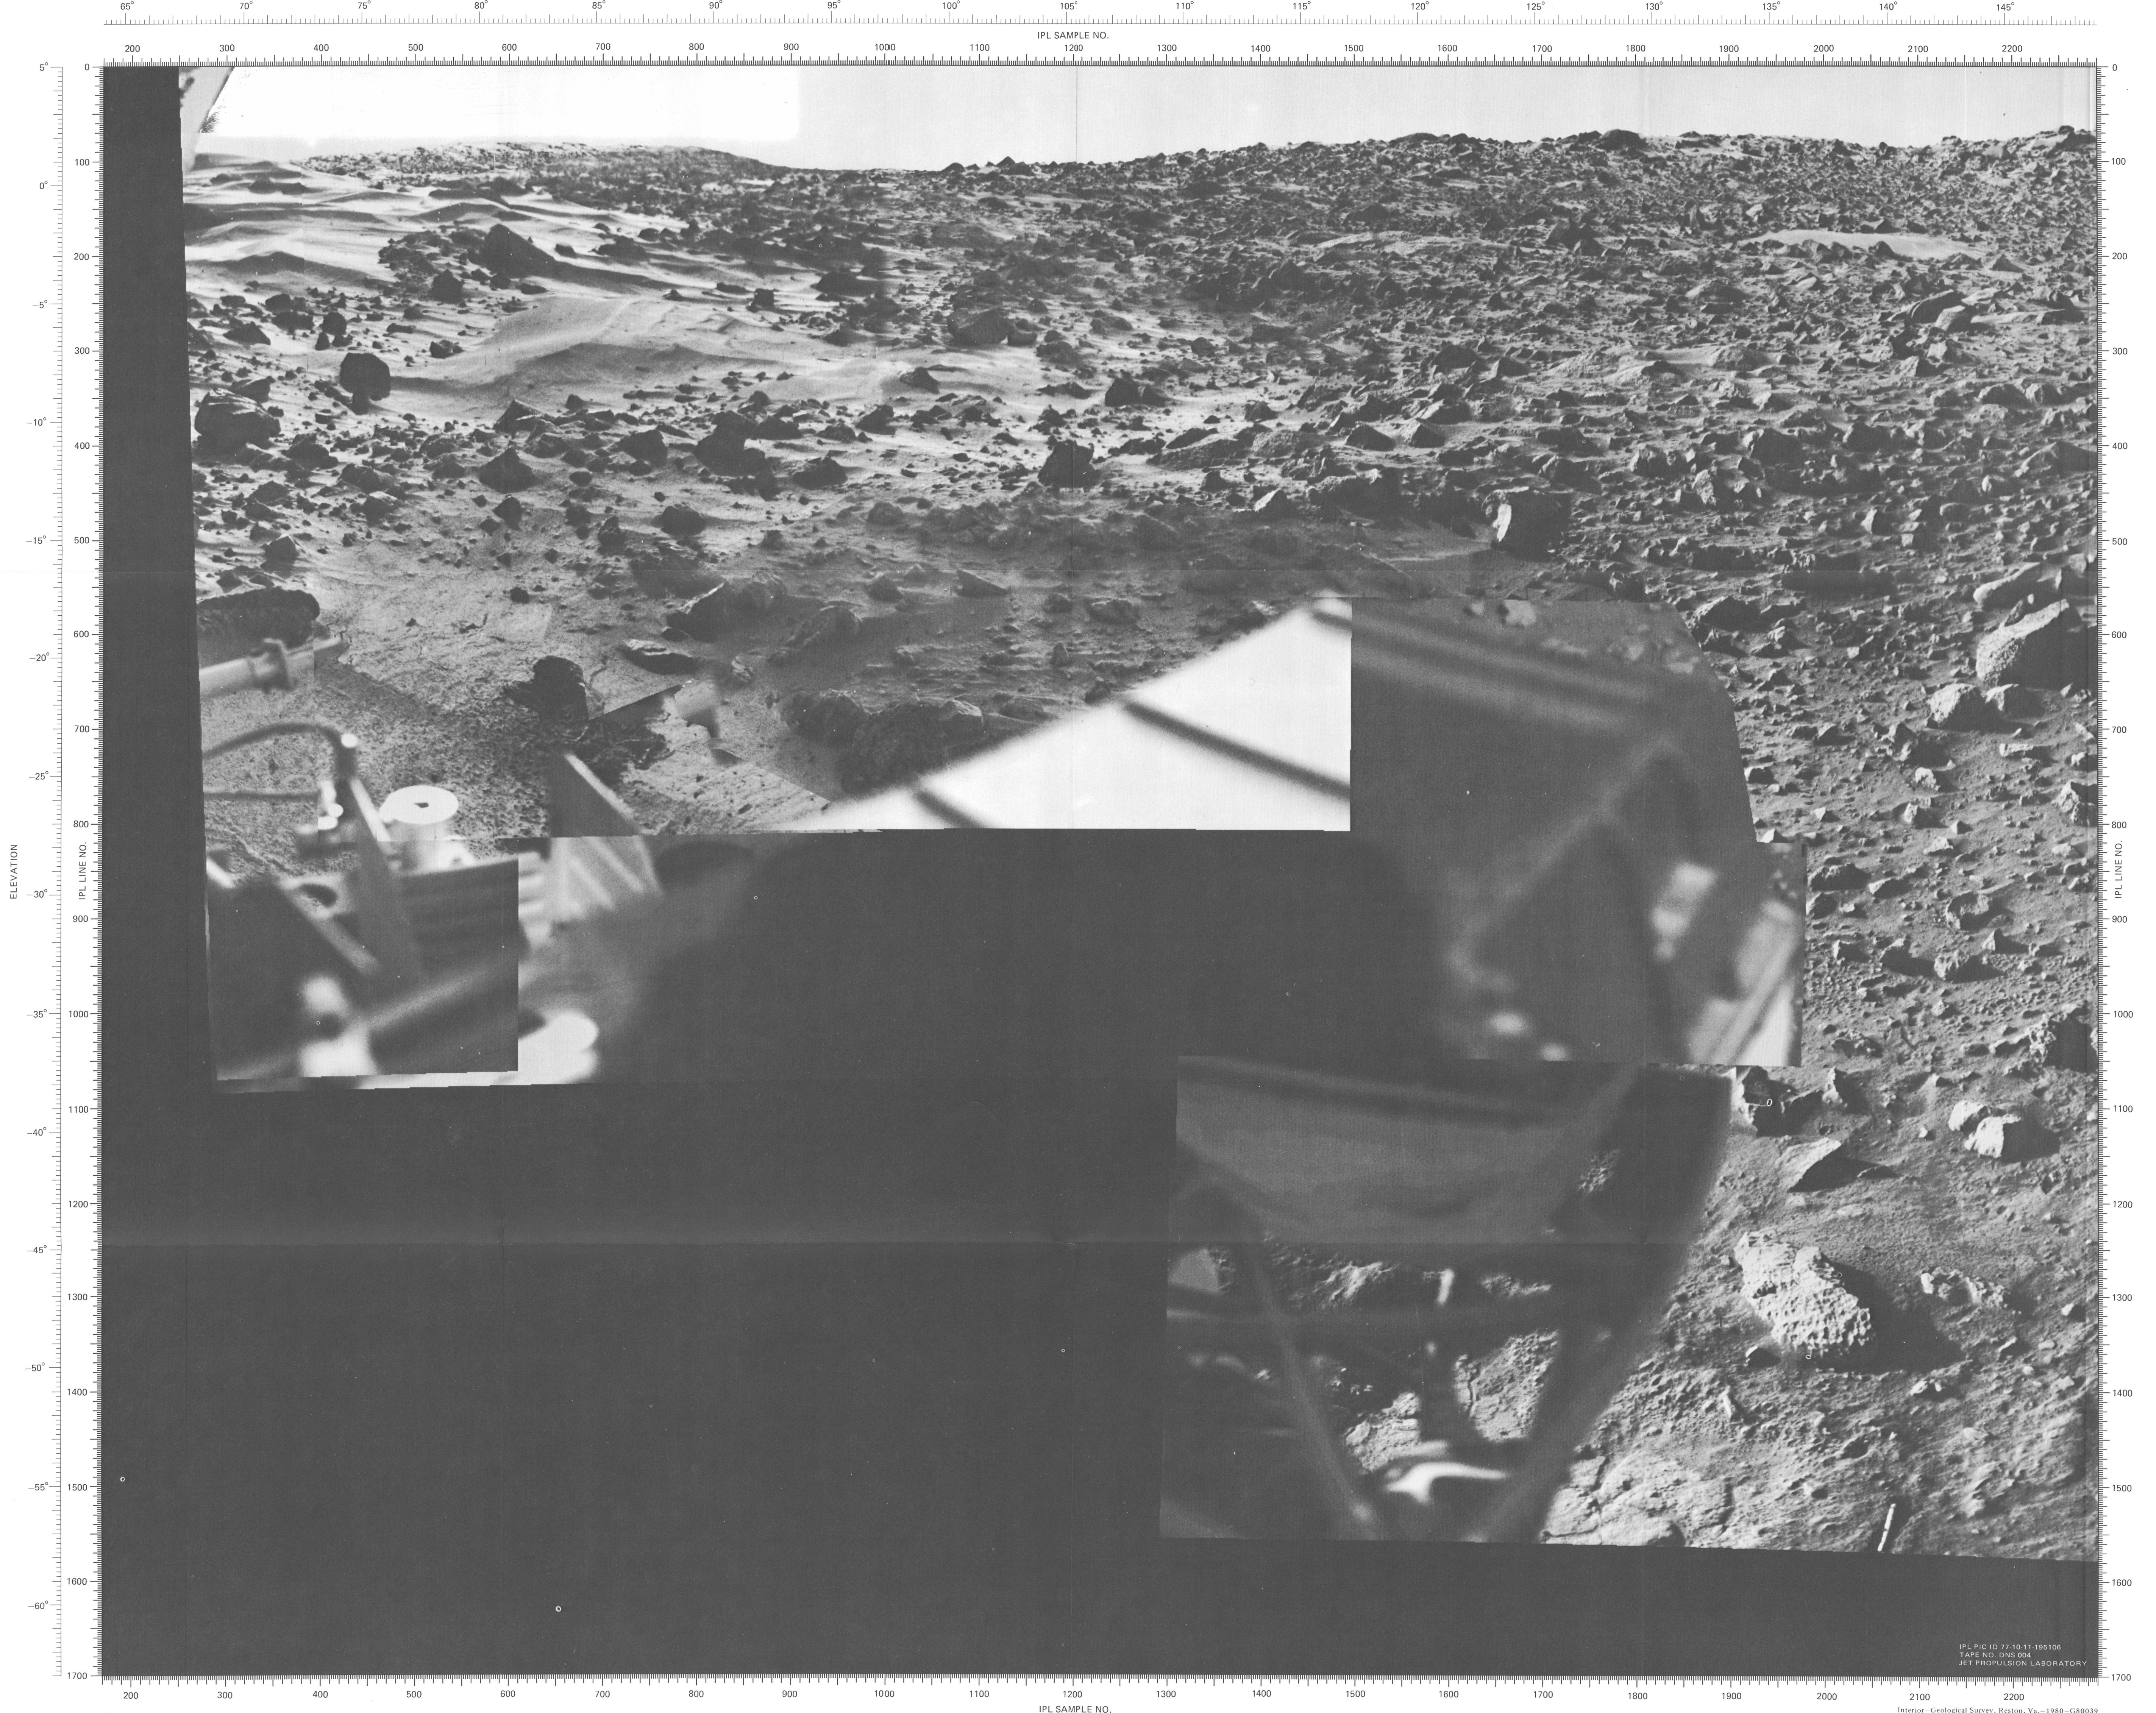
Parts of the lander are visible in the lower right. The large object at the center of the scene is the surface sampler in its stored position. Only the back of the instrument housing is visible in the mosaic of two pictures that include it. Most picture-taking sequences for the Viking cameras were planned to avoid parts of the lander, except for the surface sampler, and to image as much of the surface as possible.

At the lower left (line 650, sample 650) just above the lander is a trench dug by the surface sampler to obtain specimens of the martian soil for analysis by instruments on board the lander. The soil was analyzed for biologic activity and for organic and inorganic content. The trench, about 85 mm wide, was dug in a drift of the very fine grained material. During landing, one of the footpads of the spacecraft was buried in this drift.

At the lower right, (line 1550, sample 1750) exhaust from the retro rockets has swept away fine-grained material from beneath the lander during its landing maneuvers and has exposed a firm layer of "Martiancrete". The bright cylindrical object (line 1550, sample 2064) is a latch pin that secured the surface sampler until after landing. The latch pin was released by an extension command to the surface sampler and fell to the surface before the instrument began its sampling activities. The pin is 6 mm in diameter and 82 mm long.

GEOMETRY OF THE MOSAICS
The cameras on the Viking Lander acquire data by sampling in equal increments of elevation and azimuth angle. In the accompanying mosaic, 8 mm subpixels at 1° horizontal or vertical angle, regardless of the place of measurement within the panorama. If the martian surface were flat, one pixel (0.04°) on the surface would be 1 mm wide at 40° camera elevation and 2 m wide at imaging 0° from, most straight lines in the scene appear curved in the reconstruction. This representation of the picture data differs from that of a conventional camera having "point perspective" picture geometry, in which rays are projected from object space through the perspective point in the camera lens, to an image plane in the camera.

The geometry of the lander pictures is complicated by additional factors. Because both landers are tilted with respect to the horizon, on the uncorrected pictures the horizon resembles a sine curve. Computer rectification of the pictures measured with respect to the local gravity vector, and horizontal angles can be measured from martian north. These angles are not related in any simple way to the azimuth and elevation angles given in "camera coordinates" for the uncorrected pictures.

There are other geometric distortions due to the camera: optic path distortion that affects a light ray after it passes the camera window; and camera-stem distortions, or "bolt-down" errors, that are caused by the way the cameras are mounted on the lander. The geometric transformation used in creating the mosaic took into account the optic path distortion but not the "bolt-down" errors. However, along the horizon, the error in azimuth angle is equal to the rotational "bolt-down" error for each camera to an accuracy of less than 1 pixel. The scale "azimuth angles from Mars north" has been adjusted to take into account this correction.

The residual azimuth angle errors are less than 1 pixel along the horizon and become larger with steeper elevation angles and larger lander tilts. For the worst case, Lander 2, camera 1, this error is a maximum of 5.7 ± 1 pixel at 40° elevation. The somewhat sinusoidal azimuth-dependent residual elevation error is a maximum of 3 ± 1 pixel for Lander 2, camera 1, and approximately 1 pixel for the other cameras.

Each complete mosaic extends 34.25° in azimuth, from approximately 5° above the horizon to 60° below. A complete mosaic incorporates approximately 15 million picture elements (pixels). In order to manage the processing of such large data bases, each mosaic was compiled from four individual azimuthal sectors.
