IPL FILE NO. 27 10 11 195106
IPL FILE NO. 001 004
JET PROPULSION LABORATORY
Interior - Geological Survey, Reston, Va., 1980 - G80039

VIKING LANDER 1 RECTIFIED PHOTOMOSAIC
MORNING SCENE - CAMERA 2 - SECTOR 2
1980

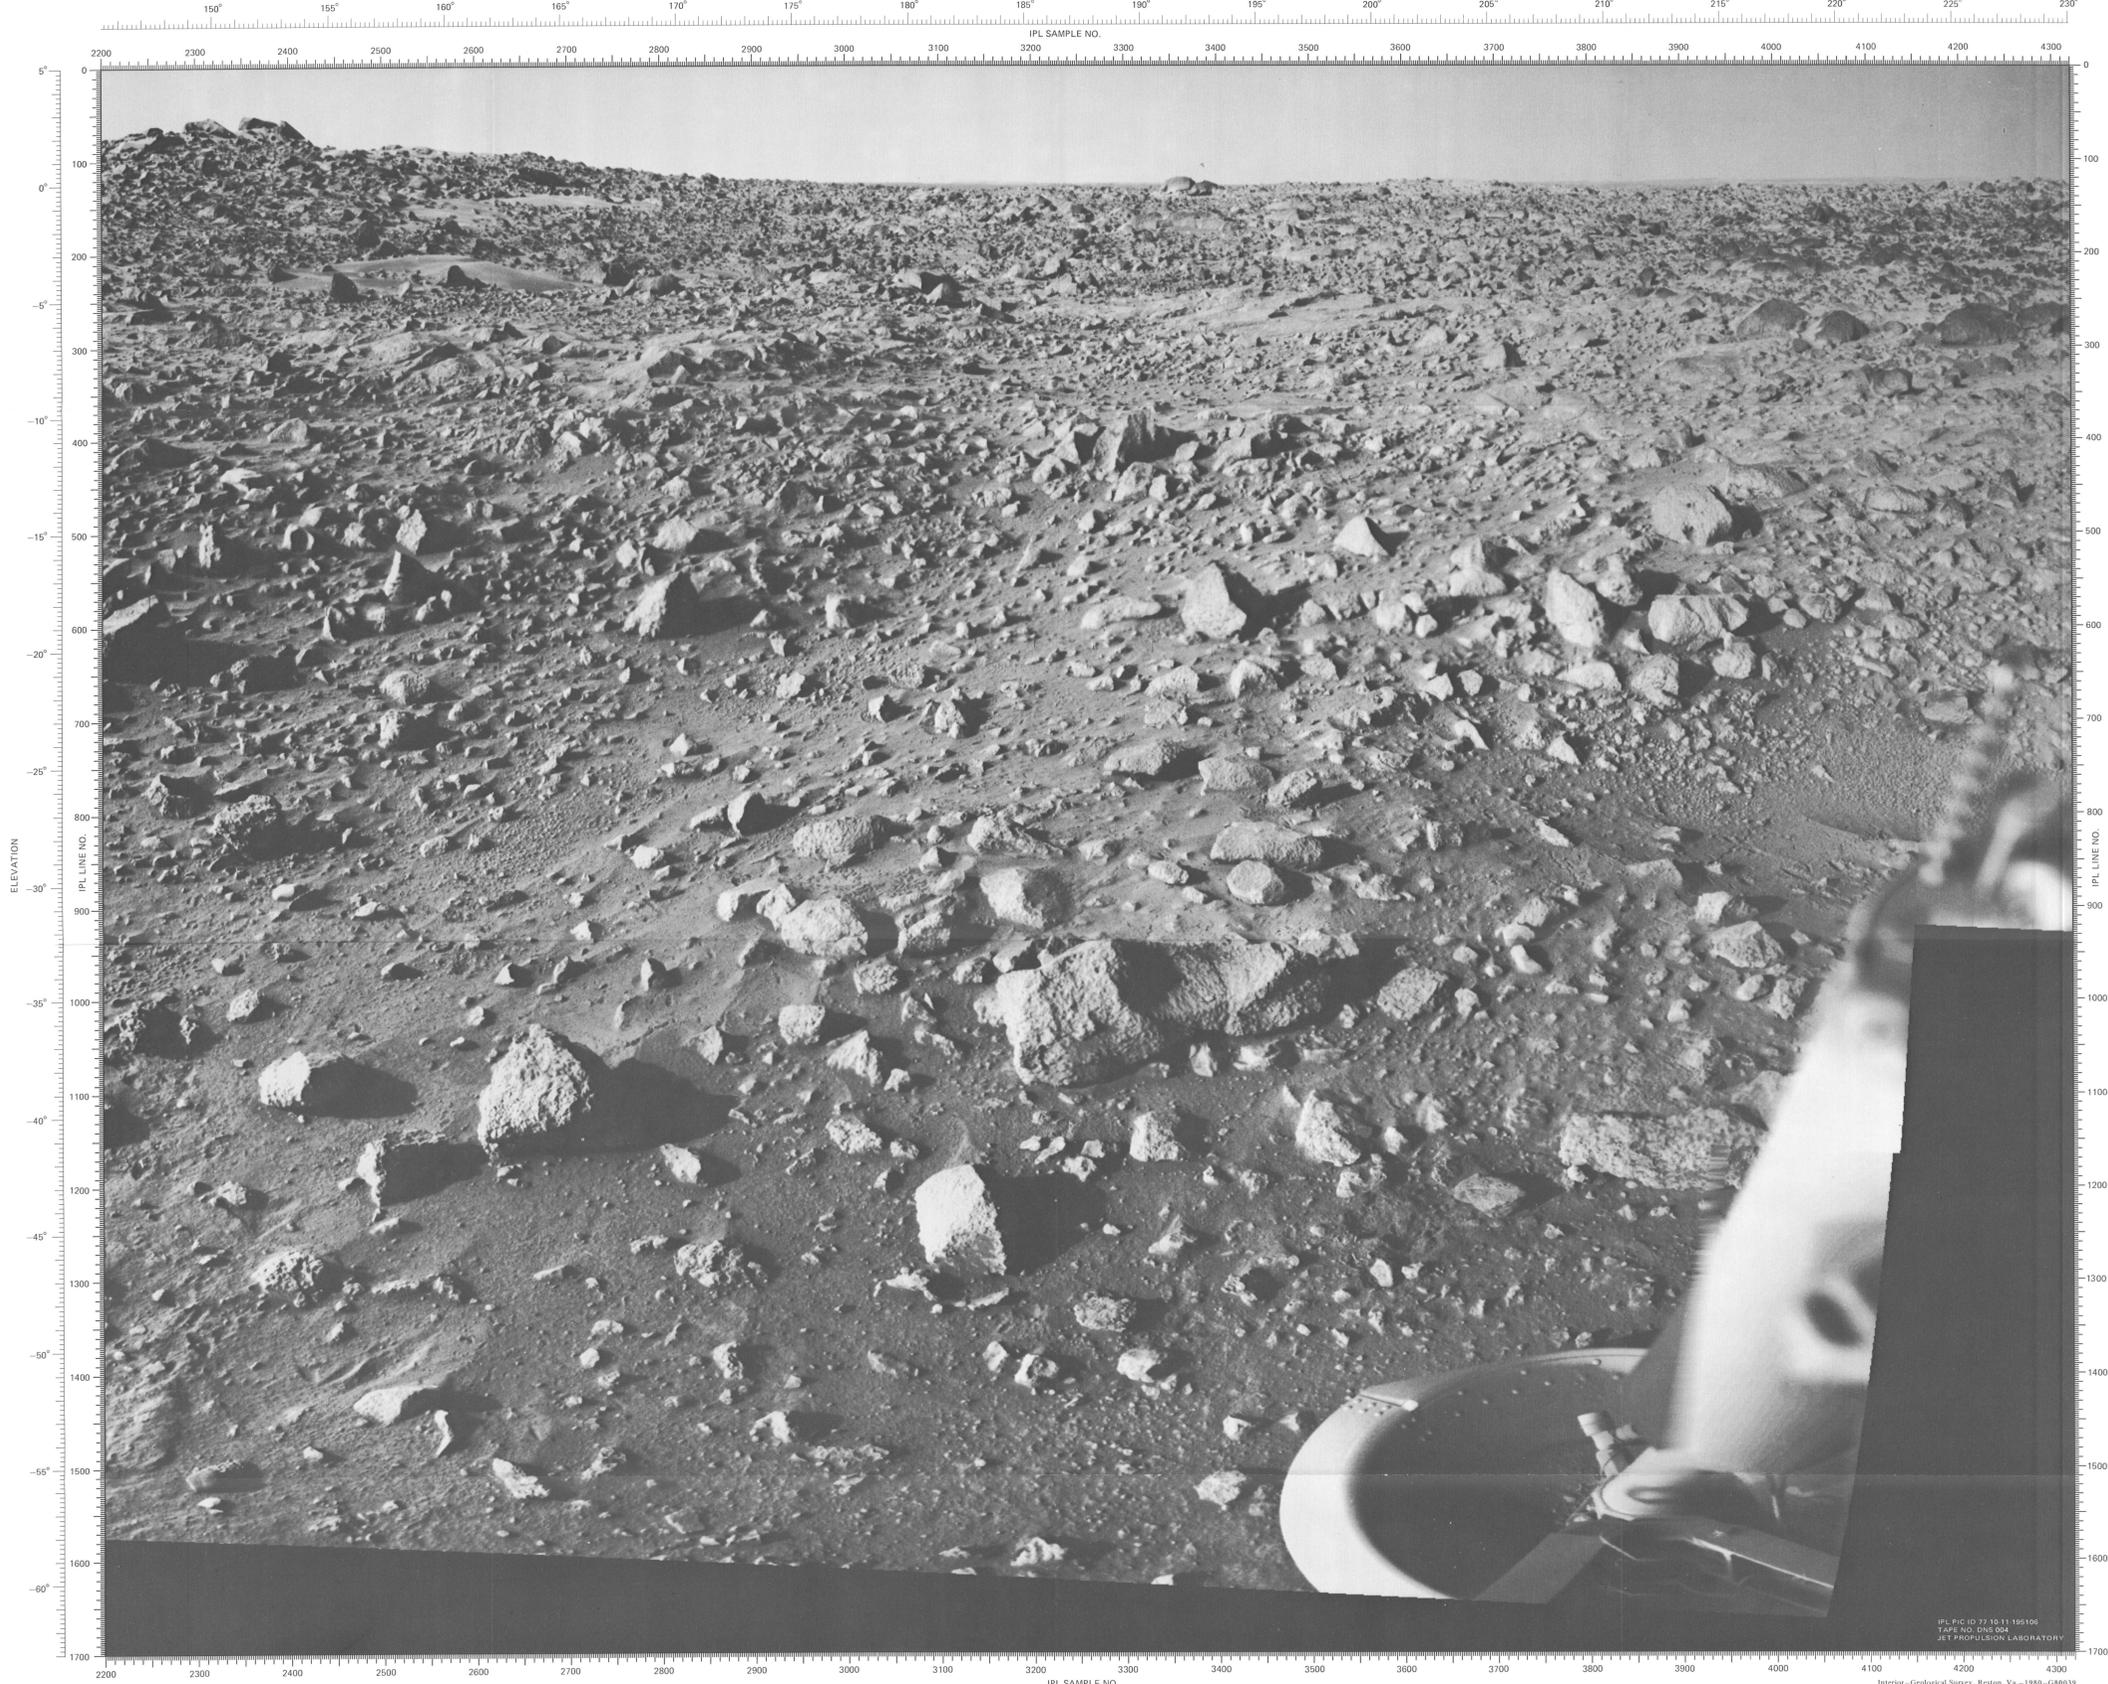
This southeast view of the terrain directly in front of the lander shows a surface strewn with rocks in the centimeter-to-meter size range; several areas interpreted as bedrock are also present (line 275, sample 2700). Much of the near field between the large blocks is blanketed by very fine grained (approximately 100 μm) material, which has been sculptured by the martian winds into tails behind rocks (line 900, sample 2700). Light and dark drifts of this material can be seen in the upper left of the mosaic; these deposits are about 15 m from the spacecraft. Large blocks on the near horizon in the upper left of the mosaic are about 80 m from the spacecraft and lie on the rim of a small (200-m diameter) degraded crater; the largest block is about 3 m across. The far horizon at the upper right is probably a ridge beyond the 3-km nominal horizon.

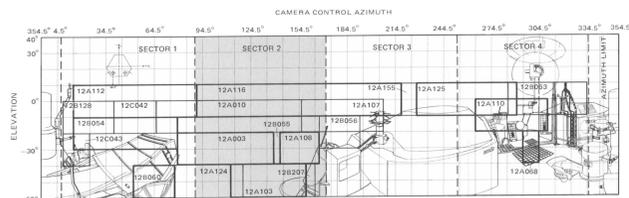
OUTLINE OF CAMERA 2 VIEW SHOWING CAMERA EVENTS USED IN MOSAIC

The Viking Lander camera acquired many high-resolution pictures of the Chryse Planitia and Utopia Planitia landing sites. Each picture is the product of computer processing on Earth of digital-image data transmitted from Mars as a result of "camera events" carried out by one of the lander camera systems. Further computer processing of data from a selected number of these events yielded a total of 10 mosaics. Two pairs of mosaics from Lander 1 data (one mosaic from each camera) consisted of one pair made from data taken in the morning (0700-0800 hours) and one pair made with data acquired in mid-afternoon (1400-1500 hours). Similarly, three pairs of mosaics for the Lander 2 site consisted of one pair between 0700 and 0800 hours, one pair at noon, and one pair between 1700 and 1800 hours.

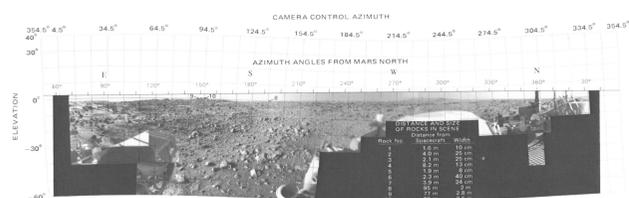
COMPLETE MOSAIC, MORNING SCENE, CAMERA 2
(Corrected for tilt)
