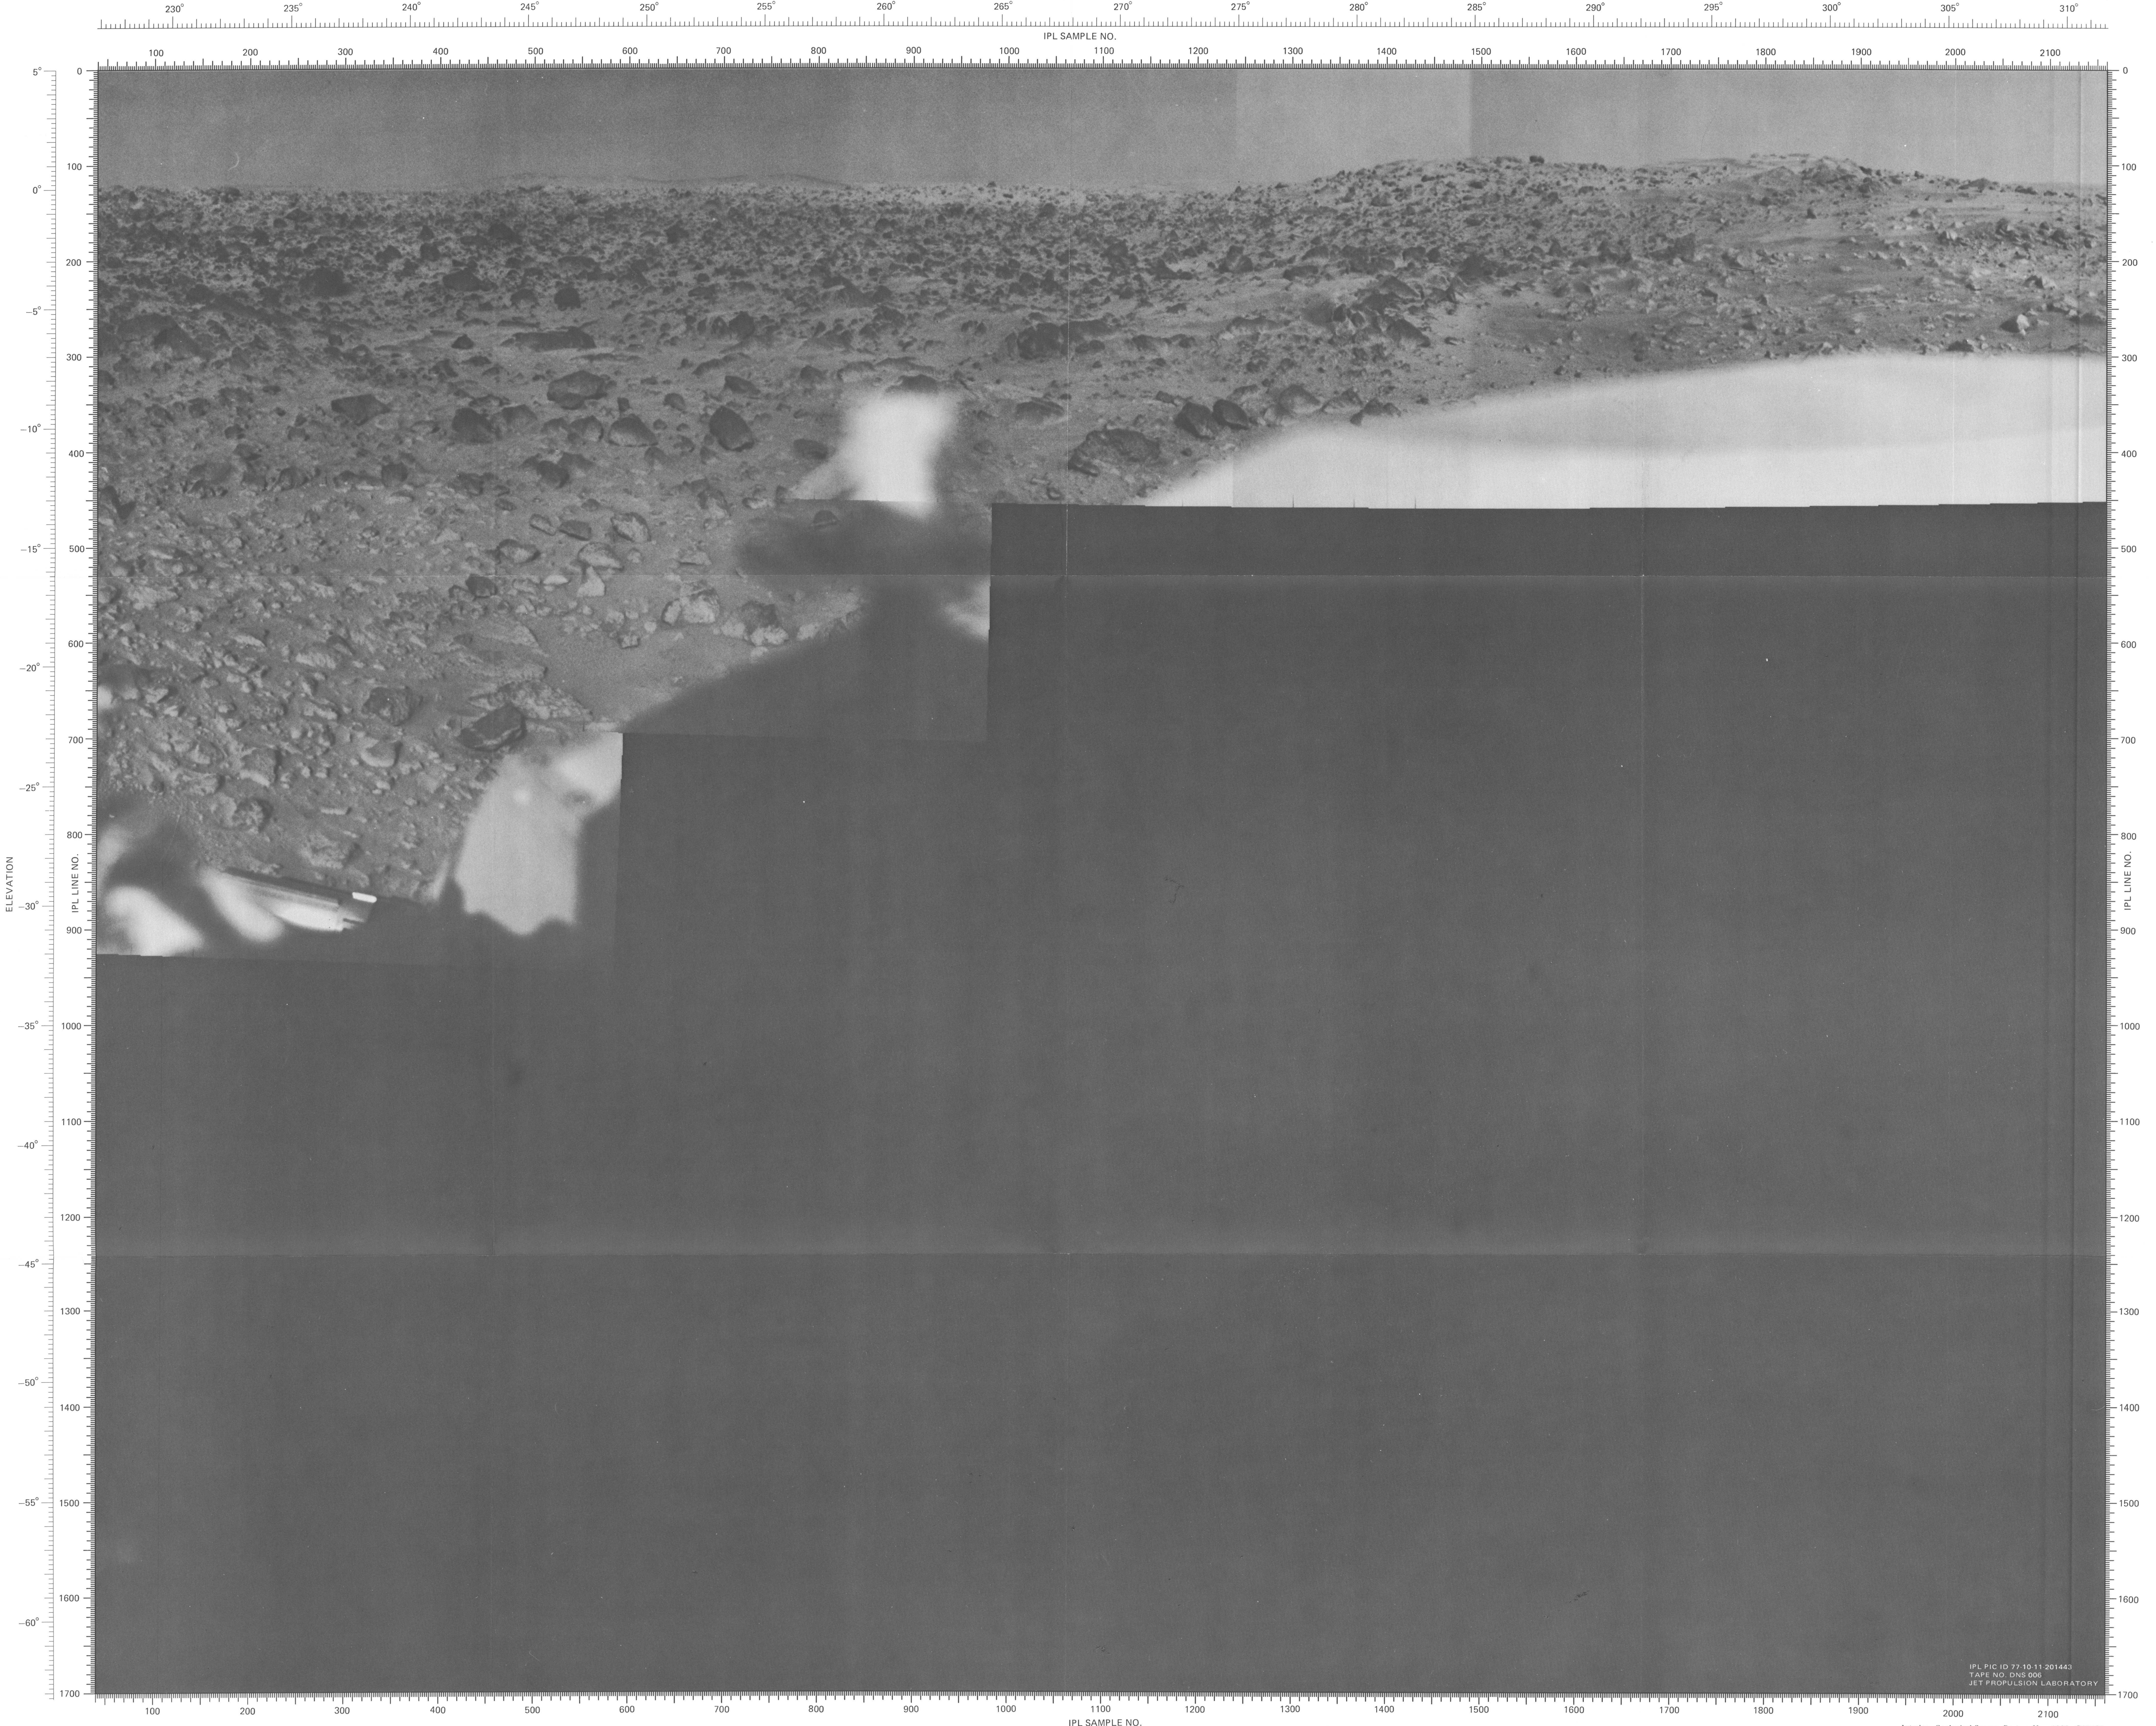
**DESCRIPTION OF SCENE**  
In this view southwest from Viking Lander 1, the raised rim of a 410m diameter crater projects above the horizon (line 100, sample 650) and subtends an angle of about 12.5°. The crater is 1.85 km from the lander. The rim of another crater (150 m in diameter) forms the near horizon west of the lander (right side of image).  
Much of the near surface is occupied by the spacecraft because the view is over the top of the lander. Parts of the lander that form the bottom edge of the panorama are: the cover of one of the Radiosotope Thermoelectric Generators (RTG) that power the lander (line 400, sample 1750), the S-band low-gain antenna (line 400, sample 900), and upper parts of leg 3 (line 850, sample 1900).

**GEOMETRY OF THE MOSAICS**  
The cameras on the Viking Lander acquire data by sampling in equal increments of elevation and azimuth angle. In the accompanying mosaic, 8 mm subframes 1° horizontal or vertical angle, regardless of the plane of measurement within the panorama. If the martian surface were flat, one pixel (0.94°) on the surface would be 1 mm wide at 60° camera elevation and 2 m wide at the horizon 3 km away. Characteristically for this type of imaging system, most straight lines in the scene appear curved in the reconstruction. This representation of the picture data differs from that of a conventional camera having "point perspective" picture geometry, in which rays are projected from object space, through the perspective point in the camera lens, to an image plane in the camera.  
The geometry of the Lander pictures is complicated by additional factors. Because both landers are tilted with respect to the horizon, on the uncorrected pictures the horizon resembles a sine curve. Computer rectification of the pictures results in a straight horizon along which vertical angles can be measured with respect to the local gravity vector, and horizontal angles can be measured from martian north. These angles are not related in any simple way to the azimuth and elevation angles given in "camera coordinates" for the uncorrected pictures.

There are other geometric distortions due to the camera: optic path distortion that affects a light ray after it passes the camera windows, and camera-system distortions, or "bolt-down" errors, that are caused by the way the cameras are mounted on the lander. The geometric transformations used in creating the mosaics took into account the optic path distortions but not the "bolt-down" errors. However, along the horizon, the error in azimuth angle is equal to the rotational "bolt-down" error for each camera to an accuracy of less than 1 pixel. The scale "azimuth angles from Mars north" has been adjusted to take into account this correction.  
The residual azimuth angle errors are less than 1 pixel along the horizon and become larger with steeper elevation angles and larger Lander tilts. For the worst case, Lander 2, camera 1, this error is a maximum of 5.3 1 pixel at 60° elevation. The somewhat sinusoidal azimuth-dependent residual elevation error is a maximum of 0.1 pixels for Lander 2, camera 1, and approximately 1 pixel for the other cameras.
