IPL PIC ID 77-10-11-201443
TAPE NO. D160 000
JET PROPULSION LABORATORY

VIKING LANDER 1 RECTIFIED PHOTOMOSAIC
MORNING SCENE - CAMERA 2 - SECTOR 4

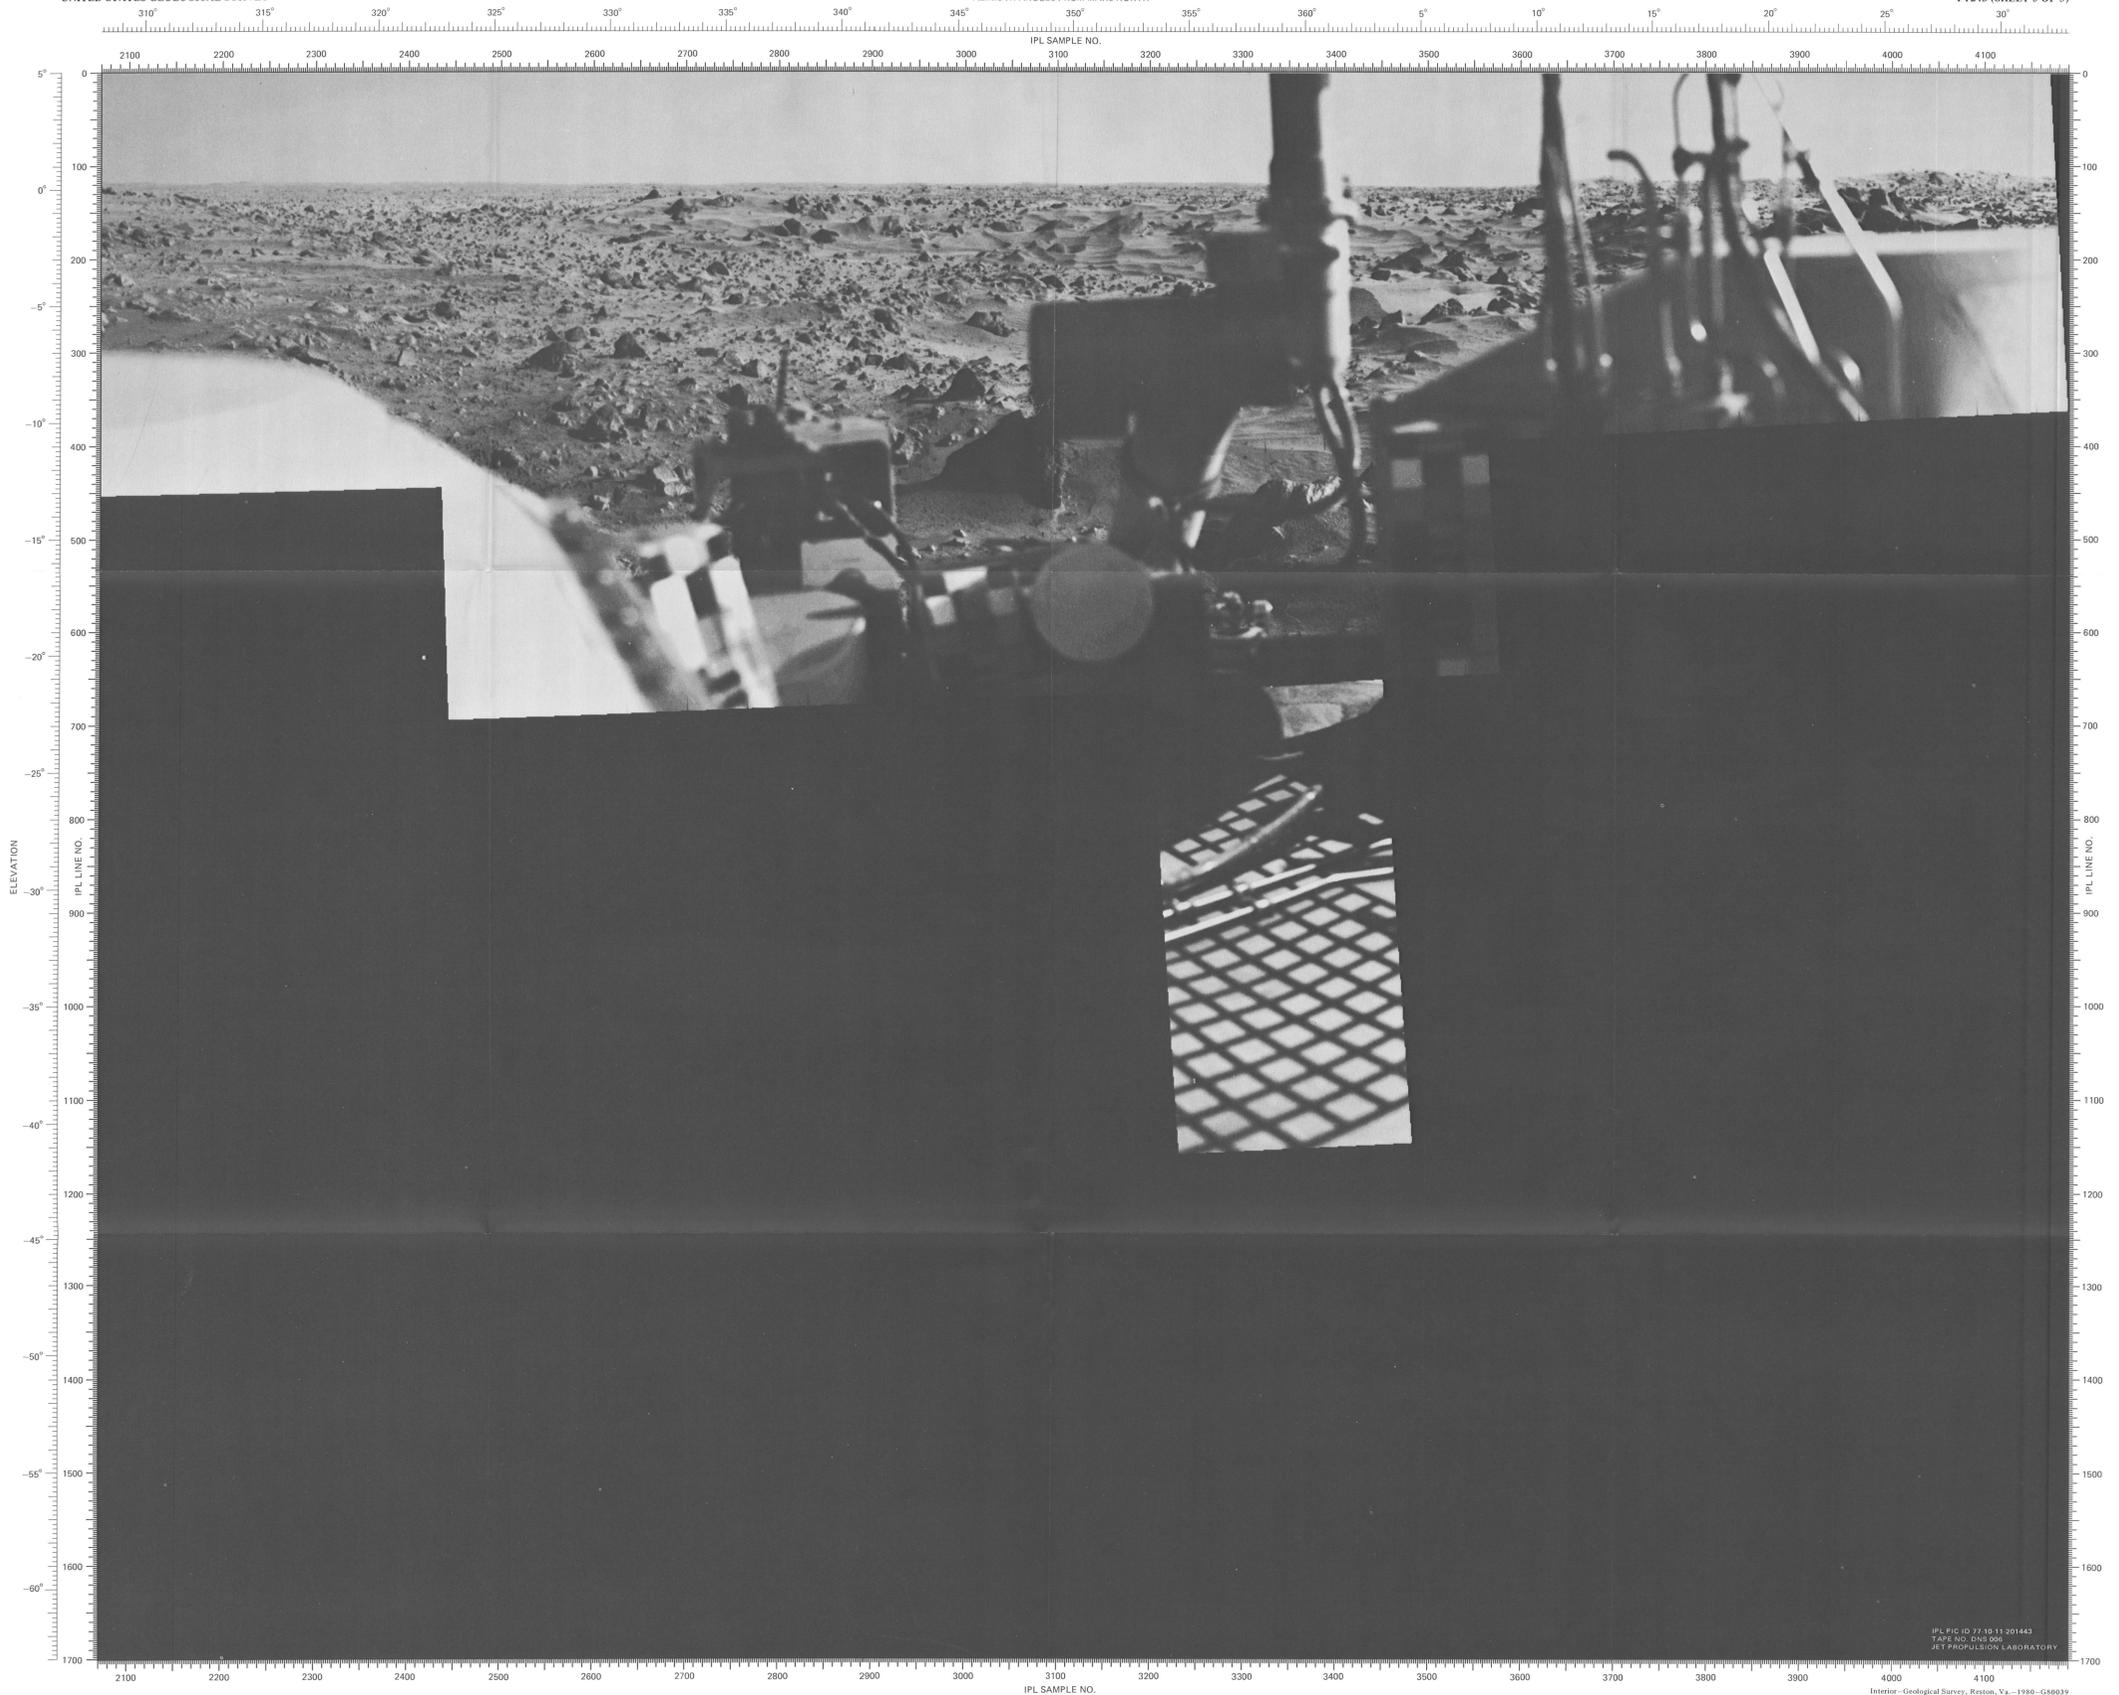
COMPLETE MOSAIC, MORNING SCENE, CAMERA 2
(Corrected for tilt)

DESCRIPTION OF SCENE

The view is north, directly over the top of the lander. The terrain behind the lander is a flat, level plain littered with angular blocks centimeters to meters in size, which are hoisted in places by drifts of very fine grained material. The surface has less relief than the terrain in front of the lander. Parts of the lander block the view of the foreground. The most of the high-gain antenna dominates the center of the scene (line 200, sample 3350). The two large bright objects on each side are covers of the Radioscience Thermoelectric Generators (RTGs) that power the lander. Three photometric calibration charts for the cameras are seen mounted on top of the lander (line 650, sample 2750; line 660, sample 2800; line 450, sample 3500). A circular magnifying mirror used to view particles on magnets mounted on the collector head of the surface sampler is at the right of one of the photometric calibration charts at the center of the lander (line 575, sample 3150). A grid pointed on top of the lander to aid in determining sizes of particles dumped onto it by the surface sampler is seen in the bottom center of the mosaic.

The cameras on the Viking Lander acquire data by sampling in equal increments of elevation and azimuth angle. In the accompanying mosaic, 8 mm subtends a 1° horizontal or vertical angle, regardless of the place of measurement within the panorama. If the martian surface were flat, one pixel (0.75 m) on the surface would be 1 mm wide at 60° camera elevation and 2 m wide at the horizon 3 km away. Characteristically for this type of imaging system, most straight lines in the scene appear curved in the reconstruction. This representation of the picture data differs from that of a conventional camera having "point perspective" picture geometry, in which rays are projected from object space, through the perspective point in the camera lens, to an image plane in the camera.

The geometry of the Lander pictures is complicated by additional factors. Because both landers are tilted with respect to the horizon, the uncorrected pictures the horizon resembles a sine curve. Computer rectification of the pictures results in a straight horizon along which vertical angles can be measured with respect to the local gravity vector, and horizontal angles can be measured from martian north. These angles are not related in any simple way to the azimuth and elevation angles given in "camera coordinates" for the uncorrected pictures.

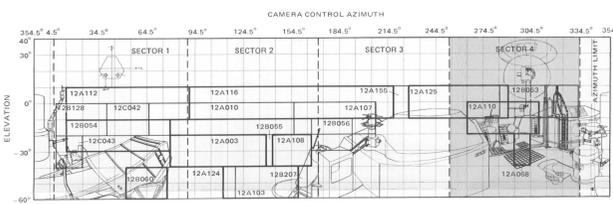
OUTLINE OF CAMERA 2 VIEW SHOWING CAMERA EVENTS USED IN MOSAIC

Procedures used for processing the Viking Lander camera data were described by Levalath and others (1977). The individual camera events used in each mosaic are identified in the outline of the accompanying camera views. Detailed descriptions and reproductions of these camera events were given by Tucker (1978). Copies of the Viking Lander pictures can be obtained from the National Space Science Data Center, Goddard Space Flight Center, Greenbelt, MD, 20771.
