VIKING LANDER MOSAICS

**VIKING LANDER 1 RECTIFIED PHOTOMOSAIC
MORNING SCENE - CAMERA 1 - SECTOR 2**

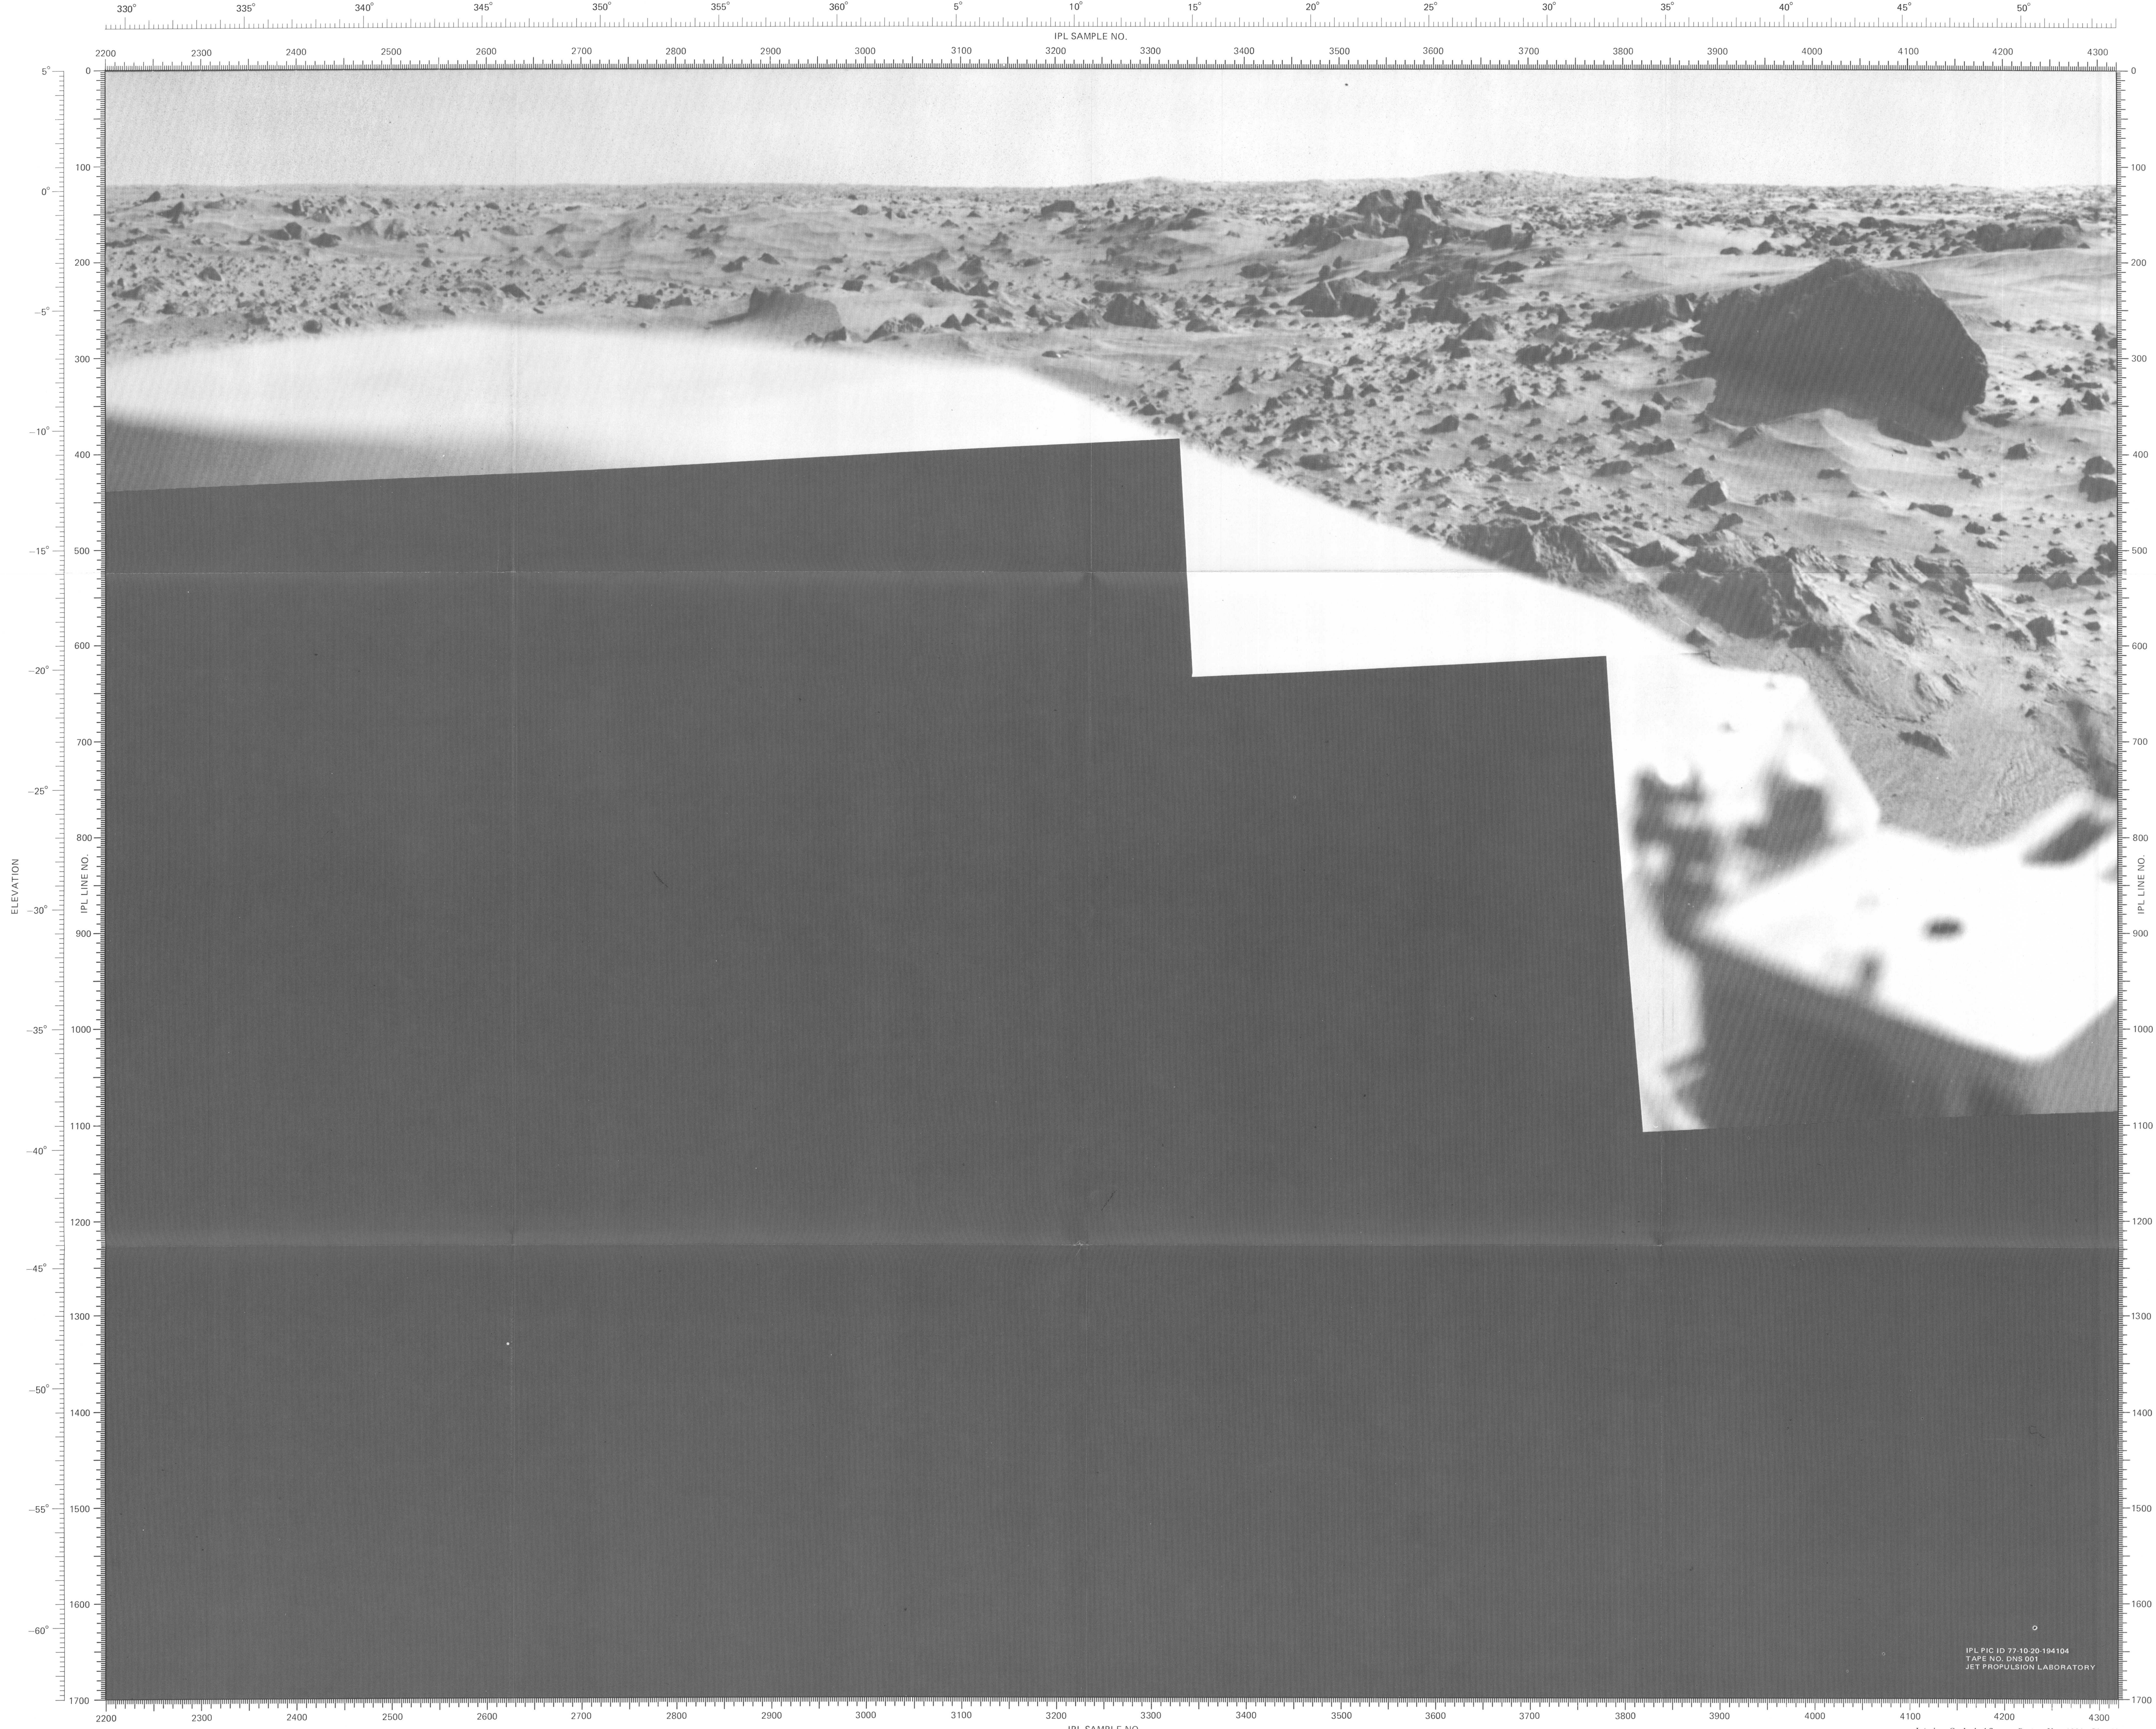
The area north of the lander is dominated by drifts of fine-grained material (about 100 μ m) that covers much of the surface. The drifts are probably remnants of a thicker layer of material that has been swept away by the wind. The large rock on the right that has been split in two (line 250, sample 4050) is about 2 m across, 1 m high, and about 9 m from the lander. Its cap of fine-grained material suggests that it was once buried by this material. The large rock is part of a boulder field that can be seen beyond it (line 150, sample 3550). This field is probably part of a ray of material from a nearby impact crater. Part of the rim of the 150-m diameter crater J can be seen (line 100, sample 3700) on the horizon northeast of the lander.

Parts of the lander visible at the bottom of the picture are the cover of a Radiometer Thermoelectric Generator (RTG) (line 300, sample 2800) and the mounting structure of leg 2 of the lander (line 850, sample 4200).

The cameras on the Viking Lander acquire data by sampling in equal increments of elevation and azimuth angle. In the accompanying mosaic, 8 mm subunits are 1" horizontal or vertical angle, regardless of the place of measurement within the panorama. If the martian surface were flat, one pixel (0.04" on the surface) would be 1 mm wide at 60° camera elevation and 2 m wide at the horizon 3 km away. Characteristically for this type of imaging system, most straight lines in the scene appear curved in the reconstruction. This representation of the picture data differs from that of a con-

The geometry of the Lander pictures is complicated by additional factors. Because both landers are tilted with respect to the horizon, on the uncorrected pictures the horizon resembles a sine curve. Computer rectification of the pictures results in a straight horizon along which vertical angles can be measured with respect to the local gravity vector, and horizontal angles can be measured from martian north. These angles are not related in any simple way to the azimuth and elevation angles given in "camera coordinates" for the uncorrected pictures.

There are other geometric distortions due to the camera: optic path distortion that affects a light ray after it passes the camera window; and camera-system distortions, or "roll-down" errors, that are caused by the way the cameras are mounted on the lander. The geometric transformation used in creating the mosaics took into account the optic path distortion but not the "roll-down" errors. However, along the horizon, the error in azimuth angle is equal to the rotational "roll-down" error for each camera to an accuracy of less than 1 pixel. The scale "azimuth angle from Mars north" has been adjusted to take into account this correction.

The residual azimuth angle errors are less than 1 pixel along the horizon and become larger with steeper elevation angles and larger lateral lifts. For the worst case, Lander 2, camera 1, this error is a maximum of 5.7 1 pixel at 60° elevation. The somewhat sinusoidal azimuth-dependent residual elevation error is a maximum of 3 1 pixel for Lander 2, camera 1, and approximately 1 pixel for the other cameras.
