#### DESCRIPTION OF SCENE

#### THE VIKING MISSION

#### VIKING LANDER MOSAICS

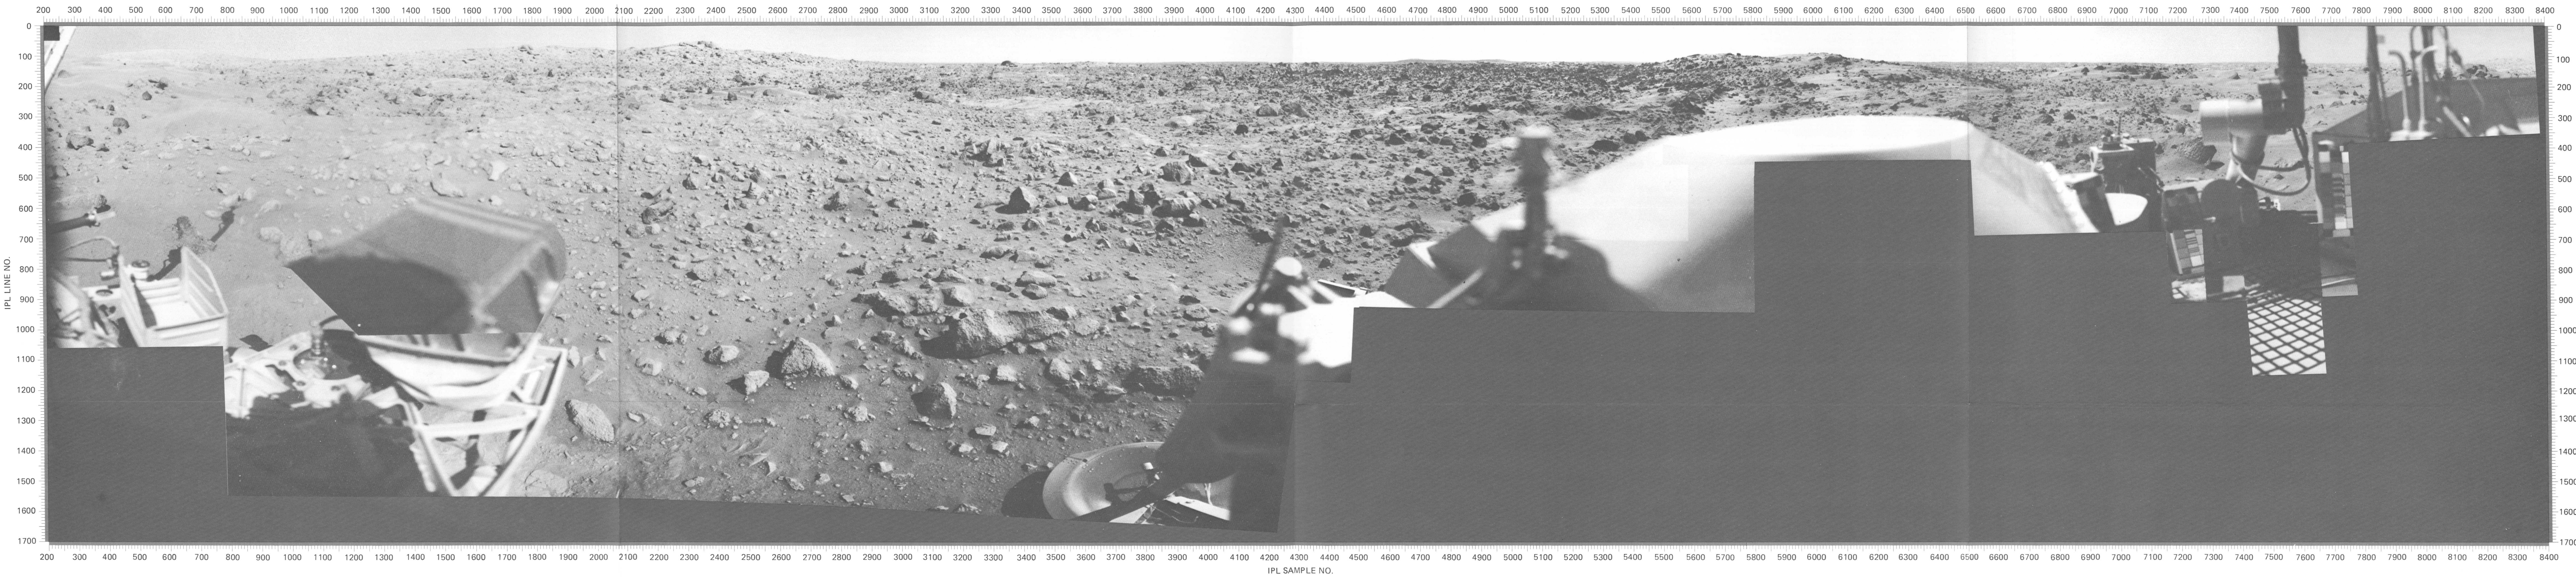
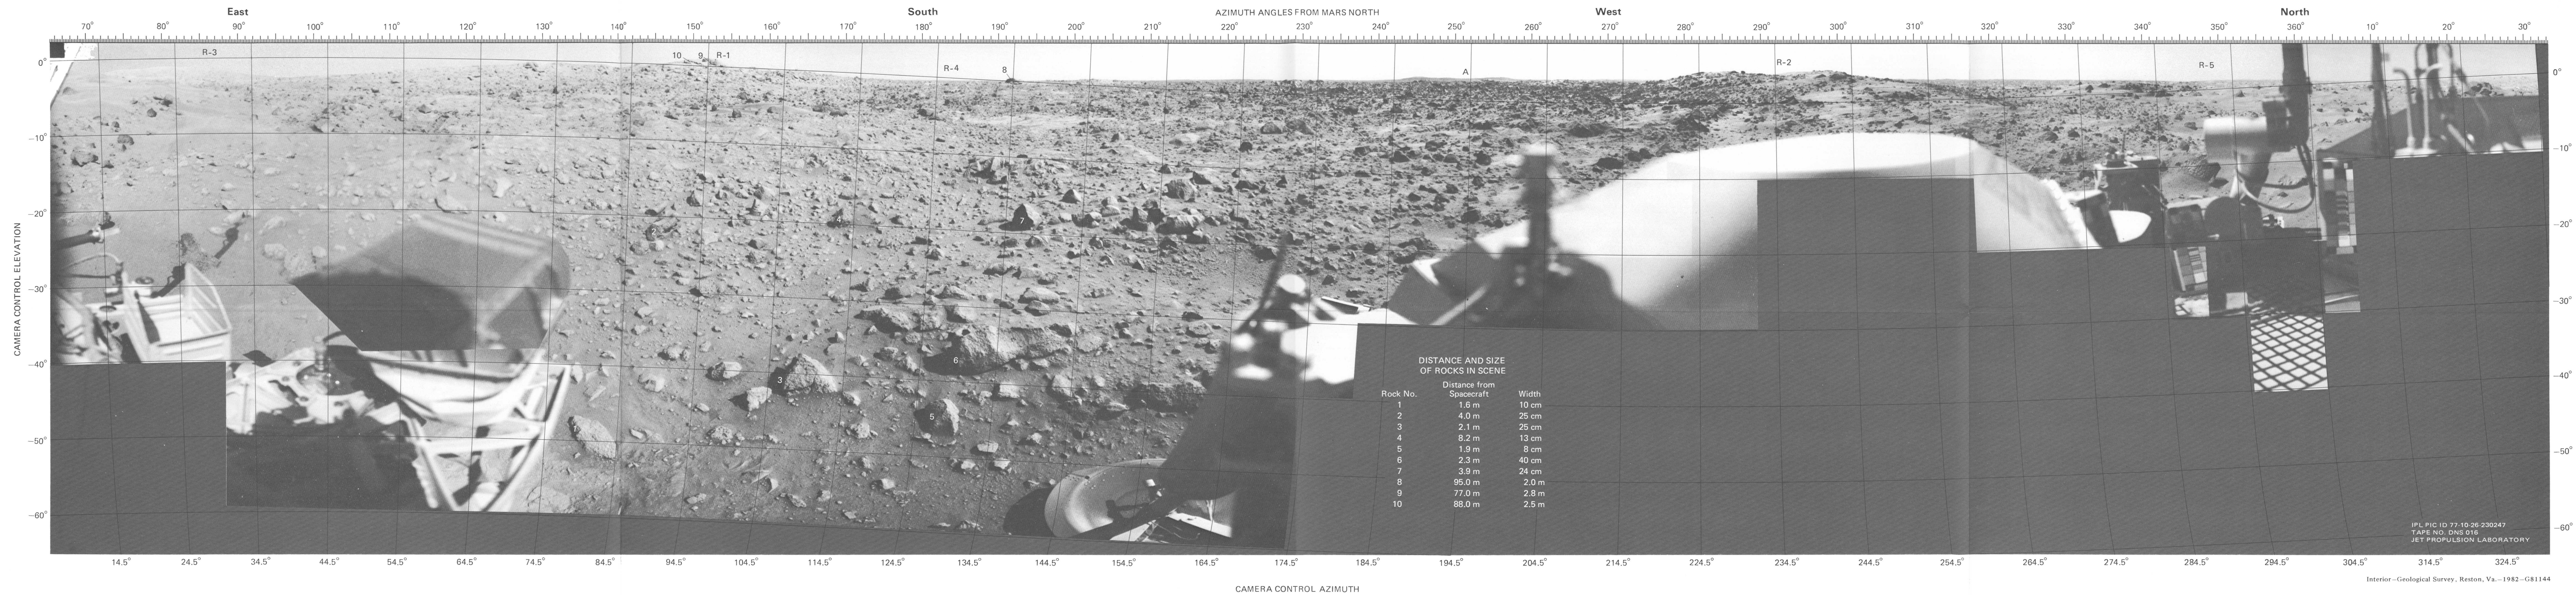
CAMERA CONTROL AZIMUTH

The Viking Lander 1 pictures show a surface strewn with rocks in the centimeters-to-meter-size range; several areas interpreted as bedrock are also present (line 310, sample 2570). Much of the foreground between the large blocks is blanketed by very fine grained (approximately 100  $\mu$ m) material that has been sculptured by martian winds into "tail"-bedded rocks (line 850, sample 2770). Light and dark drifts of this material can be seen among the blocks just below the near horizon at left center in the mosaic (line 190, sample 2080); these deposits are about 15 m from the lander. Larger drifts cover the surface at the far left. The drifts probably are remnants of a thick blanket of the very fine grained material that once covered the area and was subsequently eroded by wind. Large blocks on the near horizon in the upper left of the mosaic (line 70, sample 2300) are about 80 m from the lander; the largest block is about 3 m across. The blocks rest on the rim (R-1) of an old degraded crater (C). The far horizon at the center of the mosaic (line 130, sample 4100) is probably a ridge beyond the 3 km nominal horizon. Other distant ridges that project above the horizon are identified by number on the Viking Orbiter picture at the right. The rim of a 410 m diameter crater (A) 1.8 km southwest of the lander projects above the horizon near the center of the mosaic.

The bottom edge of the mosaic is about 1.7 m from the camera. Footprint 3 of the lander can be seen at the bottom center. Immediately above the footprint (line 1220, sample 3610) is a disturbed area or small crater made by the impact of a hollow metal canister that covered the surface sampler until after the landing on Mars; the canister was ejected from the sampler arm upon command from Earth. The windowed or scored appearance of the surface at the lower left was caused by exhaust from the rocket engines during landing. Small rock and fragments blown out by the exhaust made little pits and tracks in the fine-grained material as they rolled along the surface (line 850, sample 3970).

The cameras on the Viking Lander acquire by sampling in equal increments of elevation and azimuth angle. In the accompanying mosaic, 2.9 mm subtends a 1° horizontal or vertical angle, regardless of the place of measurement within the panorama. If the martian surface were flat, one pixel (0.04°) on the surface would be 1 mm wide at 60° camera elevation and 2 m wide at the horizon 3 km

away. Characteristically for this type of imaging system, most straight lines in the scene appear curved in the reconstruction. This representation of the picture data differs from that of a conventional camera having "point perspective" picture geometry, in which rays are projected from object space, through the perspective point in the camera lens, to an image plane in the camera.

The geometry of the lander pictures is complicated by additional factors. Because both landers are tilted with respect to the horizon, on the uncorrected pictures the horizon resembles a sine curve. Camera rectification of the pictures results in a straight horizon along which vertical angles can be measured with respect to the local gravity vector, and horizontal angles can be measured from martian north. These angles are not related in any simple way to the azimuth and elevation angles given in "camera coordinates" for the unrectified pictures.

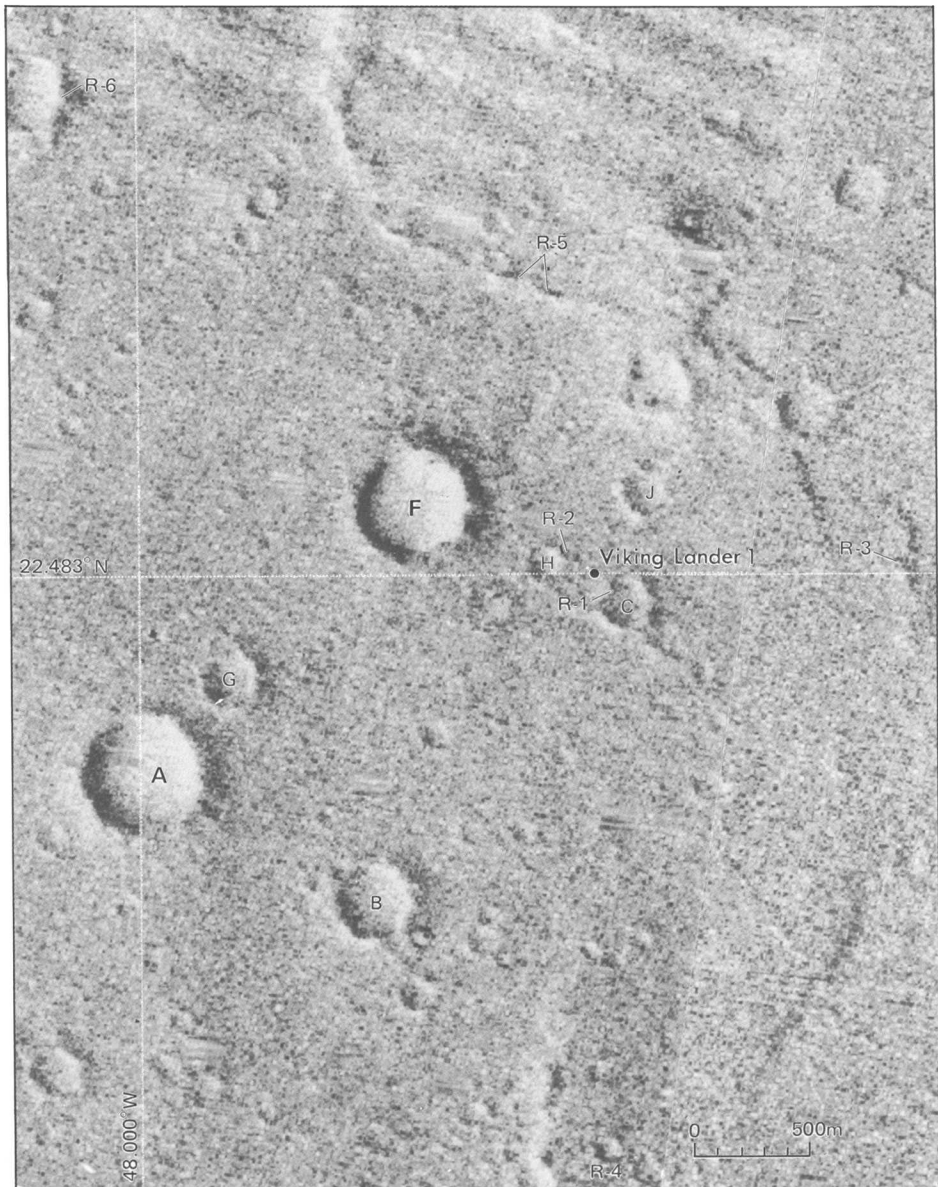
Viking Orbiter pictures 452810, 452811 showing the location of Viking Lander 1. Prominent ridges on the horizon in the lander pictures are designated by numbers; craters are designated by letters.
