COMPLETE MOSAIC, EVENING SCENE, CAMERA 1  
(Corrected for tilt)

THE VIKING MISSION

VIKING LANDER MOSAICS

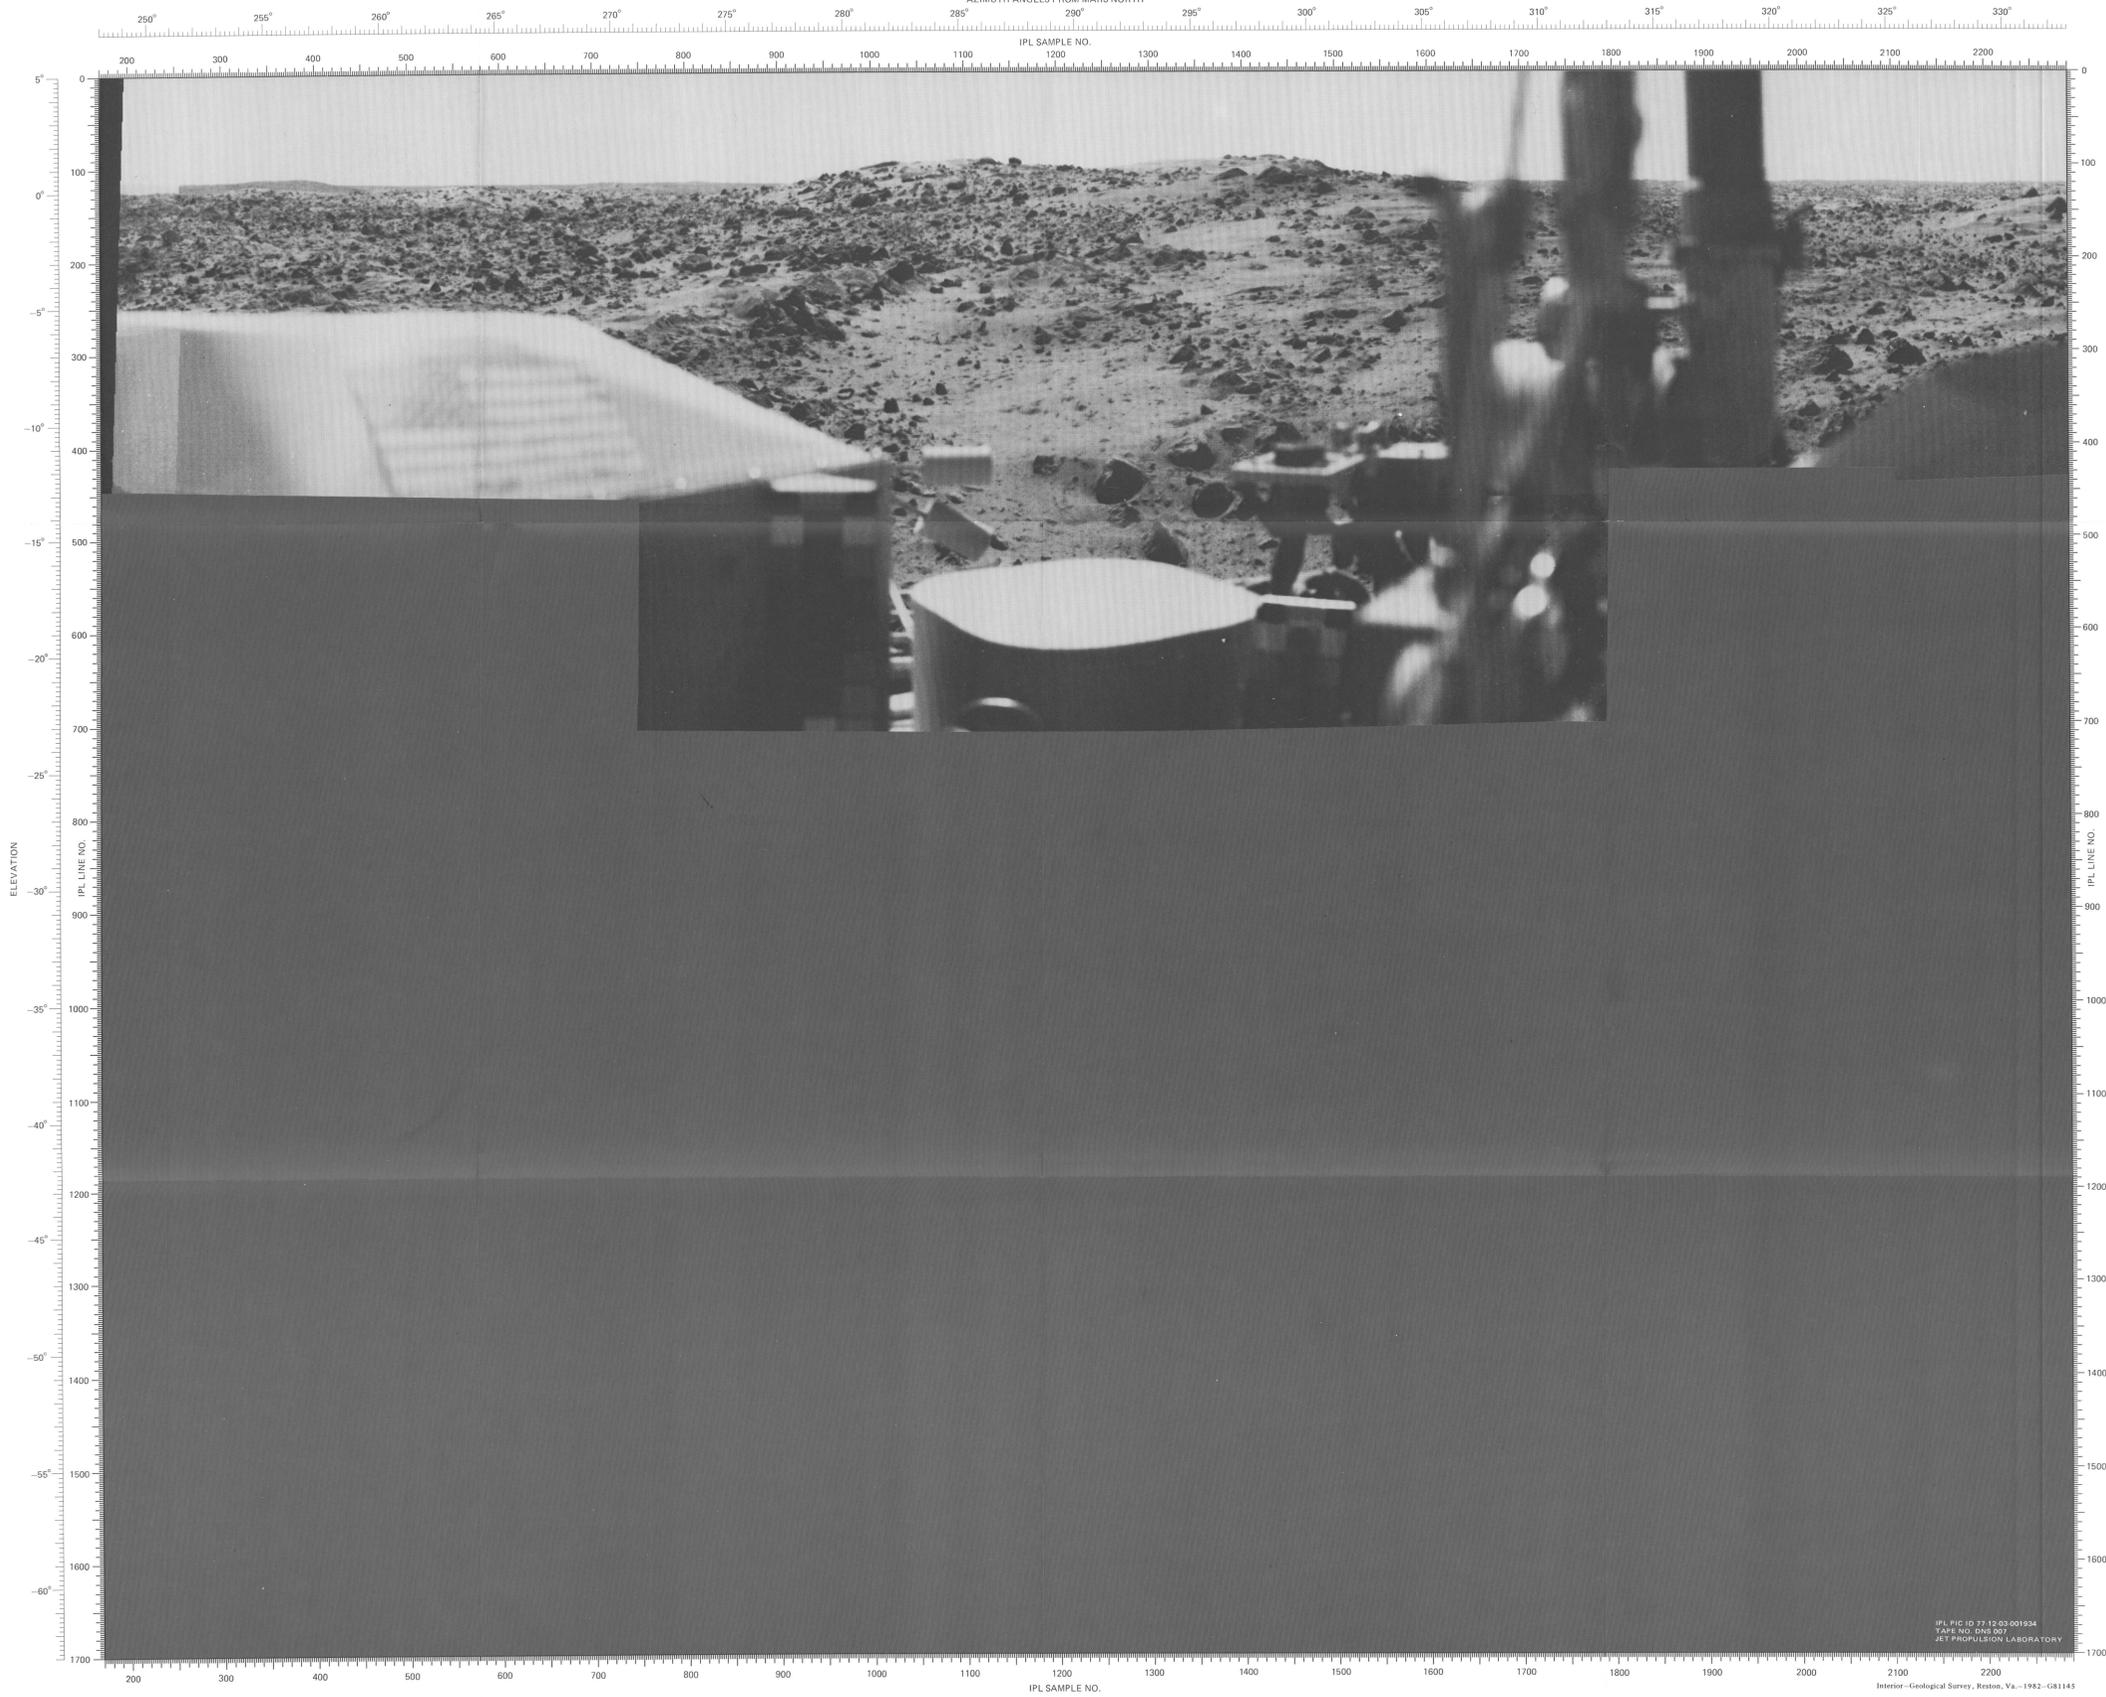
This view is seen over the top of the lander which faces southeast. A prominent ridge (line 100, sample 1300) dominates the horizon at the center of the scene. The ridge is part of the rim of Crater H, 100 m in diameter. The large rock (line 90, sample 1155) resting on the rim is about 50 cm across and 52 m from the lander. The lander is tilted down 3° to the northeast.

At the right center is the tubular mast of the high-gain 8-band antenna (line 100, sample 1930) that was used to communicate directly with Earth. The bright objects on each side of the mast are covers of the Radiosonde Thermoelectric Generators (RTGs) (line 350, sample 200, line 350, sample 2300). Other parts of the lander visible in the scene are one of three calibration charts for the cameras (line 400, sample 950), VHF relay antenna (line 430, sample 1100), and set-monometer (line 580, sample 1230).

The cameras on the Viking Lander acquire data by sampling in equal increments of elevation and azimuth angle. In the accompanying mosaic, 8 mm subtends a 1° horizontal or vertical angle, regardless of the place of measurement within the panorama. If the Martian surface were flat, one pixel (0.04° on the surface) would be 1 mm wide at 60° camera elevation and 2 m wide at the horizon 3 km away. Characteristically for this type of imaging system, most straight lines in the scene appear curved in the reconstruction. This representation of the picture data differs from that of a conventional camera having "point perspective" picture geometry, in which rays are projected from object space through the perspective point in the camera lens, to an image plane in the camera.

The geometry of the Lander pictures is complicated by additional factors. Because both landers are tilted with respect to the horizon, the uncorrected pictures the horizon resembles a sine curve. Computer rectification of the pictures results in a straight horizon along which vertical angles can be measured with respect to the local gravity vector, and horizontal angles can be measured from Martian north. These angles are not related in any simple way to the azimuth and elevation angles given in "camera event" data for the uncorrected pictures.

There are other geometric distortions due to the camera optic path distortion that affects a light ray after it passes the camera windows, and camera-system distortions, or "bold-down" errors, that are caused by the way the cameras are mounted on the lander. The geometric transformation used in creating the mosaics took into account the optic path distortion but not the "bold-down" errors. However, along the horizon, the error in azimuth angle is equal to the notational "bold-down" error for each camera to an accuracy of less than 1 pixel. The scale "azimuth angles from Mars north" has been adjusted to take into account this correction.

The residual azimuth angle errors are less than 1 pixel along the horizon and become larger with steeper elevation angles and larger lander tilts. For the worst case, Lander 2 camera 1, this error is a maximum of 5.7 ± 1 pixels at 60° elevation. The somewhat sinusoidal azimuth-dependent residual elevation error is a maximum of 3 ± 1 pixels for Lander 2 camera 1, and approximately 1 pixel for the other cameras.

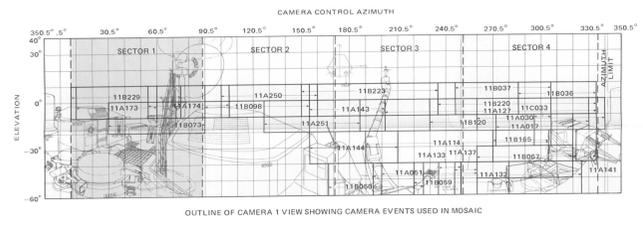
OUTLINE OF CAMERA 1 VIEW SHOWING CAMERA EVENTS USED IN MOSAIC

Procedures used for processing the Viking Lander camera data were described by Levinthal and others (1977). The individual camera events used in each mosaic are identified in the outline of the accompanying camera view. Detailed descriptions and reproductions of these camera events were given by Tucker (1978). Copies of the Viking Lander pictures can be obtained from the National Space Science Data Center, Goddard Space Flight Center, Greenbelt, MD, 20771.
