**VIKING LANDER MOSAICS**

**VIKING LANDER 2 PHOTOMOSAIC**  
**MORNING SCENE-CAMERA 1**

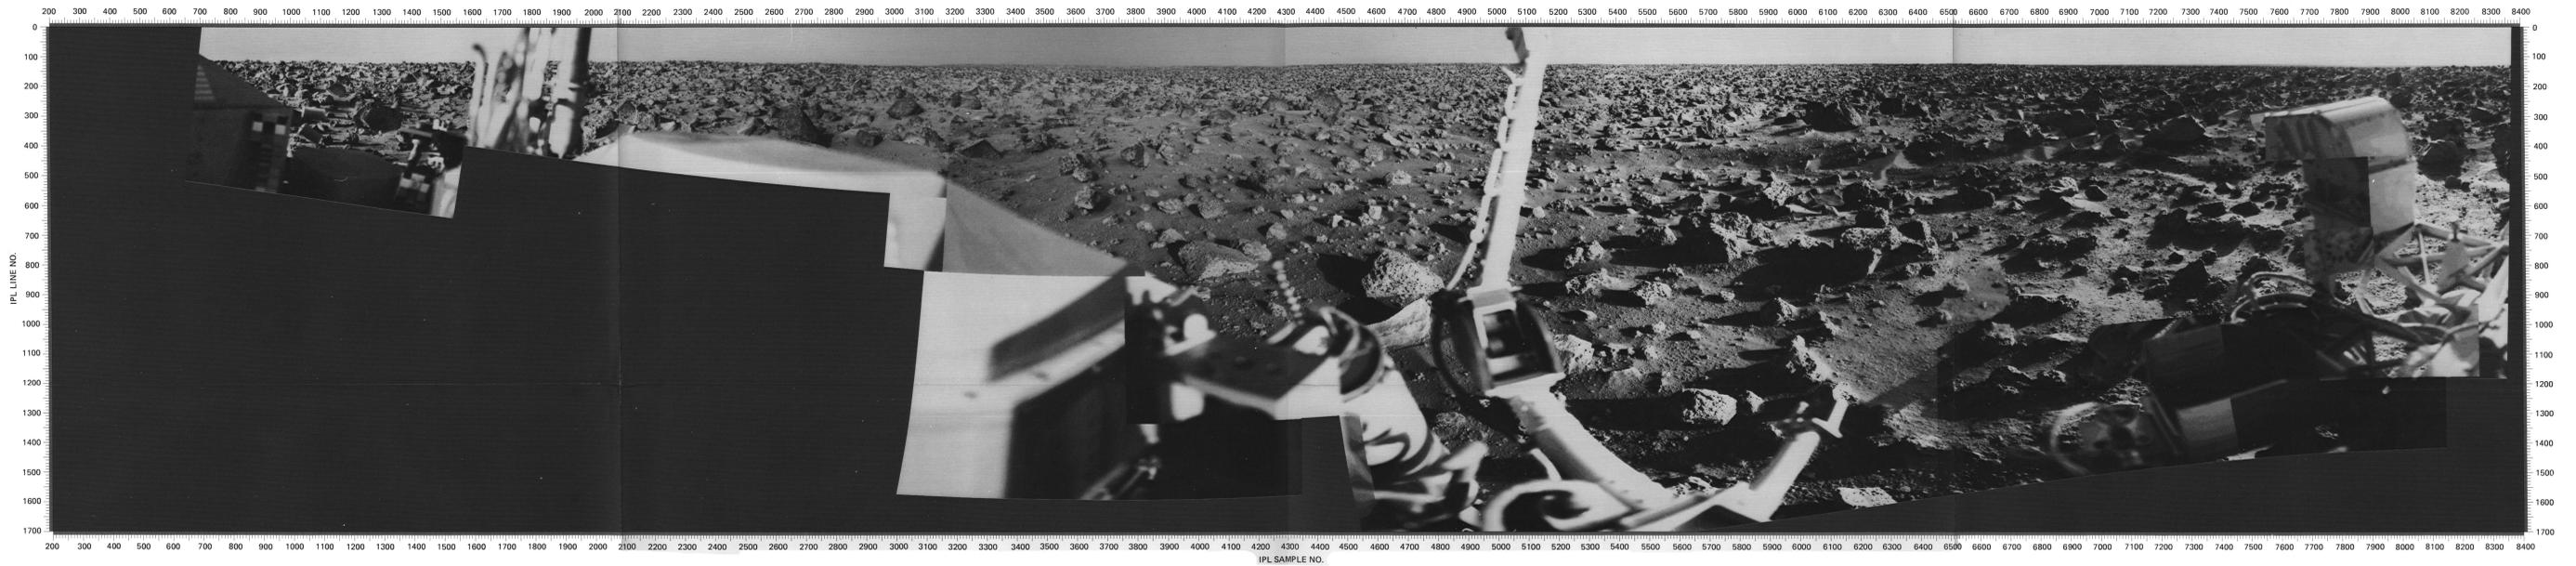
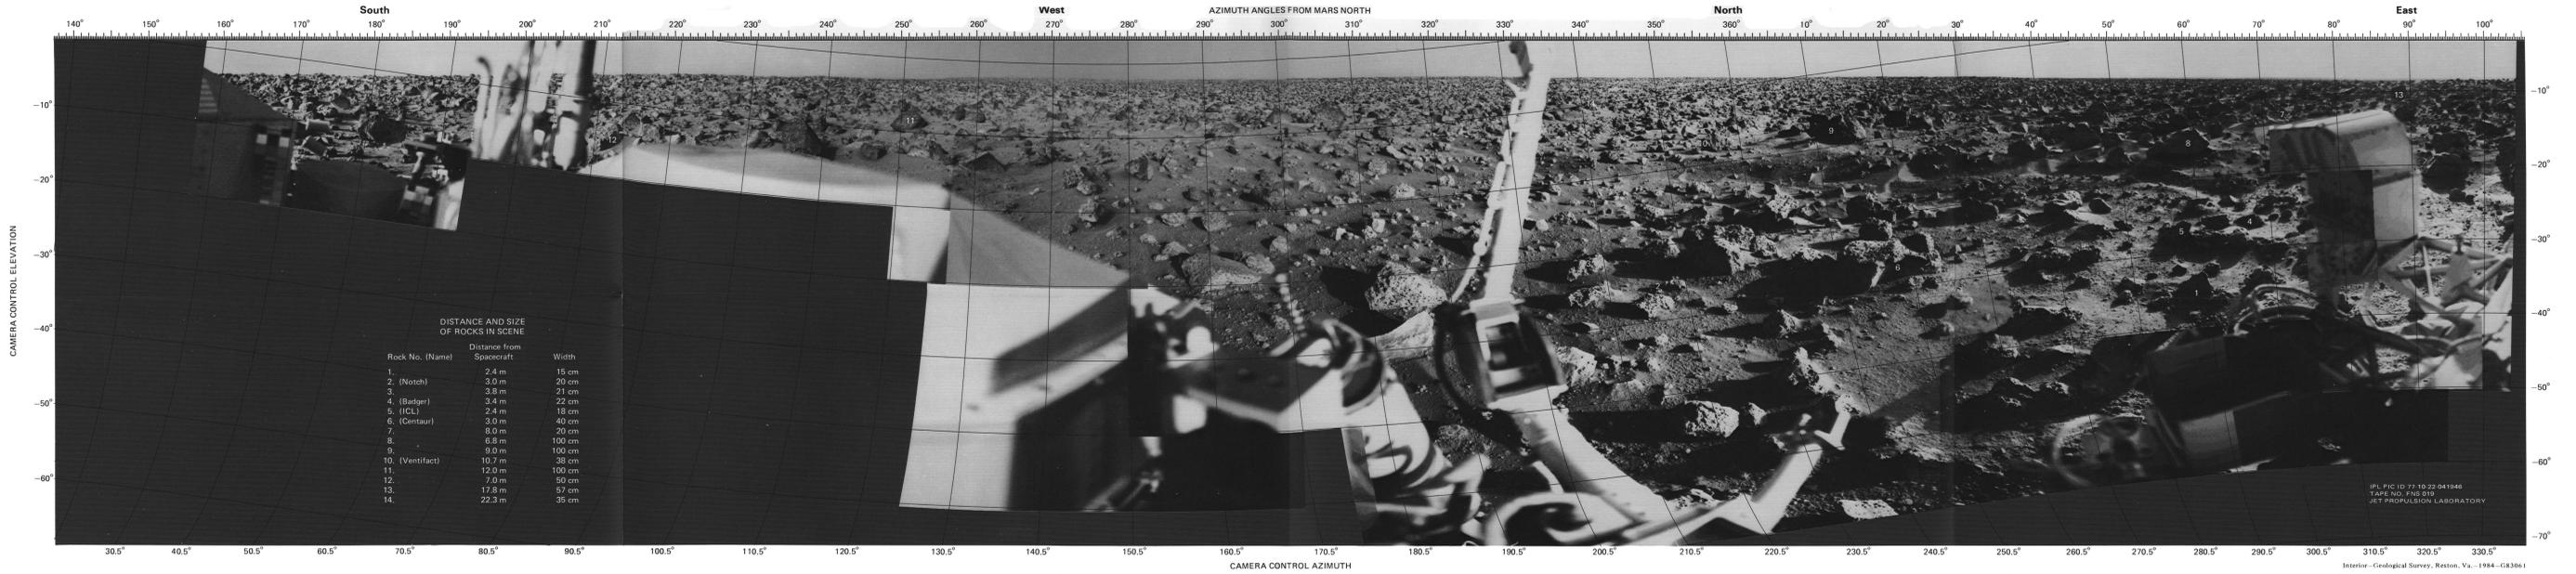
This panorama of the Viking 2 landing site on Utopia Planitia shows a flat, boulder-strewn landscape that is part of the vast plains that occupy much of the northern hemisphere of Mars. Large boulders are more numerous than at the Viking 1 site and are almost monotonous in their similarity to one another. Most boulders are sub-angular, equidimensional, and have numerous pits or holes a few millimeters to a few centimeters in diameter that impart a sponge-like appearance. The most obvious interpretation is that these pits are volcanic vesicles formed by solidification from a frothy gas-charged lava. In the interblock areas is a fine-grained material that in some places is banked into small drifts between blocks (line 325, sample 7100), and in other places forms patches of pebbly fragments (line 1000, sample 5600). The surface has a windwept or scoured appearance, and some boulders appear to stand on pedestals of protected fine-grained material (line 330, sample 5200). In many of the interblock areas, the fine material forms a discontinuous crust which breaks into dirty fragments (line 870, sample 6450). A series of intersecting troughs, typically 1 m wide and 10-15 cm deep, are seen at the Lander 2 site and not at the Lander 1 site (line 300, sample 6460; line 550, sample 7450). Several small drifts of fine-grained material occupy the floor of the troughs (line 455, sample 5600) and are relatively free of boulders. The trough form a polygonal network that probably developed from contraction either by cooling of lava or from thermal expansion and contracting of frozen ground. Desiccation of water-saturated soils could also cause similar cracking.

Several flag-topped bluffs or plateaus are barely visible in the far distance just above the horizon (line 125, sample 8500); these features may be parts of ejecta flow lobes from the large impact crater, Mic, that lies about 170 km east of the Lander site.

Parts of the spacecraft visible in the panorama from the left are: the cover of a Radiolabeler Thermoelectric Generator (RTG) (line 200, sample 800); color test chart for calibration of the camera (line 400, sample 900); seismology instrument (line 500, sample 1200); a second color test chart (line 550, sample 1400); tubes and mast of the high gain 58-dB antenna (line 200, sample 1900); the second RTG cover (line 530, sample 2600); support structure (line 1130, sample 4200); stroke arm (line 900, sample 4200) and shock absorber of Leg 2 (line 1250, sample 4600); the boom on which the meteorological instruments are mounted (line 320, sample 5100); sun-brush assembly for closing magnets on the backhoe of the surface sampler (line 1300, sample 6100); the housing used to store the meteorological instruments during transit to Mars (line 1200, sample 7500); and the surface sampler (line 300, sample 7800). Only part of the surface sampler is shown in the mosaic of three pictures. Most picture-taking sequences for the Viking cameras were planned to avoid parts of the Lander and to image as much of the surface as possible.

The bottom edge of the panorama is about 1.7 m from the camera. If the surface were perfectly smooth and level, the horizon would be 38m away.

The Viking Lander cameras acquired many high-resolution pictures of the Utopia Planitia and Utopia Planitia landing sites. This representation of the picture data differs from that of a conventional camera having "point perspective" picture geometry, in which rays are projected from object space, through the perspective point in the camera lens, to an image plane in the camera. The geometry of the Lander pictures is complicated by additional factors. Because both landers are tilted with respect to the horizon, on the uncorrected pictures the horizon resembles a sine curve. Computer rectification of the pictures results in a straight horizon along which vertical angles can be measured with respect to the local gravity vector, and horizontal angles can be measured from meridian north. These angles are not related in any simple way to the azimuth and elevation angles given in "camera coordinates" for the uncorrected pictures.

There are other geometric distortions due to the camera's optic path distortion that affects a light ray after it passes the camera windows and camera-system distortions or "roll-down" errors, that are caused by the way the cameras are mounted on the lander. The geometric transformation used in creating the mosaics took into account the optic path distortion but not the "roll-down" errors. However, along the horizon, the error in azimuth angle is equal to the rotational "roll-down" error for each camera to an accuracy of less than 1 pixel. The scale "azimuth angles from Mars north" has been adjusted to take into account this correction.

The residual azimuth angle errors are less than 1 pixel along the horizon and become larger with steeper elevation angles and larger lander tilts. For the worst case, Lander 2, camera 1, this error is a maximum of 5.7 ± 1 pixels at 40° elevation. The somewhat sinusoidal azimuth-dependent residual elevation error is a maximum of 3 ± 1 pixels for Lander 2, camera 1, and approximately 1 pixel for the other cameras.
