IPL PIC ID 77-10-10-213201  
JET PROPULSION LABORATORY

Interior-Geological Survey, Reston, Va.—1984—G83063

**VIKING LANDER 2 RECTIFIED PHOTOMOSAIC  
EVENING SCENE - CAMERA 1 - SECTOR 3**

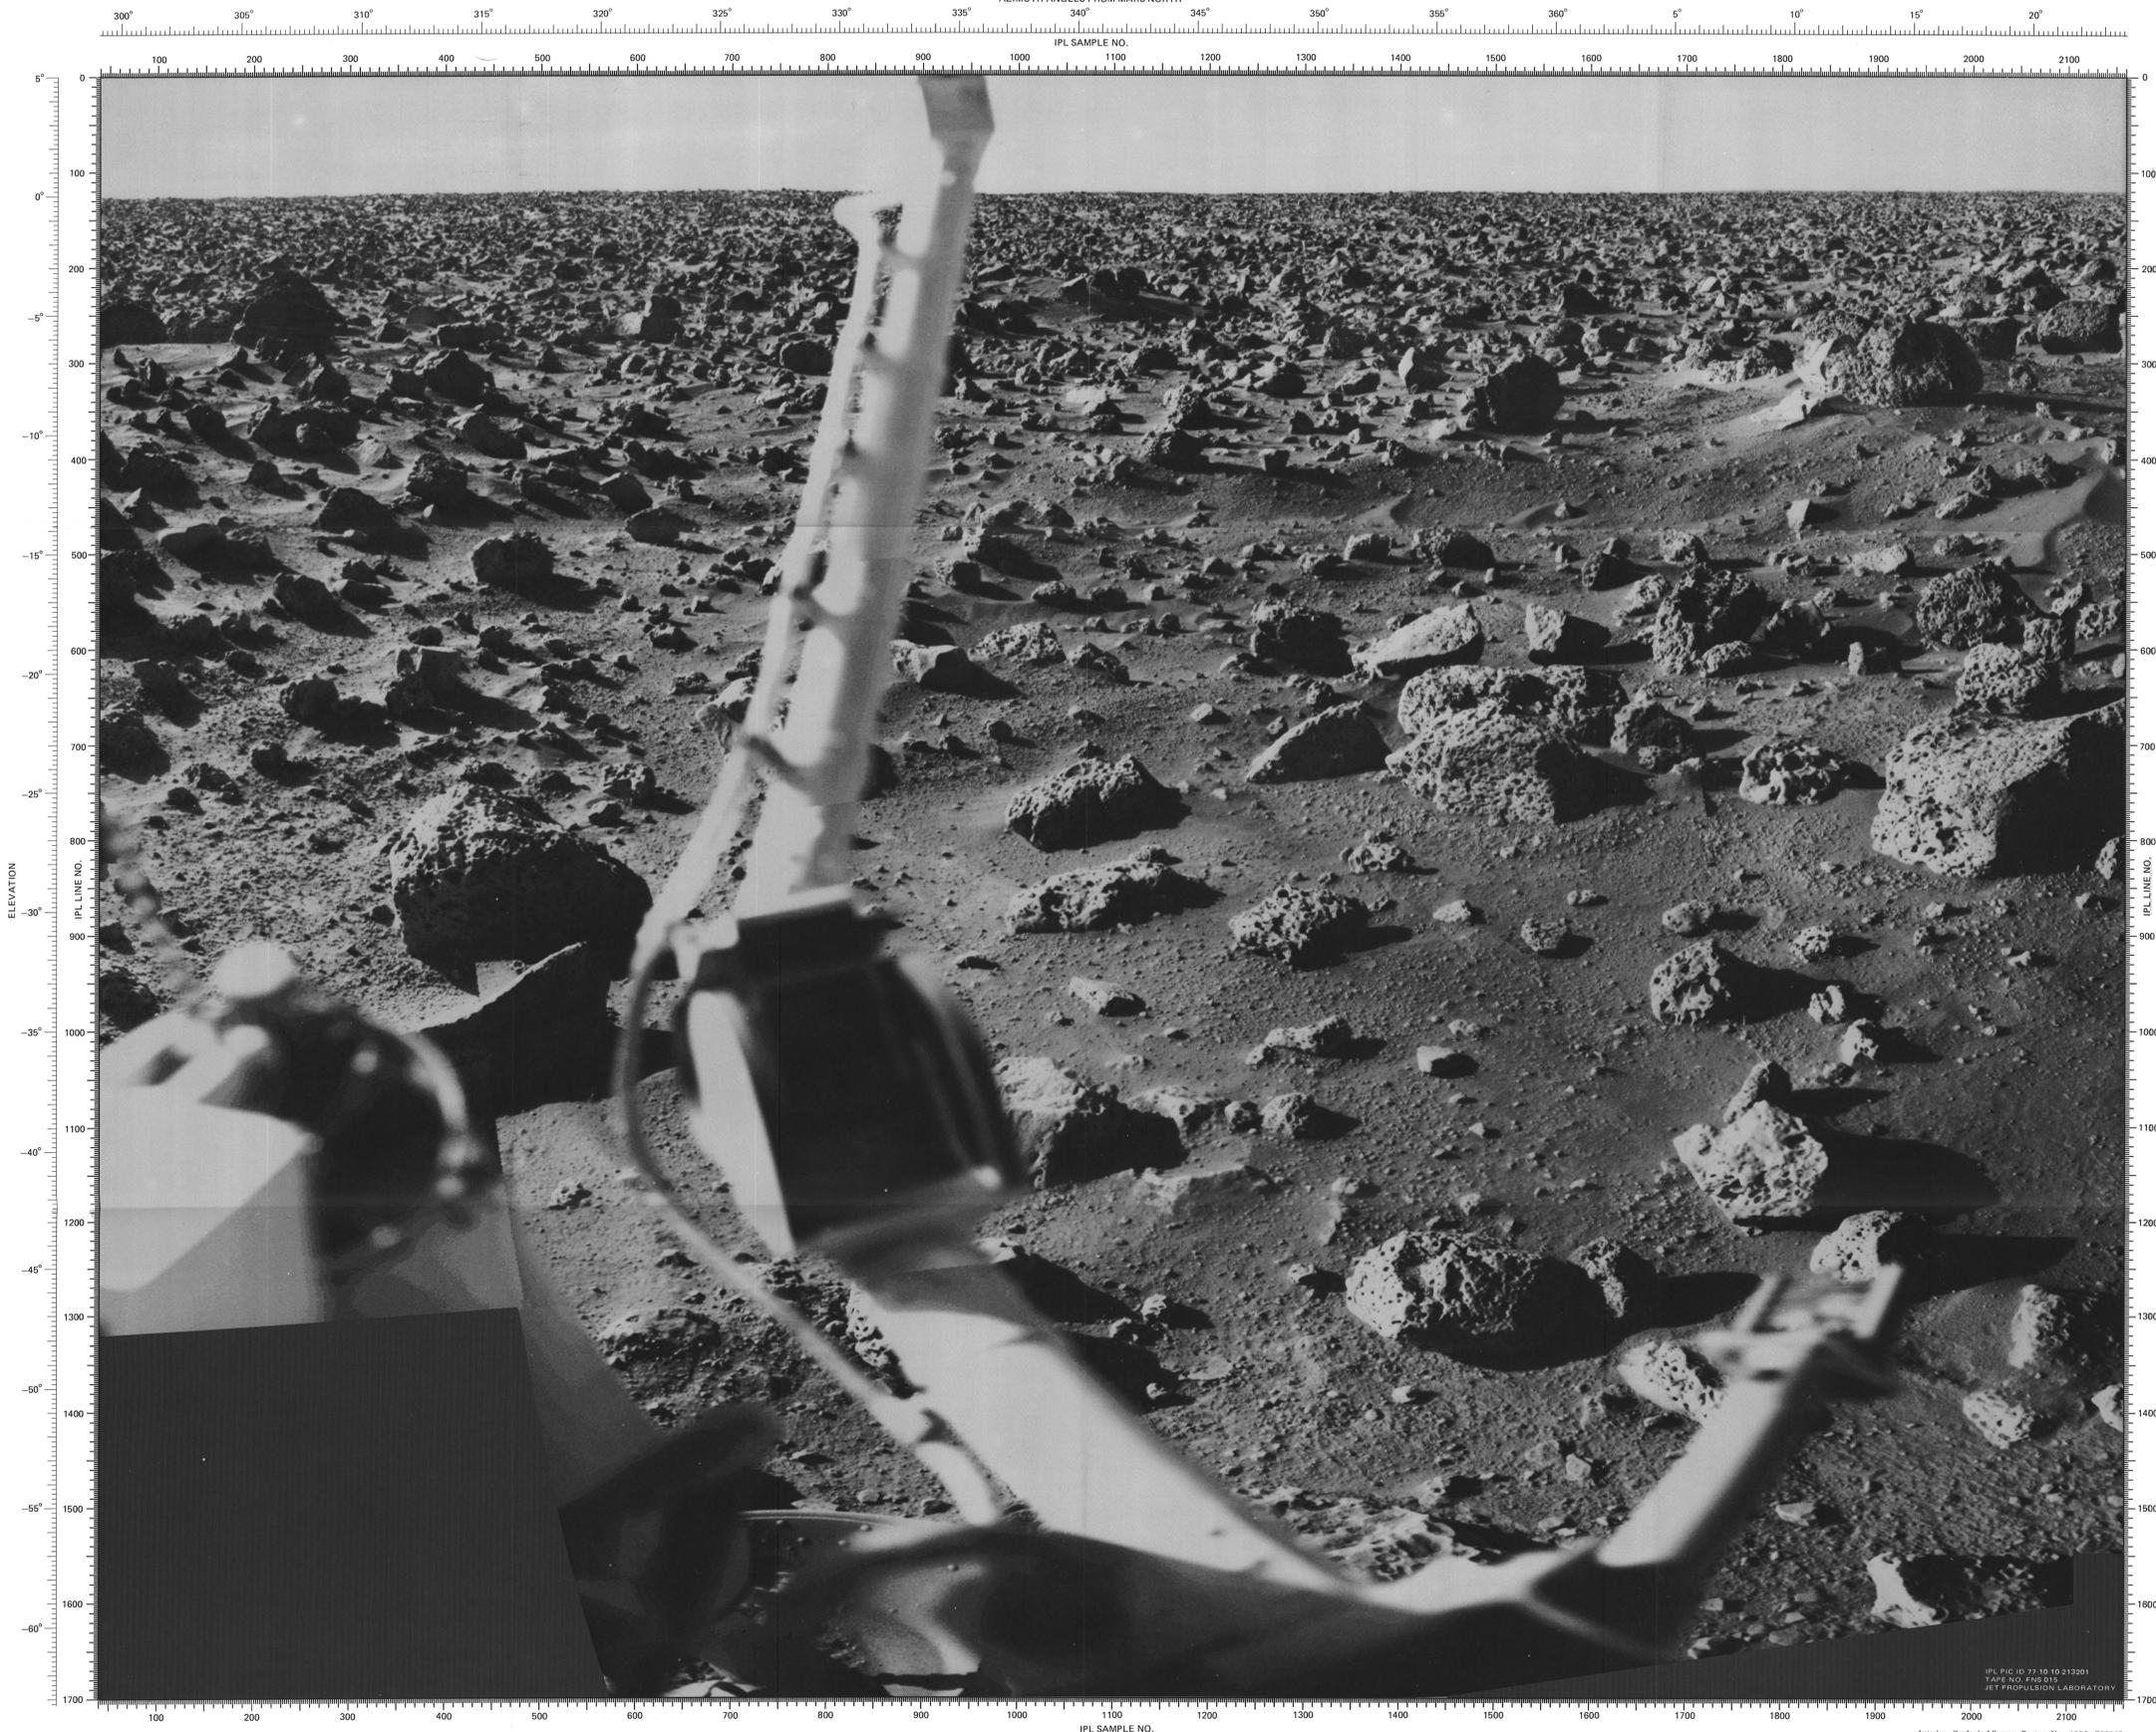
North of the lander the scene is a flat, boulder-strewn landscape. The boulders are highly pitted or vesicular. The vesicles probably originated from gas bubbles in cooling lava. The interblock areas are composed of fine-grained material that is bound in a coherent crust that breaks into shaly fragments (line 1200, sample 2100). A shallow trough crosses the near field (line 320, sample 430, to line 450, sample 2200), trending approximately east-west. The trough is 8 m from the lander, about 1 m wide, and 10 cm deep. Small drifts (10 cm high) of fine-grained material occupy the floor of the trough (line 460, sample 1400). The trough is part of a polygonal network suggesting that the trough may have formed from cracks resulting from contraction owing to either cooling of a basaltic lava flow or thermal expansion and contraction of frozen ground.

The mosaics are composites of the best pixels of all the Lander pictures used for each sector. In the computer mosaicking process, the image data derived from the camera events for each sector were assigned priorities on the basis of quality of detail. These data were examined by the computer to sequence according to the priorities, and the best pixel of each scene was used to compose the mosaic.

The geometry of the Lander pictures is complicated by additional factors. Because both landers are tilted with respect to the horizon, the uncorrected pictures of the horizon resemble a sine curve. Computer rectification of the pictures results in a straight horizon along which vertical angles can be measured with respect to the local gravity vector, and horizontal angles can be measured from martian north. These angles are not related in any simple way to the azimuth and elevation angles given in "camera coordinates" for the unrectified pictures.

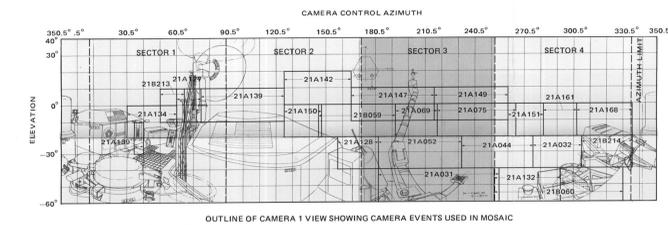
OUTLINE OF CAMERA 1 VIEW SHOWING CAMERA EVENTS USED IN MOSAIC

Procedures used for processing the Viking Lander camera data were described by Levinthal and others (1977). The individual camera events used in each mosaic are identified in the outline of the accompanying camera view. Detailed descriptions and reproductions of these camera events were given by Tucker (1978). Copies of the Viking Lander pictures can be obtained from the National Space Science Data Center, Goddard Space Flight Center, Greenbelt, MD, 20771.

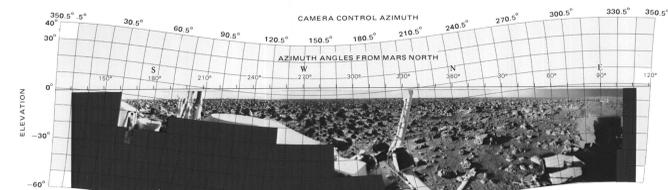
COMPLETE MOSAIC, EVENING SCENE, CAMERA 1  
(Corrected for tilt)

Each complete mosaic extends 342.5° in azimuth, from approximately 5° above the horizon to 60° below. A complete mosaic incorporates approximately 15 million picture elements (pixels). In order to manage the processing of such large data bases, each mosaic was compiled from four individual azimuthal sectors.

The cameras on the Viking Lander acquire data by sampling in equal increments of elevation and azimuth angle. In the accompanying mosaic, 8 mm subtends a 1° horizontal or vertical angle, regardless of the place of measurement within the panorama. If the martian surface were flat, one pixel (0.04°) on the surface would be 1 mm wide at 60° camera elevation and 2 m wide at the horizon 3 km away. Characteristically for this type of imaging system, most straight lines in the scene appear curved in the reconstruction. This representation of the picture data differs from that of a com-
