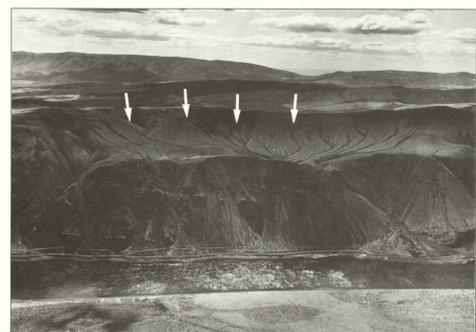
View 2.—Mc Coy Canyon landslide area. This slump block in the Yakima Basalt Subgroup of Umtanum Ridge probably was formed during the Pleistocene. Slump block is about 2.0 mi (3.2 km) wide (left to right) and 100 ft (30.5 m) high. Arrows indicate head scarp.

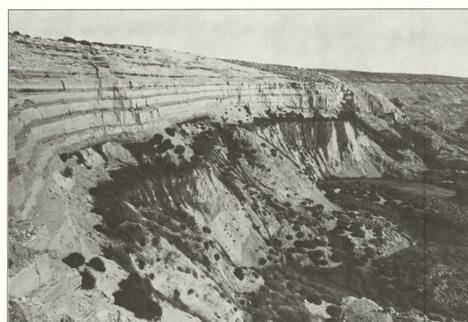
View 3.—Landslide scarp, Locke Island landslide area. Note seepage line at contact between top of Ringold Formation and overlying silts and sands. Scarp here is about 150 ft (45 m) high.

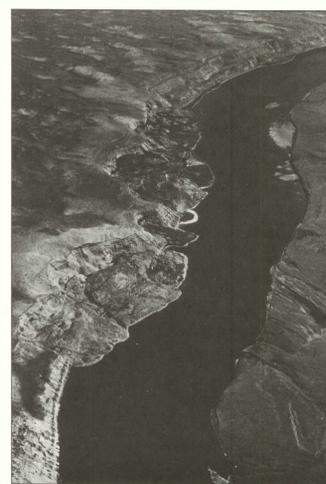
View 4.—Locke Island landslide area, looking down Columbia River toward the southeast. Earth slumps, avalanches, and flows are active here in the Ringold Formation. Active landslide area is about 1.5 mi (2.5 km) long. Maximum height of bluff above river is about 330 ft (100 m). Land mass at right is Locke Island.

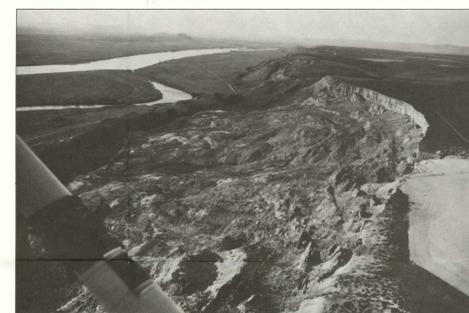
View 5.—Savage Island landslide area. These earth slumps, avalanches, and flows in the Ringold Formation have been active since 1973. Note irrigated and plowed fields that are being encroached upon by landslide head scarp. Landslide measures about 0.25 mi (0.4 km) in direction of movement (right to left); its cross dimension (into the photograph) is about 0.75 mi (1.2 km). Maximum height of head scarp is 80 ft (25 m).

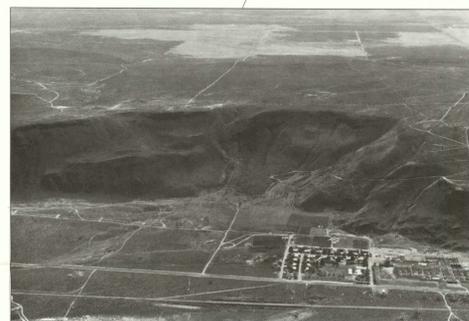
View 1.—Juniper Springs landslide area. This landslide mass in the Yakima Basalt Subgroup of Umtanum Ridge consists of one large landslide block and many smaller chaotic landslides. It is probably of Pleistocene age. Height of landslide and head scarp is about 750 ft (225 m).

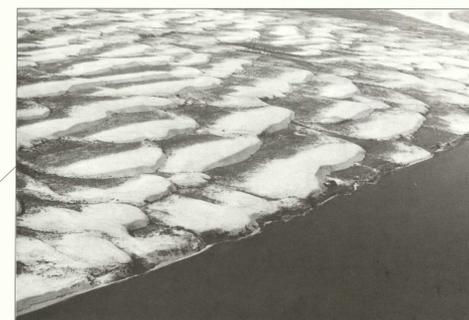
View 6.—Active sand dunes along the west bank of the Columbia River. Prevailing winds are from the west (upper left). The longest dimension (transverse to wind) of the largest dunes is about 1,000 ft (305 m).

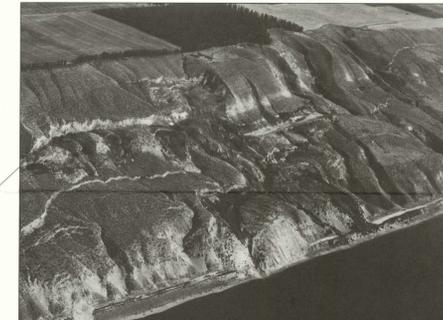
View 7.—Johnson Island landslide area. Note recent landslides in the Ringold Formation that have blocked county road along the east bank of Columbia River. Height of bluff is about 530 ft (160 m).

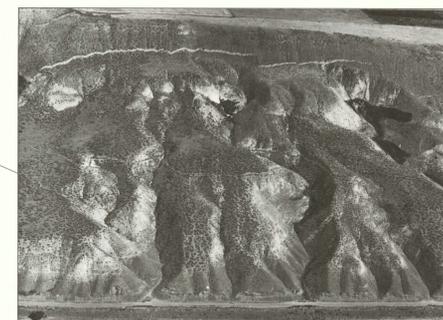
View 8.—Bluffs along the Columbia River at southern end of Johnson Island landslide area. Note large new tension crack near top of bluffs. This crack, which has a scarp height of as much as 10 ft (3 m), is an indication of possible future slope movement.
