HYDRAULIC MAP OF HOUSE ROCK RAPIDS, GRAND CANYON, ARIZONA

By
Susan Werner Kiefer
1988

Hydraulic data collected in October–November 1985 by Susan Werner Kiefer, assisted by Megan Marley. Contour lines compiled on analytical stereograms at the U.S. Geological Survey, Flagstaff, Arizona, from aerial photographs flown in 1984 by the Bureau of Reclamation, Series 025. Although a variety of hydraulic features by Patricia Wagner, U.S. Geological Survey. Prepared on behalf of the Bureau of Reclamation under Interagency Acquisition No. 8-44-40-04190.

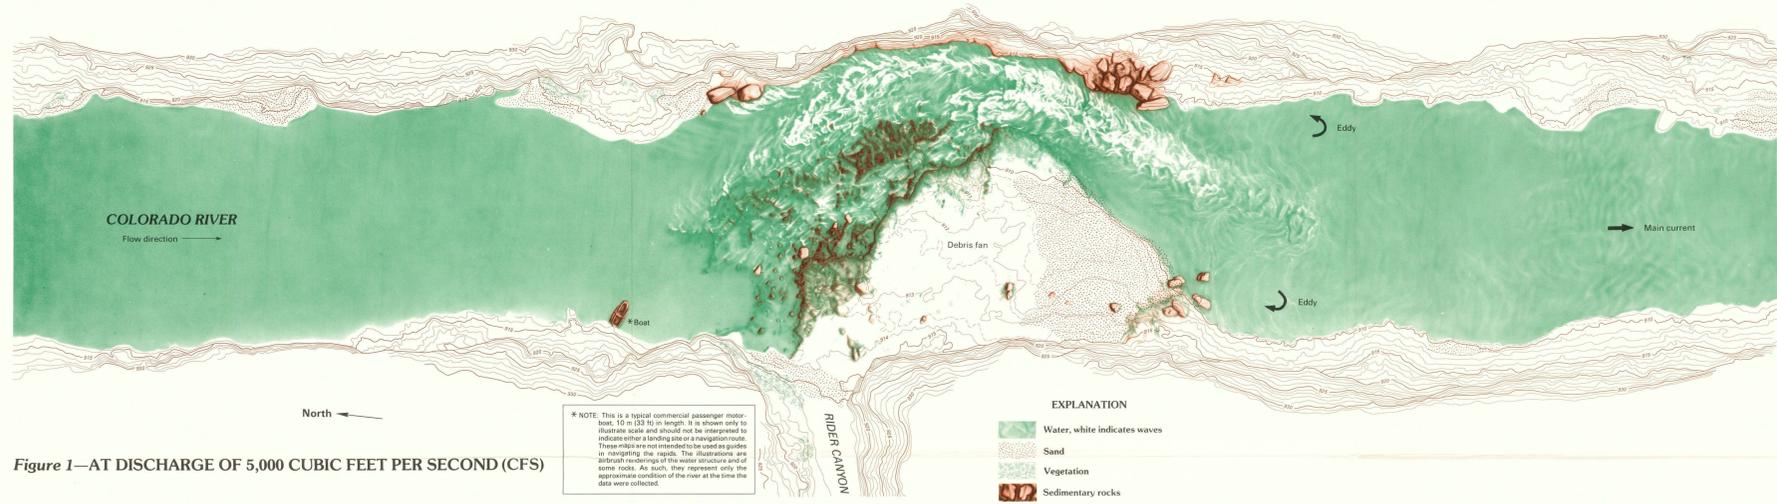
House Rock Rapids is caused by a debris fan from Rider Canyon (figs. 1 and 2). The drop of the water surface through the rapids is approximately 4 m at 5,000 cubic feet per second (cfs) (from approximately 913.5 m to 909.5-m elevation, fig. 3). As discharge changes, the average slope of the water surface in the rapids changes: at 5,000 cfs, the average slope is about 1 ft/100 ft, whereas at 30,000 cfs, the average slope is only about 0.75 ft/100 ft. Centrifugal force pushes the water higher on the east wall than on the west debris fan (this effect is especially prominent from the shoreline shown in fig. 2).

The Rider Canyon debris fan has forced the Colorado River over to the east wall of the canyon. Much of the Rider Canyon debris fan is exposed when the discharge is below 5,000 cfs (fig. 1); however, water ponds behind the fan (in the vicinity of the boat shown in fig. 1) even at low discharges. Because the debris fan has a shallow gradient everywhere, high discharges cause water from this pond to spill across the fan into a backwater in Rider Canyon, as shown at 30,000 cfs in figure 2.

The flow pattern in the main channel is determined by the constrictions and divergences of the channel; these changes in channel shape occur both laterally (map view, fig. 1) and vertically (cross sections, fig. 4). For a general discussion and hydraulic analysis of the flow patterns in rapids, see Kiefer (1985, 1987).

The runoff from the rapid (F, fig. 3) consists of six to seven gently breaking waves and several minor swells that appear to be in flow that is at $Fr = 1$. There are eddies (H and I, fig. 3, and indicated schematically in figs. 1 and 2) both east and west of the main current below the rapid. The west eddy is the larger and can produce a large sandy beach at high flows if sediment is available (J, fig. 3). Note the reverse flow in the eddy (shown schematically in figs. 1 and 2) and in cross section Z-Z' (fig. 4). The shearing between the eddies and main jet produces pronounced vortices and small whirlpools in the region of the tailwaters.

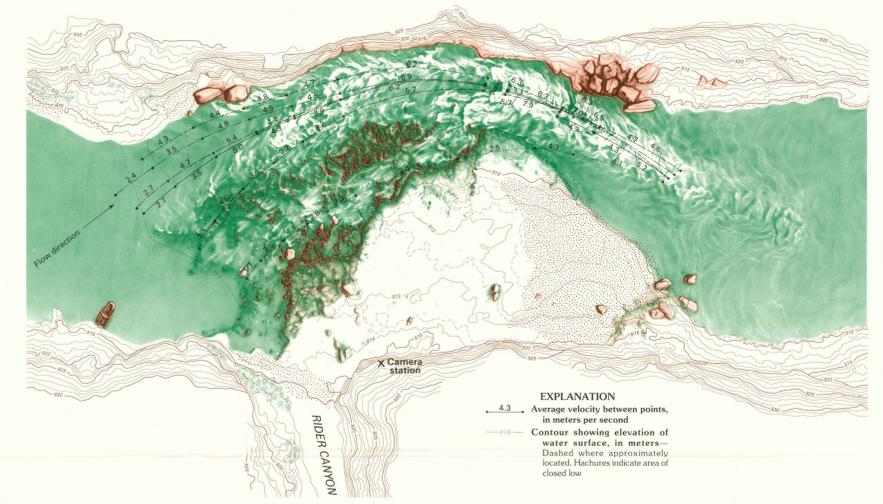
At discharges higher than about 30,000 cfs, the only significant wave in House Rock Rapids is a right-lateral wave at the top of the rapids where the water begins to converge into the channel narrowed by the debris fan (approximately 0.4 m/s at 5,000 cfs, compare with fig. 2). At 30,000 cfs (fig. 2) the stage of the river is about 3 m higher above the rapid and 5 m higher below the rapid than it is at 5,000 cfs. Velocities of the river have not been measured at 30,000 cfs; however, they are probably not dramatically different from the values obtained at 5,000 cfs. If so, the increase in depth in the main channel with increasing discharge is sufficient to cause the Froude number to drop from the values above unity (1.8 in the constriction at Y-Y') to below unity. Thus, the absence of waves on the east side of the river at House Rock Rapids during high discharges reflects the change of the flow regime in the main channel to subcritical flow conditions. The only area of supercritical flow at high discharges is along the west part of the channel where the flow is shallow over the upstream side of the debris fan.

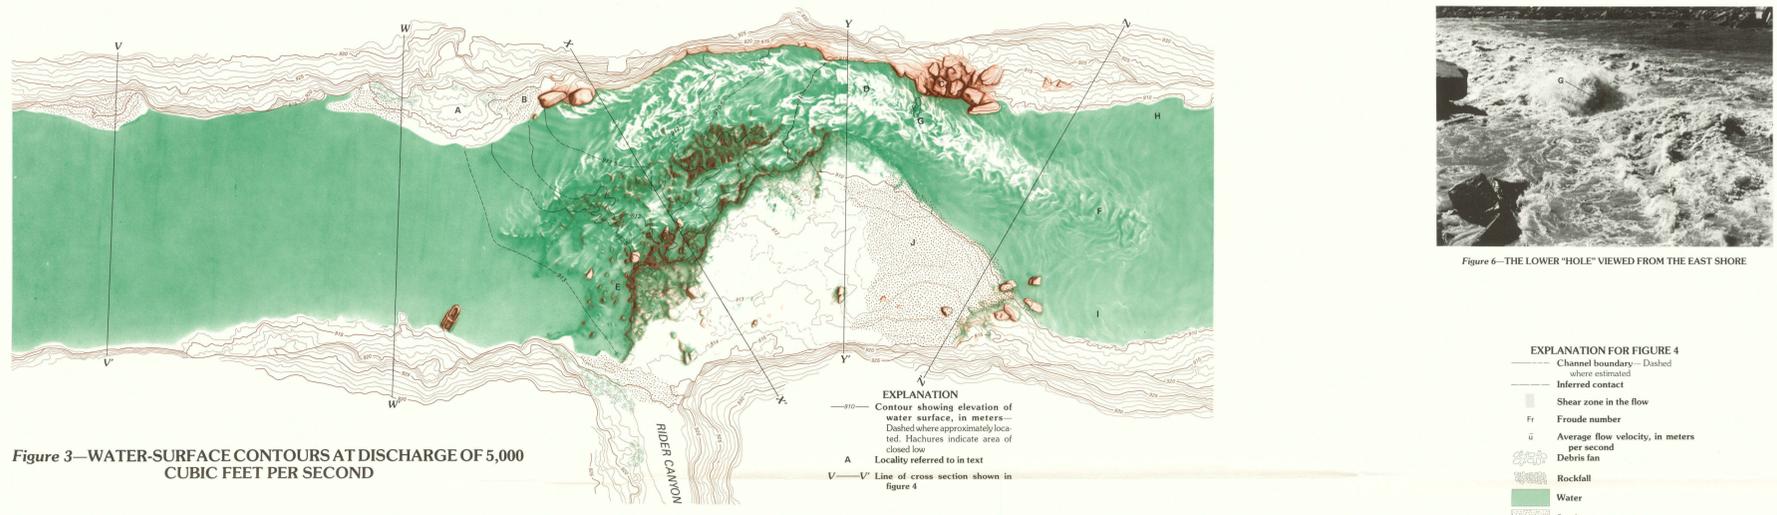
Discharge in all cross sections (fig. 4) is 5,000 cfs. Depths in the cross sections V-V' and W-W' (fig. 4) were measured during lathometer traverses; depths in the other cross sections (fig. 3) were calculated from the mass continuity equation as described in Kiefer (1987). Streamlines (paths of floats) and velocities of floats launched upstream of the rapid (fig. 5) were determined from Super 8 motion pictures taken from the camera station indicated. The floats and experimental technique were described by Kiefer (1987). Each velocity (fig. 5) refers to the section of streamline between dots adjacent to the velocity numeral; the different dash and dot patterns are used to distinguish float trajectories.

Between W-W' and X-X', the water surface drops 1.5 m (at 5,000 cfs) and the channel bottom rises about 3 m back to the elevation of 909 m. At 5,000 cfs, the average water depth at X-X' is about 2 m. The water surface drops another 1 m between X-X' and Y-Y', but the elevation of the bottom appears to be relatively constant at about 909 m; the flow reaches its minimum average depth of only about 1 m in the constriction. The drop of water surface elevation in the diverging section of the channel is small (approximately 0.5 m between Y-Y' and Z-Z'), but the bottom elevation drops, reaching 907 m at Z-Z'.

These data indicate a local point of minimum elevation (906 m) in the channel bottom topography above House Rock Rapids (cross section W-W'). This "hole" may represent local bed of bedrock (or very coarse, relatively immobile debris) above which (upstream) fine-grained sedimentary deposits (silt and sand) mantle the channel and below which (downstream) coarse boulders from the Rider Canyon debris fan mantle the channel. If this interpretation is correct, the sand deposits may have been about 3 m thick (between the elevations of 906 and

909 m) at the time the lathometer and velocity measurements were made (November 17, 1986, during fluctuating flow from Glen Canyon Dam; compare V-V' and W-W' in fig. 4). Debris transported downstream from the debris fan may mantle the bedrock channel as far as several hundred meters below the rapid. Where the bedrock channel is covered by sedimentary deposits (particularly, fine material upstream of a rapid), the geometry can be expected to change with discharge and with sediment load of the river.

The standing waves of House Rock Rapids are features in supercritical flow. In the converging part of the channel, water accelerates down a smooth tongue into a trough and breaking wave (D, fig. 3). The turbulence in the breaking wave is sufficient to entrain air into the water so that clear (nonbubbly) water of the tongue becomes a bubbly foam in this wave. Downstream of this aerating wave, a large hole and wave stand where water pours over the large rocks on the east shore (G, fig. 3, fig. 6). As shown by the streamlines (fig. 5) and the cross sections (fig. 4), most water in the channel passes through these two large waves at low discharges.
