MAP OF RAINFALL, DEBRIS FLOWS, AND FLOOD EFFECTS OF THE JUNE 27, 1995, STORM IN MADISON COUNTY, VIRGINIA

By Benjamin A. Morgan, Gerald F. Wiczonek, and Russell H. Campbell
1999

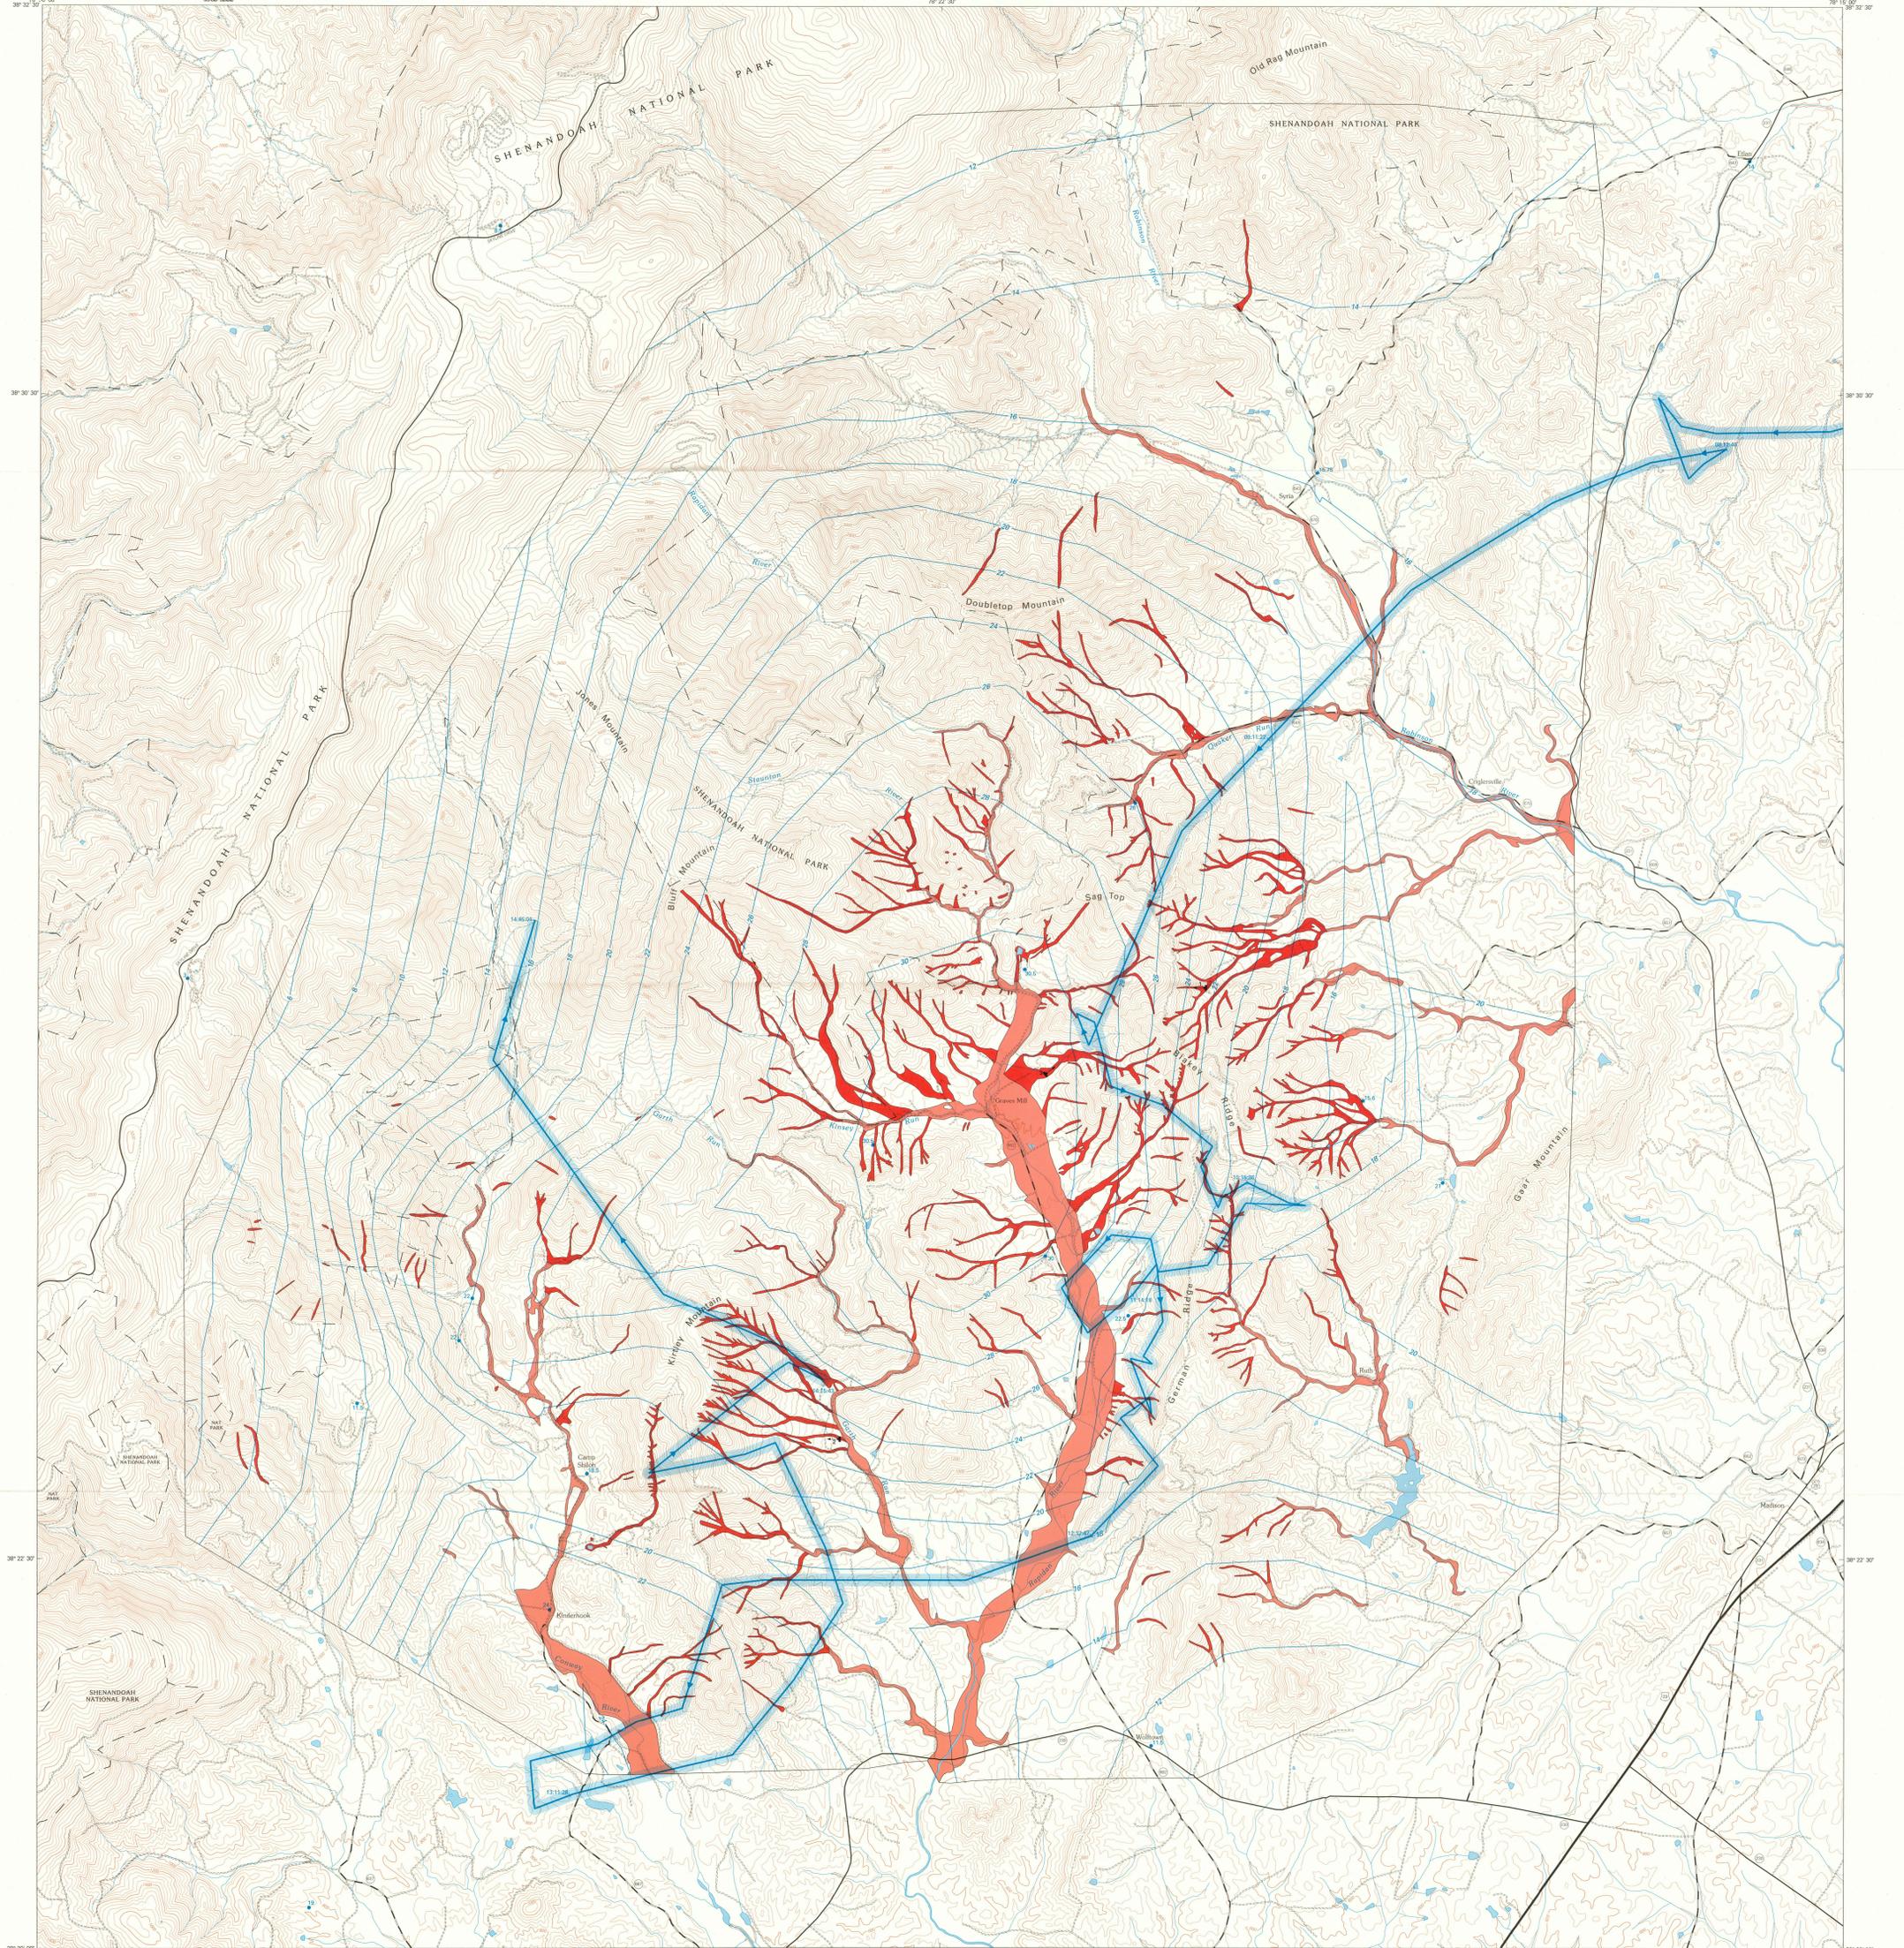
Scale: 1:24,000. Contour interval: 40 feet. National Geographic Vertical Datum of 1985. Digital compilation by Russell H. Campbell and Peter Chivco. Edited by Elizabeth D. Kucner. Digital cartography by D. Paul Mathews and Jordan N. Mitchell.

- EXPLANATION OF MAP SYMBOLS**
- Debris-flow track
 - Flood erosion or deposition
 - Isobars (lines of equal precipitation amount) at 2-inch intervals
 - Storm track and selected time locations—Data collected at 6-minute intervals, eastern daylight saving time (EDT)
 - Boundary of study area
 - Boundary of Shenandoah National Park
 - Rainfall measurement location—Rainfall in inches
 - Location of figure

On June 27, 1995, an unusually severe storm wreaked havoc on a small area of about 50 square miles in Madison County, Virginia. During a period of about 16 hours, as much as 30 inches of rain fell in the area of maximum storm intensity, probably about 23 inches fell within a five-hour period over small areas. The results of this extreme rainfall event were: 1) mass wasting of steep hillslopes in the form of soil slides and slumps, rock slides, and numerous debris flows; 2) downstream flooding; and 3) consequent destruction of houses, roads, utilities, livestock, and crops. A general description of landslides and debris flow caused by the storm was reported by Wiczonek and others (1995). A preliminary inventory of the effects of the storm and the extent of the debris flows and floods in the area were reported by Wiczonek and others (1996). A more complete discussion of the debris flows resulting from the storm was reported by Morgan and others (1997). This map shows areas of debris flows, flood erosion and deposition resulting from the storm, and contours of storm rainfall totals (isobars) derived from measurements taken in the area and surrounding areas. The locations of these measurements are recorded on the map as are the approximate times of the position and track of the principal storm as reported by Smith and others (1996).

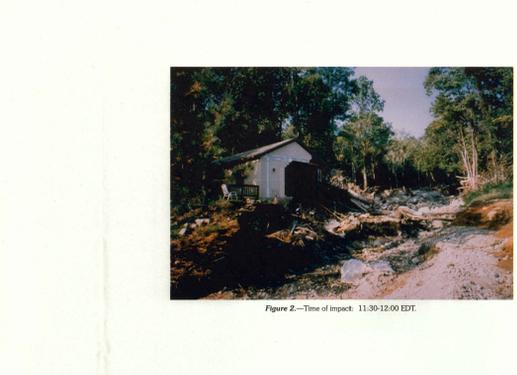
Figure 2—Time of impact: 11:30-12:00 EDT.

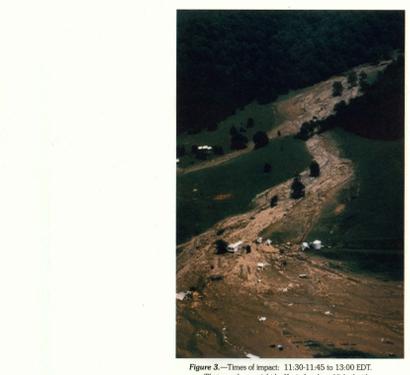
Figure 3—Times of impact: 11:30-11:45 to 13:00 EDT. (Photograph copyright by Kevin Lamb, published with permission.)
