HISTORICAL AND POTENTIAL DEBRIS-FLOW AND FLOOD HAZARD MAP OF THE AREA AFFECTED BY THE JUNE 27, 1995, STORM IN MADISON COUNTY, VIRGINIA

By
Benjamin A. Morgan, Gerald F. Wiczorek, and Russell H. Campbell
1999

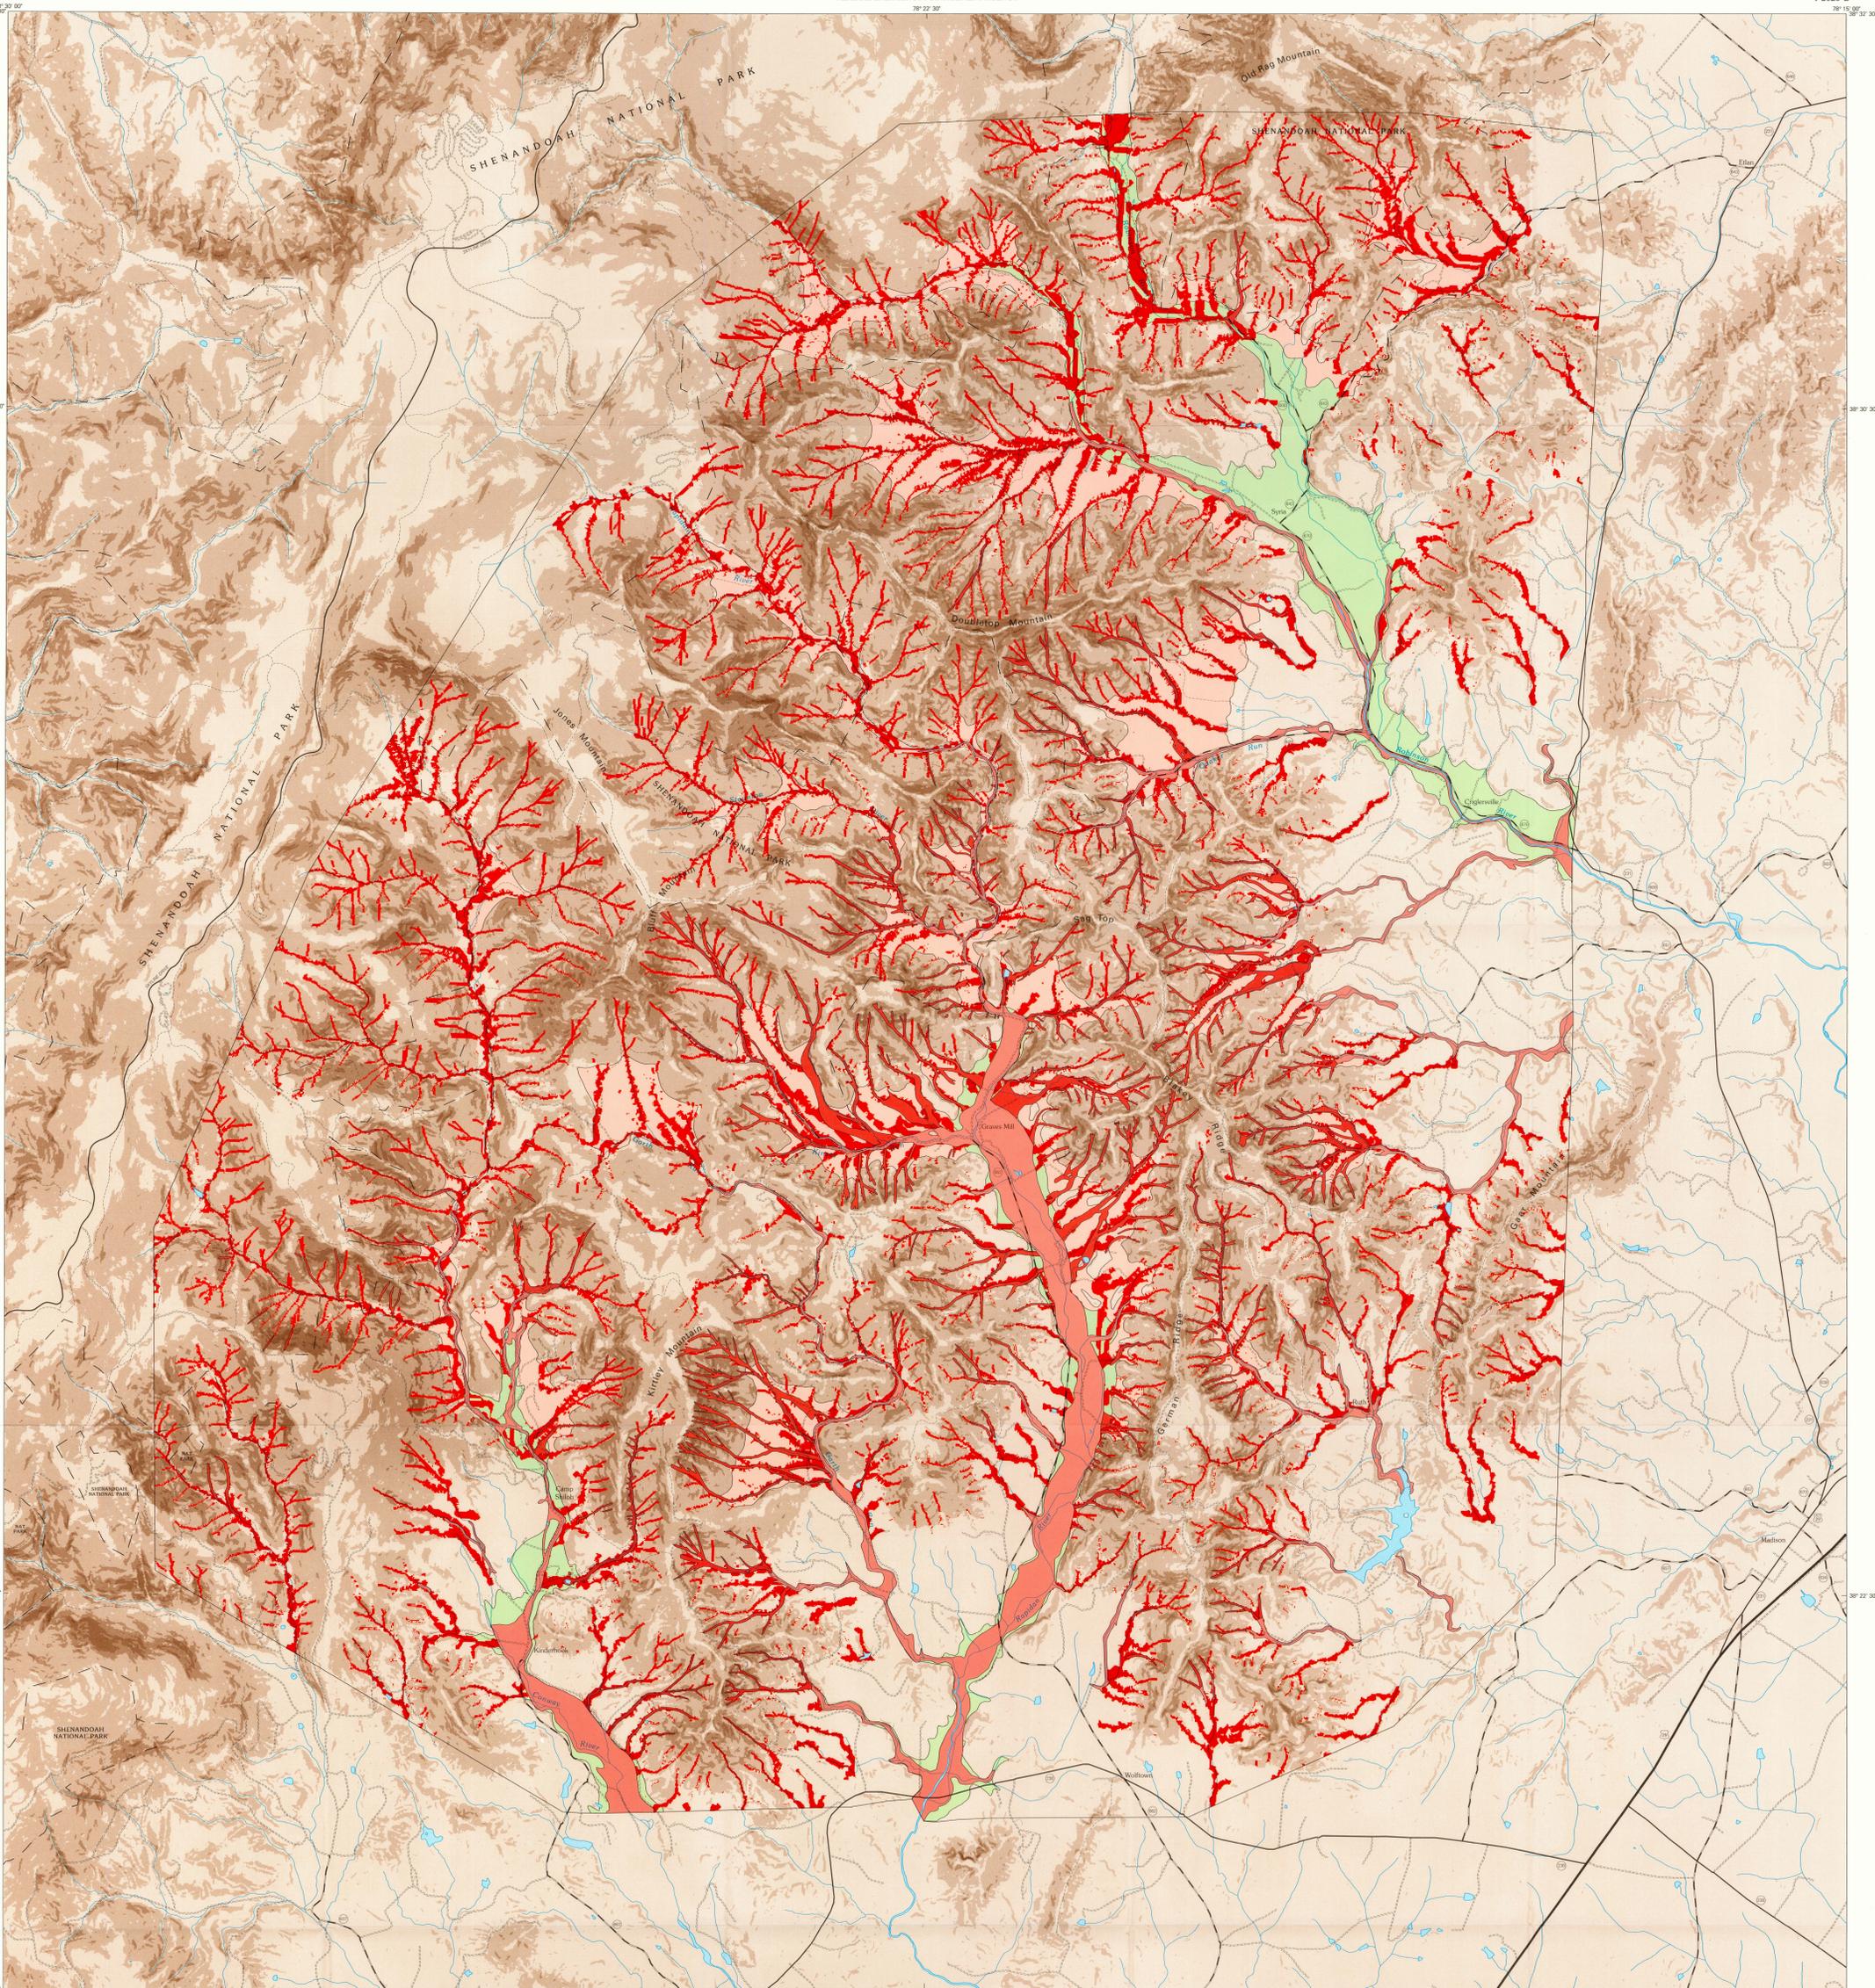
On June 27, 1995, an unusually severe storm wreaked havoc on a small area of about 50 square miles in Madison County, Virginia. During a period of about 16 hours, as much as 30 inches of rain fell in the area of maximum storm intensity, probably about 25 inches fell within a 6-hour period over small areas. The results of this extreme rainfall event were 1) mass wasting of steep hillsides in the form of soil slides and slumps, rock slides, and numerous debris flows; 2) downstream flooding; and 3) consequent destruction of houses, roads, utilities, livestock, and crops. A general description of landslides and debris flows caused by the storm was reported by Wiczorek and others (1996). A preliminary inventory of the effects and the extent of debris flows and floods in the area was reported by Wiczorek and others (1996). A more complete discussion of the debris flows resulting from the storm was reported by Morgan and others (1997). This map depicts hazards associated with the June 27, 1995, storm and shows debris-flow paths in the area. Debris flows and flood erosion and deposition resulting

from the storm are projected onto a slope map. Analyses of field measurements reported in Morgan and others (1997) show that most failures occurred on colluvium-covered slopes with an average slope steepness of 30 degrees with a standard deviation of only 3.5 degrees. Active and intermittent stream channels draining slopes steeper than 26 degrees constitute the principal pathways for debris flows and provide a guide for predicting the sites of future ground failures and channels for debris flows. Preliminary accumulations of debris-flow fans and the extent of the modern flood plains of the Cuscow, Raupunk, and Robinson Rivers also provide guides for areas of potential hazards. Accordingly, the areas having the potential for ground failure and flood hazards are based on the following criteria: (1) areas traversed by the debris flows from the June 1995 event; (2) areas flooded by the June 1995 event; (3) areas identified by the distribution of terrace and alluvial sediments deposited by earlier floods; (4) areas underlain by prehistoric debris-flow deposits; (5) areas underlain by slopes greater than 26 degrees; and (6) topographic channels having an origin on slopes greater than 26 degrees that could fill with a hypothetical debris flow 10 feet in elevation above the channel floor.
