Map and Description of the Active Part of the Slumgullion Landslide, Hinsdale County, Colorado

Pamphlet to accompany
GEOLOGIC INVESTIGATIONS
SERIES MAP I-2672

1999

U.S. DEPARTMENT OF THE INTERIOR
U.S. GEOLOGICAL SURVEY

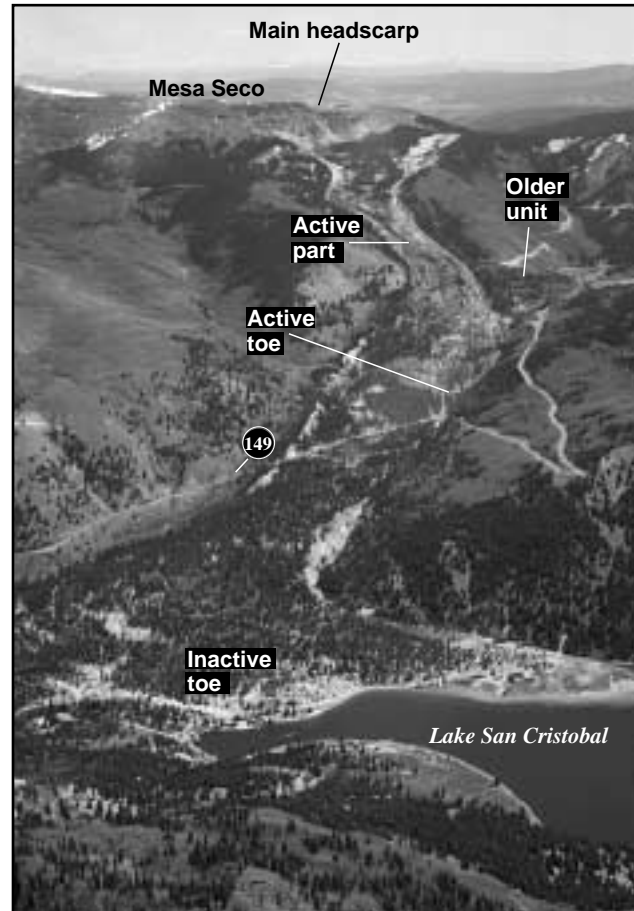
Figure 2. A, Outline map of inactive and active parts of the Slumgullion landslide. Inactive part of landslide is made up of materials that blocked Slumgullion Creek and spilled over a local topographic divide farther upslope, subsequently blocking the Lake Fork of Gunnison River and creating Lake San Cristobal. A collapse of west side of main scarp that provided a surcharge load to upper part of older landslide deposits apparently triggered currently active part of landslide. B, Aerial view of Slumgullion landslide, looking northeast (photograph by David Varnes).

a large area of inactive landslide deposits and a smaller area that is active (fig. 2A and B). The currently active part of the landslide is itself complex; it consists of a variety of different materials moving at different rates along irregular boundaries. One of the more interesting aspects of the currently active landslide is that it has been moving for more than 100 yr, and observations during the 100 yr indicate that annual rates of movement might have been about constant throughout that time.

At least three separate events are recognizable in deposits of the Slumgullion landslide. Crandell and Varnes (1960, 1961) recognized an older, inactive deposit and a younger, active landslide (fig. 2). Our mapping has determined that the currently active landslide is a result of loading caused by collapse of the north side of the scarp on Mesa Seco. Thus, there are three clearly identifiable events, although the collapse of the north side of the scarp and reactivation of part of the old landslide was probably a continuous process.

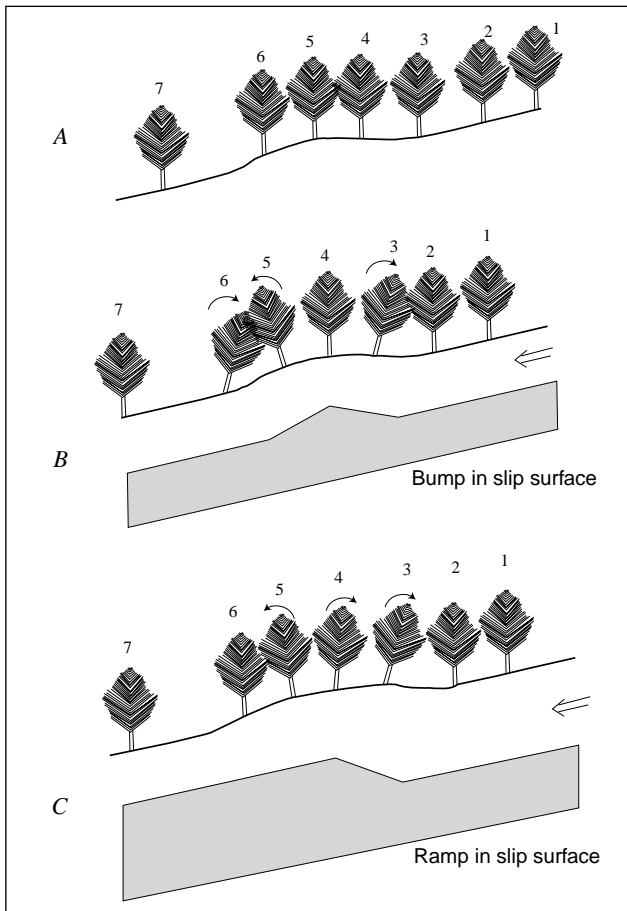
Figure 3. Typical deformation to trees in two different kinematic settings on landslide surface. Measurements of change in orientation of tilted trees can provide information on shape of buried failure surface. *A*, Initial condition of upright trees. *B*, Pattern of tilted trees created by landslide movement over a bump in slip surface. *C*, Pattern of tilted trees created by landslide movement over a ramp in slip surface. Amount of displacement is given by length of arrow and by change in position of numbered trees in *B* and *C* compared to *A*. (From an unpublished figure provided by A.M. Johnson.)

Trees are tilted in active landslides by movement over an irregular failure surface (fig. 3) and by deformation caused by differential rates of displacement. A tree that is undisturbed tends to grow vertically. Tilt of a tree produces new vertical growth at the tip, and the tree develops a kink or curve in the trunk with continued growth. New vertical growth at the tips of tilted trees was used by Fleming and Johnson (1989) to show that a long, linear ridge on the Twin Lake landslide, Utah, was actively enlarging. Tilted trees were used by Fleming and others (1988) to estimate the shape of the failure surface of a slump in the crown of the Manti landslide and by Baum and others (1993) to evaluate a bump in the failure surface of the Aspen Grove landslide, Utah.

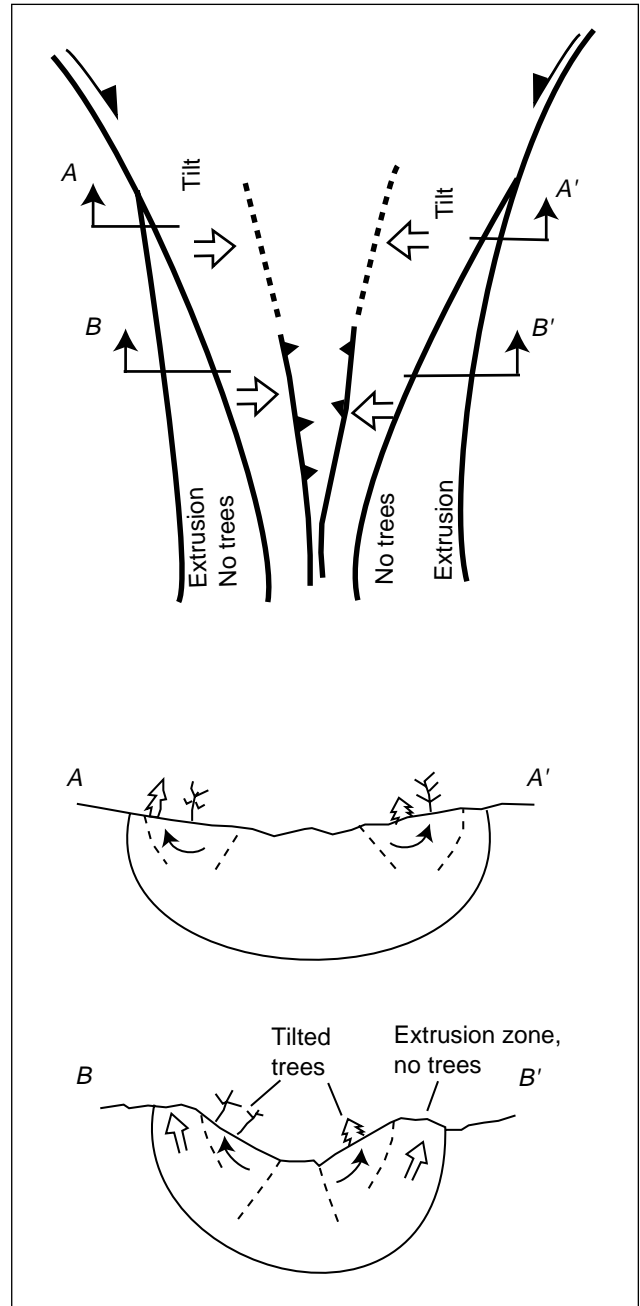
Figure 7. Cartoon of an idealized plan view and cross sections through two places in the hopper. As the ground surface is tilted toward middle of the hopper, fresh material is extruded onto ground surface between landslide flanks and edges of tilted blocks. Width of extrusion deposits increases downslope. The two thrust faults shown trending down the axis of the landslide on the plan view represent shortening and compression.

The inferred deformation within the hopper is depicted in two idealized cross sections across the landslide (fig. 7). Trees on the tilted surface on the side near *A* and *B* (fig. 7) are uniformly inclined toward the middle of the landslide and are tilted approximately normal to the ground surface. Trees are generally absent on the south side of the hopper.

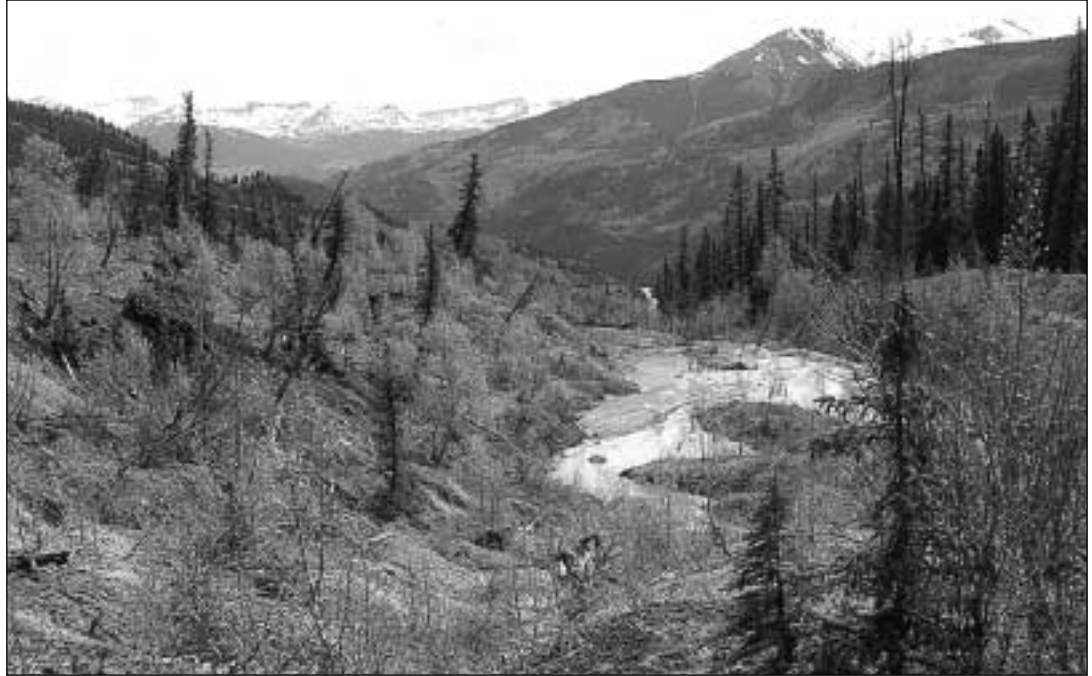
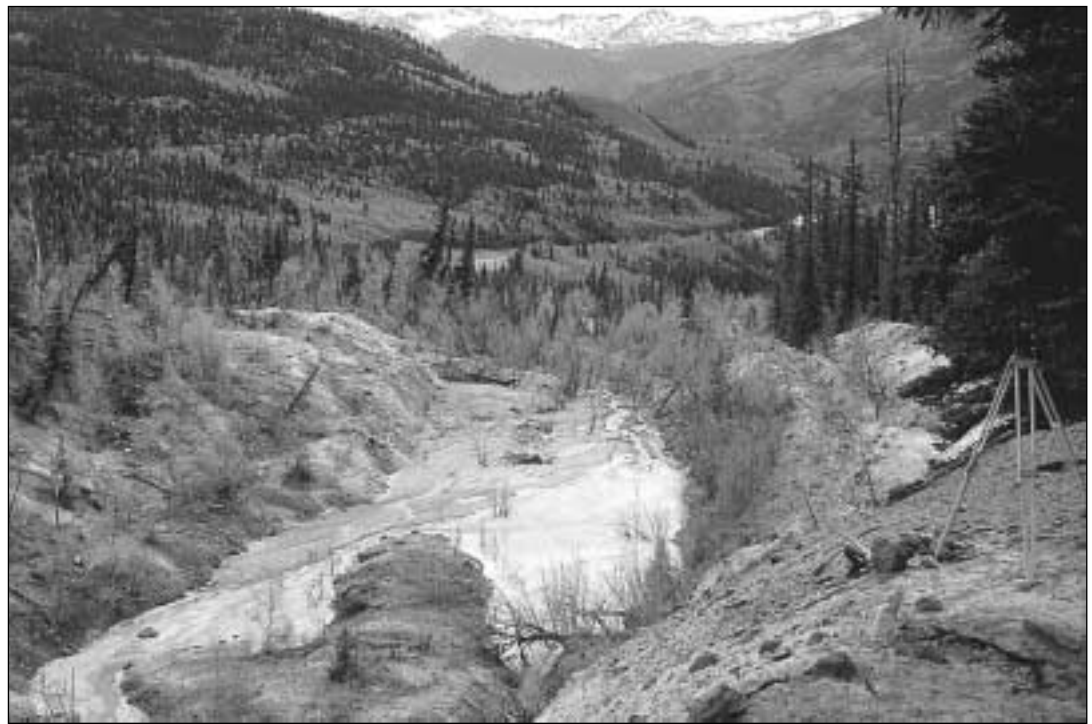
Figure 9. Two views of the deepest part of the pull-apart basin looking downhill or westerly. *A*, Pond sediments contribute to filling the deepest part of the basin. Small spruce trees to left of pond are tilted to the right and curved in response to a component of thrusting in that direction. The jumbled aspen trees in the right foreground are the result of a component of movement from left to right along an oblique-slip fault. *B*, Closer view of pond and pond sediments in the deepest part of the basin. The bounding flank fault is visible in the small troughs to the left of and downhill from the tripod. The dark-colored material in the left foreground that is surrounded by pond sediments is a compressional structure produced by a component of movement into the basin. Overall displacement rate at this part of the landslide is about 4 m/yr. The deformational features within the pull-apart basin are the result of a small component of the overall displacement rate.

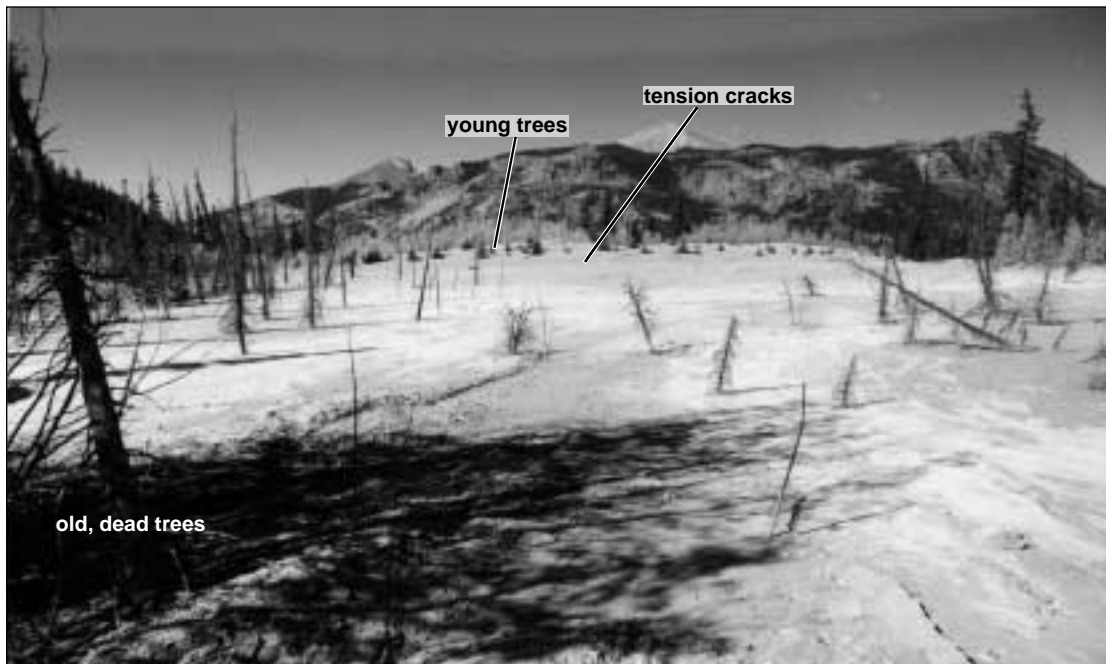
Figure 12. View (looking downslope) of pond sediments on back-tilted surface at the location of emergent toe of active landslide. Note young spruce and aspen trees growing along divide at downslope end of pond. Note also that older spruce trees in foreground have been buried by pond sediments. Evidence such as this indicates that location of pond has remained fixed while trees have been transported into pond and beyond.

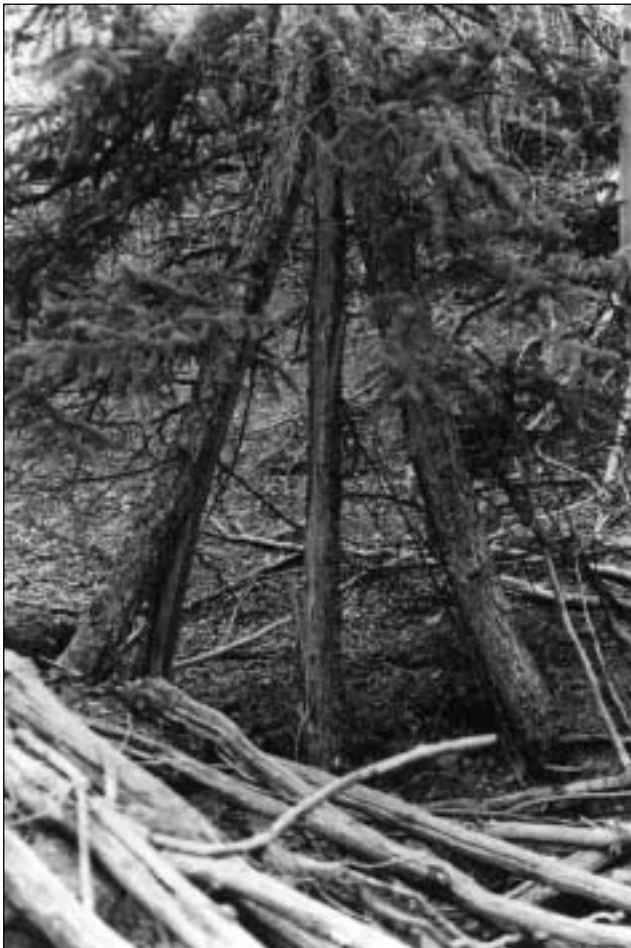
Figure 14. View of split tree. The tree is broken into four parts by right-lateral and spreading movement. Fault that caused rupture of tree has not fractured ground surface, but it does form a linear trough about 1 m deep.

The deformation structures on the north side of the landslide consist of strike-slip and oblique-slip (right-lateral slip and opening or spreading) faults. Pure strike-slip faults are difficult to identify in this part of the landslide because the crumbly landslide debris does not preserve fractures well. In a few places along the trends of some strike-slip faults, there are scarps that enable the fault positions to be accurately located. Where pure strike-slip faults change orientation a scarp is produced and stretched roots or split trees (fig. 14) show that the fault

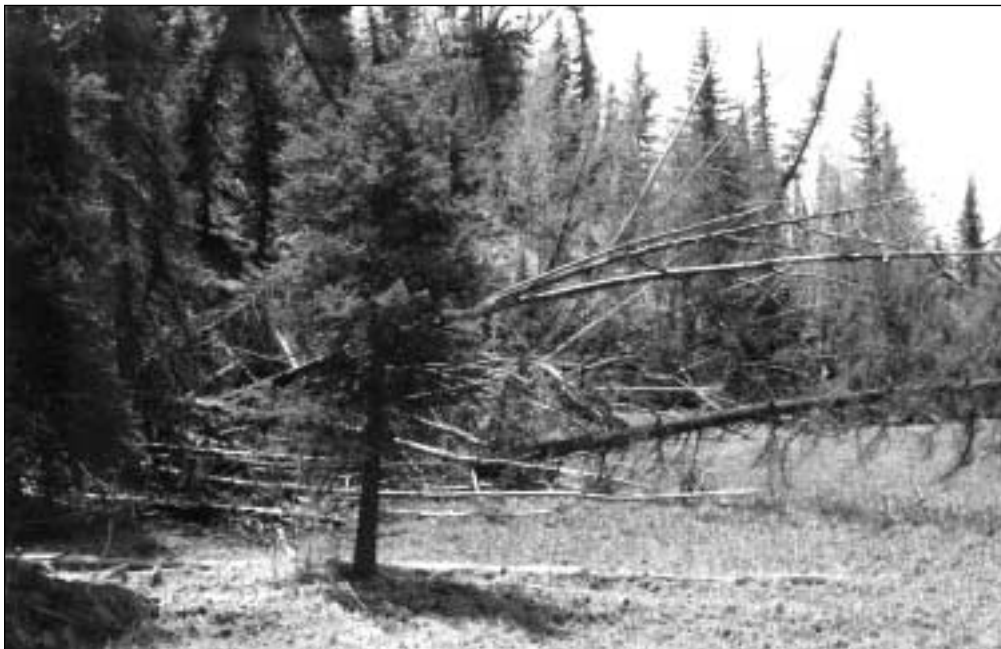
Figure 15. View of north side of active toe (zone 7), where trees are being over-riden by bulldozer-like movement of landslide. Moving ground on left pushes trees over and buries them.
