**PHOTO INTERPRETIVE MAP SHOWING AREAS UNDERLAIN BY LANDSLIDE DEPOSITS AND AREAS SUSCEPTIBLE TO LANDSLIDING IN THE LOUISVILLE QUADRANGLE, BOULDER AND JEFFERSON COUNTIES, COLORADO**

By  
Roger B. Colton and Jeffrey A. Holligan  
1977

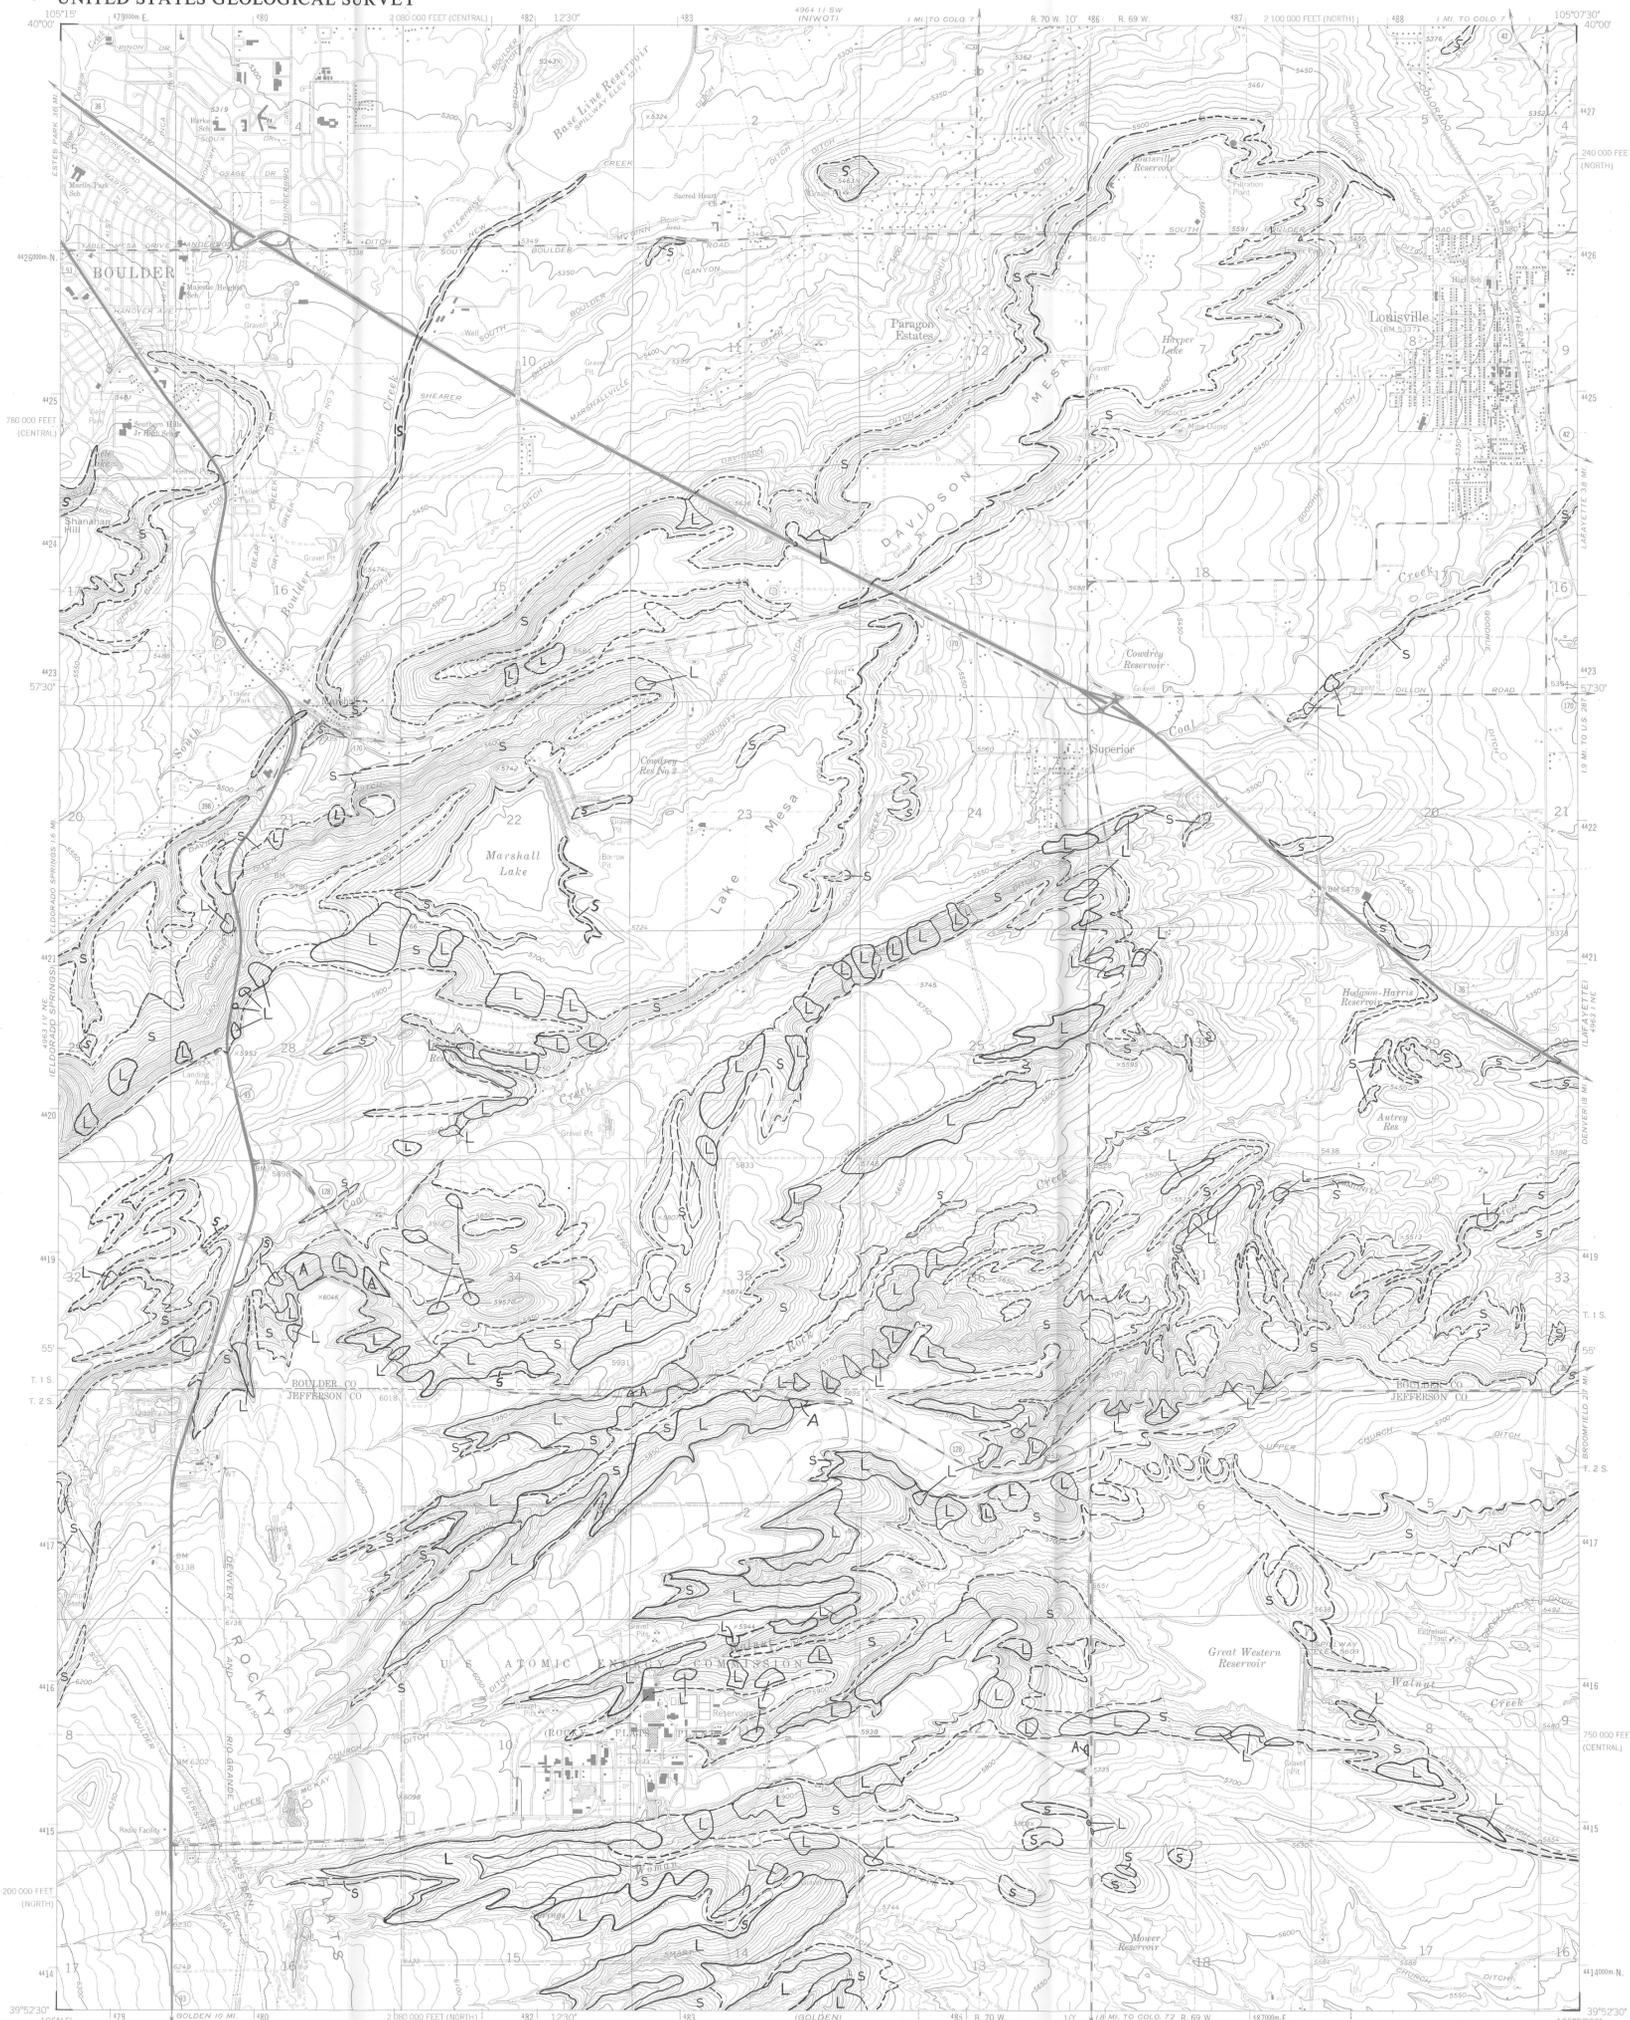
- EXPLANATION**
- L** LANDSLIDE DEPOSITS—Masses of earth and rock that have moved downslope as earthflows and slumps that have formed along the margins of gravel-capped mesas where springs and seeps have saturated the underlying shaly or clayey parts of the Pierre Shale, the Laramie and the Arapahoe Formation (all Upper Cretaceous). The term landslide deposit is used for these mapped features because it is not known if they are actively moving at the time the aerial photographs were taken or sometime in the past. For a more complete discussion of landslides and their activity in the adjoining Golden quadrangle, the reader is referred to Simpson (1973).

- A** ACTIVE LANDSLIDE—Man-induced and natural landslides. Induced landslides were caused by oversteepened slopes, excavation at the base of inactive landslides and leaking irrigation ditches. Activity of this type has been observed since 1971—particularly in May 1973 when as much as 4 inches of rain fell in the general area.

- S** AREAS SUSCEPTIBLE TO SLIDING—Generally slopes steeper than 10 percent, which is equivalent to a 10 m vertical rise for every 100 m measured horizontally. Geologic factors including rock type, seasonal water-table conditions and slope orientation also influence slope stability. For example, slopes of only a few degrees on saturated shale have failed. South-facing slopes are drier because the rate of evaporation is much higher and thus more stable than equally steep north-facing slopes. Slopes steeper than 10 percent that are underlain by sandstone units of the Fox Hills Sandstone (Upper Cretaceous) and the lower part of the Laramie Formation are generally not susceptible to large slope failures. However, they are included with this unit because the overlying veneer of colluvium is unstable and subject to slow to rapid downhill movement. Eroded deposits that lack recognizable landslide morphology may be present locally. Locally, slopes of less than 10 percent may be unstable, and a detailed geologic and engineering investigation should be conducted at sites prior to development.

- AREAS BELIEVED TO BE STABLE UNDER CONDITIONS EXISTING IN 1971
  - CONTACT—Dashed where approximately located. Contacts around landslide areas are shown as solid lines but were compiled from aerial photographs several years old; consequently they may not exactly show the present outlines of landslide deposits. Limits of areas susceptible to landsliding are very approximate and thus are represented by dashed lines.

Landslides were recognized on aerial photographs by a combination of such general features as (1) small isolated ponds, lakes, and other closed depressions; (2) springs; (3) abrupt and irregular changes in slope and drainage pattern; (4) hummocky or irregular surfaces; (5) steep, arcuate scarps; (6) irregular soil and vegetation patterns; and (7) level areas within steeper slopes. Most problems associated with the photo-interpretation of aerial photographs are related to scale and quality of the photographs. Generally, features smaller than 60 m in largest dimension are not shown because they are too small to be clearly identified on the aerial photographs or clearly shown on the topographic base map. Photographs used to compile this map are of good quality and are from the following U.S. Geological Survey contracts: GS-WUC (1971) scale 1:24,000; GS-VAP (1953) scale 1:46,000; GS-VAQC (1963) scale 1:17,400 and 1:25,600; GS-VBRL (1964) scale 1:17,400 and also Army Map Service photography made in 1955, scale 1:60,000.
