MAP SHOWING SEACLIFF RESPONSE TO CLIMATIC AND SEISMIC EVENTS, DEPOT HILL, SANTA CRUZ COUNTY, CALIFORNIA

By Cheryl J. Hapke, Bruce M. Richmond, and Mimi M. D'Orto

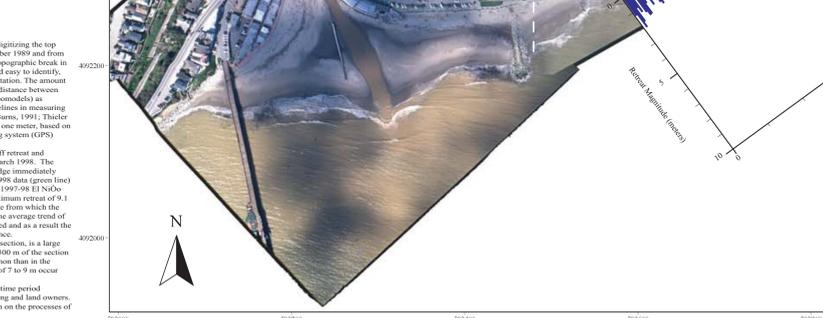
Figure 6. Orthophotomosaic from CAMS imagery showing retreat magnitude and cliff edge positions.

A narrow beach that is consistently flooded at high tide lies in front of the cliffs along Depot Hill. Therefore, the base of the cliff is subjected daily to marine hydraulic and abrasive scouring. This results in undercutting which is accelerated in areas where faults intersect the beach (Fig. 4). Differential retreat occurs as a result of factors variation and structural weaknesses exposed at water level. This differential retreat is reflected in the cliff morphology by numerous embayments and terraces at a scale of tens of meters. This morphology variation is shown in the orthophotomosaic (Fig. 6).

The orthophotomosaic in figure 7 shows the cumulative seaciff retreat and morphologic evolution of this stretch of coast from October 1989 to March 1998. The October 1989 data (orange line) shows the position of the upper cliff edge immediately following the magnitude 7.1 Loma Prieta earthquake, and the March 1998 data (green line) represents the position of the cliff edge following the last of the severe 1997-98 El Niño storms. The amount of retreat in the bar graph in figure 6 shows a maximum retreat of 9.1 m; the average retreat along this section of coast is 2.1 m. The baseline from which the cliff edge positions are measured for retreat calculations is parallel to the average trend of this section of cliffs. However, the cliff morphology is highly eroded and as a result the length of the baseline (Fig. 6) is shorter than the actual along-cliff distance.

The maximum cliff retreat, located near the eastern end of the section, is a large blockfall, the deposit is visible in the beach on figure 6. The western 300 m of the section appear to be more stable, retreat amounts of 2 to 6 m are more common than in the eastern portion of the section where localized retreat amounts of 7 to 9 m occur approximately every 100-200 m.

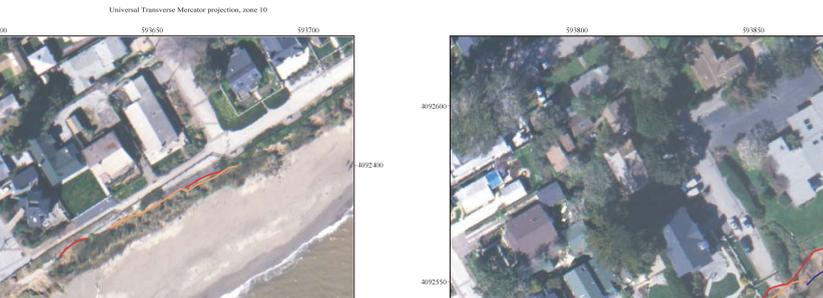
Figure 7b. Enlarged section of the central part of orthophotomosaic.
