# CONTENTS

## VOLUME II

### SECTION 5. CHANNEL ADJUSTMENTS

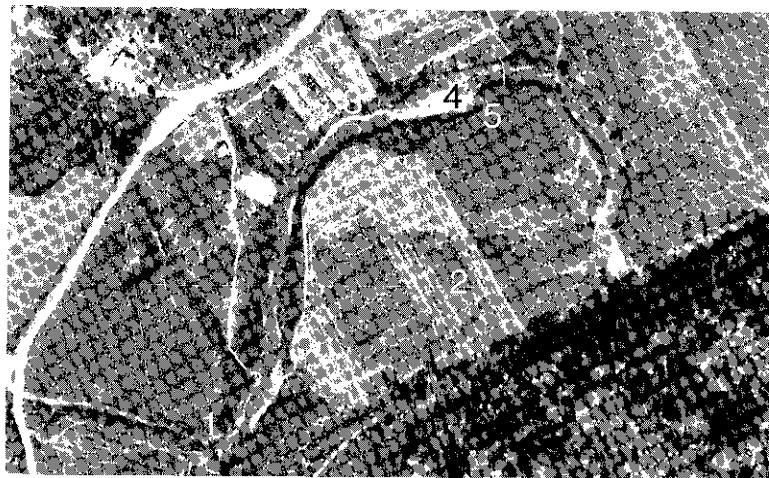
a. November 13, 1971

b. October 18, 1976

c. October 17, 1977

d. March 7, 1983

between them. The outer bank just below the center of the first bend is sharply defined and appears to be eroding (location 3). At the entrance to the second bend, a prominent bar extends across the channel from the outer bank (location 4). Erosion caused by diversion of flow toward the inner bank has created a distinct notch just upstream of the axis of the bend (5). Below the axis of the bend, the bank is vegetated on both sides and appears stable. Photogrammetric evidence of major channel instability is confined to the area described above; no features of comparable importance are visible between here and the mouth of Smoky Creek.

Comparison of figure 2c with figure 2d, taken in 1983, reveals continuing change. Deposition of gravel below the mouth of Bowling Branch has formed new bars in the channel, and accretion is continuing along the right bank (1). Extensive aggradation has occurred on the floodplain (2); the flood deposits shown here may have been left behind after a cloudburst in late summer of 1982 that affected Bowling Branch but was not detected upstream on Smoky Creek (B.A. Bryan, U.S. Geological Survey, personal communication, 1985.) Photogrammetric mapping of these deposits may be used as a guide in field investigations to determine distribution of sediment thickness and volume and mass of aggraded material. Further bank erosion has occurred at locations 3 and 5, and the formerly irregular pattern of bar growth and channel widening by bank erosion appears now to have developed the smooth curvature of a convex point bar (4) and concave bank, with a chute cutting across the point bar. Completion of photogrammetric mapping will allow estimation of net change in the amount of sediment stored in the floodplain and the bar complex.

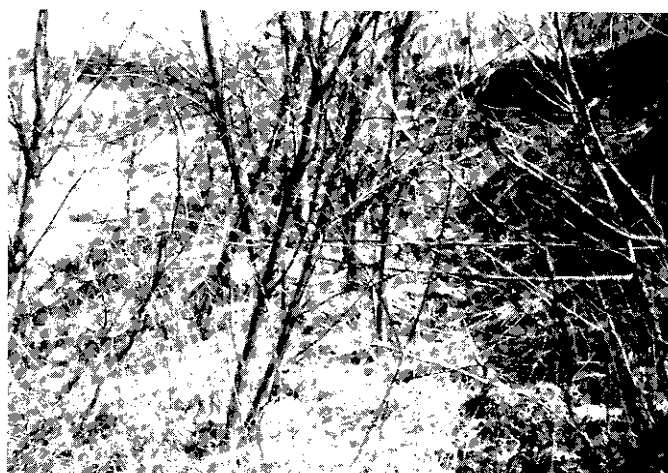
Figure 3-- Typical bank forms on modified streams with active widening. Note tree-ring evidence and slump block widths.
