## SECTION 10

### MAN-CAUSED PROBLEMS AND THEIR CONTROL

## CHANNEL INSTABILITY IN A STRIP-MINED BASIN

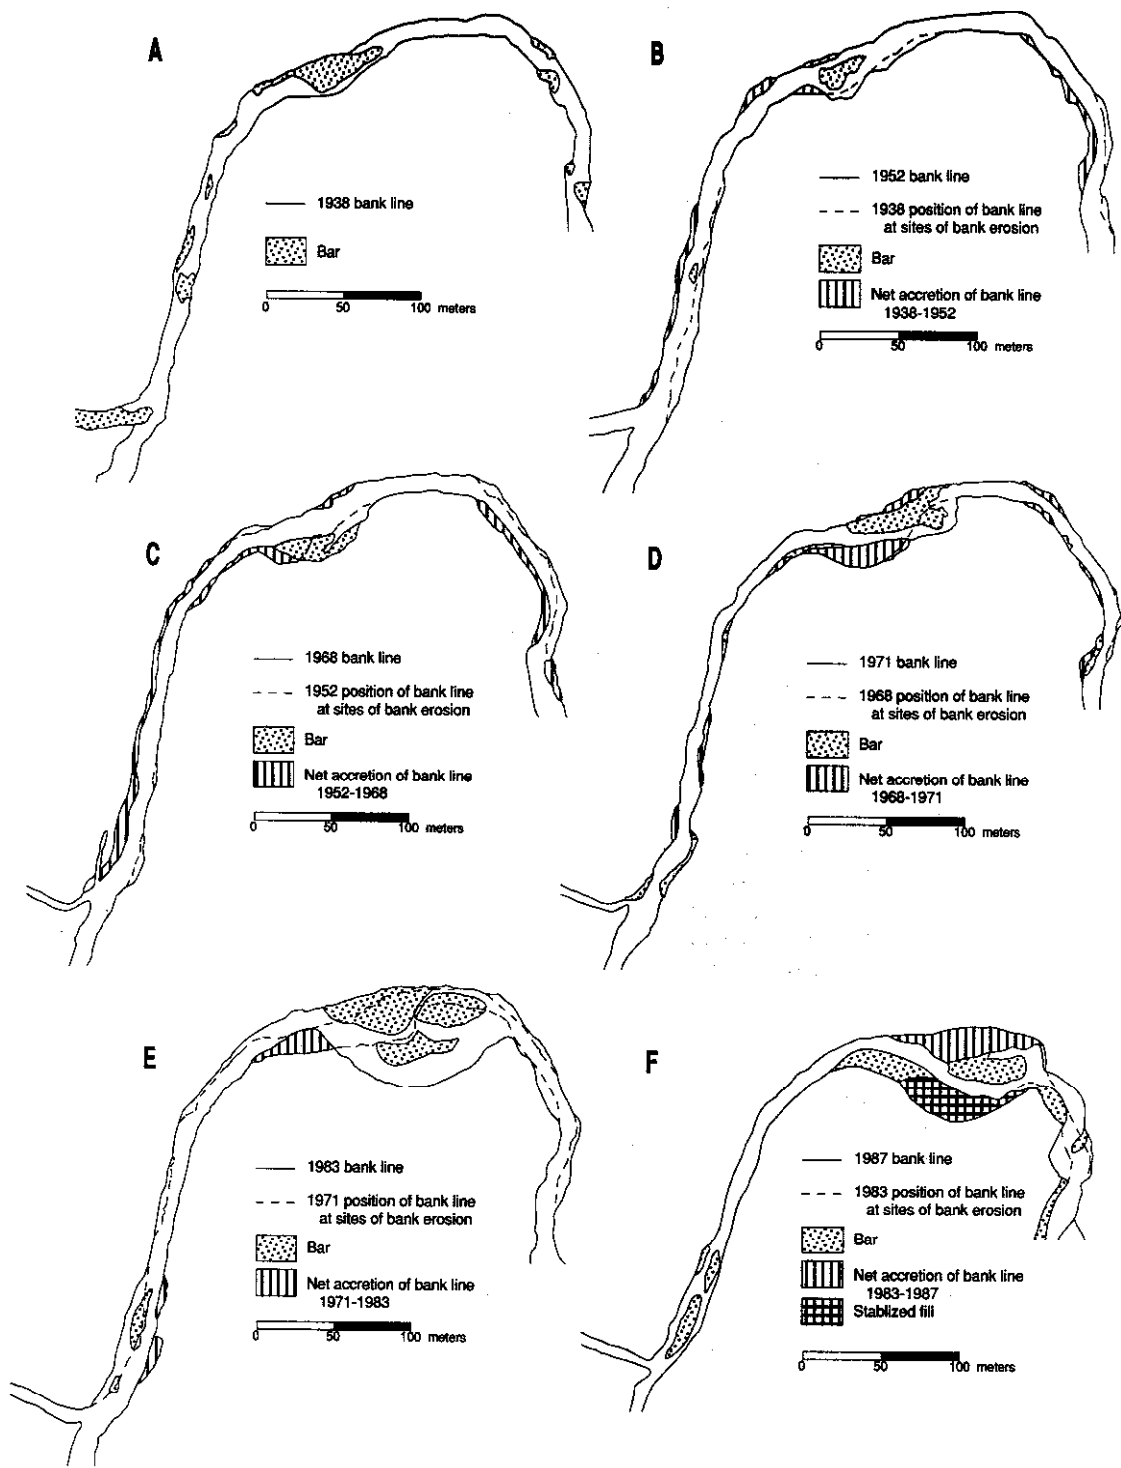
Figure 3. Channel changes on Smoky Creek downstream of Bowling Branch, 1938 - 1987.

A 50-year record of channel change at one site affected by recent bar growth and bank erosion was obtained using digital photogrammetric techniques (Miller, 1986). The observed series of changes may serve as an analogue to explain development of vegetated bar/island complexes elsewhere along the channel. The study site extends about 650 m downstream from the confluence with Bowling Branch. The sequence of changes, beginning with the earliest available aerial photographs, is illustrated in fig. 3. Areal extent of channel bars is not strictly comparable between dates, as the amount of the bed exposed to view varies with water level from one date to another. Nevertheless the shifting location of the major bars and the overall trend toward channel widening associated with progressive growth of the bar complex is clearly shown. Maximum bank retreat of 50 m occurred between 1971 and 1983 (figs. 3d,e).

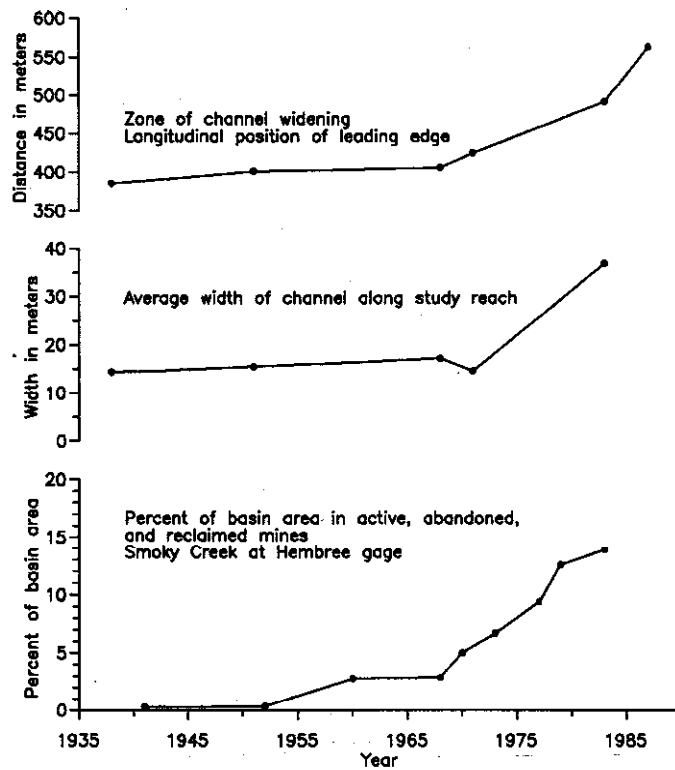
Figure 4. Comparison of channel changes at site downstream of Bowling Branch with historical trend in percent of basin area in strip mines.

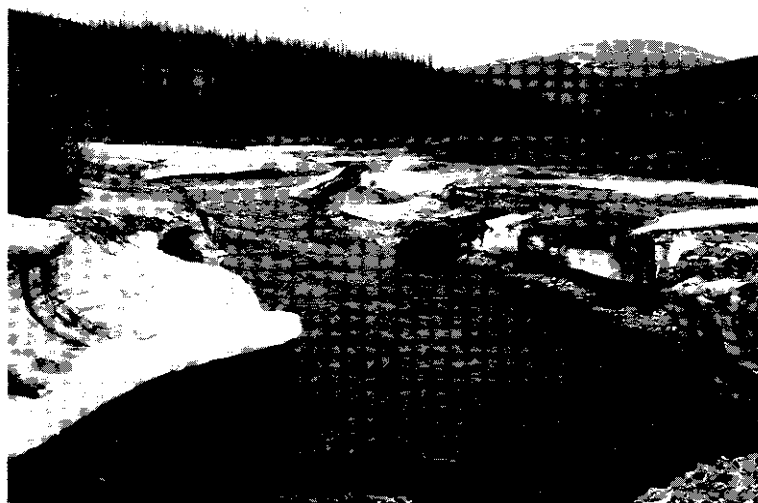
Figure 2. Aufeis influences stream channel morphology and behavior.
