## Volume 1

## II. Stream Restoration

## **AN OVERVIEW OF THE USACE STREAM RESTORATION GUIDELINES**

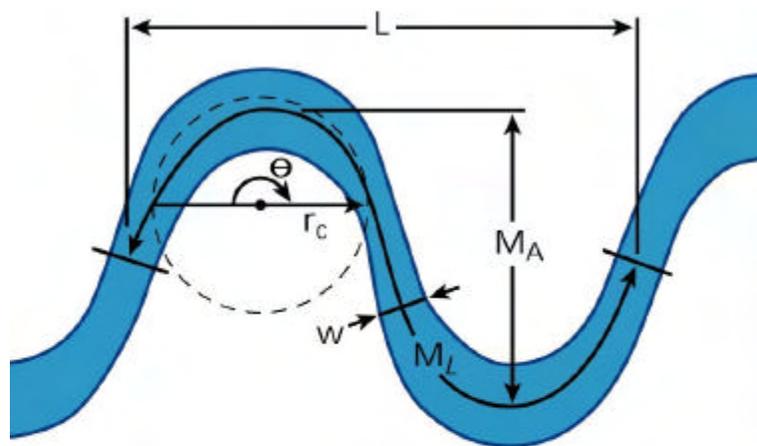
- L meander wavelength
- $M_L$  meander arc length
- w average width at bankfull discharge
- $M_A$  meander amplitude
- $r_c$  radius of curvature
- $\theta$  arc angle

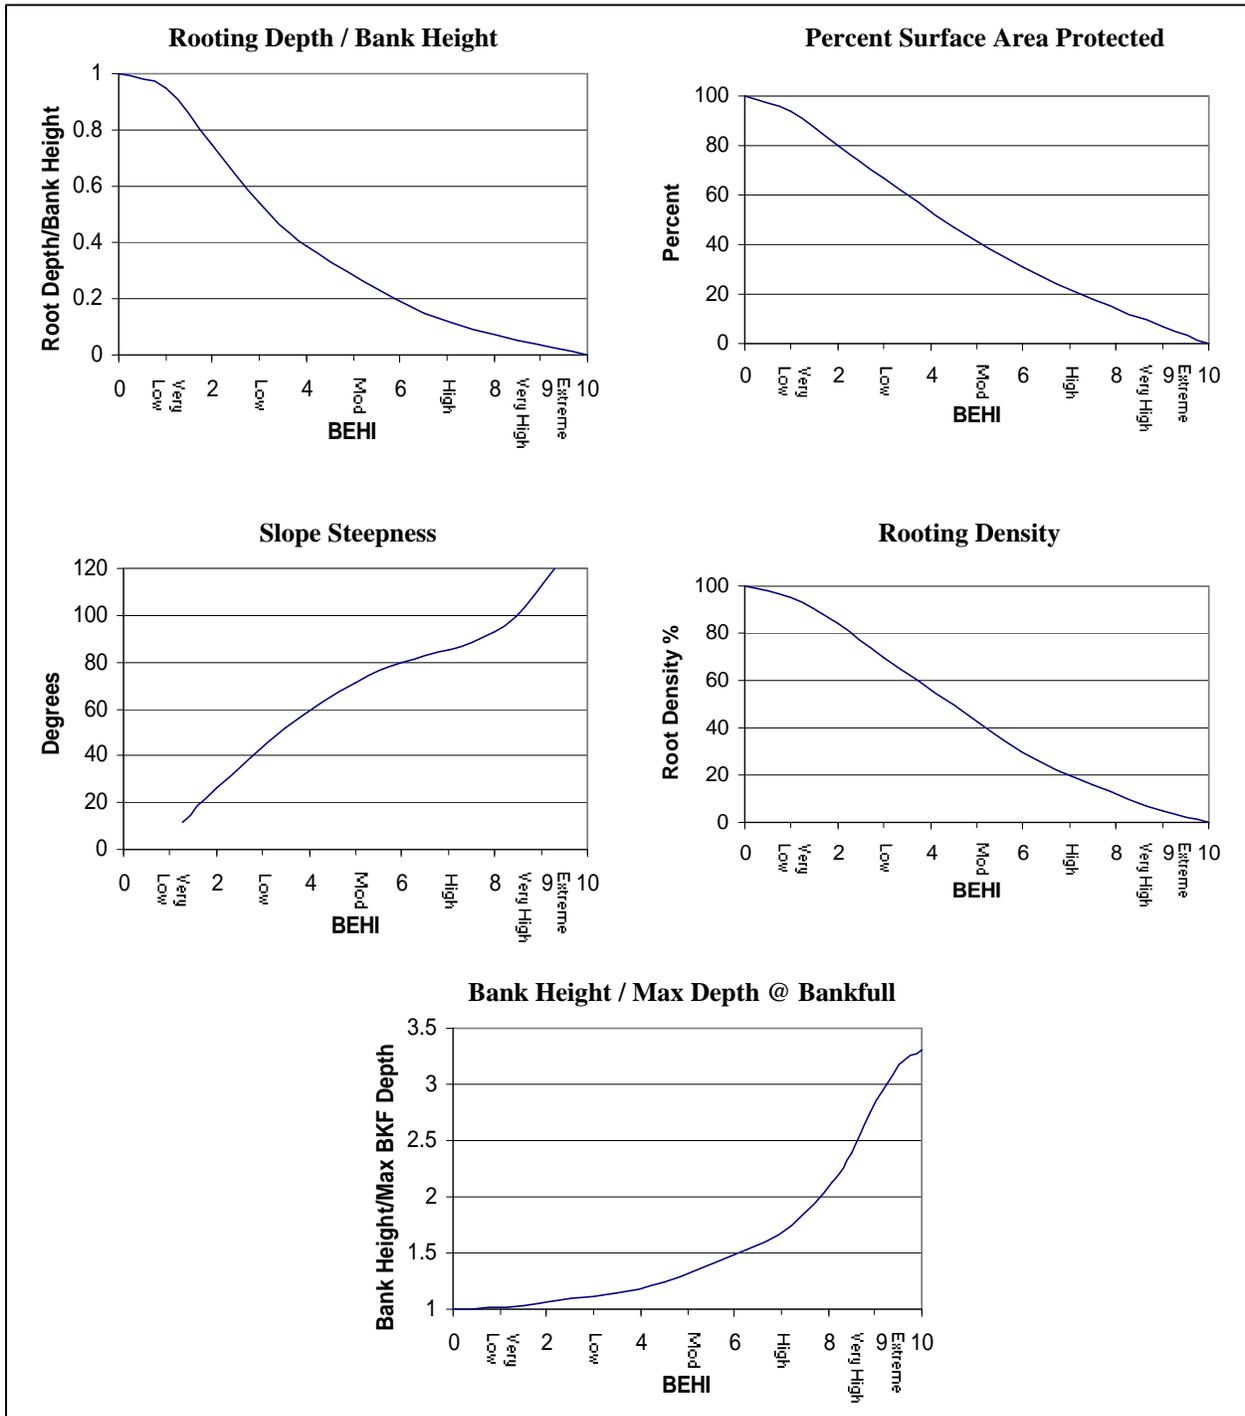
Figure 1. Example of streambank erodibility variables in relation to the Bank Erosion Hazard Index (BEHI)

Table 1. Streambank characteristics used to develop Bank erosion Hazard Index (BEHI)

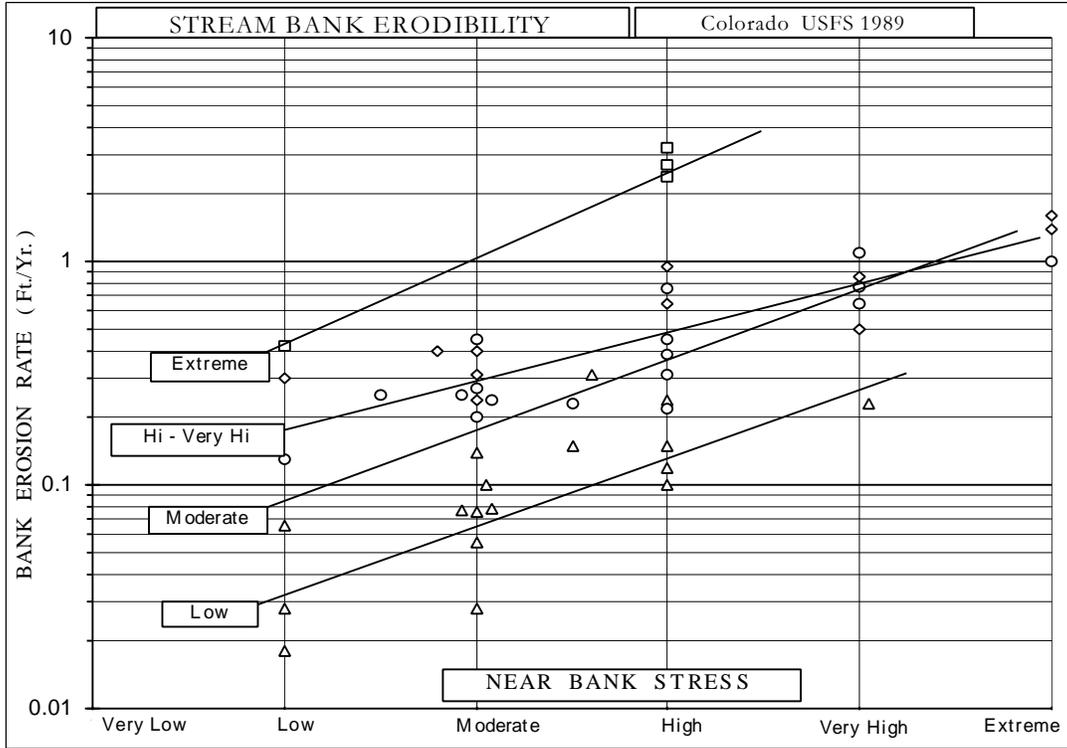
Figure 2. Relation of Streambank Erodibility (BEHI), Near-Bank Stress (NBS) and measured streambank erosion rates for the Front Range of Colorado, USFS data, 1987 to 1988

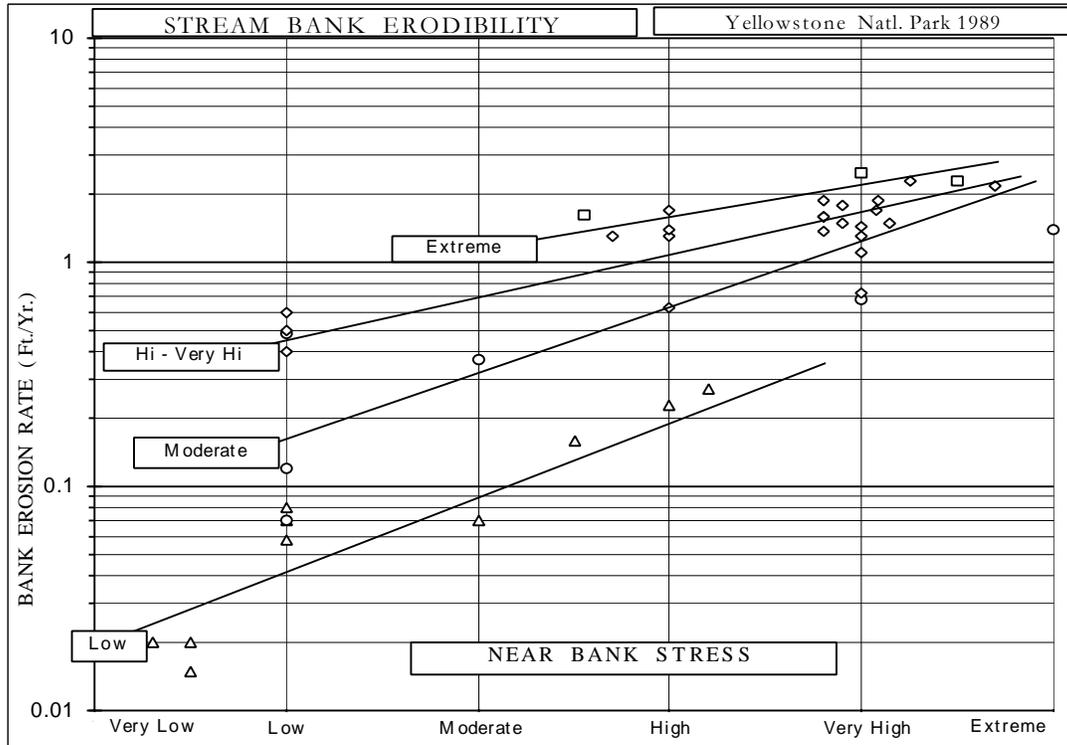
Figure 3. Relation of Streambank Erodibility (BEHI), Near-Bank Stress (NBS) and measured streambank erosion rates for the Lamar River and Tributaries from 1987 to pre-fire, 1988 (Yellowstone N.P.), (from: Rosgen, 1996)

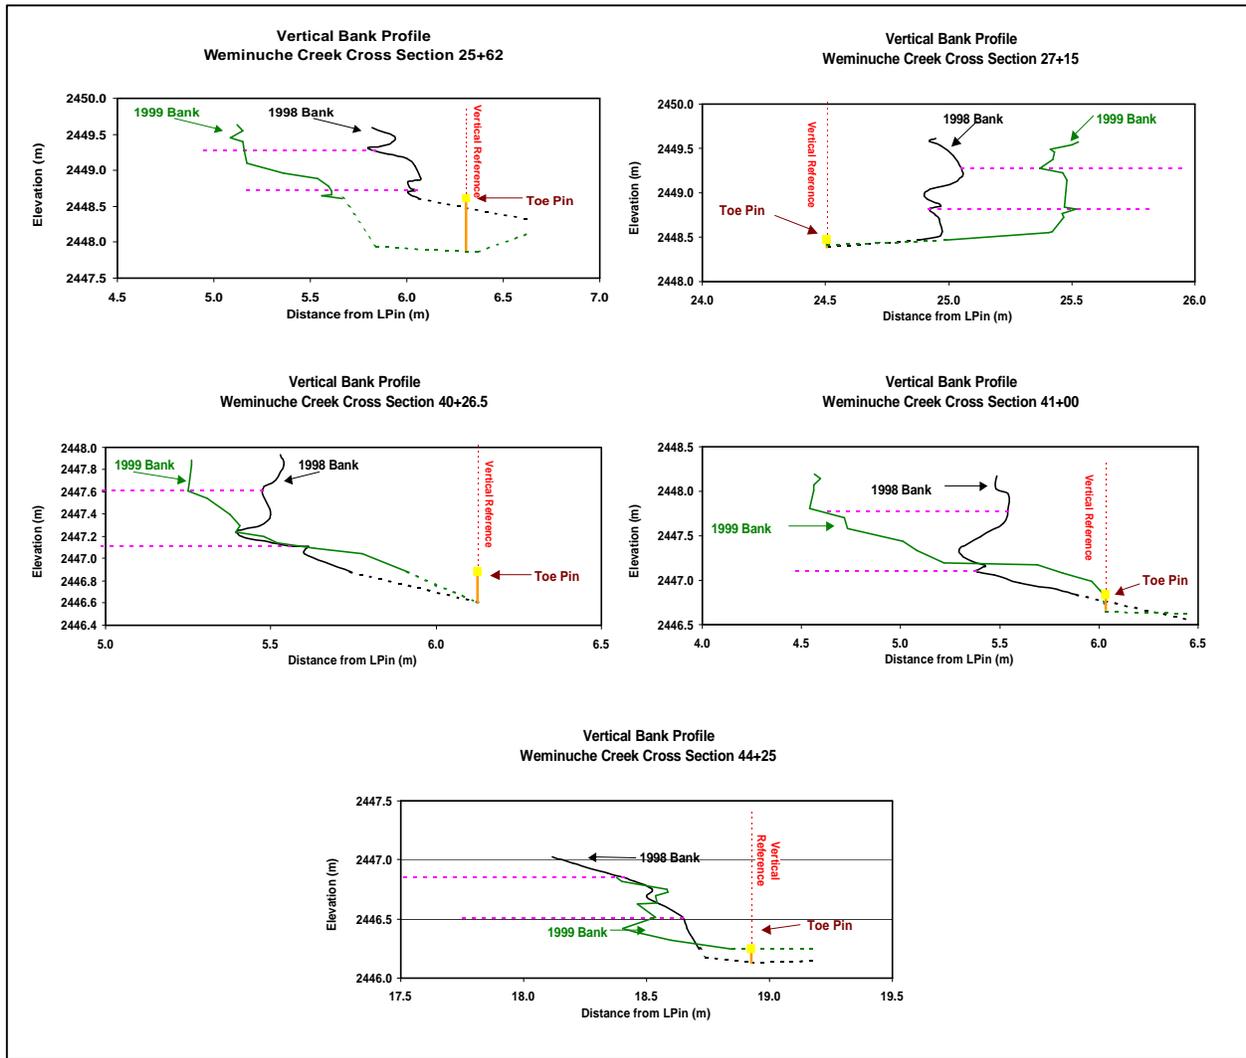
Figure 4. Streambank profiles on the Weminuche River Study – Colorado, showing streambank erosion rate for several locations during one runoff season, (1998-1999). Streamflows included a bankfull event.

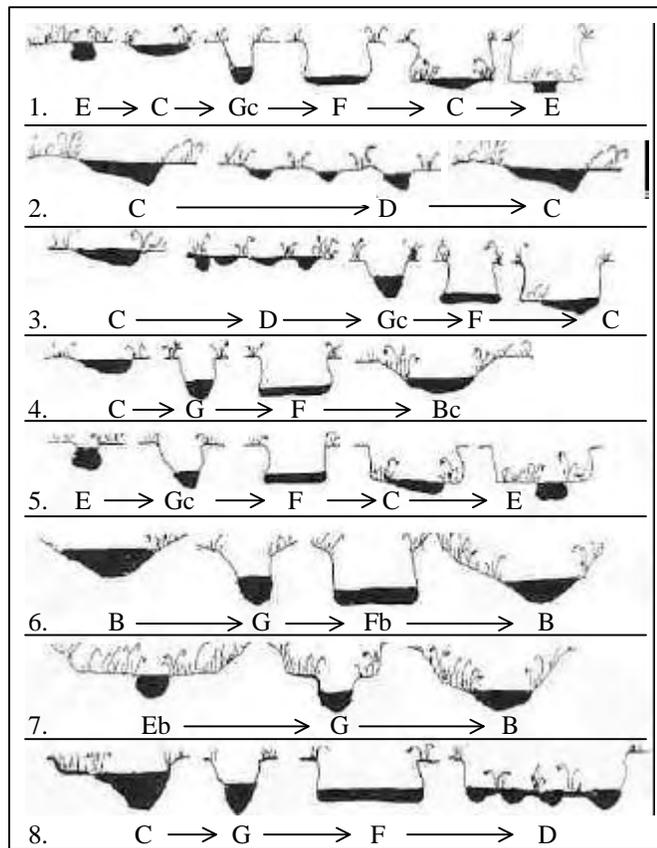
Figure 1. Various Stream Type Evolution Scenarios

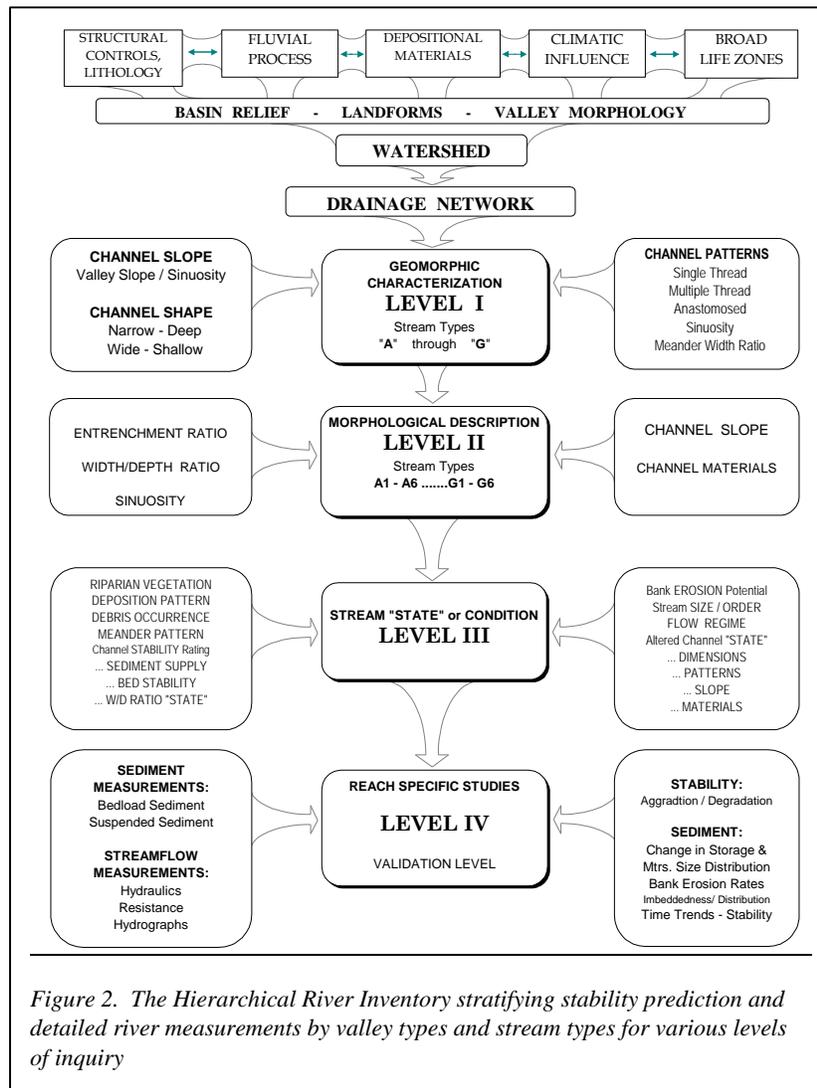
Figure 2. The Hierarchical River Inventory stratifying stability prediction and detailed river measurements by valley types and stream types for various levels of inquiry

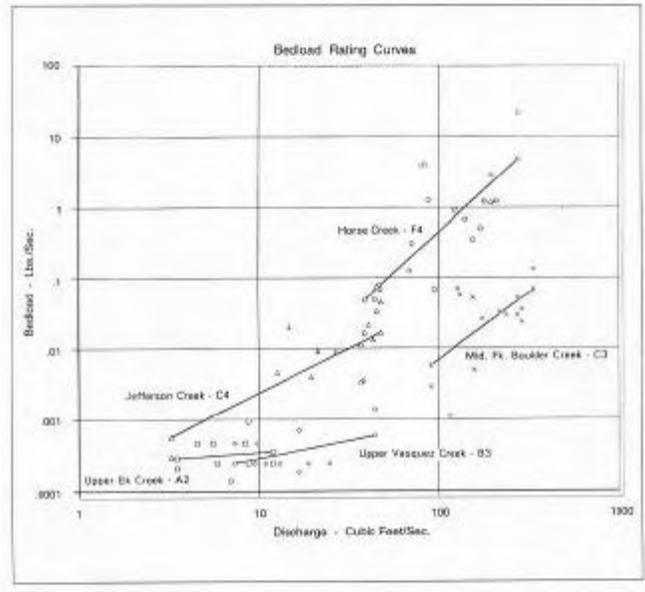
Figure 4. Bedload rating curves stratified by stream type (Rosgen, 1996, data from Williams and Rosgen, 1989)

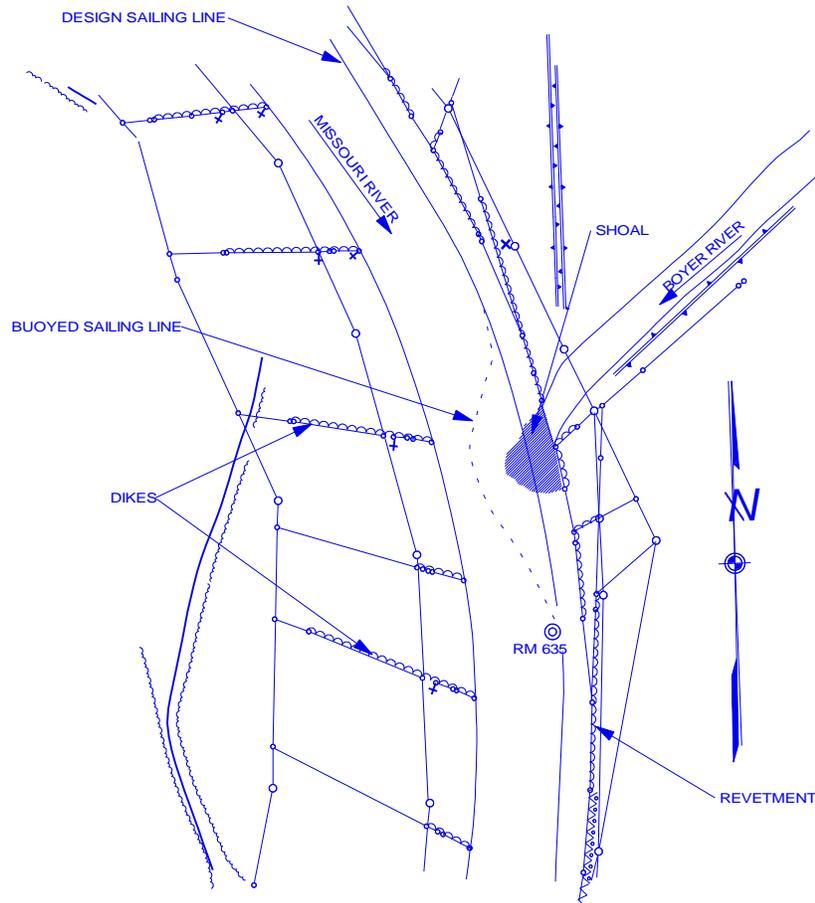
Figure 1. Plan View of Boyer Bend

minor flood events in the Boyer River basin, allowed a shoal to develop at the mouth of the Boyer River during the 1991 navigation season. This shoal continued to increase in size and in 1992 presented a significant hazard to navigation. Depths over the shoal were as low as seven feet and the shoal at one time extended over 200 feet into the channel (Figure 3). This required commercial navigators to pass through a narrow channel adjacent to the end of the dikes (Figure 1). The normal response to these types of shoaling problems is to dredge or structurally modify the project. Structural modifications traditionally include increasing the length and/or elevation of the dikes. However, due to endangered species concerns, state and federal resource agencies were opposed to any alterations that would remove the shoal. The resource agencies would however, support a project modification that would move the shoal from the sailing line to some other location in the channel.

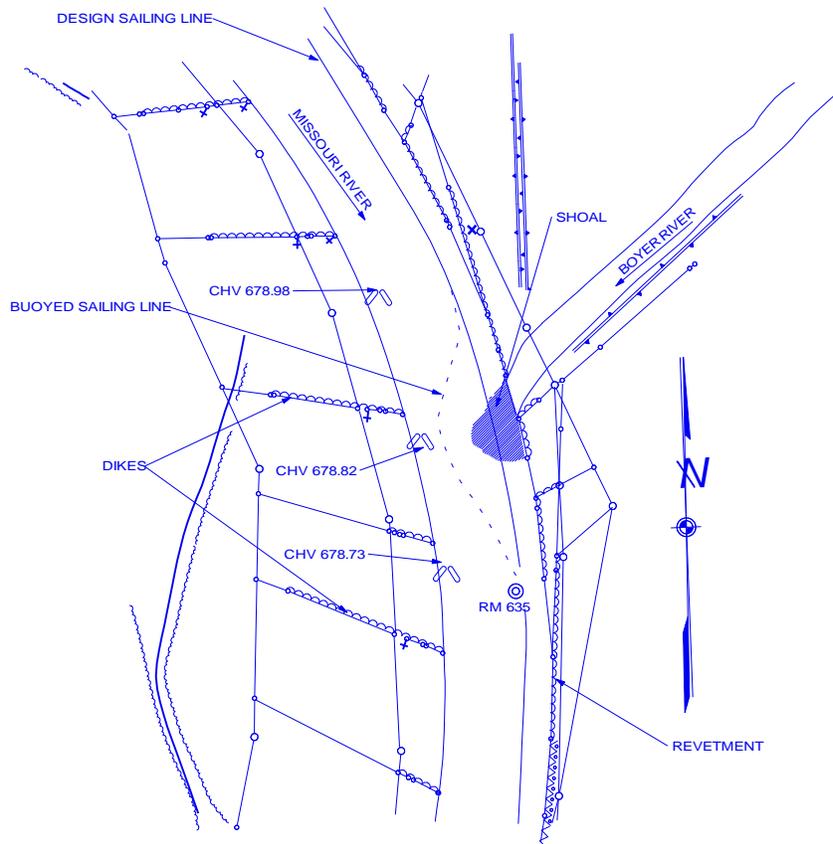
Figure 2. Boyer Bend with Chevrons.

**Channel Response:** Construction of the chevrons was complete in the fall of 1992. By the winter reconnaissance of January 1993, the shoal at the mouth of the Boyer River had reduced in size by approximately 50 percent. By the beginning of the 1993 navigation season the shoal was nearly gone and by the end of the 1993 season was completely removed. Figures 4 and 5 are channel cross section and profile surveys taken in December 1994. In Figure 4, the unaltered cross section is located approximately 0.75 miles upstream of Chevron 678.98, and is representative of a typical river channel (See Figure 3). Comparison of the three cross sections located downstream of the chevrons (Figure 4), indicates that there is a considerable increase in the amount of 0-5 foot depths relative to the CRP (15 to 25 percent of the section), and a decrease in the amount of 5-10 deep water, with relatively little change in the average bed elevation. The shoaling area along the left bank of the river has been removed, and subsequent reconnaissance inspections of the area show no evidence of the shoal reforming.

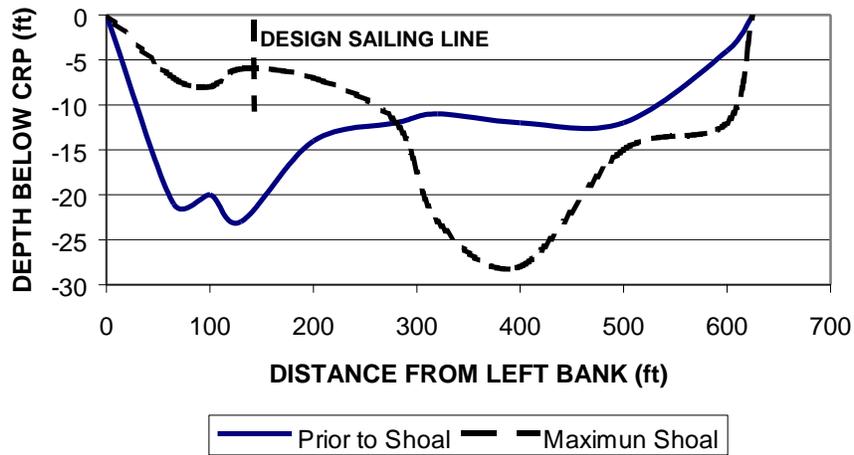
Figure 3. Pre and post shoaling cross sections at the mouth of the Boyer River.

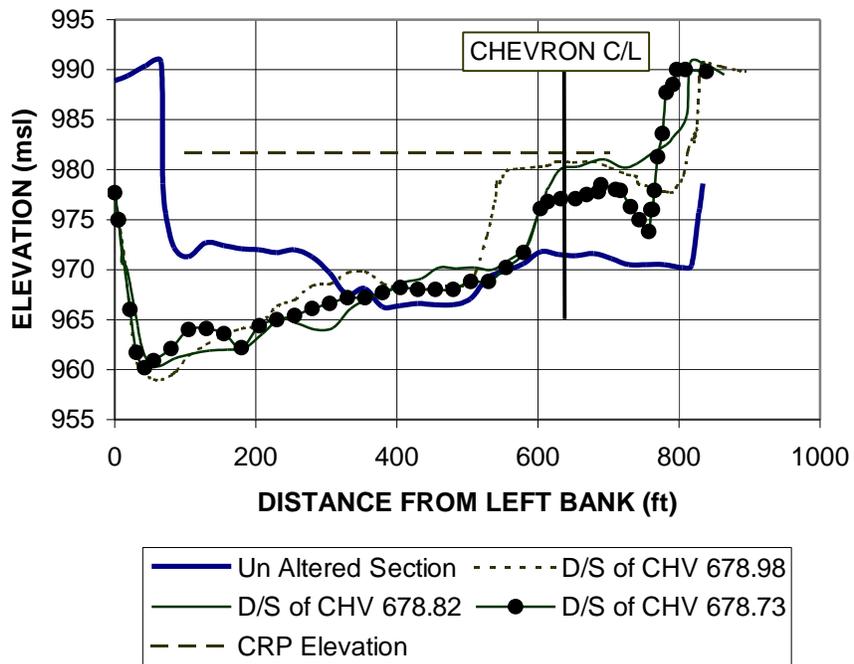
Figure 4. Post Construction Cross Section Surveys (December 1994).

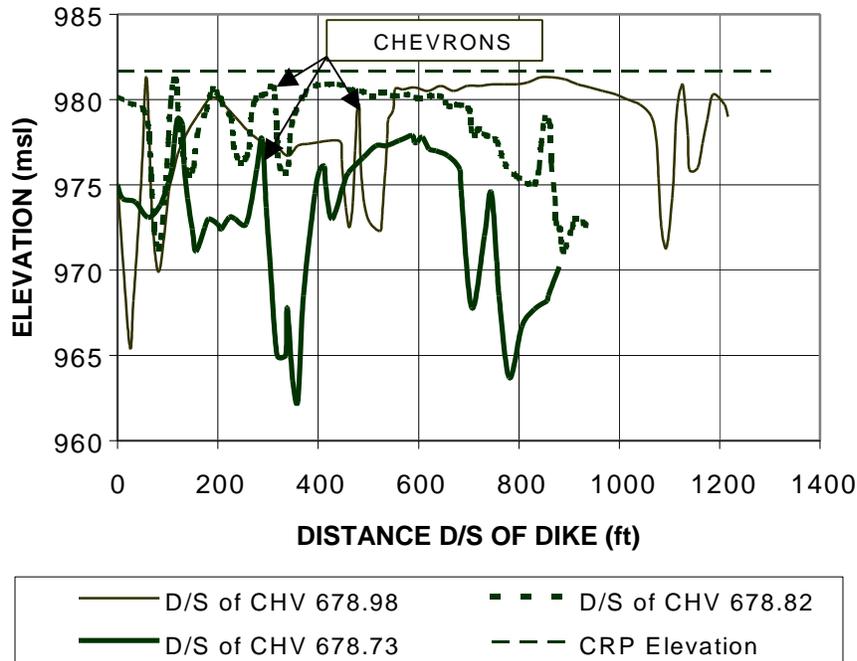
Figure 5. Post Construction Profile Surveys (December 1994).

The sailing line has been restored, and the sandbars have remained through an extended period of high flows (1993-1997). The elevations of the sandbars extended several feet above the crown of the chevrons after the 1995 and 1996 high flow years and were at or slightly below the crown elevations other years. The chevron with the highest crown elevation (CHV 678.98) maintained the highest and longest sandbar. However, it should be noted that the gap between the upper two dikes is considerably larger than the gaps between the downstream dikes. Re-circulation flows upstream of each dike would tend to truncate the downstream ends of the sandbars. This undoubtedly influences the length of the sandbars.

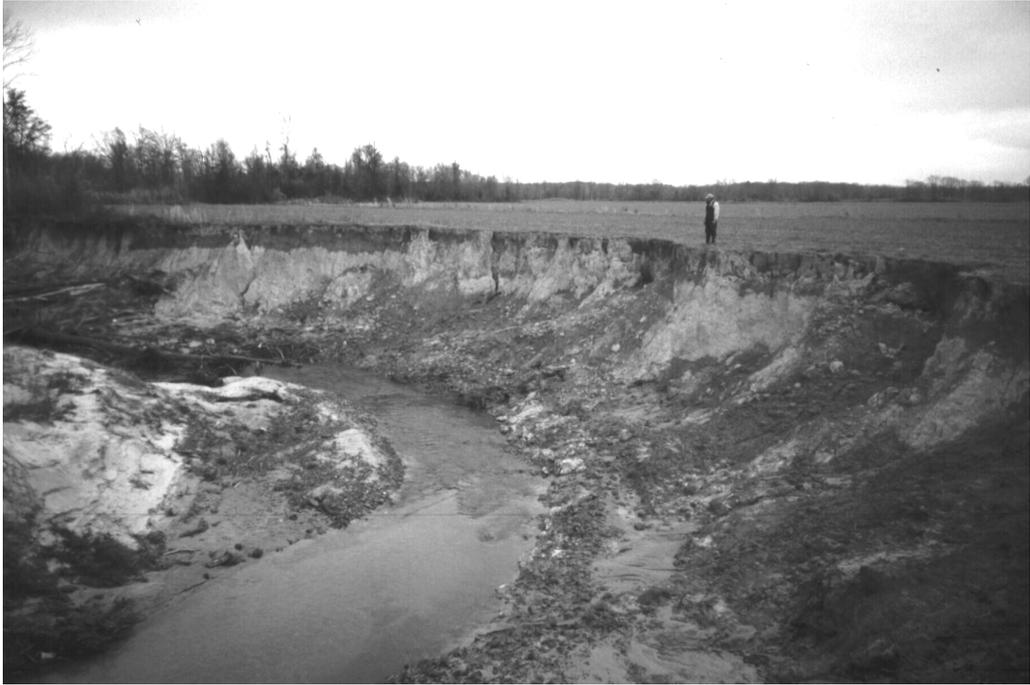
Figure 1. Typical bank erosion in study reach, 1999.

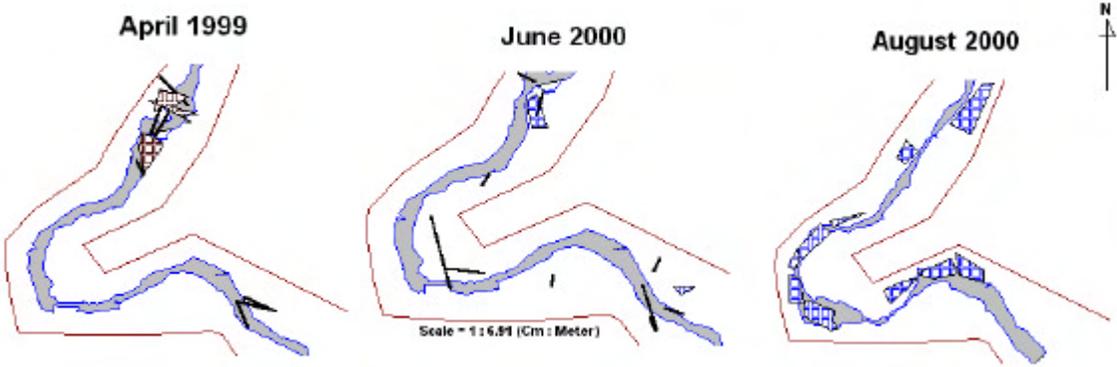
Figure 2. Map of selected segment of study reach showing top banks, water's edge at base flow, LWD formations and individual logs (April 1999 and June 2000) and LWDS (August 200)

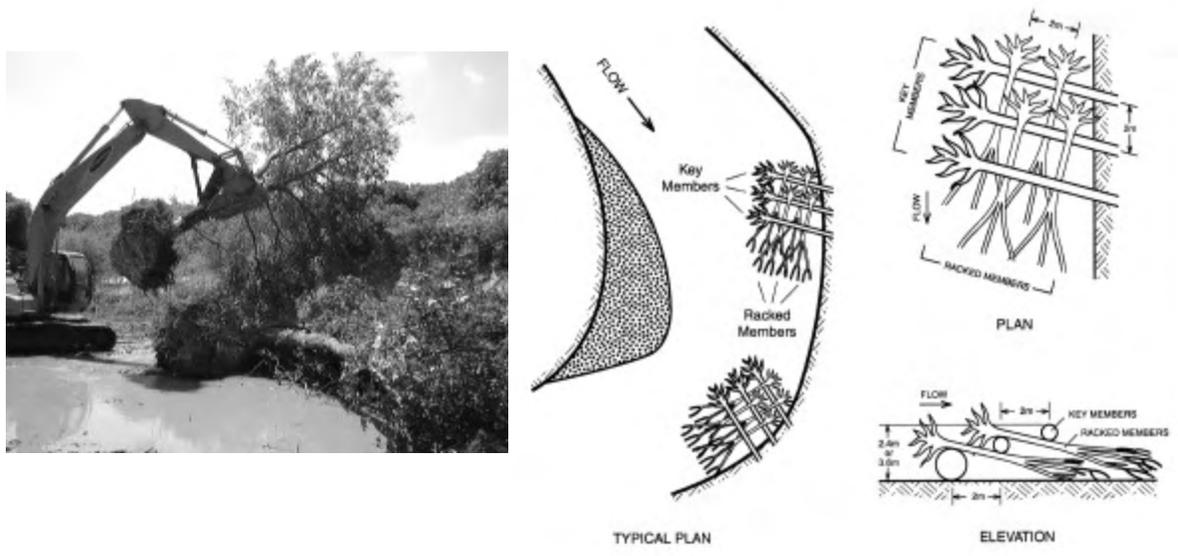
**Figure 3.** Typical plan and elevation of large woody debris structures. Inset photo shows LWDS under construction.

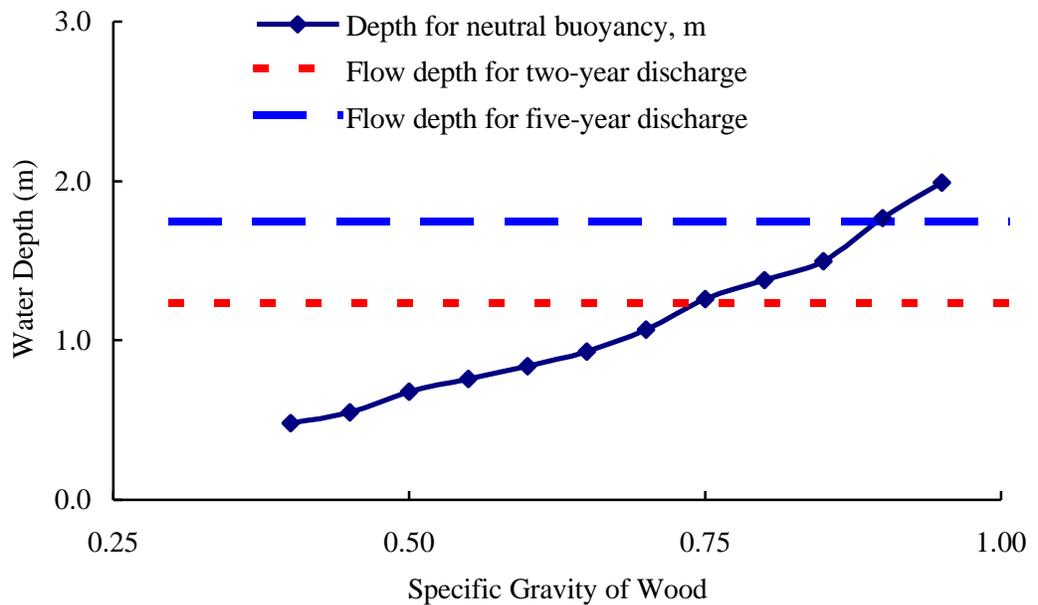
**Figure 4.** Flow depth required for buoyant force on large woody debris structure to equal weight of wood as a function of flow depth.

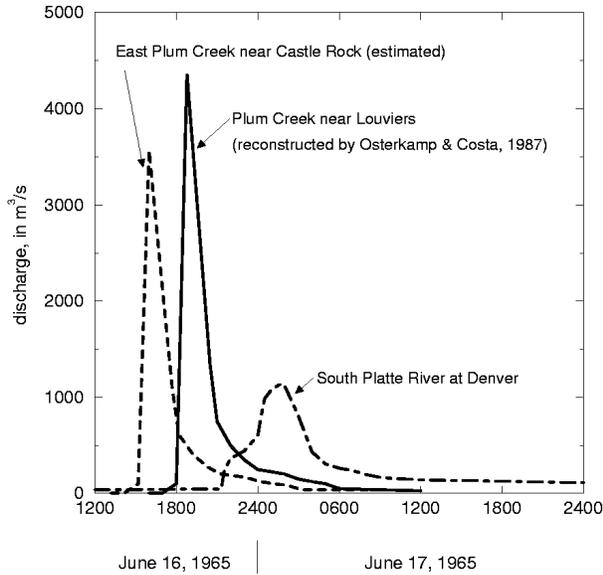
**Figure 2.** Reconstructed flood hydrographs for Plum Creek and East Plum Creek (our estimate), and the gage record for the South Platte River at Denver.

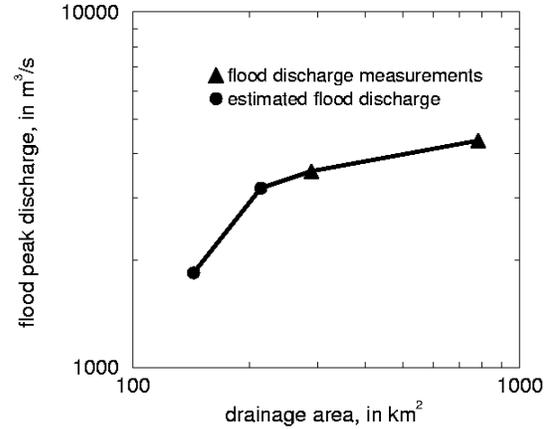
**Figure 3.** Flood peak discharge along East Plum Creek and at Plum Creek near Louviers.

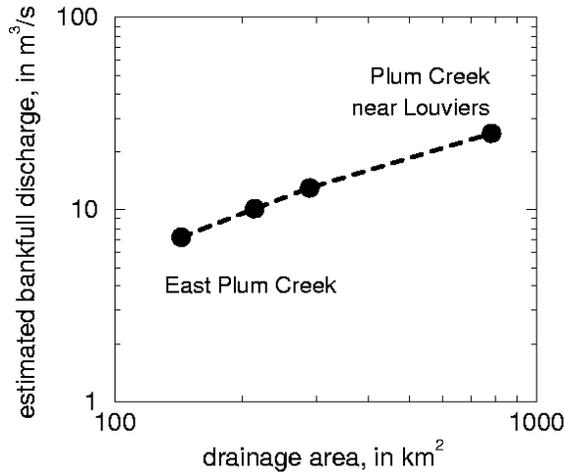
**Figure 4.** Estimated pre-flood bankfull discharge at the three locations along East Plum Creek and for Plum Creek near Louviers.

In equation 1, the value of the exponent was determined from the 1965 flood peak discharge as a function of drainage area along East Plum Creek. We then used equation 1 to estimate bankfull discharge along East Plum Creek upstream from Castle Rock (figure 4).

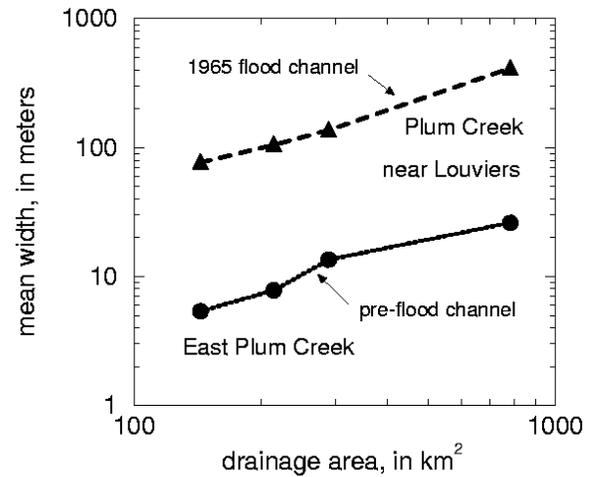
**Figure 5.** Mean flood and pre-flood bankfull widths determined from large-scale aerial photographs.

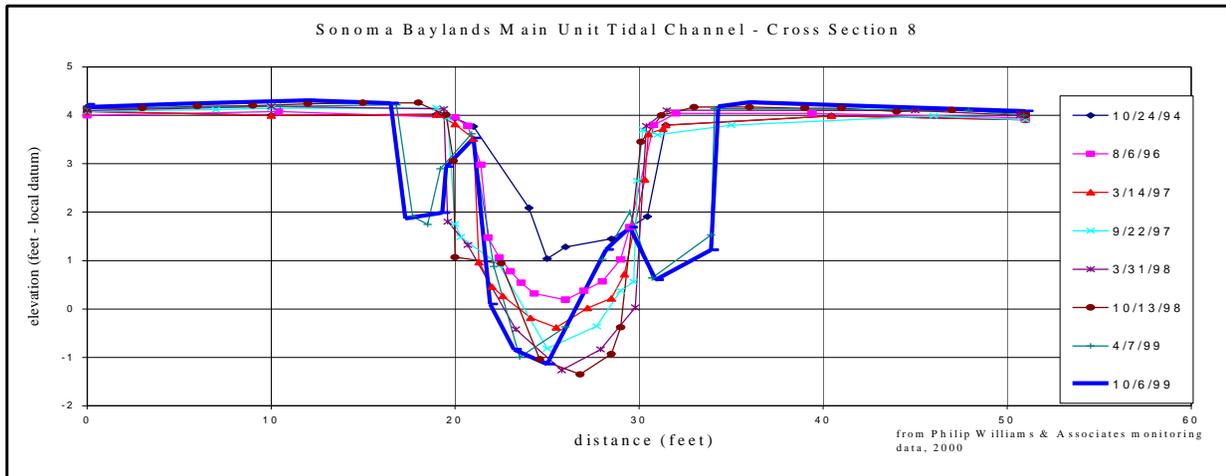
Figure 1 – Sonoma Baylands tidal channel evolution

While the process has been slow, the tidal channels between the restoration site and San Pablo Bay have been evolving. Analysis of cross sections (see Figure 1) shows that the channels are experiencing a cycle of deepening and widening. Scour in the channels first deepens them to the point where the channel banks become unstable. Slump blocks then fall into the channels, widening them but also causing them to become shallower. The channel bottoms then scour again and the process continues.

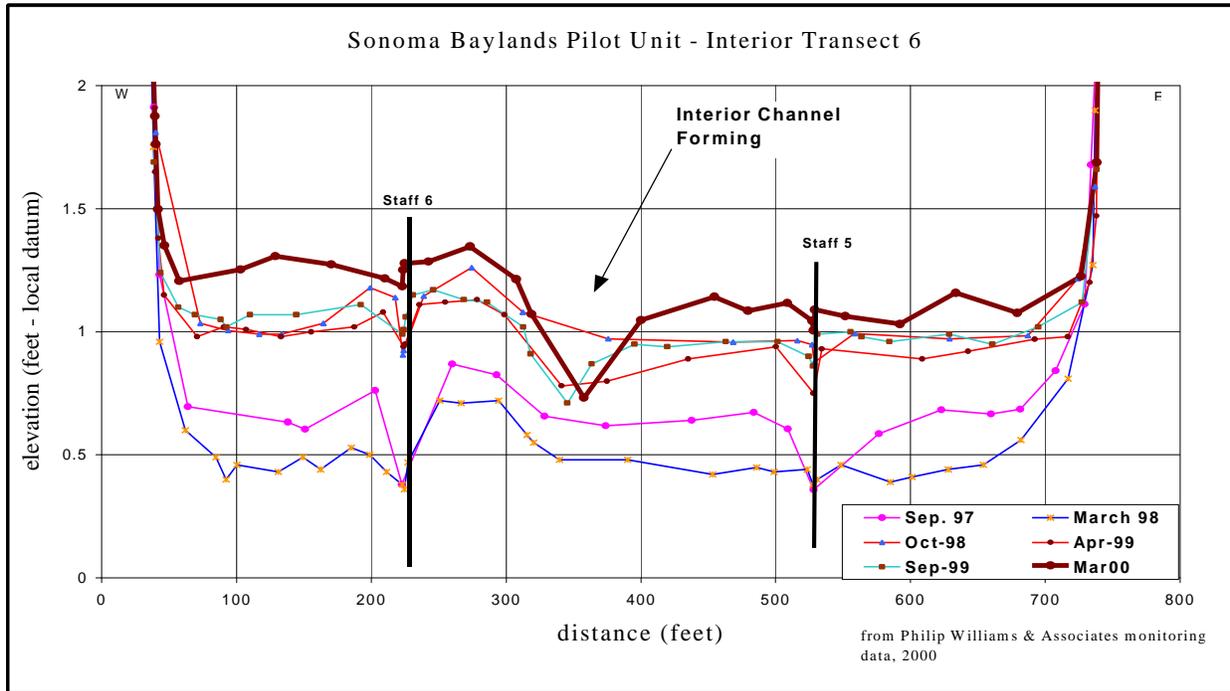
Figure 2 – Sonoma Baylands transect showing the start of interior channel formation

Slower than anticipated sedimentation in the restoration site has also slowed the formation of interior subtidal channels. While interior channels started to form by April 1999, they have only become visibly noticeable since March 2000 (see Figure 2).

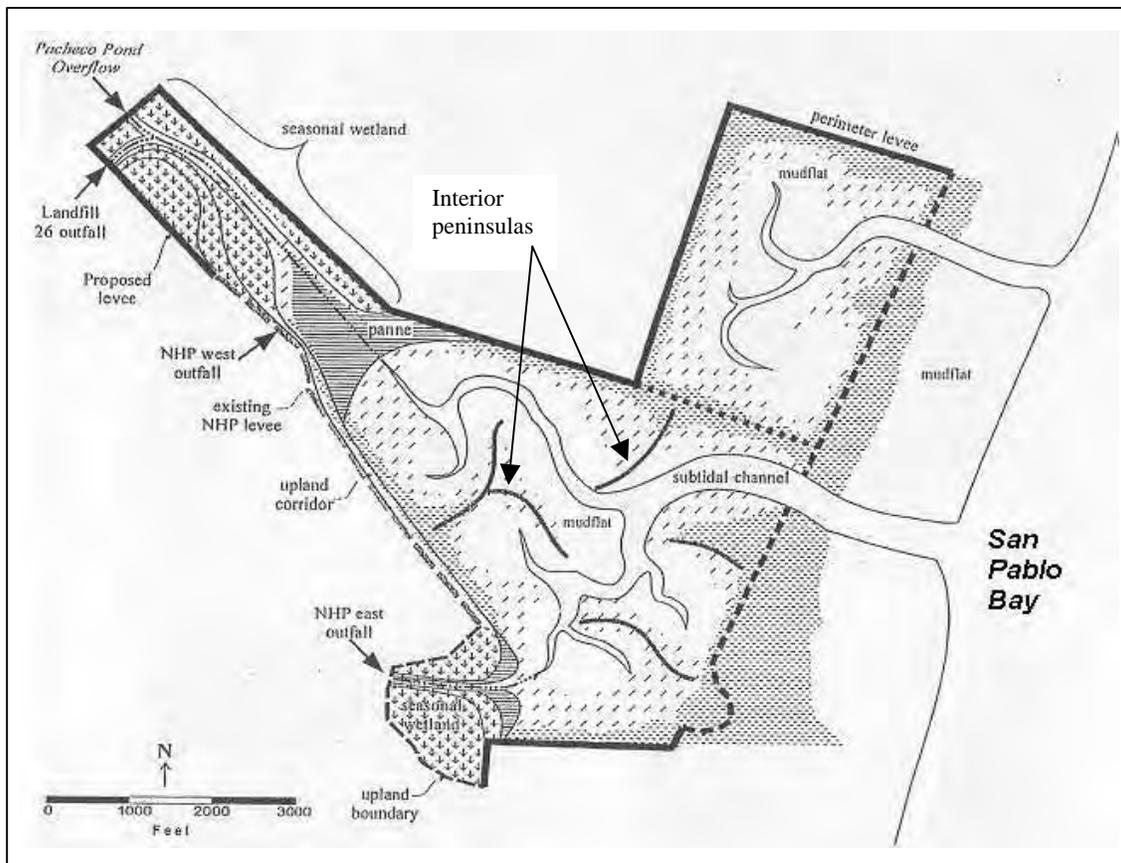
Figure 3 – Hamilton wetland restoration project conceptual plan

**Initial Design:** The basic design of the Hamilton site is very similar to that of Sonoma Baylands (see Figure 3). Initially, a levee will be constructed around the site to protect abutting property owners from flooding. This levee, however, will be over 200 feet wide and will slope gently down from an upland type habitat to seasonal wetlands and then to the tidal salt marsh. The seasonal wetland will also cover the entire northern and southwestern portions of the site, where local stormwater runoff will be directed. This area will be completely filled with dredged material, to within a few feet of its final elevation. Because the dredged material is mostly silty clay, with some silty sand, and is unsuitable for the final vegetative cover of the seasonal wetland area, the final cover will be composed of loamy topsoil from adjacent farmland.

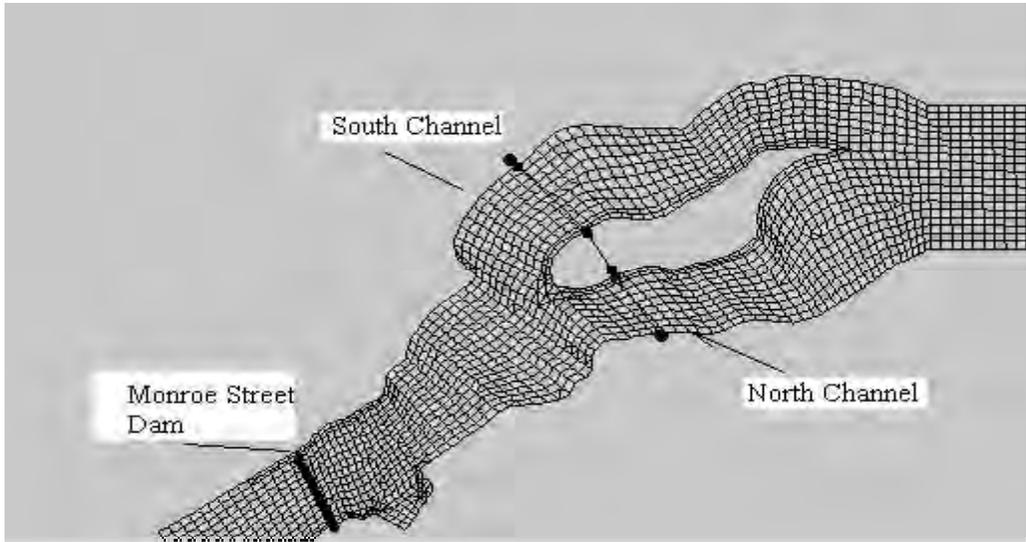
Figure 2. Spokane River Finite Element Mesh

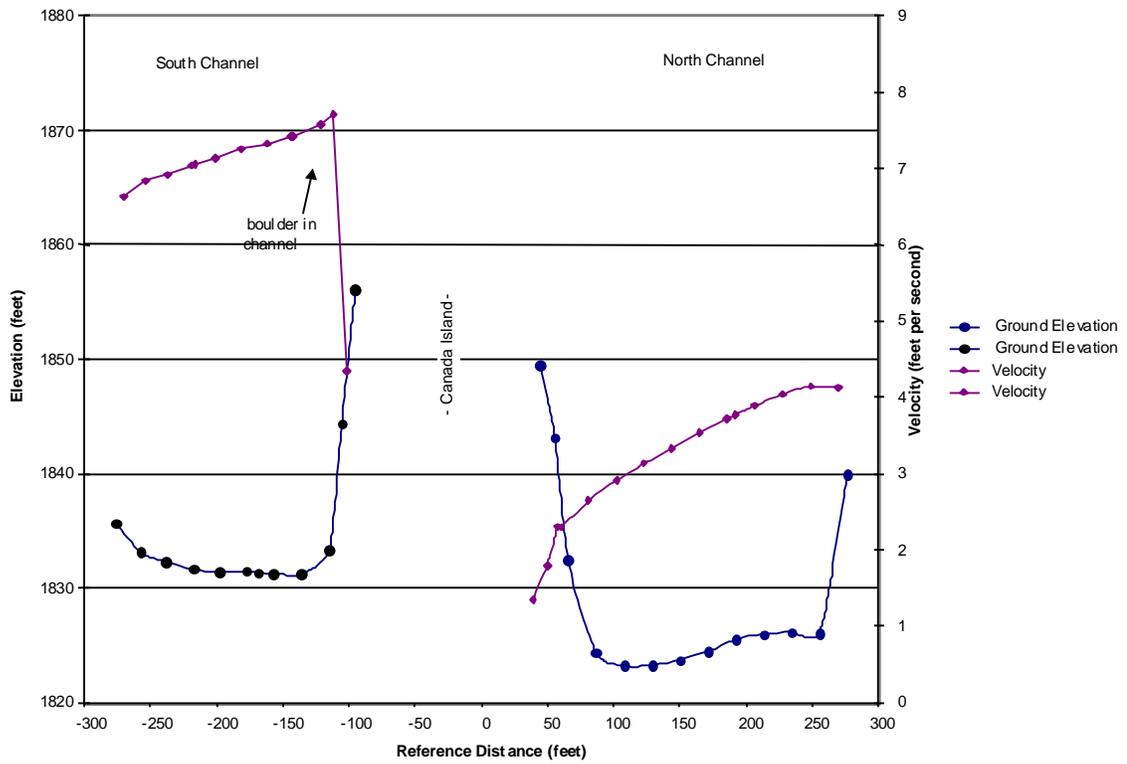
Figure 3. Spokane River Cross Section: 2-Year Flow Velocities

Preliminary results for the 2-year, 10-year, 25-year, and 100-year storm event flows have been determined. Larger velocities have been observed in the southern channel around Canada Island (see Figure 3) and along several riverbank areas for all of the flows modeled. These areas will be the focus of further sediment transport modeling and restoration measures.

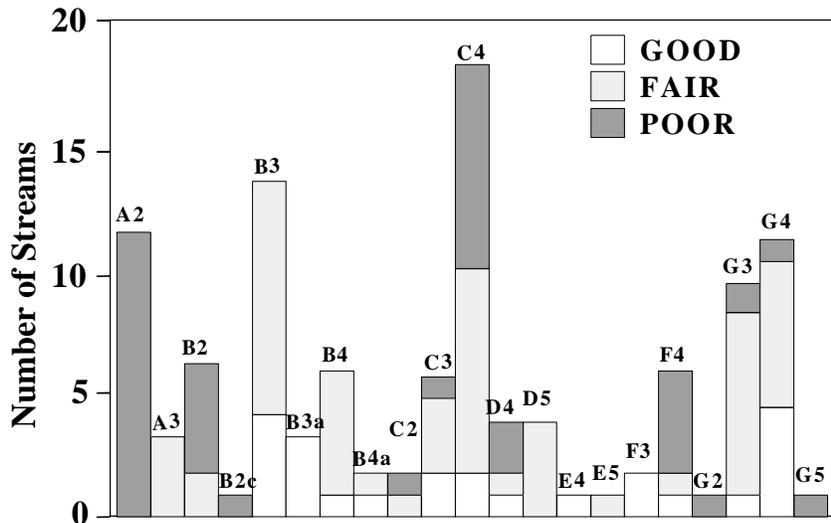
Figure 1. Stream type and channel stability rank.

sampled than FAIR or POOR streams (Figure 1). At first, some of the results of the analysis appeared somewhat unexpected, but understandable. As expected, bedload and suspended load respond to discharge differently and at different rates with suspended sediment being the larger component of the total sediment transport. For bedload transport, however, we failed to show significant differences between dimensionless transport within and between stream types for both GOOD and FAIR stability ratings. Streams with POOR stability ratings exhibit differences within and therefore, by default, between stream types. This implies POOR streams exhibit significantly different dimensionless sediment transport characteristics (departure) from each other as well as from either FAIR or GOOD streams. This pattern was not as clear, or well demonstrated, for suspended sediment transport as there appears to be more inherent variability both within and between stream types and stability rankings. However, the tendency to fail to show departure among streams and between stream types is still quite strong as 86% of all comparisons failed to document departure. Although differences in dimensionless suspended sediment transport appear to exist within stream types, we cannot conclude they are differences attributable to stream type.

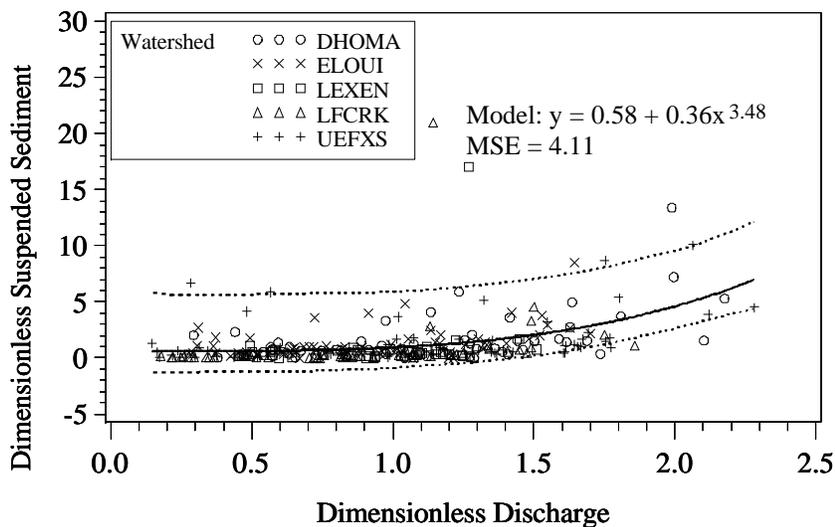
Figure 2. Reference suspended sediment transport model with 95% individual bootstrap prediction intervals.

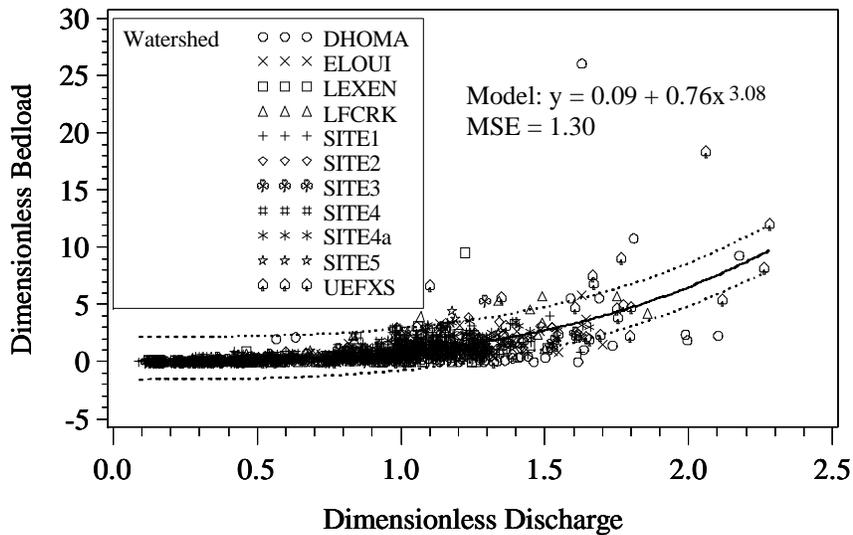
Figure 3. Reference bedload transport model with 95% individual bootstrap prediction intervals.

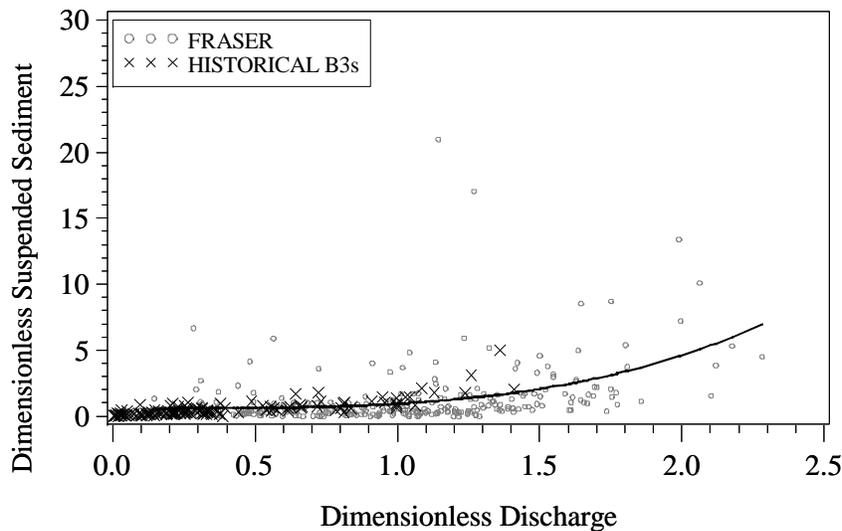
Figure 4. Suspended sediment for all historical B-3 streams plotted over pooled model for reference streams.

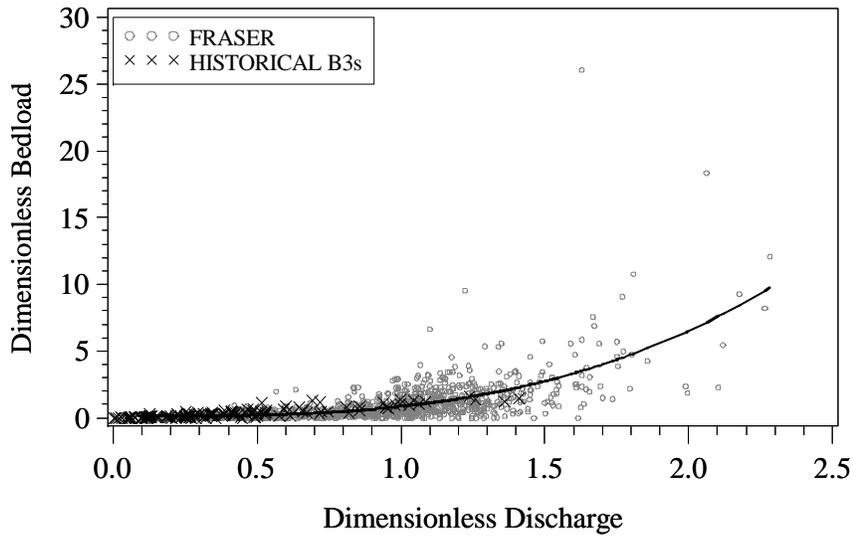
**Figure 5. Bedload transport for all historical B-3 streams plotted over pooled model for reference streams.**

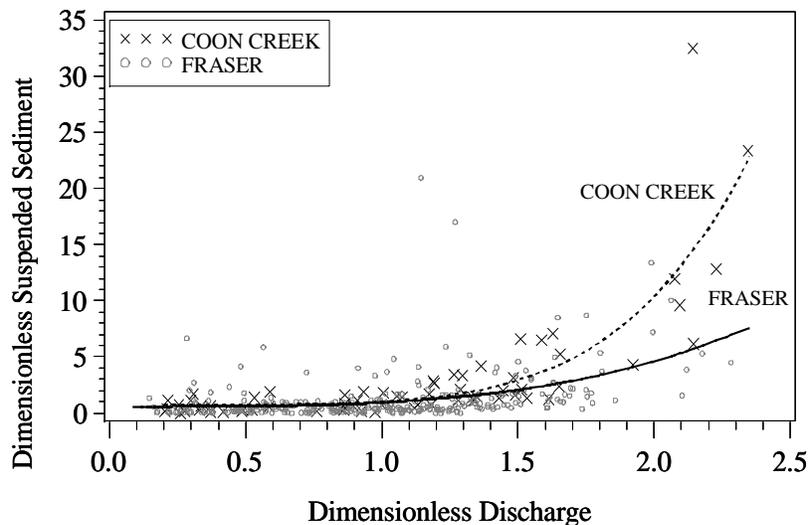
**Figure 6. Comparison of the dimensionless suspended sediment model for Coon Creek and the pooled model for reference conditions.**

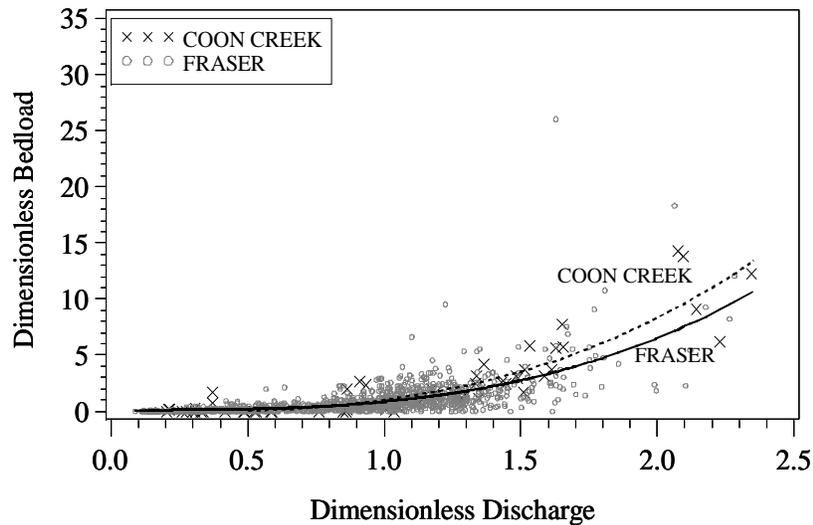
**Figure 7. Comparison of the dimensionless bedload transport model for Coon Creek and the pooled model for reference conditions.**
