## Volume 1

## II. Stream Restoration

## **AN OVERVIEW OF THE USACE STREAM RESTORATION GUIDELINES**

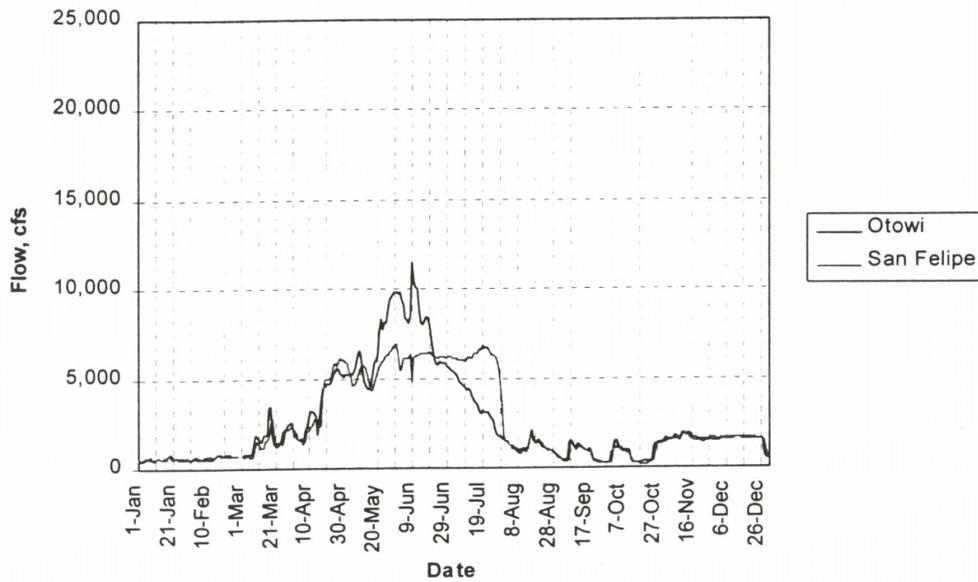
**Figure 2. Cochiti Reservoir Inflow (Otowi) and Outflow (San Felipe) 1979 Hydrograph**

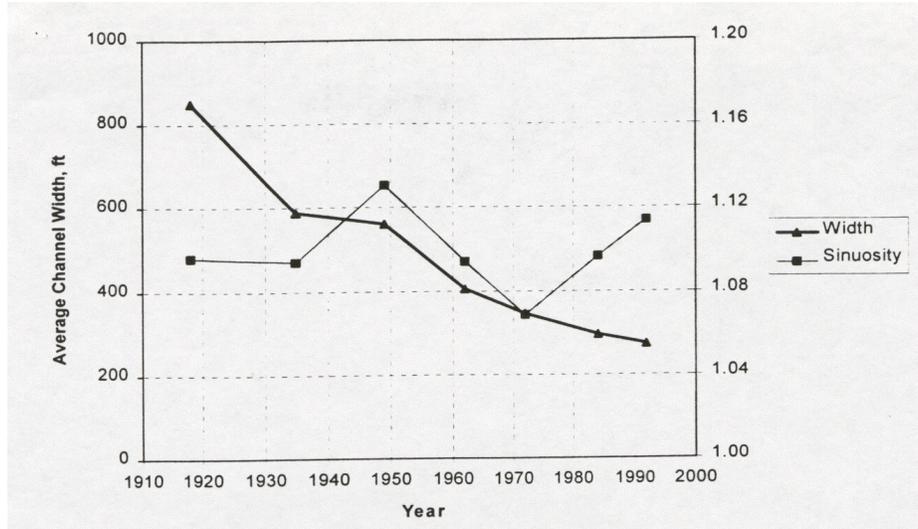
**Figure 3. Active Channel Width and Sinuosity from Cochiti to Bernalillo**

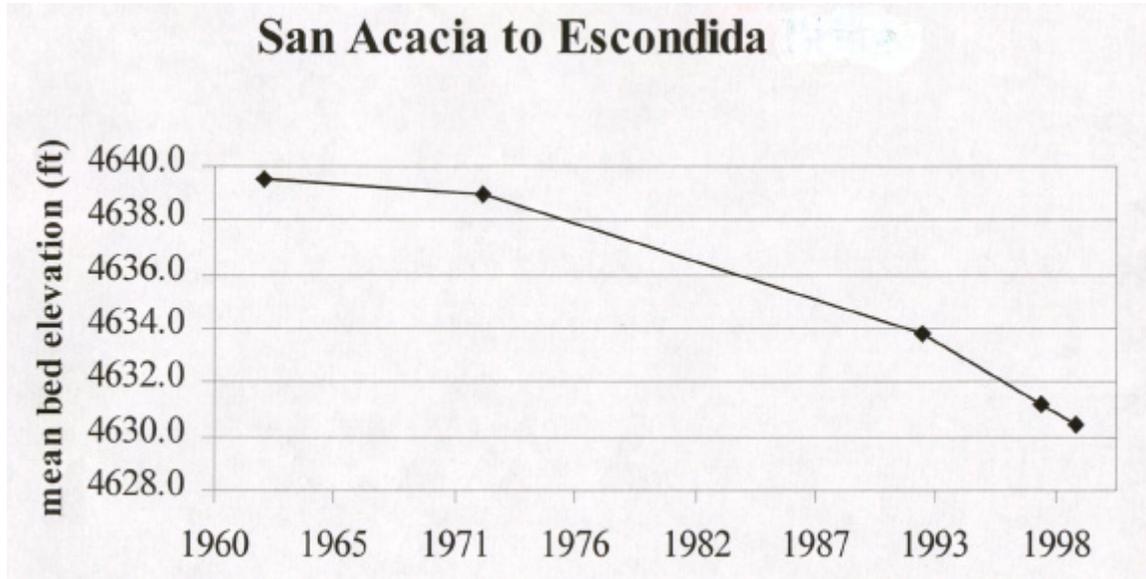
**Figure 5. San Acacia to Escondida Average Bed Elevation**

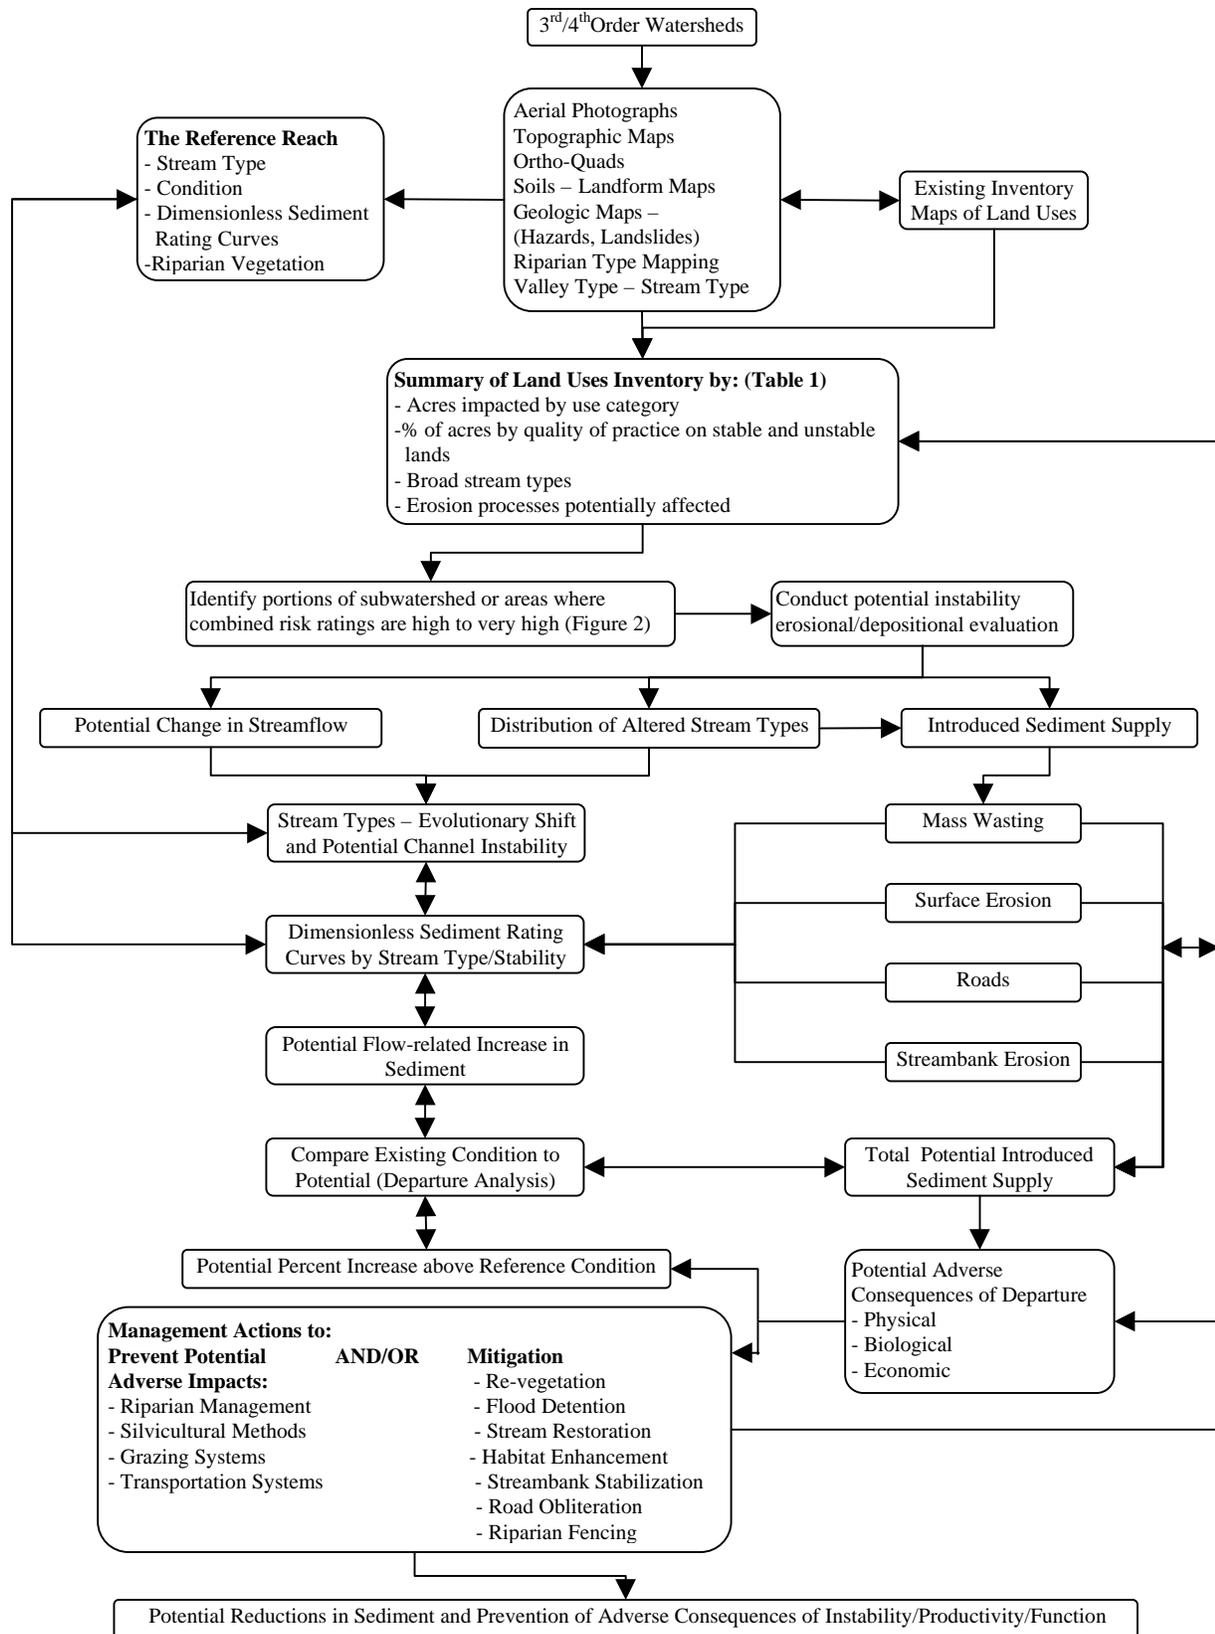
Figure 1. The Broad and/or Initial Level of Assessment

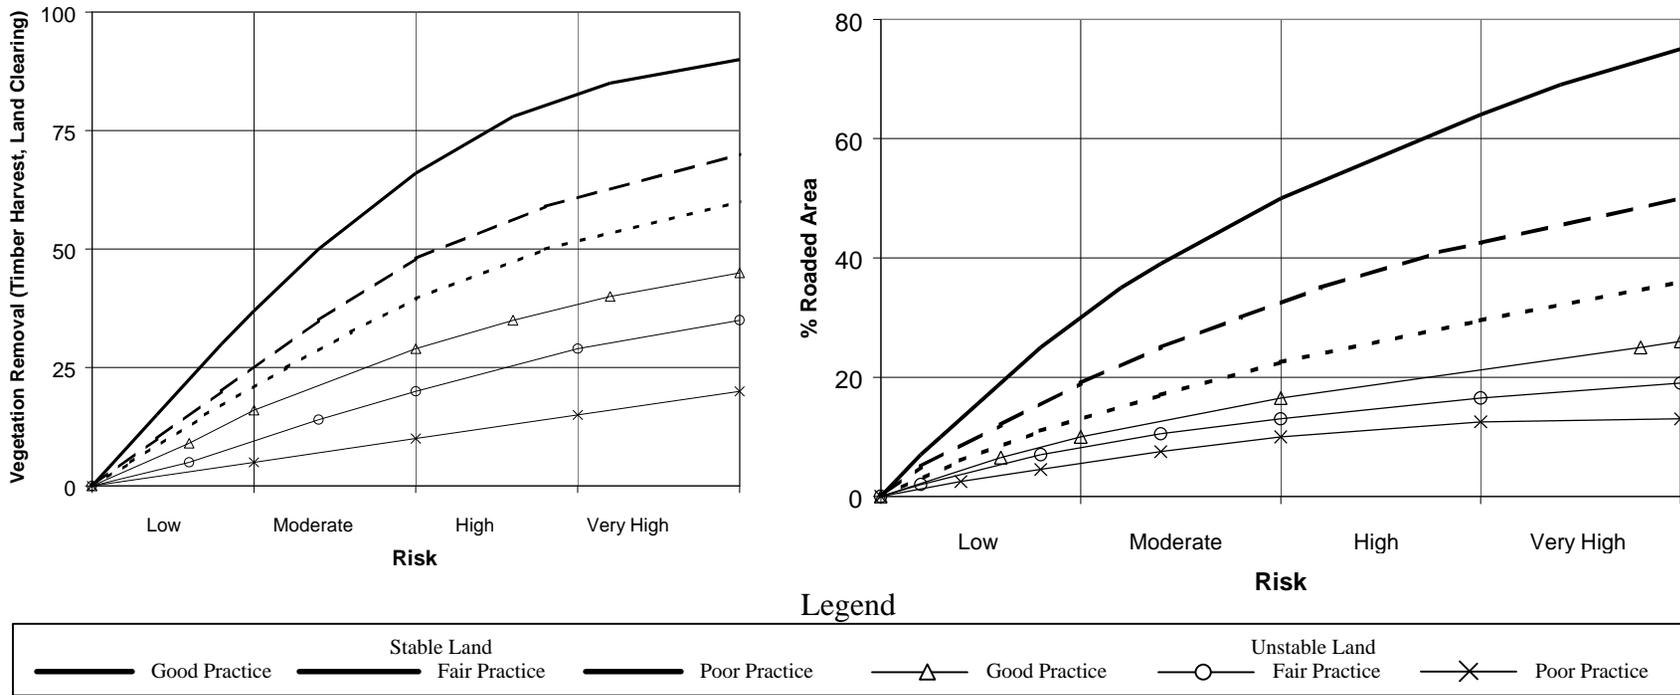
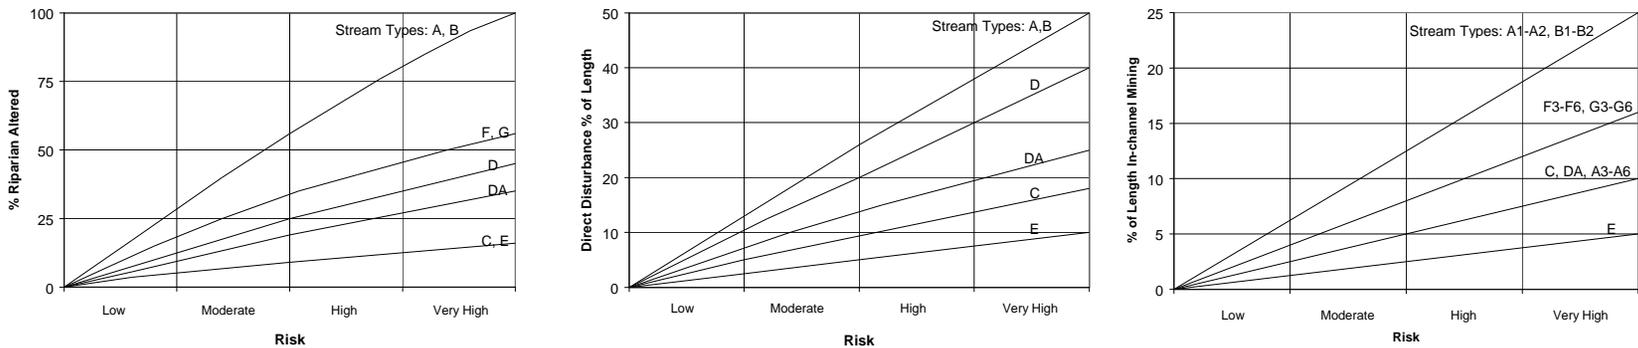
Figure 2: Examples of watershed assessments to determine potential increases in sediment due to the extent of various land use activities, stability of the landscape and rivers, and the quality of land use practices.

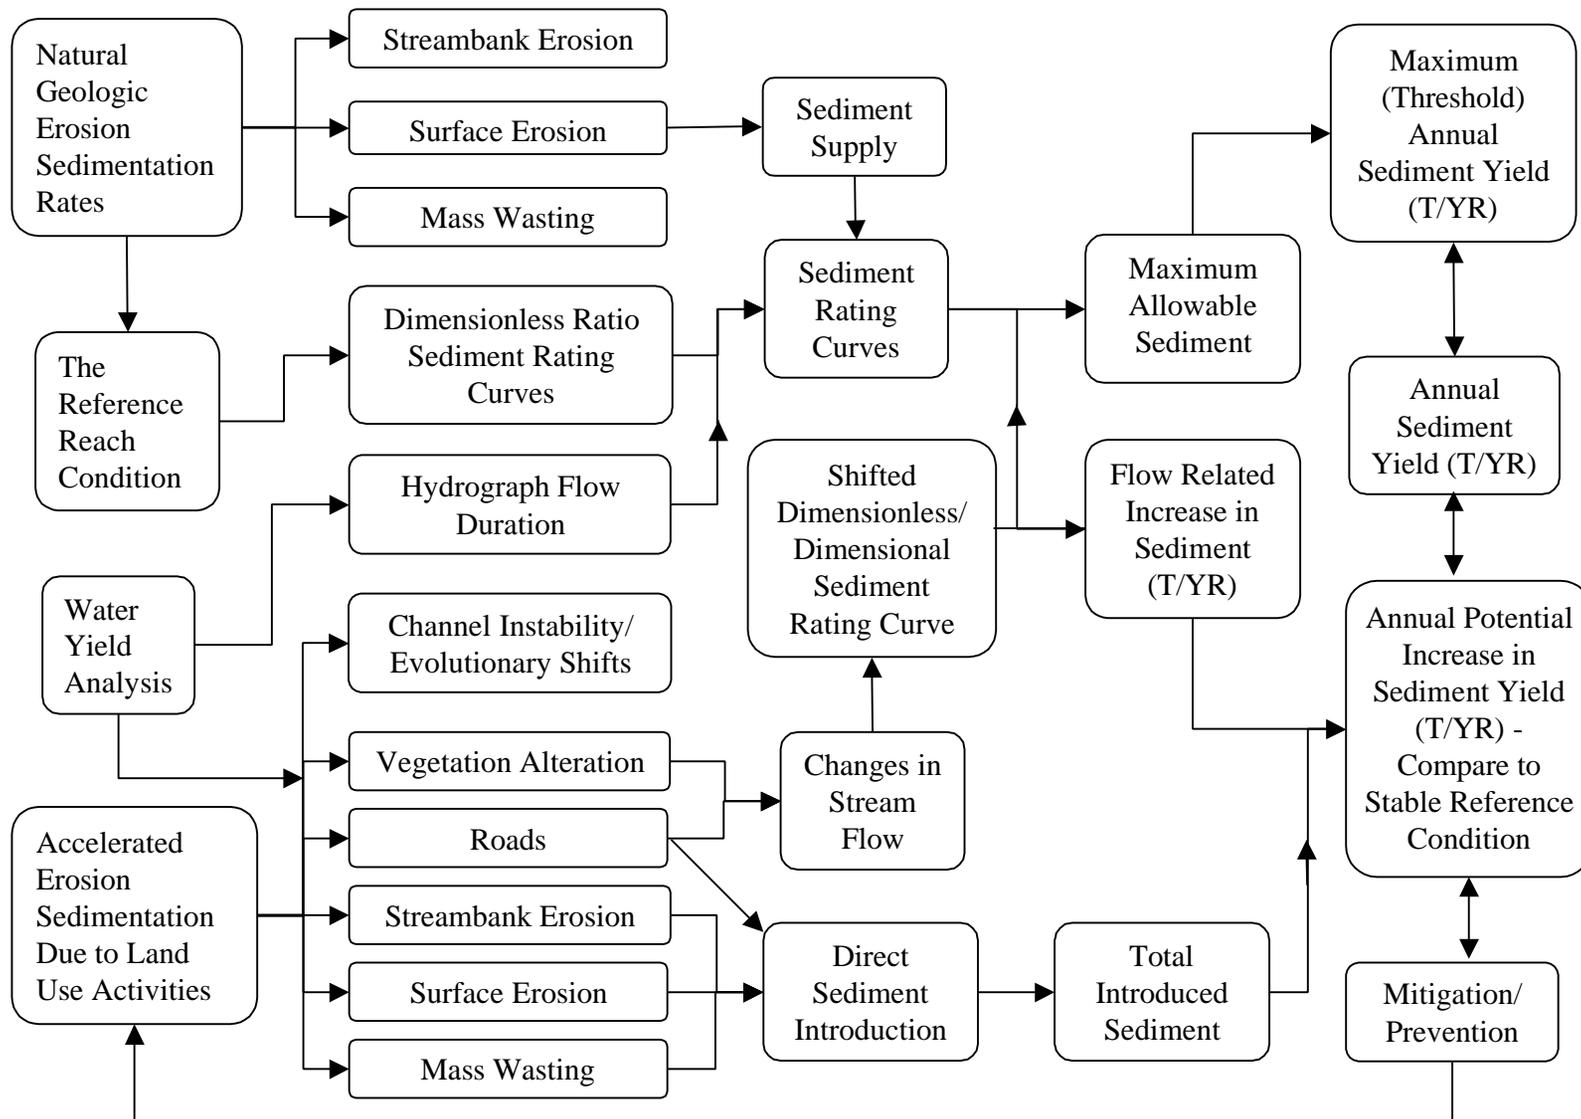
Figure 3. Flow Chart of the Intermediate Level of Assessment, Showing Predicted Comparison of Natural Rates of Sediment Compared to Potential Increase Due to Land Use Activities (from: Rosgen, 1999)

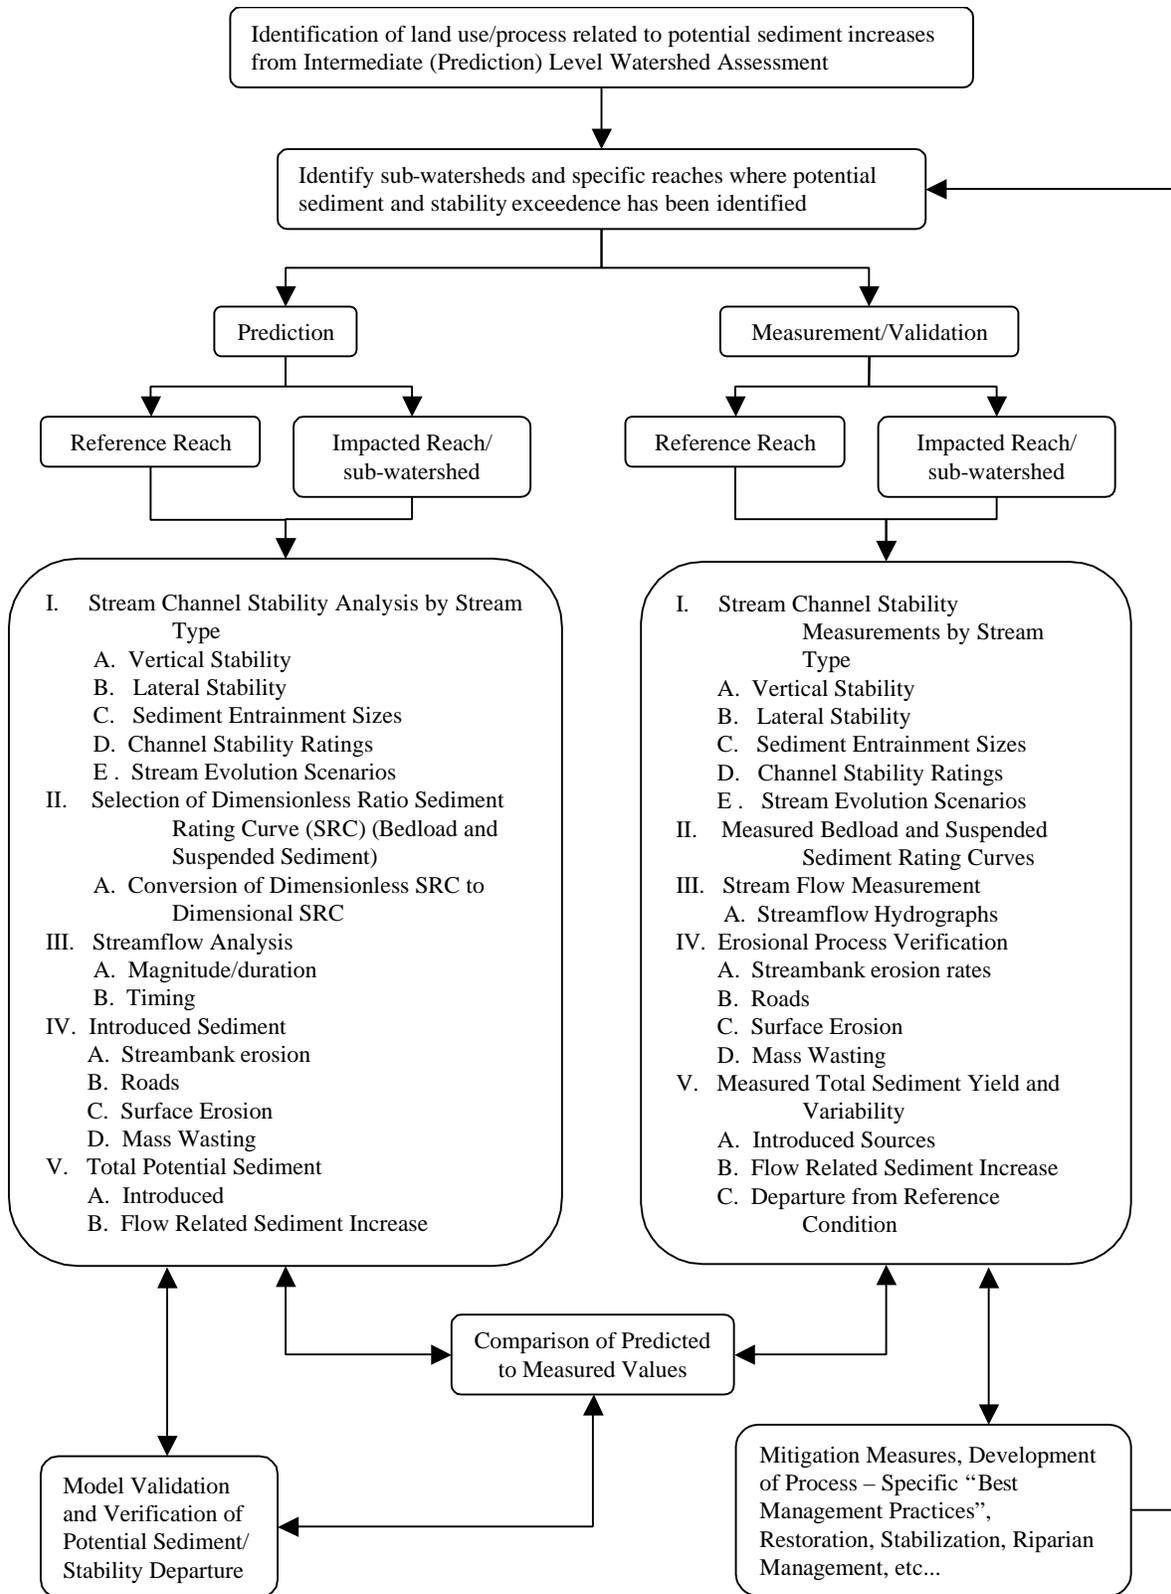
Figure 4. Prediction and Validation Assessment Levels to Determine Magnitude and Extent of Sediment and Stability Departure from a Reference Condition

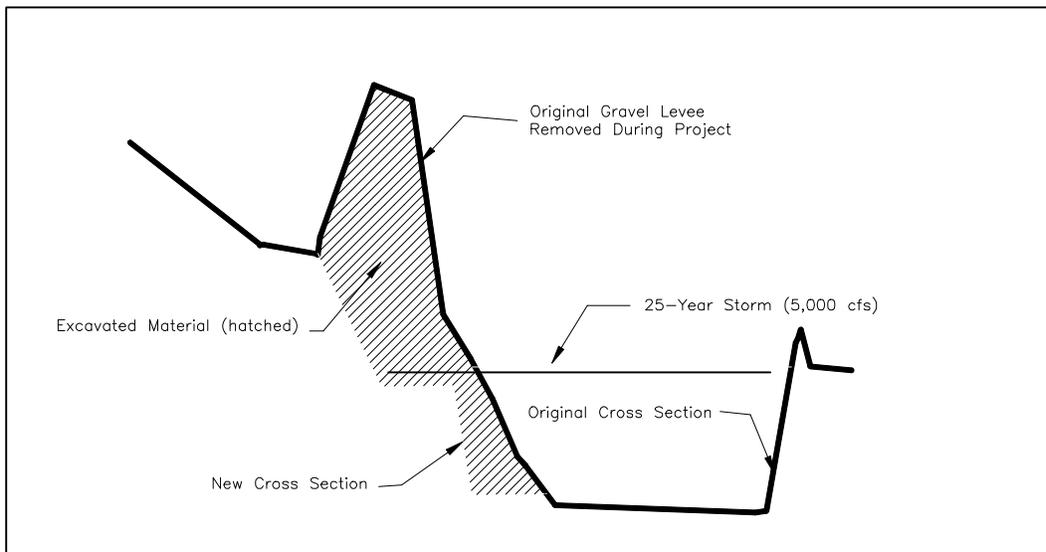
Figure 3. Constructed channel cross section compared to original channel cross section

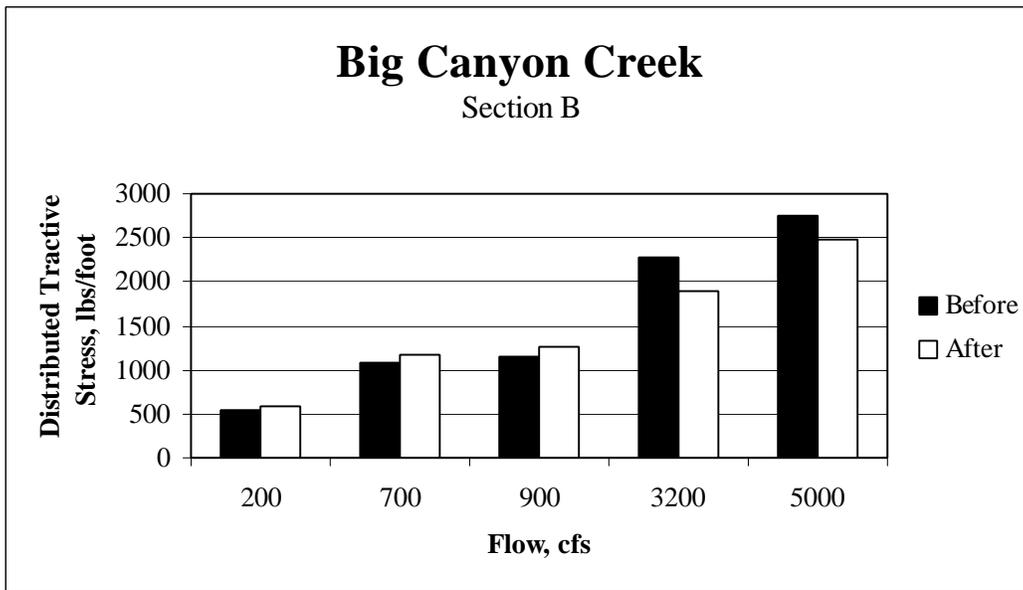
Figure 4. Change in reach-averaged tractive stress after completion of construction on Big Canyon Creek.

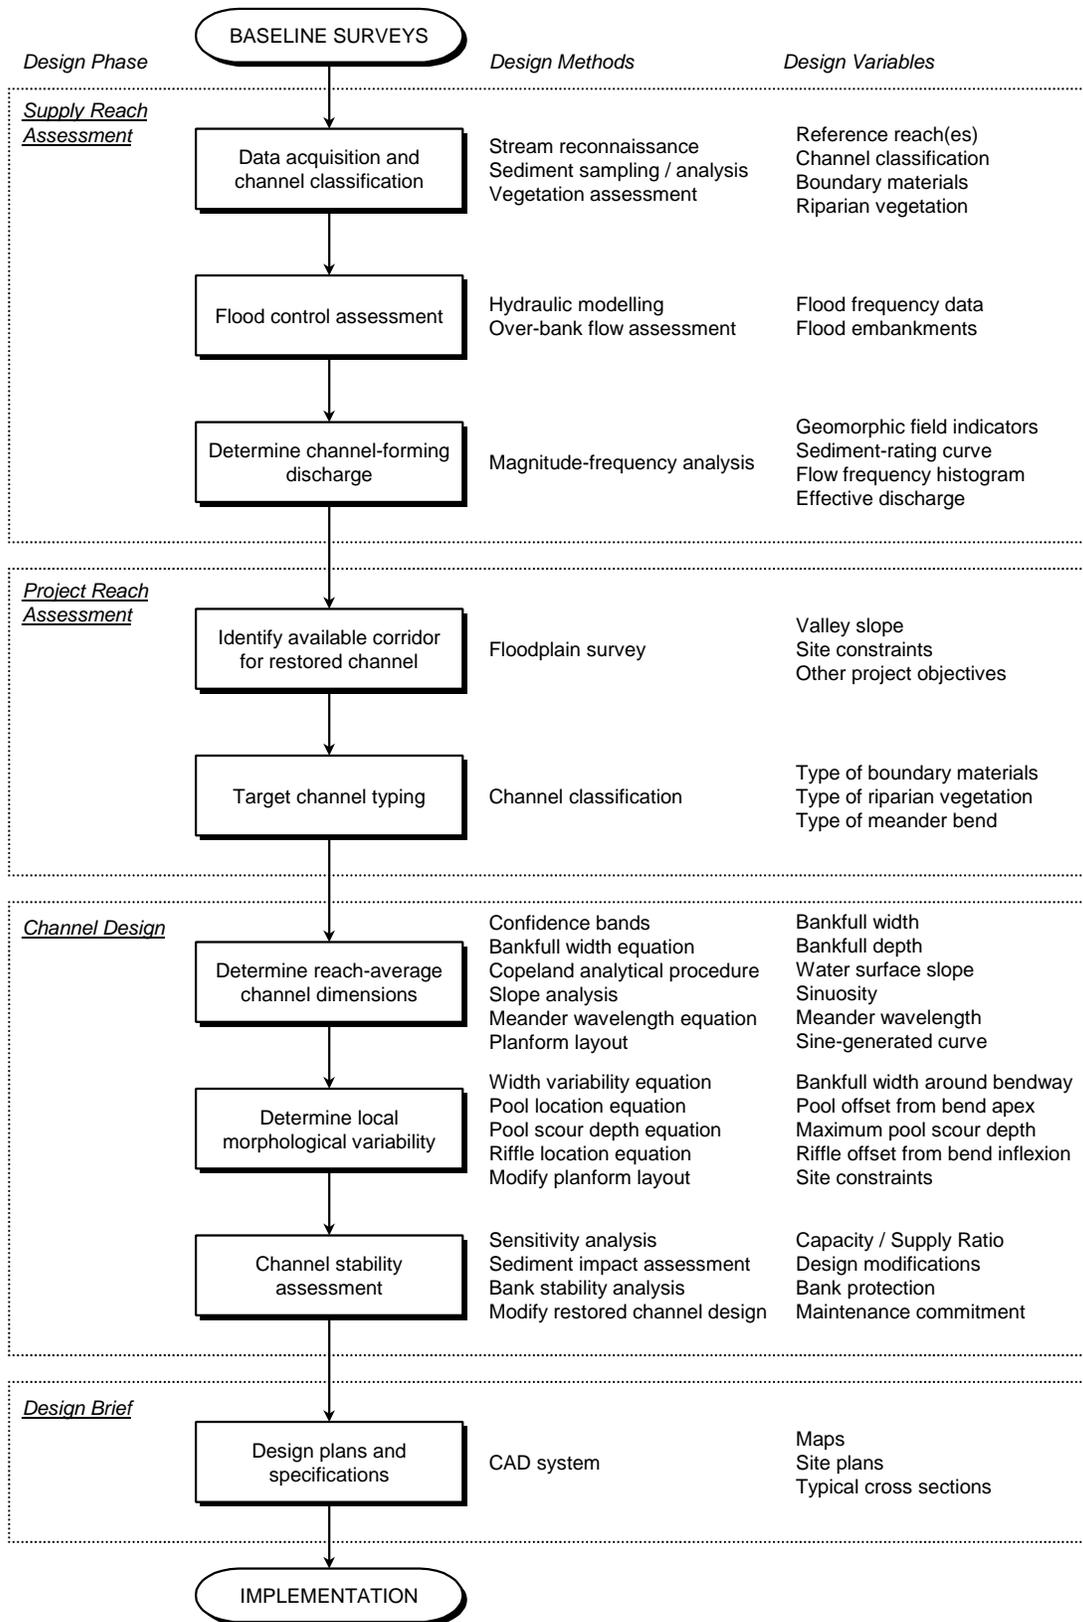
Figure 1 Best practice channel restoration design procedure.

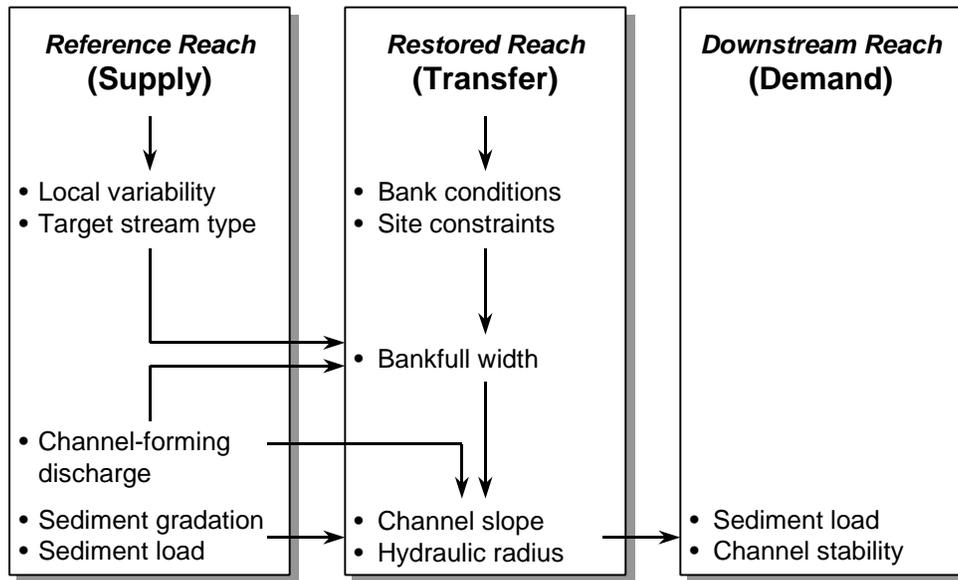
**Figure 2** The fluvial system in terms of sediment supply, transfer and demand.

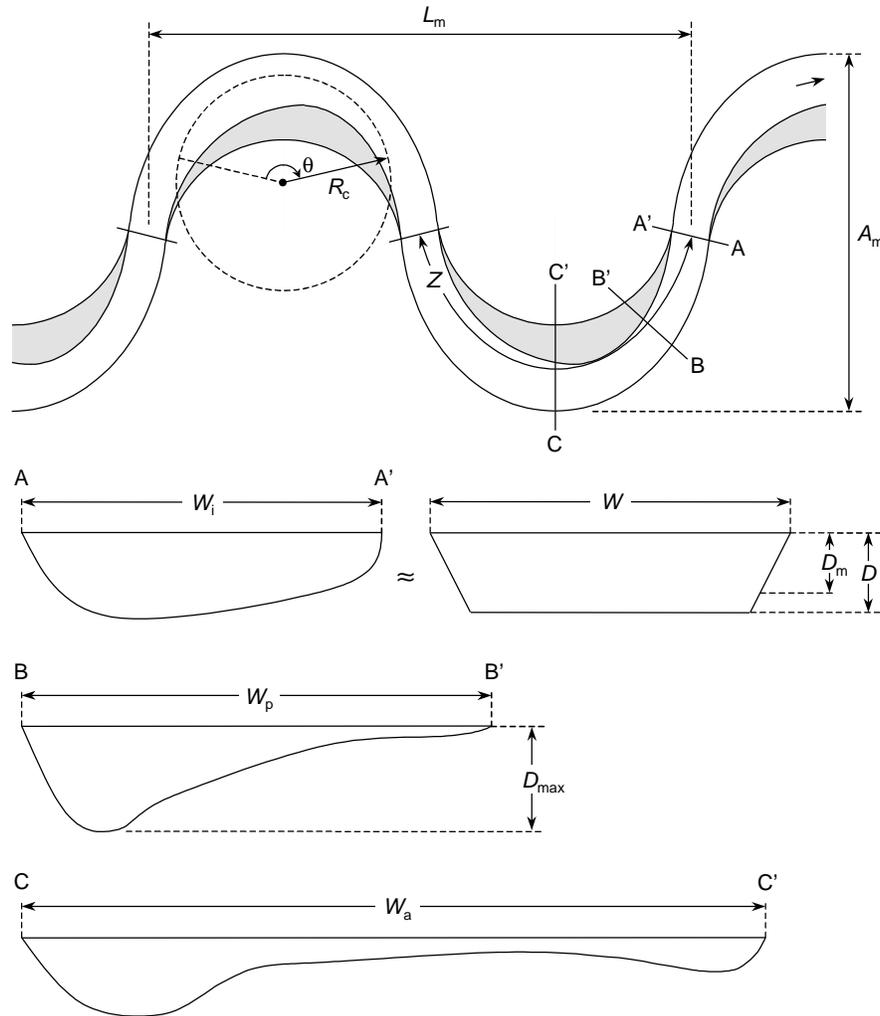
Note: point bars are defined by shaded regions;  $L_m$  = meander wavelength,  $Z$  = meander arc length (riffle spacing);  $A_m$  = meander belt width,  $R_c$  = radius of curvature;  $\theta$  = meander arc angle;  $W$  = reach average bankfull width;  $D$  = depth of trapezoidal cross section;  $D_m$  = mean depth (cross-sectional area /  $W$ );  $D_{max}$  = maximum scour depth in bendway pool;  $W_i$  = width at meander inflexion point;  $W_p$  = width at maximum scour location;  $W_a$  = width at meander bend apex.

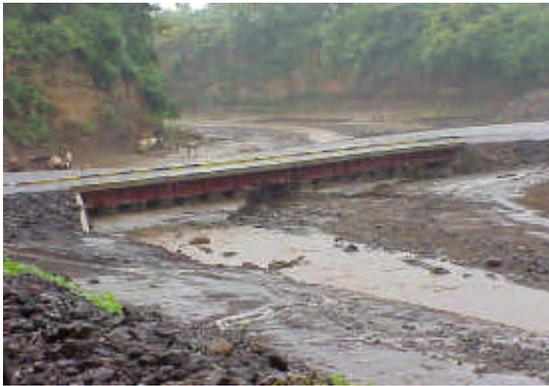
Typical Post Mitch Bridge

Many river crossings have been rebuilt with structures that were intended to be permanent. However, many of these sites are already experiencing stability problems. Materials and funding are available for construction of new bridges through groups such as the Catholic Relief Fund, Peace Corps, and other non-governmental organizations. Engineering analysis of proposed sites needs to be performed which incorporate appropriate hydrologic, hydraulic and sedimentation considerations prior to initiating construction. The following photographs depict typical channel and bridge conditions.

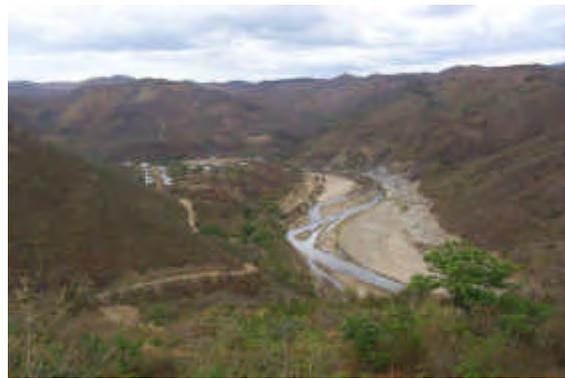
Post Mitch Rio Coco River

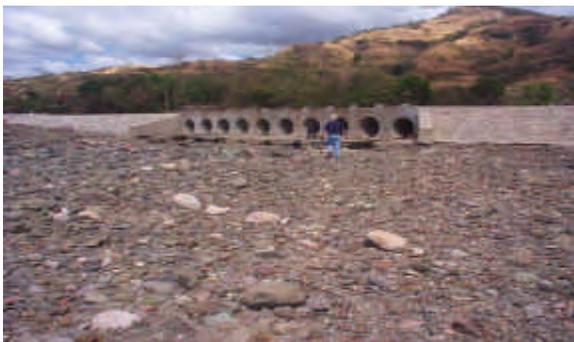
New Bridge Construction @ Gualilica

Several sites were observed during the initial reconnaissance of the Rio Negro basin that could serve as demonstration projects. These sites would provide guidance on design considerations that will enhance the survivability of roadway crossings by stabilizing flow conditions in the proximity of those structures. Two sites consist of new roadway crossings at El Pederal, and Gualilica. The crossings are similar in design, with multiple culverts and single span bridge components. The structures are already experiencing downstream scour and the flow conveyance of the structures are reduced due to deposition upstream and poor channel alignments through the structures. The demonstration project would provide guidance for the use of training dikes and protection of structures from downstream scour. At the third site, El Platanos, near San Juan De Limay a school was lost to bank caving, villages were relocated, and roadways were washed out as a direct result of Mitch.

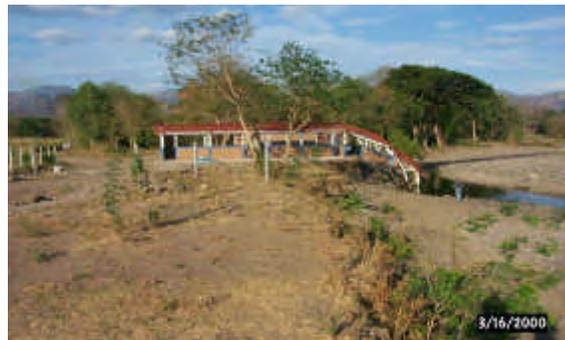
School Destroyed by Bank Caving

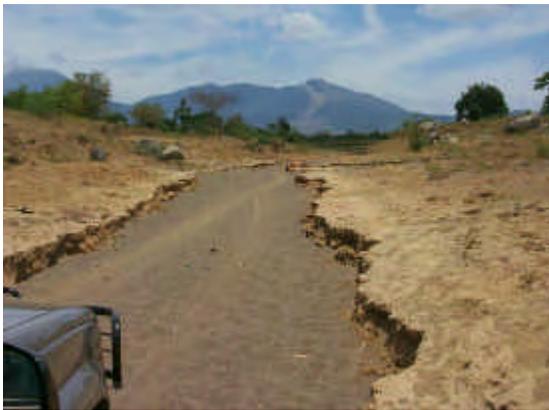
New Channel Cut by Mitch

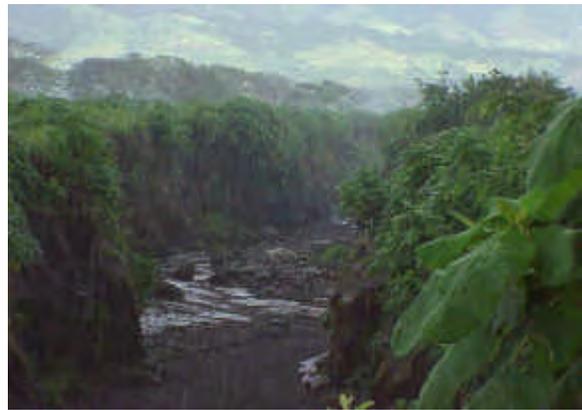
Deepened Original Channel

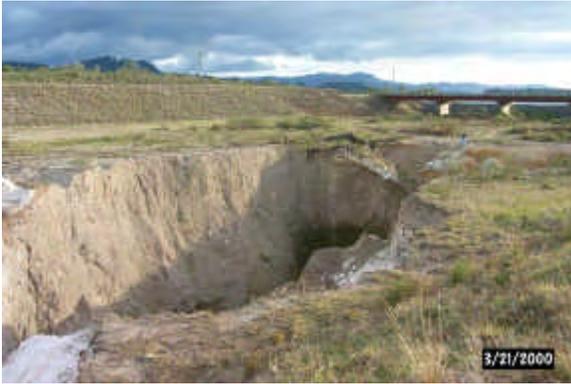
Downstream of Spillway Bridge

**Spillway Study and Repair at Lago de Apanas de Rio Grande de Tumas:** The control sill, several downstream baffle-type energy dissipaters, and the end sill were completely severed, as the spillway eroded as a result of head cutting. The eroded channel is approximately 10-meters deep. Presently this emergency spillway is partially blocked by two parallel, post-Mitch dikes. These features were constructed immediately upstream of the spillway bridge with the intent of preventing spillway discharge except in the most severe storm events. A morning-glory type (primary) spillway is the only unrestricted discharge device that remains as originally constructed. The total discharge capacity of the emergency spillways appears to be substantially reduced due to the recently constructed dikes. Furthermore, it appears that this spillway cannot withstand another spillway flow without breaching the reservoir and losing the pool.

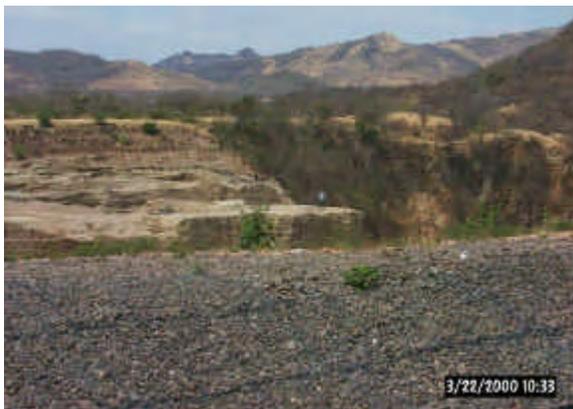
Looking Downstream from Spillway

**Spillway Study and Repair Lago La Virgen de Rio Viejo:** At this site, the original structure was a “fuse plug” spillway. The fuse plug concept reportedly functioned as designed, and the dam did not overtop. However, during the spillway discharge, the exit portion of the spillway was severely eroded by head cutting and existing spillway lining and a roadway were destroyed. The eroded channel is approximately 20-meters deep. Presently, a rebuilt *pervious* rockfill dike essentially restores this emergency spillway to pre-Mitch conditions. This dike was constructed on the same alignment as the original fuse plug. Installation of gabion matting for channel protection is in progress. The intent is to allow some spillway discharge by flow through the pervious dike. For severe flooding, the lake level would overtop the dike and erode it down to some unknown level. The discharge capacity of the new spillways should be equal to the original design. Although this concept performed adequately during Mitch (i.e. the dam was not overtopped), it appears that another spillway discharge would erode up to, and possibly through the reservoir rim at the spillway.

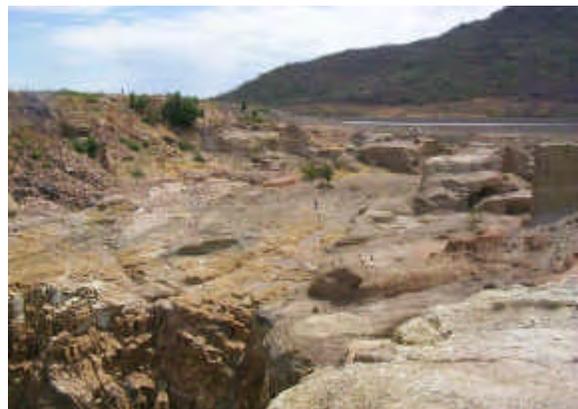
Looking Upstream from Headcut
