**Volume 2**

# **X. Managing Watershed Sediment**

### **TABLE OF CONTENTS**

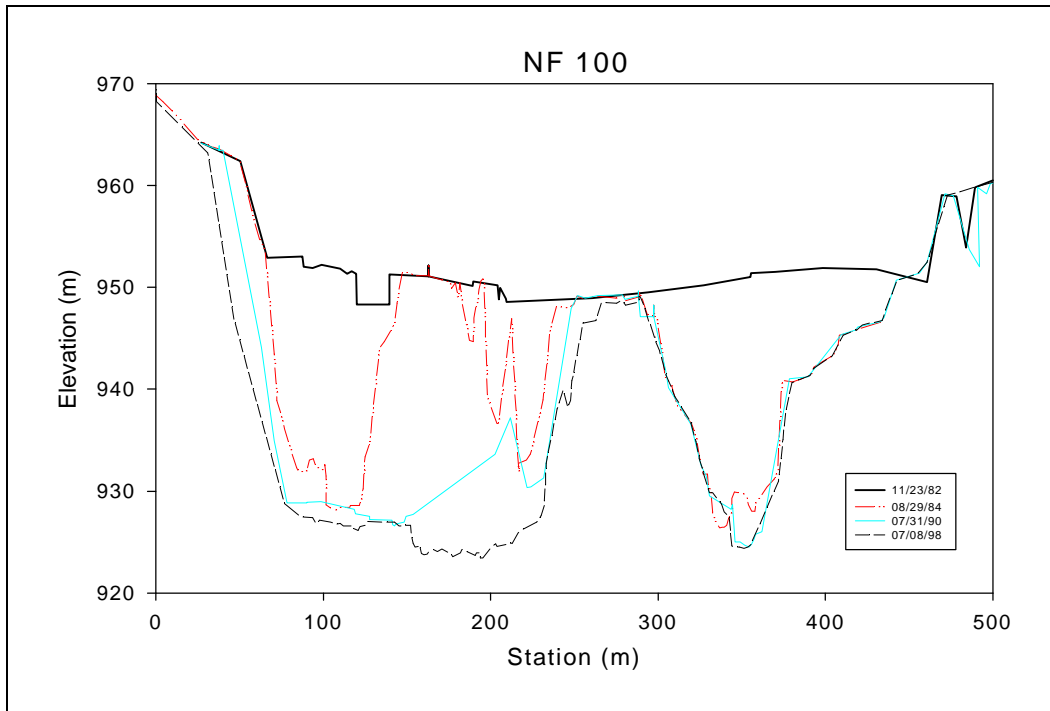
**Figure 1 Typical cross section data for the North Fork Toutle River.**

Historic cross section survey information was evaluated to identify trends in channel cross section development such as channel widening and channel degradation. The rate at which channel cross section development has occurred and whether or not the channel has stabilized was assessed. Surveyed cross sections (USGS, 2000) along the North Fork Toutle, South Fork Toutle, and Toutle Rivers were utilized in the analysis. Cross sections have been repeatedly surveyed at more than 100 locations along these three rivers. Cross section surveys began as early as 1980, and have been resurveyed periodically up through 1999. Typical results are shown in Figure 1. Cross sections on the North Fork Toutle, South Fork Toutle, and Toutle Rivers show a general trend of increased cross sectional area since the eruption. A majority of the cross sections have had a significant amount of streambank erosion and channel degradation. As a result, many locations show an increase in channel width and lowering of the thalweg elevation

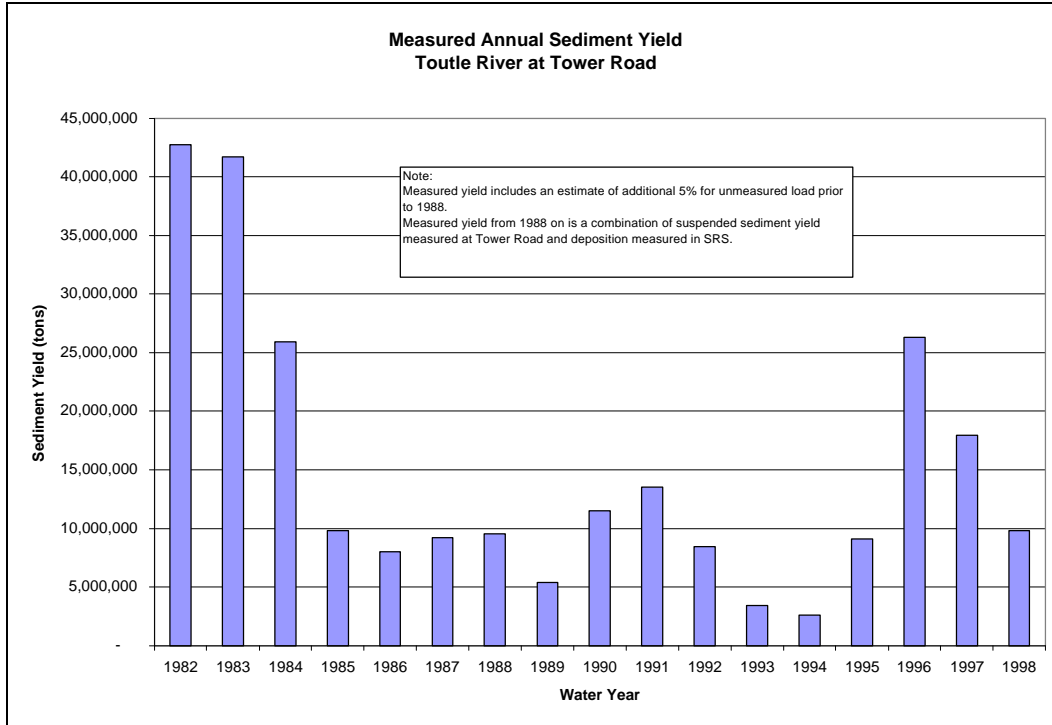
**Figure 2. Measured annual sediment yield from Toutle River at Tower Road.**

As seen in Figure 2, annual sediment yields measured at Tower Road were significantly large during the early 1980's, but then reduced fairly rapidly throughout the late 1980's and early 1990's. This would indicate that recovery in the watershed was causing a reduction in sediment supply to downstream areas. However, this time period was also a period of below average runoff. Total annual runoff was approximately 15 percent below normal for the period 1985 to 1995. A significant increase in sediment yield occurred during the 1996 and 1997 water years as total annual runoff was approximately 45 percent above normal. This would indicate that sediment yield from the watershed is highly dependent upon the hydrology. Variability in the hydrologic cycle would tend to mask trends in the reduction of sediment yield. However, the fact that the sediment yields measured for 1996 and 1997, the largest water years of record, were less than those measured in 1982 and 1983 would indicate that some recovery has taken place. However, the sediment yield in 1996 was nearly the same as occurred in 1984, which further indicate the dependence of sediment yield on the involved hydrology. To account for the dependence between sediment yield and hydrology, the annual sediment yield was divided by the annual runoff to determine the yield of sediment per unit volume of runoff or average sediment concentration. As seen in Figure 3, the yield of sediment in 1996 was approximately 11.7 tons per acre-ft of runoff while the yield in 1984 was approximately 15.3 tons per acre-ft of runoff, a reduction of approximately 24 percent, providing further evidence of watershed recovery.

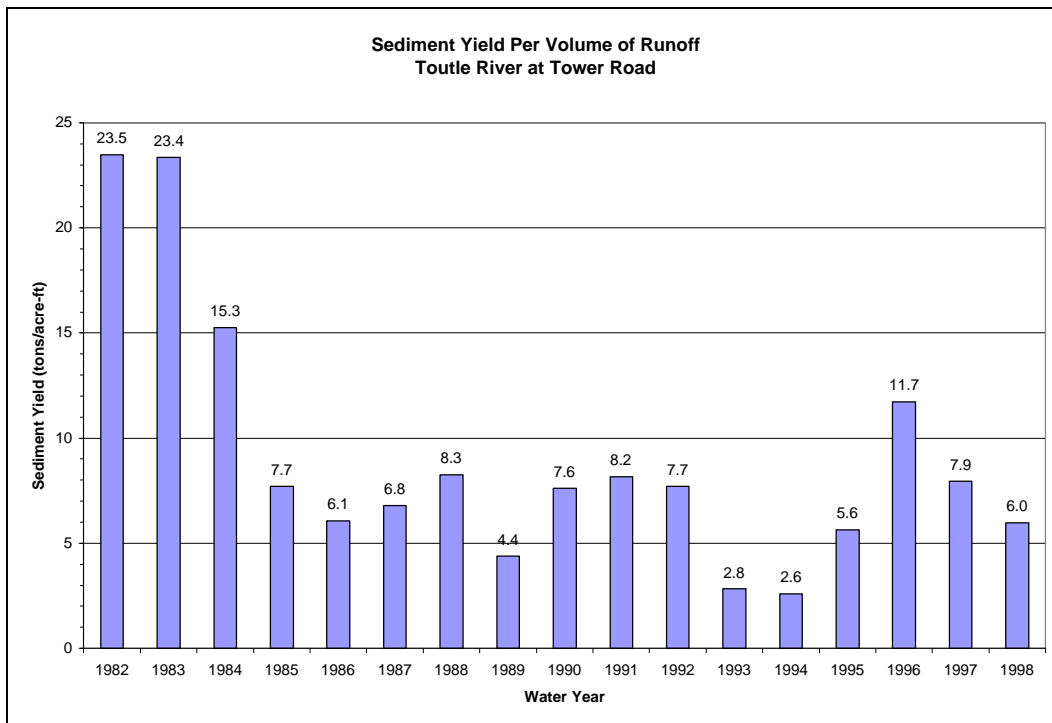
**Figure 3. Annual sediment yield per unit volume of runoff.**

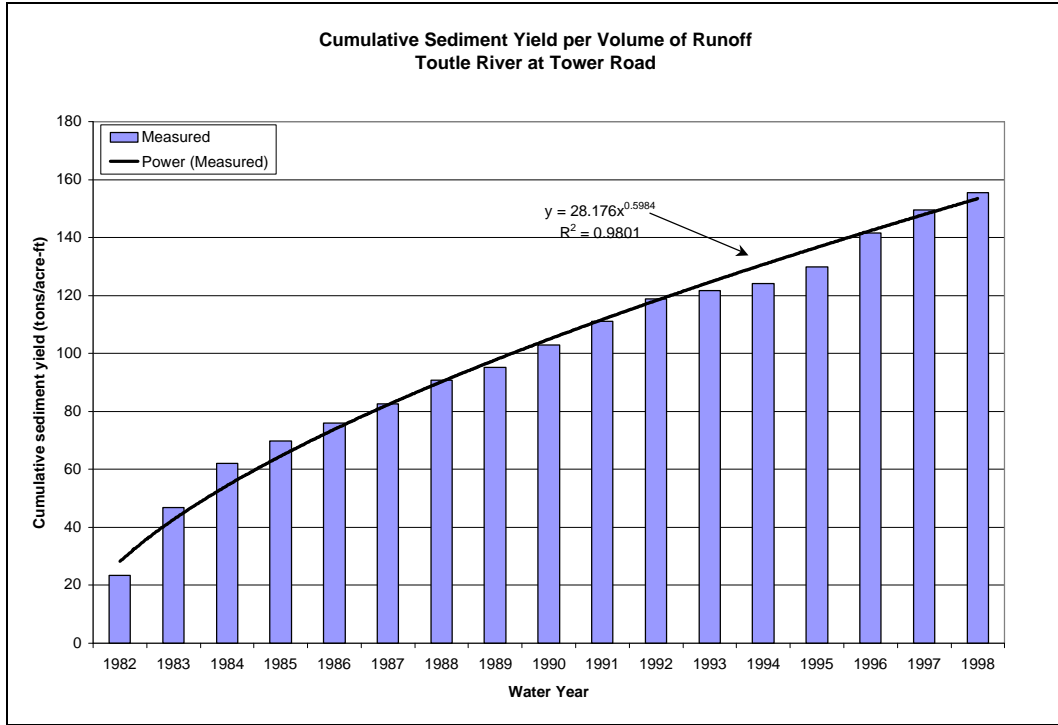
**Figure 4. Cumulative sediment yield per unit volume of runoff.**

Figure 4). A trend line was fit to the cumulative concentration data to develop a sediment concentration decay curve. This decay curve was then extended to the end of the MSH Project planning period to estimate the reduction in average annual sediment concentration that might be expected to occur by the year 2035. The predicted annual sediment concentrations were multiplied by the average annual runoff volume to estimate the annual yield of sediment from the debris avalanche. Figure 5 shows that over the next 35 years, the annual sediment yield would reduce by 2.3 million cubic yards or approximately 36 percent. It is noted that this estimate is based upon average hydrologic conditions that have occurred between 1931 and 1998. Future hydrologic conditions that differ from those considered in the analysis as well as significant vegetative recovery in the watershed or future volcanic eruptions would significantly alter the estimated rate of reduction in sediment yield.

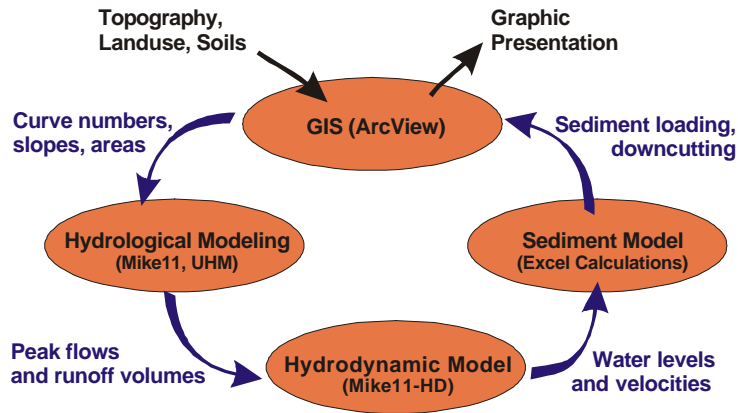
Figure 1. Nemadji Sediment Transport Model System

**Description of the Model System:** The modeling system consists of GIS-database components, a hydrologic model, a river hydrodynamic model and a sediment transport model as shown in Figure 1. ArcView GIS is used to create geographic data, analyze the data, and prepare the data for input to the hydrologic model and the hydrodynamic model. The hydrologic model generates time-series runoff for input to the river hydrodynamic model. The hydrodynamic model provided the hydrodynamic parameters such as water velocity, depth and discharge to the sediment transport model. Lastly, the sediment transport model predicts sediment erosion and deposition in the river. Based on a review of a range of options for the three key model components, the Danish Hydraulic Institute (DHI) MIKE system was chosen for the hydrological model and hydrodynamic model. A customized sediment transport model was developed because the

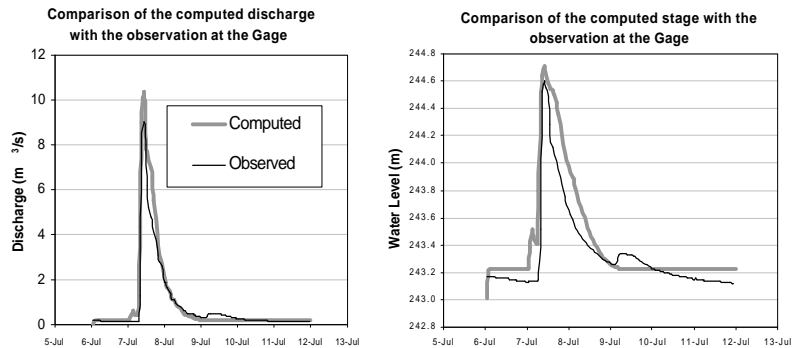
Figure 2. Verification of the Rainfall/Runoff Component

The Rainfall/Runoff model calibrations are carried out to verify the aggregated Curve Number (CN) calculated in the GIS component and the estimated lag time. The CN value is a main parameter influencing the excess rainfall which should be equal to total runoff in a single storm event. The lag time is another key parameter that distributes the excess rainfall in time and influences the duration of the runoff period. Both parameters are adjusted according to calibration results.

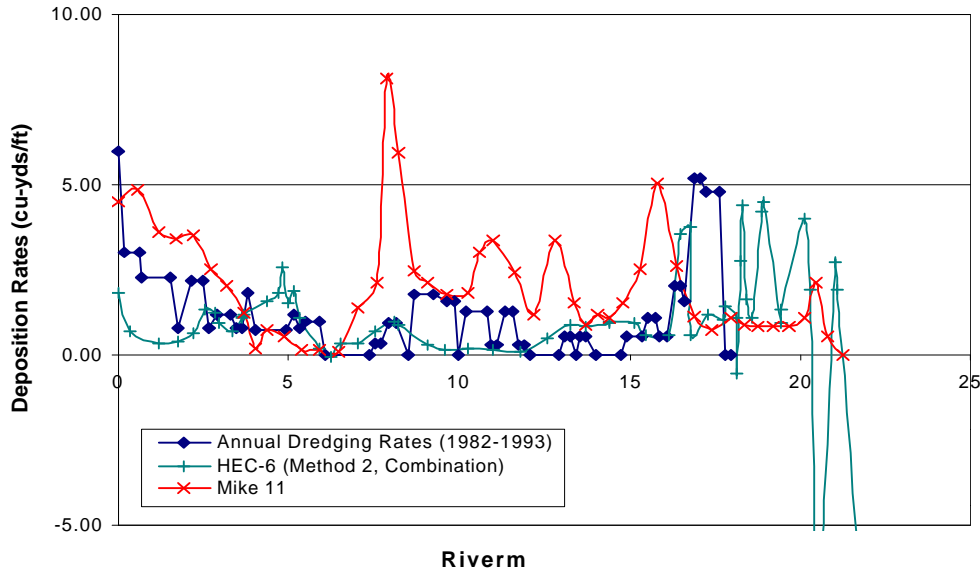
**Figure 6. Comparison of deposition rates computed by HEC-6 and MIKE 11 to the dredging rate**

To demonstrate the difference between the unsteady model, MIKE 11, and the variable steady model, HEC-6, the sediment deposition rates along the river computed by both models are compared with the average annual dredging rate and shown in Figure 6. River Mile 0 coincides with the river mouth at the downstream end of the model domain. The HEC-6 result shown in Figure 10 is computed using Method 1 for clay and silt transport and the Combination equation for sand transport. The HEC-6 model underpredicts the sediment deposition in the downstream section of the river near the mouth. This may be induced by the steady hydraulic calculating scheme, which may not account for the flow speed reduction at the mouth resulting in increased deposition. In contrast, the hydrodynamic model, MIKE 11, reproduces the physical process of sediment deposition near river mouth reasonably well.

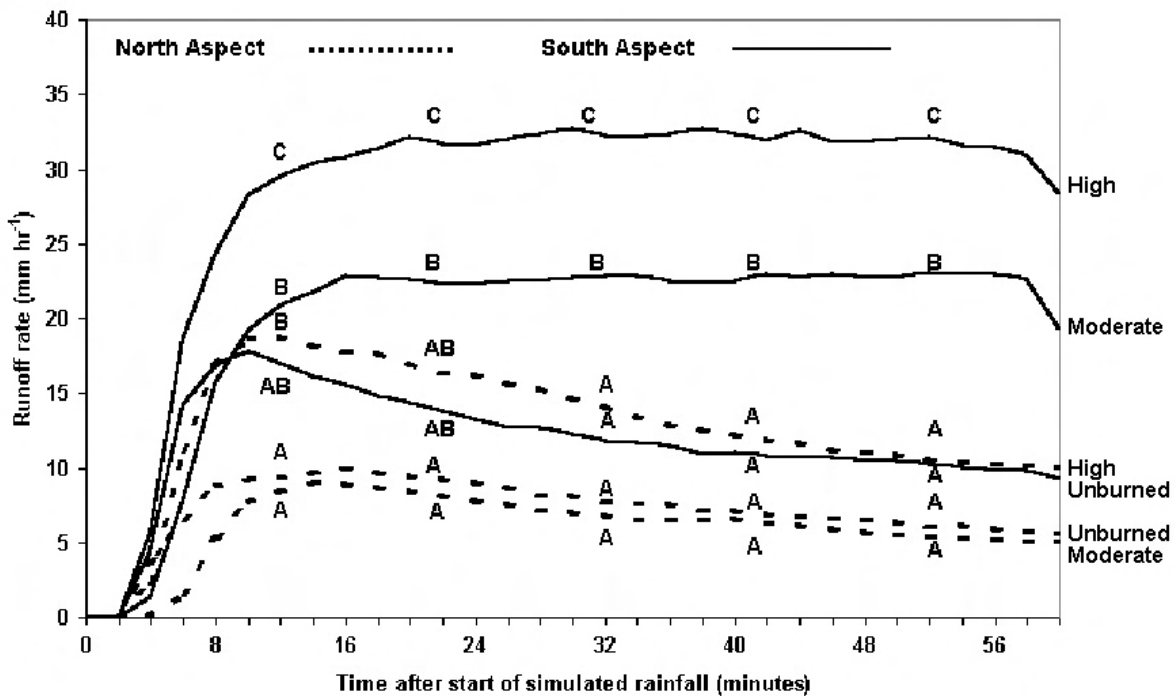
**Figure 1.** Runoff rate over time for burned (high and moderate fire intensity) and unburned, north and south slopes, Eighth Street Fire, Boise Front, Idaho. Means for each time period with a different letter are significantly different ( $P \leq 0.05$ ).

Fire intensity had the greatest impact on runoff on the south slopes (Figure 1). Intensively burned south-facing slopes had the lowest cumulative infiltration (34.2 mm) followed by the moderately burned south slopes (46.2 mm), compared to the unburned south slopes (58.0 mm). This represents nearly a two-fold increase in runoff produced by the fire. Fire intensity also produced significantly greater erosion from south aspects as well (Figure 2). Cumulative erosion was up to 34 times higher on intensively burned south slopes compared to unburned conditions or even burned north aspects. This was due to the devastating removal of nearly all the vegetative ground cover that protects the soil and much of the soil organic matter that helps to bind soil particles together.

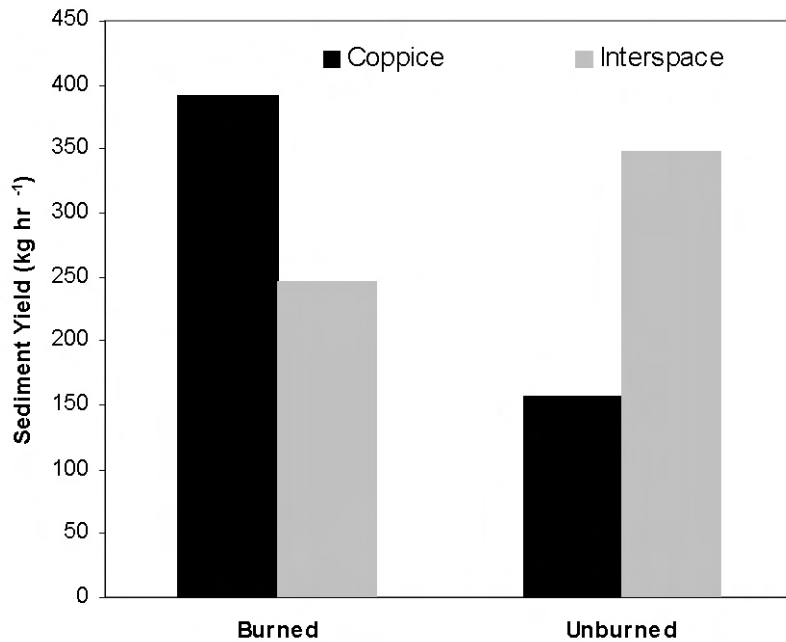
**Figure 4.** Average sediment yield for burned and unburned coppice and interspace areas, Denio Fire, Pine Forest Range, Nevada.

(Figure 3). In addition, fire had the greatest impact on erosion from burned coppices as well (Figure 4). However, the fire impacts on infiltration and erosion were relatively small, but do indicate that fire can produce a hydrophobic condition on the densely vegetated coppices whereby infiltration is decreased and soil erodibility is increased.

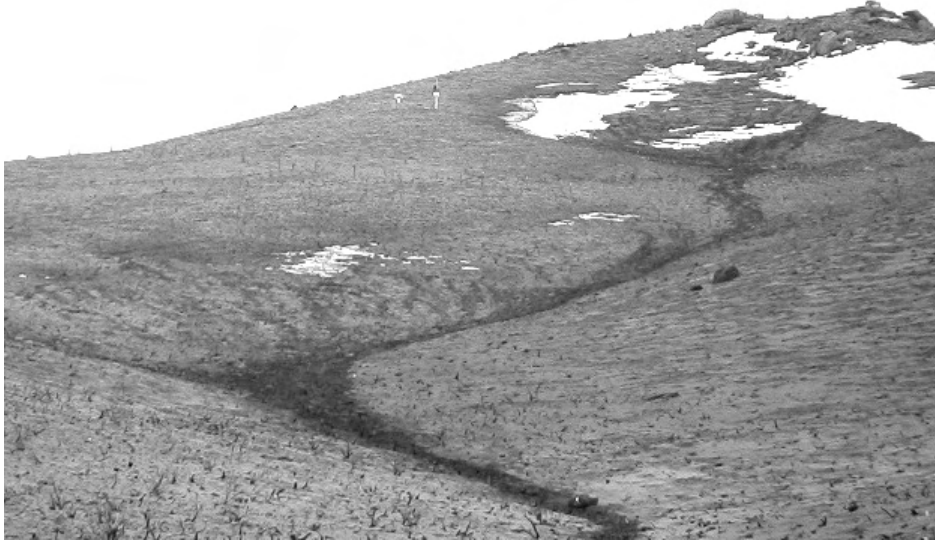
**Figure 5.** Photo of rill erosion during period of rapid snowmelt in late March following the Denio Fire, Pine Forest Range, Nevada.

Significant rilling was observed on the burned Denio study sites following periods of rapid snowmelt during the first winter following fire (Figure 5). No rills were observed on the unburned sites. Measurements of rill erosion were then initiated, but results have not yet been summarized. However, very strong differences were observed in overland flow characteristics and rill formation between burned and unburned areas (Figure 6). While fire may not significantly affect infiltration and interrill erosion in these sagebrush/grass ecosystems, it may have a profound effect on concentrated flow paths and rill erosion processes.

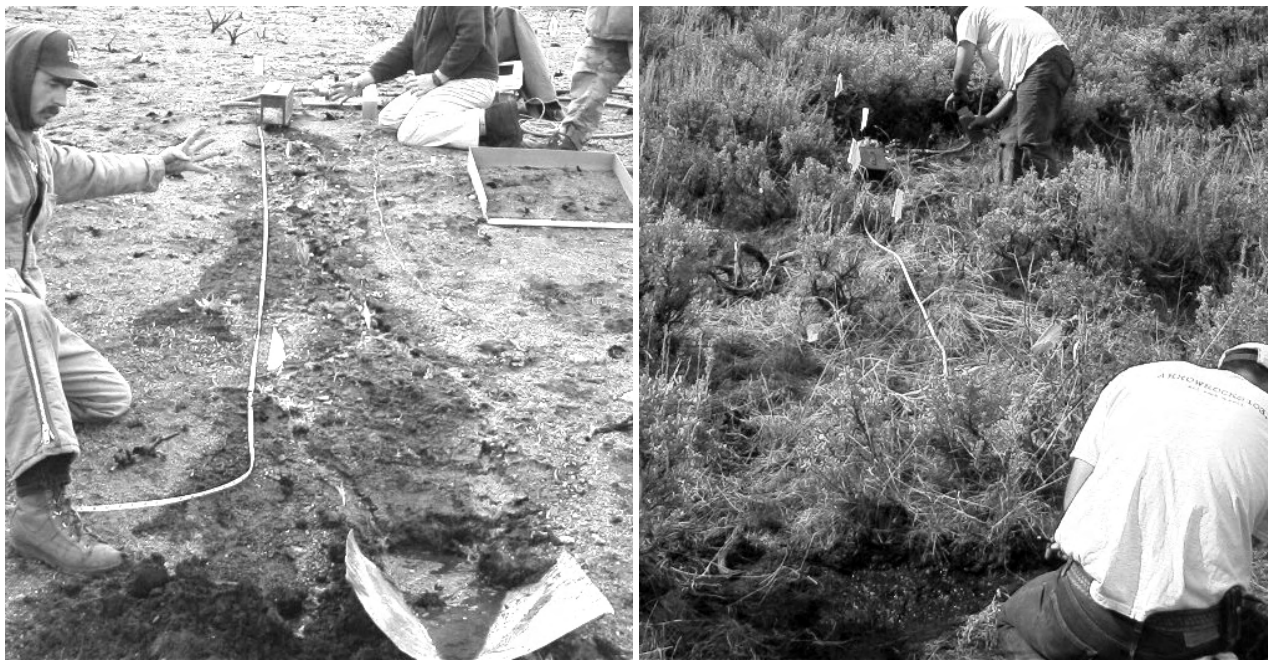
**Figure 6.** Contrasting photos of concentrated flow and subsequent rill formation between intensely burned areas on the Denio Fire and adjacent unburned areas, Pine Forest Range, Nevada.

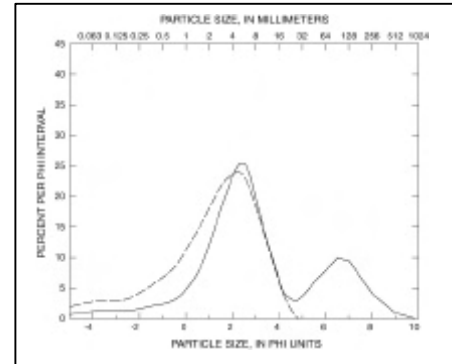
Figure 3. Particle-size distribution of the hillslope source of sediment (dashed line) and the channel bed material (solid line) composing the superslug. The median diameters of the hillslope source, the surficial sediment in the bed material, and the bank material in the bed material are  $2.8 \pm 0.4$ ,  $4.6 \pm 2.7$ , and  $110 \pm 3.2$  mm respectively.

**Particle-Size** Bed material composing the superslug had a bimodal distribution with components from the hillslopes and from the pre-flood channel banks. Particle-size distribution of the hillslope sources had a median diameter of 2.8 mm, a dispersion of 4.6, and was similar to the particle-size distribution of the surficial sediment of the superslug (Figure 3). Characteristics of surficial sediment varied from upstream to downstream and indicated that some sorting had occurred. At about 5000 m upstream from the mouth of Spring Creek, the median diameter of the surficial sediment was about 2.5 mm and was consequently better sorted (dispersion = 3.4) than the hillslope sources. The median diameter increased downstream and was about 4.4 mm (dispersion = 2.9) at the mouth.
