CHANNEL WIDTHS CHANGES ALONG THE MIDDLE RIO GRANDE, NM

Paula Makar, Hydraulic Engineer, Bureau of Reclamation, Denver, CO, pmakar@do.usbr.gov; Tamara Massong, Hydrologist, Bureau of Reclamation, Albuquerque, NM, tmassong@uc.usbr.gov; and Travis Bauer, Hydraulic Engineer, Bureau of Reclamation, Denver, CO, trbauer@do.usbr.gov.

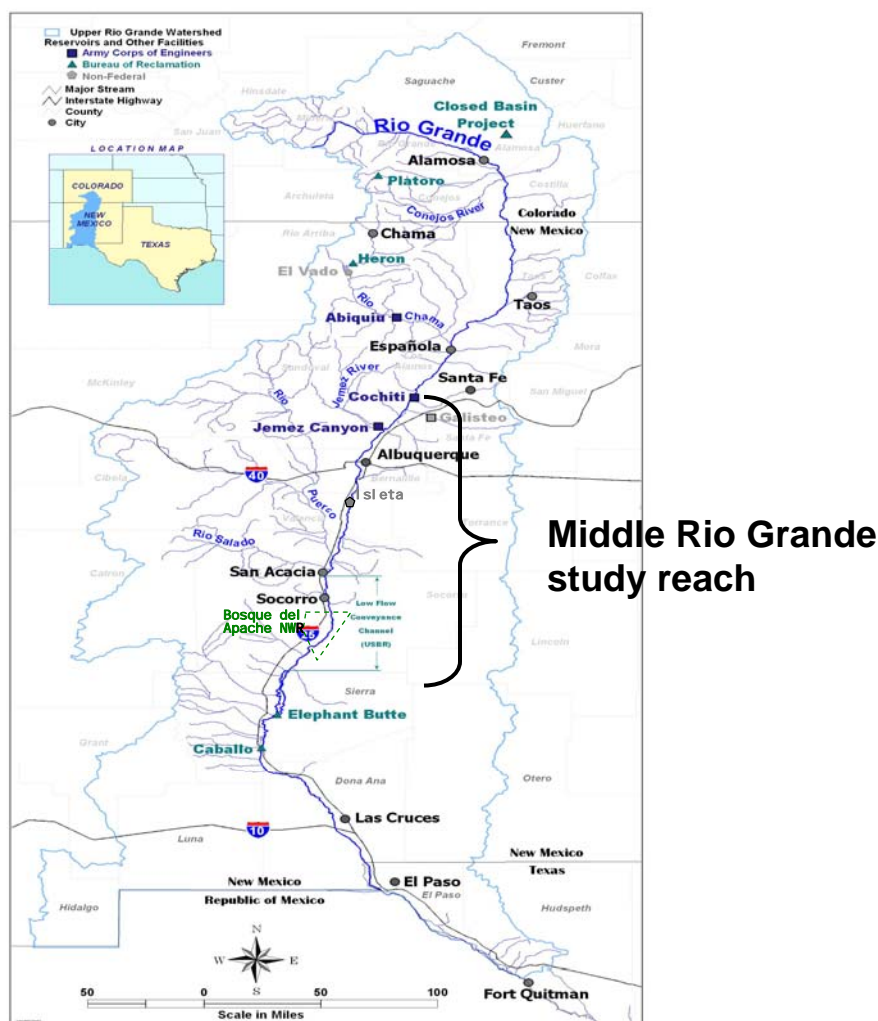
Figure 1 Middle Rio Grande study reach

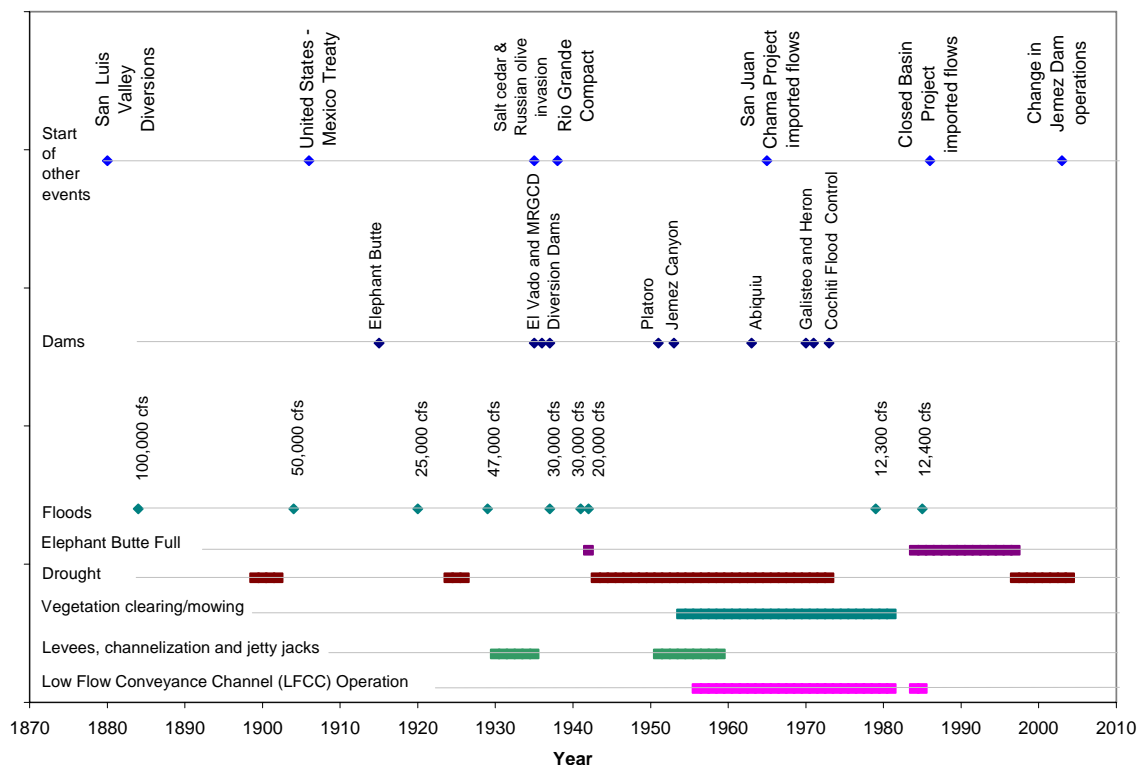
Figure 2 Timeline of significant events (adapted from Makar and Bauer 2004)

The flow regime of the Rio Grande has varied over time. There are two primary sources of change: climate and water resource development. Periods of extended drought or wet hydrology have in particular influenced the magnitude, duration, and frequency of channel forming flows and the river morphology as have water delivery and flood control facilities. Figure 2 shows a timeline of these events. The general effect on the middle Rio Grande hydrology has been that peak flows have decreased in magnitude while the discharge has increased during winter base flow periods.

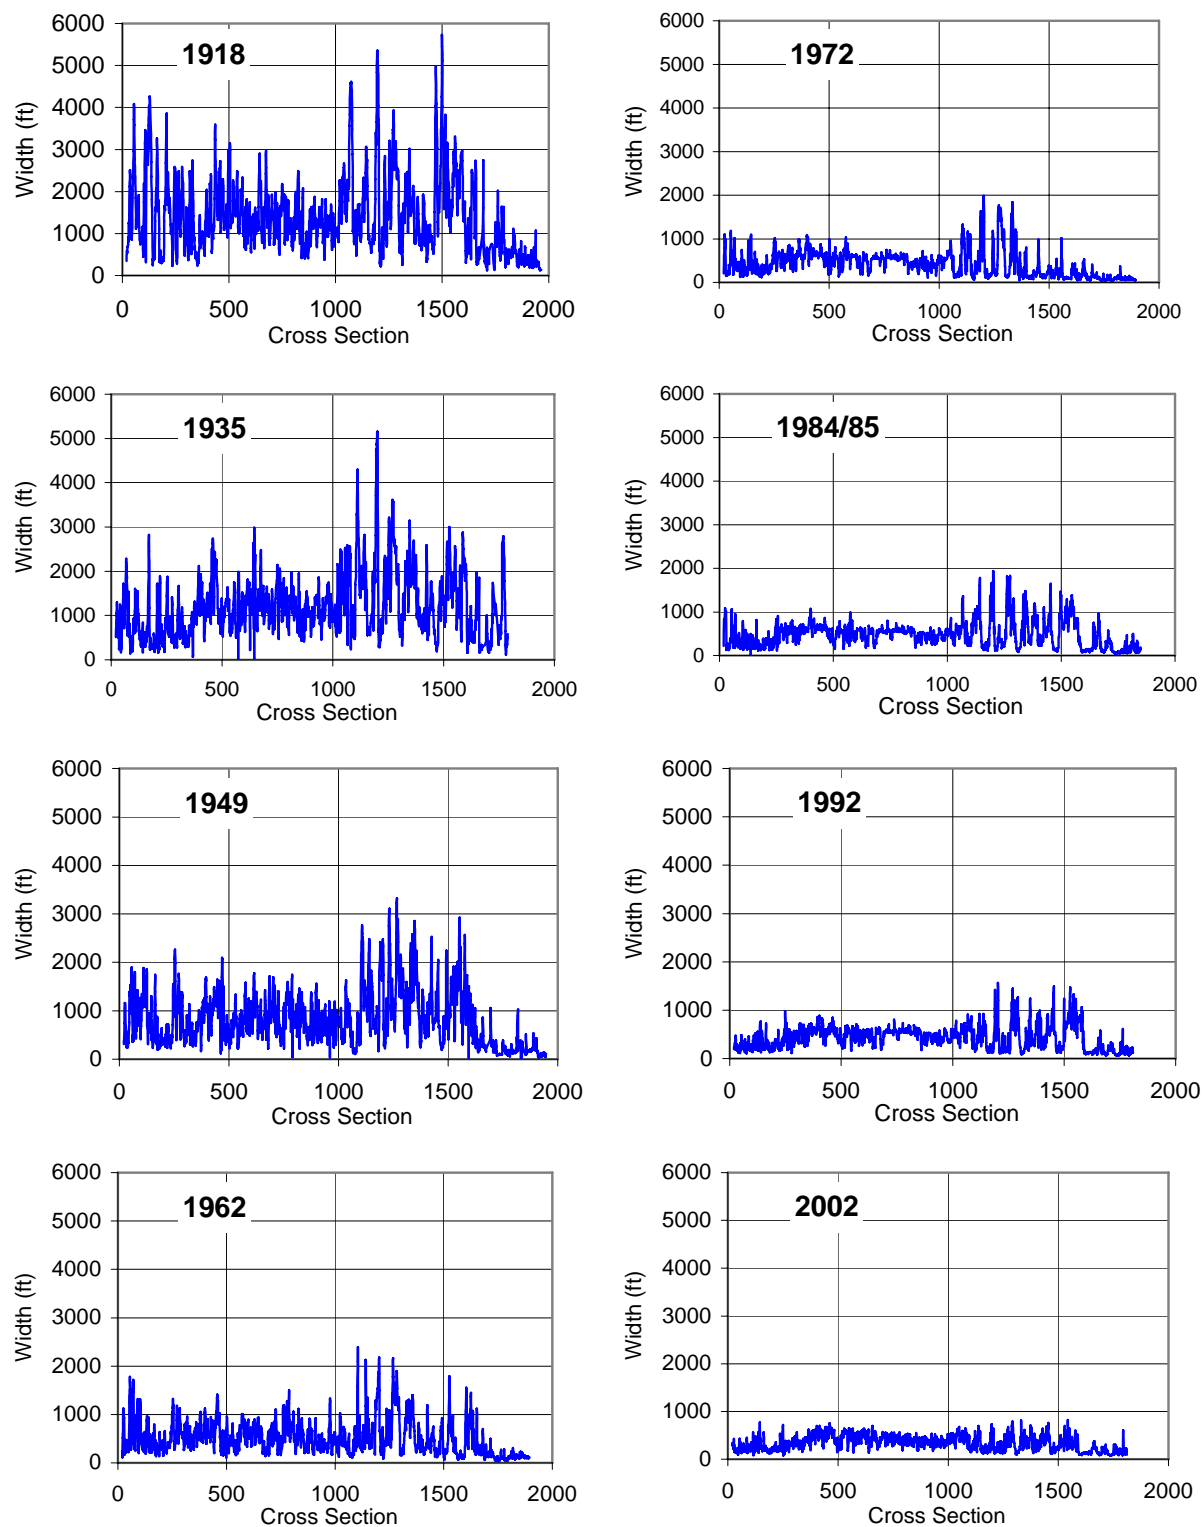
Active channel widths from Cochiti Dam to Elephant Butte Reservoir, at established cross sections with an approximate 500 foot spacing (cross section lines 19 through 1800 in Oliver 2004 and referenced by just the cross section number in this paper), are taken from digitized information in the GIS database. A few cross section lines are not perpendicular to the channel or the flow path, resulting in a small error in the channel widths. For this study, the active channel is the area of no or sparse vegetation cleared by the river which does not include vegetated islands or mechanically cleared areas. Figure 3 presents the widths for each set of

Figure 3 Active channel widths

Figure 3 illustrates the general narrowing trend over time; such that channel widths in 1918 are the widest and 2002 the narrowest. Channel width data in 1918 shows that the reach was generally wider than 1,500 feet, with many areas in excess of 2,500 feet. By 1949, most of the reach was still wider than 1,000 feet, but few areas were greater than 2,000 feet and the extensive variability found in the 1918 channel width data is gone. The 1972 data set continues the decreasing width trend, such that nearly all the cross sections are less than 1,000 feet wide. The most recent data set from 2002 shows that at present, all of the cross sections have channel widths less than 1,000 feet, and that the majority are also less than 750 feet.

Decreases in width between 1918 and 1935 can be partially attributed to construction of riverside irrigation facilities such as drains and canals that are protected by levees. After 1941, there was an extended period of below average stream flows and peak flows. The river channel narrowed through vegetation encroachment on bars and islands that were no longer cleared by flooding. Drought conditions were still prevalent in 1962, but narrowing was also due to channelization. Beginning in the 1950s, large sections of the river were narrowed with jetty jacks to more efficiently transport water and sediment downstream. The jacks also trapped sediment and protected the banks. The Low Flow Conveyance Channel (LFCC) between San Acacia Diversion Dam and Elephant Butte Reservoir reduced flows by diverting up to 2,000 ft³/s from the floodway from the late 1950s through the early 1980s. Widths continued to narrow through 1972, with vegetation encroachment during drought and channelization largely responsible for the narrowing.

Beginning in 1979 through the late 1980s, there were higher flows in the river. With minor exceptions, the LFCC has not been operated since the early 1980s, also increasing the flows in the river. In the 1960s through the 1980s, large sections of the river were mechanically cleared of vegetation to maintain flood capacity. By 1985, the active channel width widened to near the edge of the cleared floodway along much of the river. Low water levels were seen in the years around 1990 and after 1995 and mean channel width decreased more in the 1992, 2001, and 2002 photos.

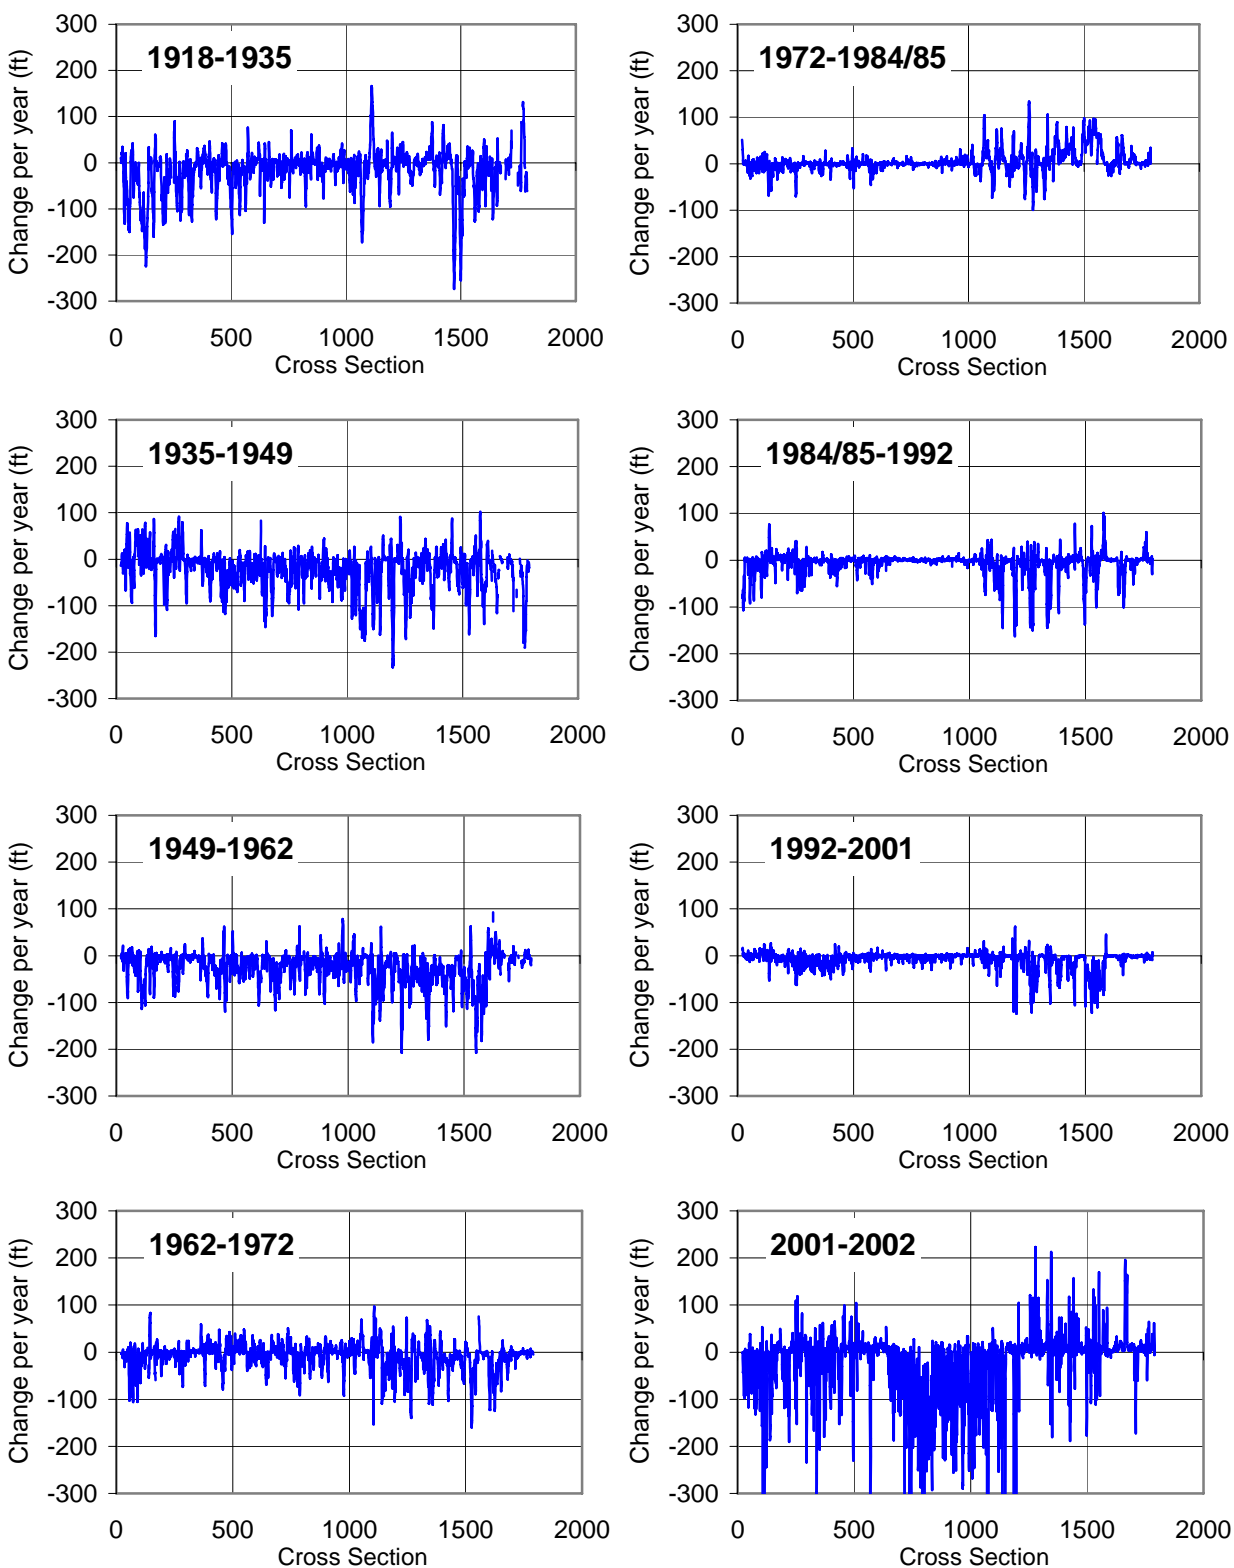
data. Data in Figure 4 is normalized to an average annual change and illustrates the rate of change in width between dates of photography.

Figure 4 Average annual changes in active channel width

The trend of general narrowing is also evident in Figure 4 in that the majority of changes are negative. Note that the 2001-2001 data only represents one year of change, while the other figures are yearly averages of multiple years. The narrowing between 2001 and 2002 is still striking and generally a consequence of the drought and significant vegetation encroachment.
