Landslides and related features interpreted from aerial photographs:
 1:78,000 (black and white) 1977
 Photointerpretation and field check 1978-1979
 This map has not been edited or reviewed for conformity with Geological Survey standards and nomenclature.

LANDSLIDES AND RELATED FEATURES

OF THE KEATING SUMMIT, PA. QUADRANGLE
 by
 John S. Pomeroy
 1981
 U.S. Geological Survey
 OPEN FILE MAP 81-238 (F-15)

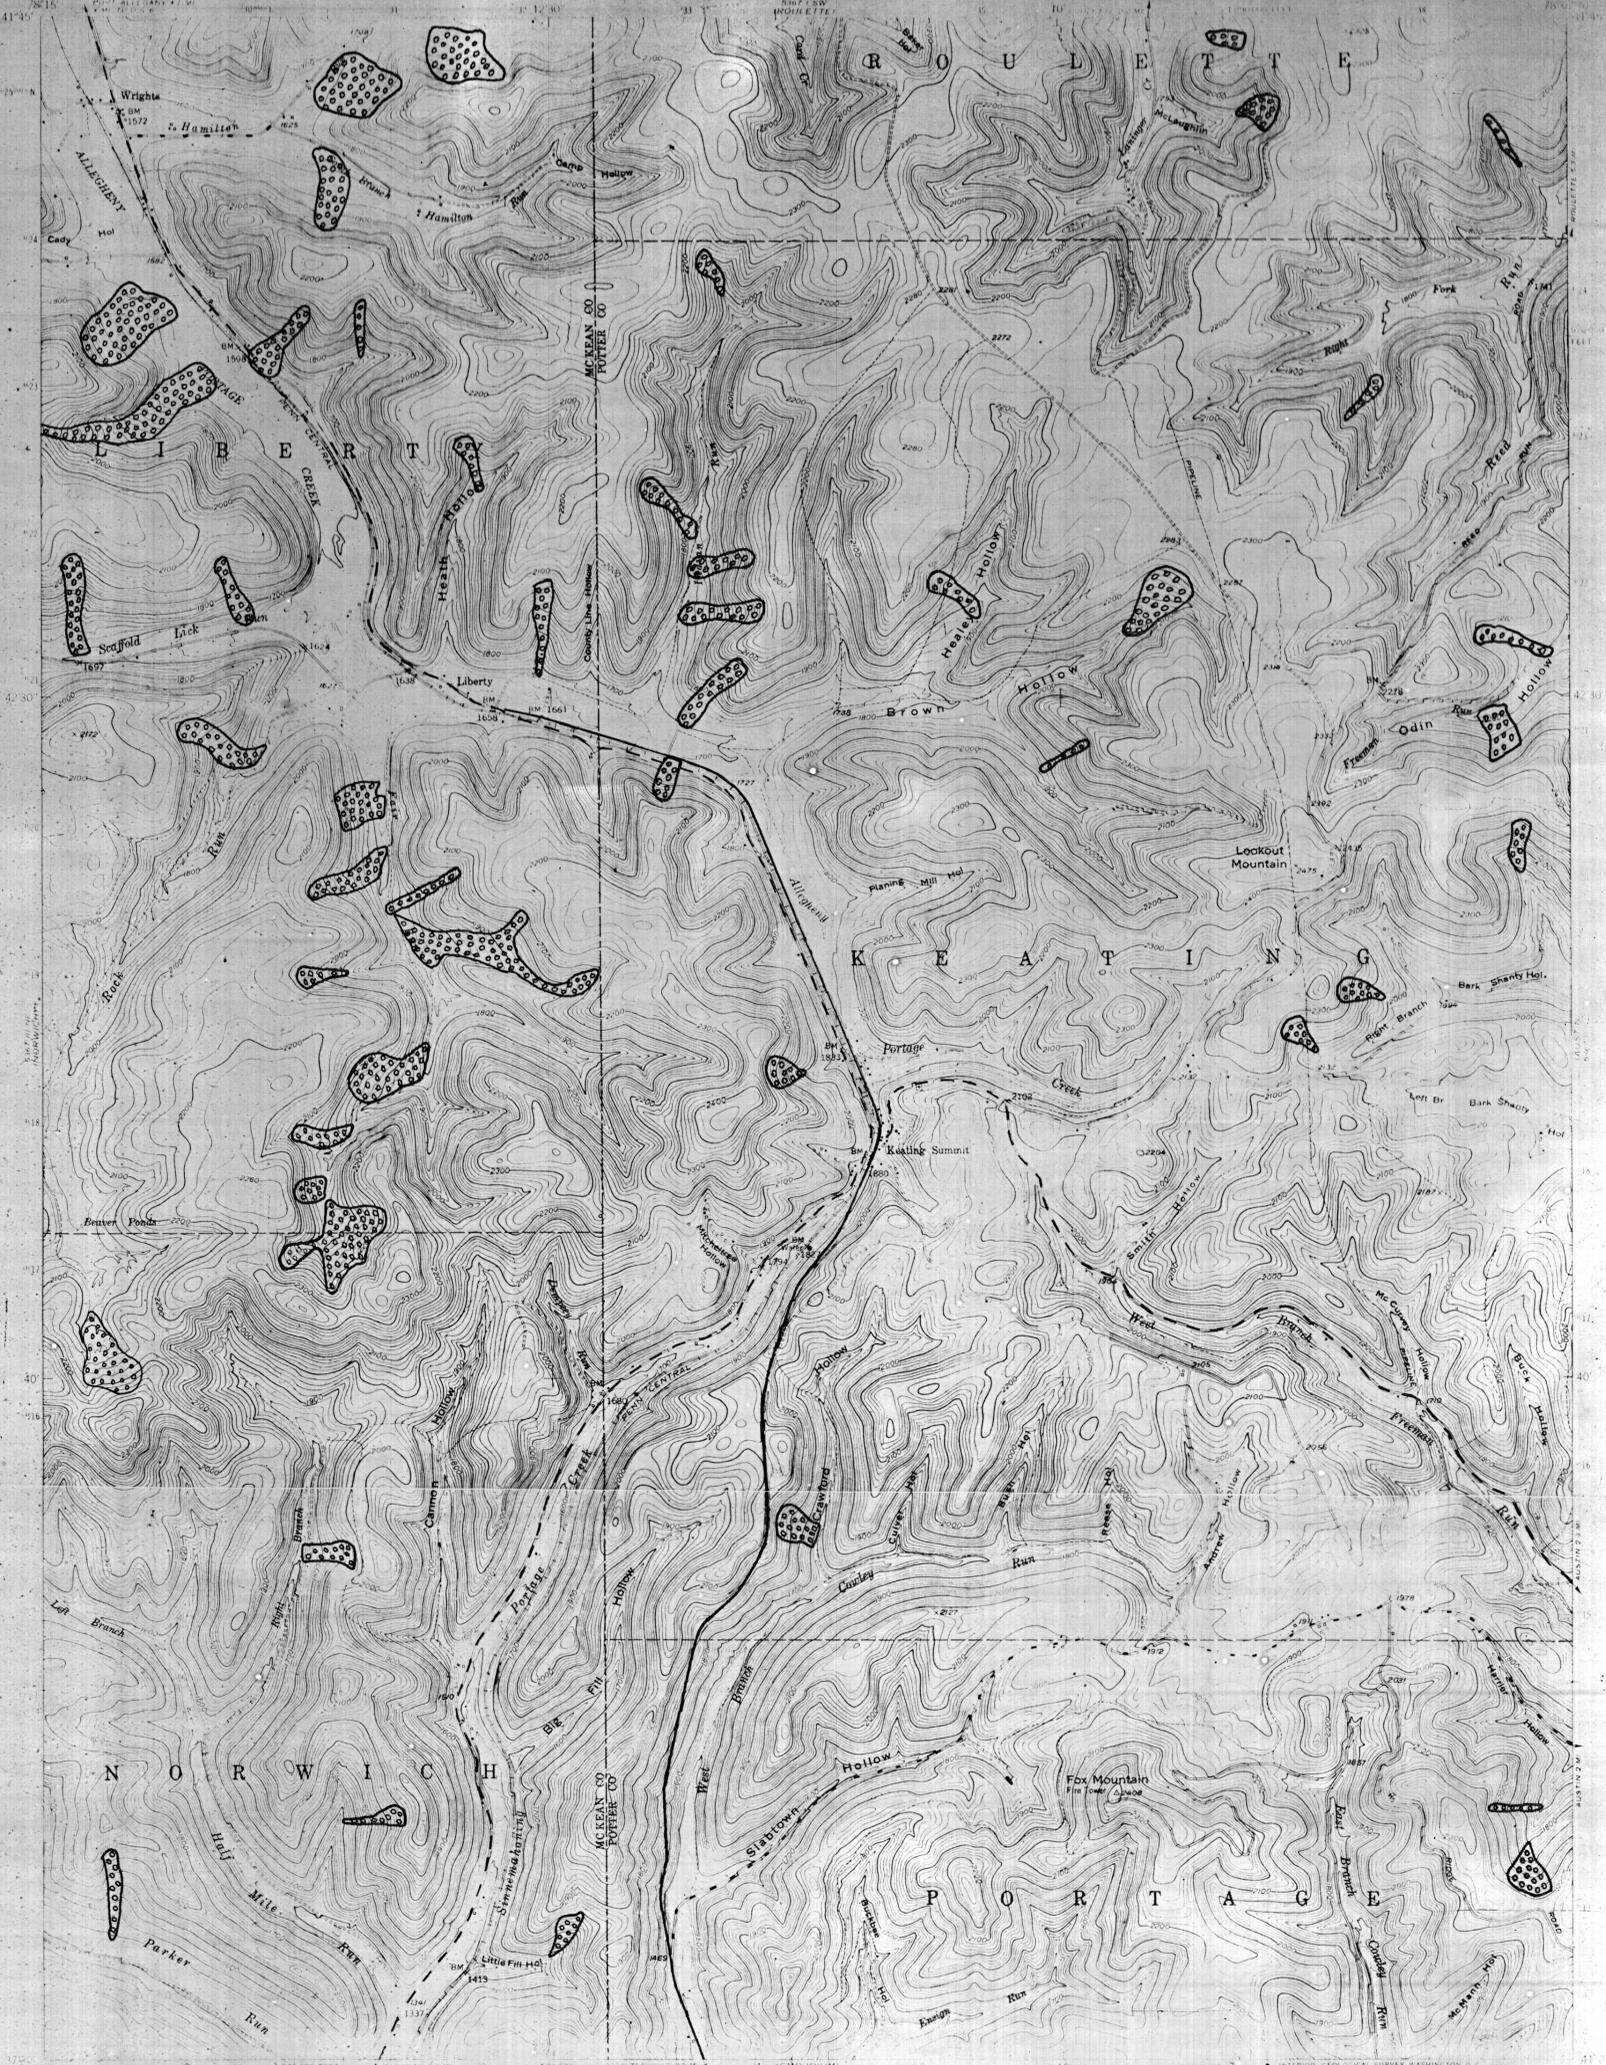
**ACTIVE OR RECENTLY ACTIVE LANDSLIDE**
 Complex landslide composed of earthflow, debris slide, earth and rock slump. Identified from historical records, and from scars, debris and other field evidence. Ground extremely unstable; sliding accelerated by excavation; loading and changes in drainage conditions. May include areas with several active slides too small to be shown separately. Questioned where doubtful. May be shown with symbol (A) where difficult to discern.

**OLD LANDSLIDE**
 Area of extensive hummocky ground caused by earthflow and earth and rock slump. Lacks clear evidence of active sliding. Relatively stable in natural, undisturbed state, generally not affected by small structures properly sited in areas away from the edge of the toe; can be reactivated by extensive, rapid excavation, loading, and changes in ground water and surface water conditions. Area of old landslide probably includes recent ones not identified from field evidence or otherwise documented. Upslope boundary of landslide generally defined by modified scarp, but downslope (toe) may be gradational and not well defined. Questioned where doubtful.

**COLLUVIAL SLOPE**
 Valley wall along major streams with slope as steep as 40° (85%); stony, clayey silt soil up to 50 ft. (15 m) thick; commonly buttressed by a terrace or bench at the toe of the slope; very susceptible to sliding by cutting of toe area, removal of terrace or bench, and overloading; slide commonly activated without apparent cause.

**AREAS SUSCEPTIBLE TO DEBRIS FLOWS AND DEBRIS AVALANCHES**
 Primarily shallow, narrow ravines and chutes with accumulation of stony colluvium generally 10 ft. (3 m) or less in thickness; susceptible to rapid movement during intense rainfall. Most ravines and chutes designated show evidence of former debris flows and avalanches. Symbol (A) designates historical debris flow or debris avalanche.

**AREAS SUSCEPTIBLE TO ROCKFALL**
 Steep, locally vertical, natural and man-made slopes and cliffs, 15 ft. (4.5 m) or more high; formed dominantly of sandstone, limestone, sandy shale, mudstone and claystone. Interbedded mudstone, claystone and shale weather rapidly leaving sandstone and limestone rock faces unsupported.

**SOIL AND ROCK SUSCEPTIBLE TO LANDSLIDING**
 Soil and rock similar to that involved in landslides elsewhere in map area; primarily areas underlain by claystone, mudstone and shale associated with other rock types. Rock weathers rapidly on exposure forming clayey soil highly susceptible to sliding. Includes covers (U-shaped, shallow valleys) containing thick layers of clayey soil that are very susceptible to sliding where excavation breaks continuity of slope and where overloaded by artificial fill.
