**FLOOD OF
OCTOBER 8, 1977
IN ST. CROIX,
U.S. VIRGIN ISLANDS**

**U.S. GEOLOGICAL SURVEY
WATER-RESOURCES INVESTIGATIONS 82-262
OPEN-FILE REPORT**

**SAN JUAN, PUERTO RICO
DECEMBER 1982**

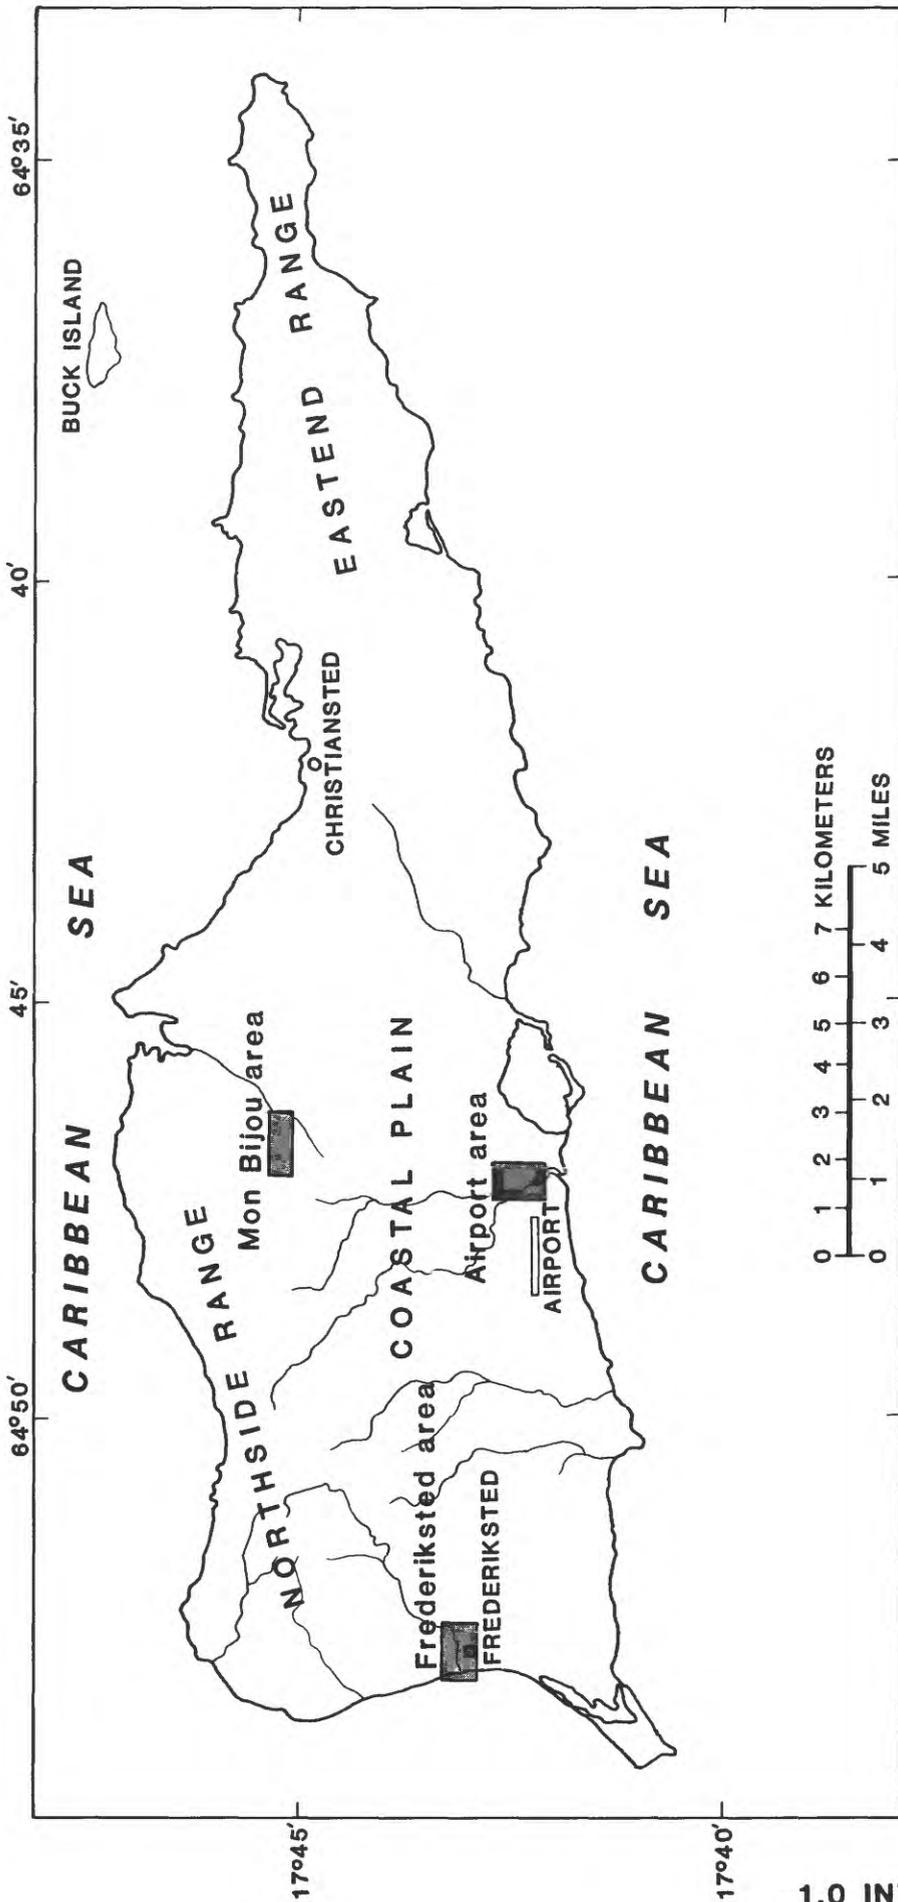
Figure 1.2-1. General features of St. Croix and flooded areas.

The northwestern part of St. Croix is a rugged area of mountains of volcanic origin (fig. 1.2-1). The crest of the mountains ranges from 600 to 1,100 feet above mean sea level. The south and southwest parts of the Island form a gently rolling alluvial plain underlain by limestone and marl. The eastern part of St. Croix is a peninsula of mountain and shallow valleys, with some peaks reaching 800 ft above mean sea level.

The principal areas affected by the flood of October 8, 1977 were near the Frederiksted, (Jolly Hill Gut); and Mon Bijou, (Salt River); Airport (River Gut).

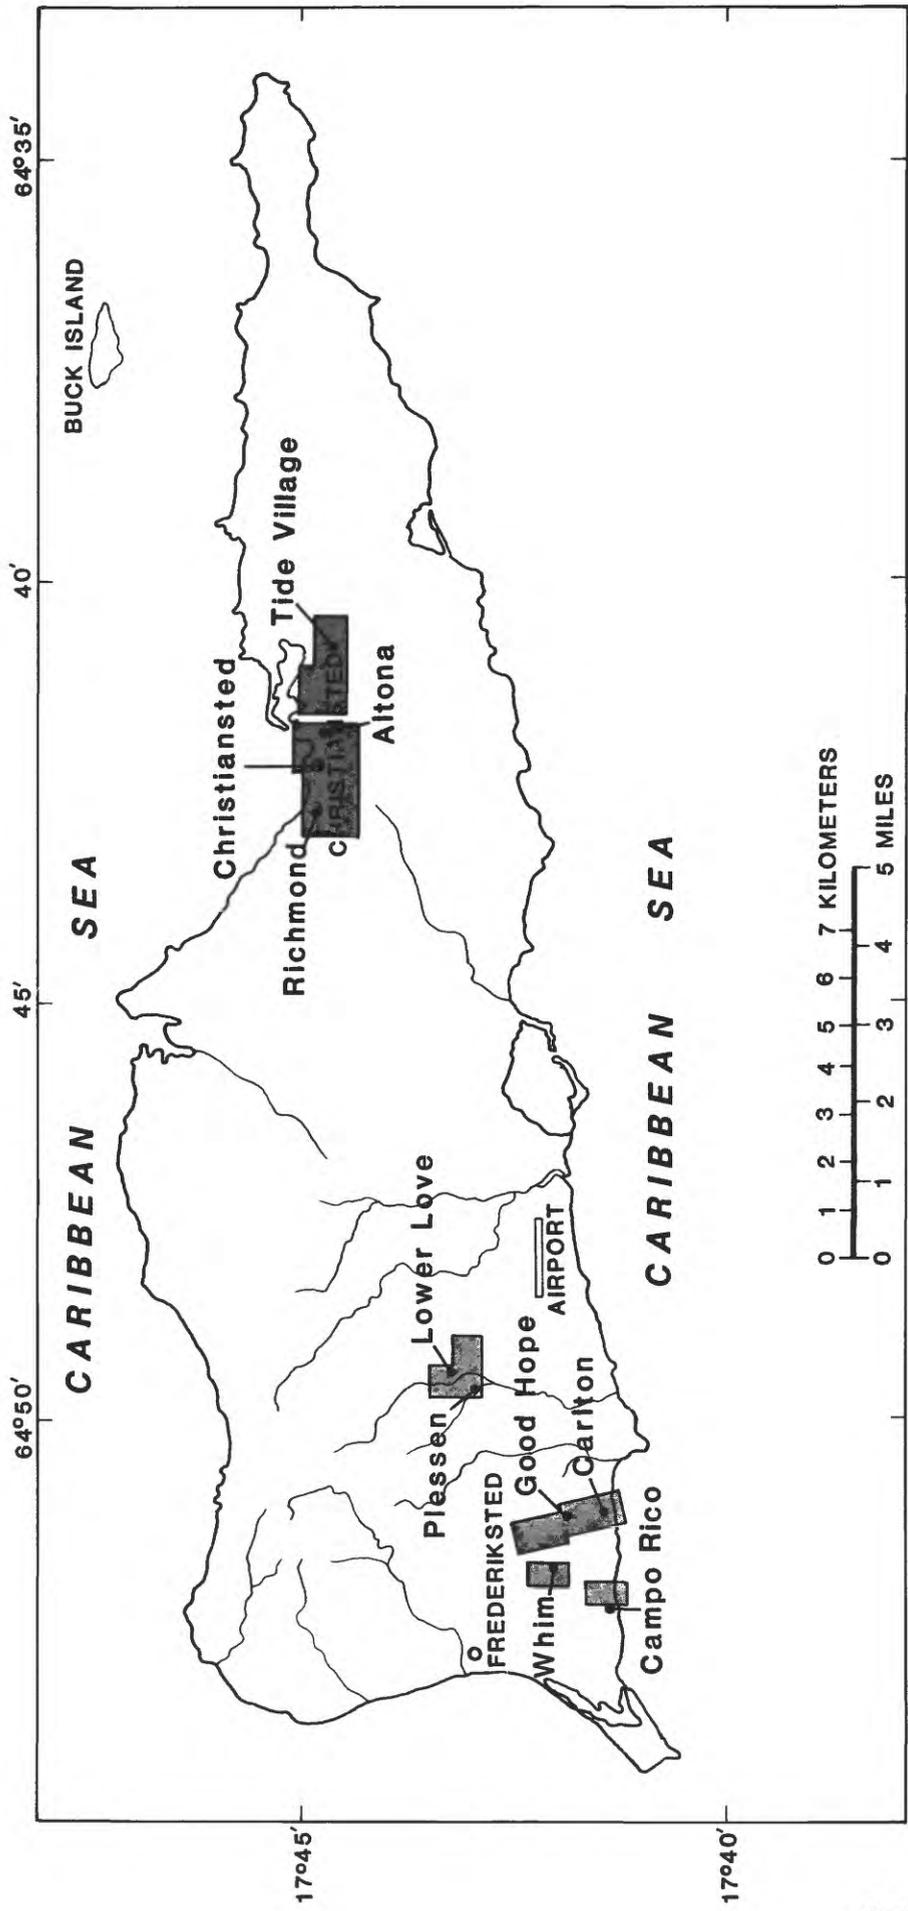
Figure 2.0-1. Areas flooded in 1974.

The island of St. Croix has been affected by severe floods twice during the last ten years. The storm of November 11-13, 1974 inundated large areas at Campo Rico, Whim, Carlton, Plessen, Christiansted, and Tide Village (fig. 2.0-1). In 1977, these areas as well as areas near Frederiksted, Mon Bijou, and the Airport were flooded.

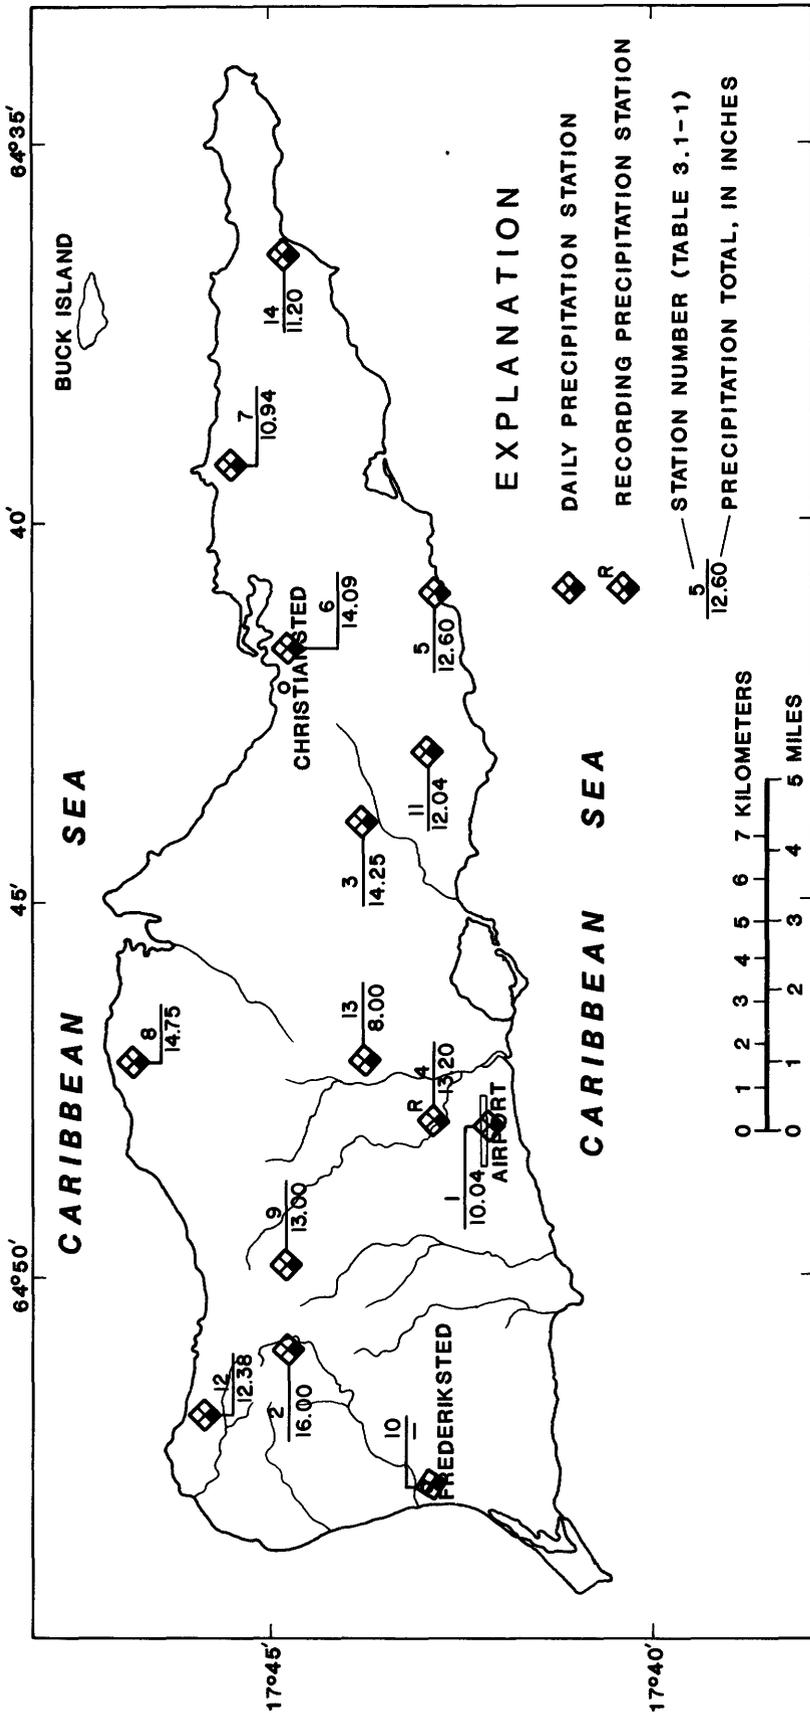
Figure 3.1-1. Rainfall distribution during October 7-8, 1977 storm in St. Croix.
(See Appendix)

The tropical disturbance that produced the floods of October 8, 1977, moved over St. Croix on October 7. Precipitation was intense and cumulative totals over the Island ranged from 8 to 16 inches (fig. 3.1-1 and table 3.1-1). The largest amounts of rainfall during the storm (about 16 inches) were recorded in the headwater of Jolly Hill Gut, northeast of Frederiksted. From 12 to 14 inches were recorded at sites in the basins of River Gut and the Salt River.

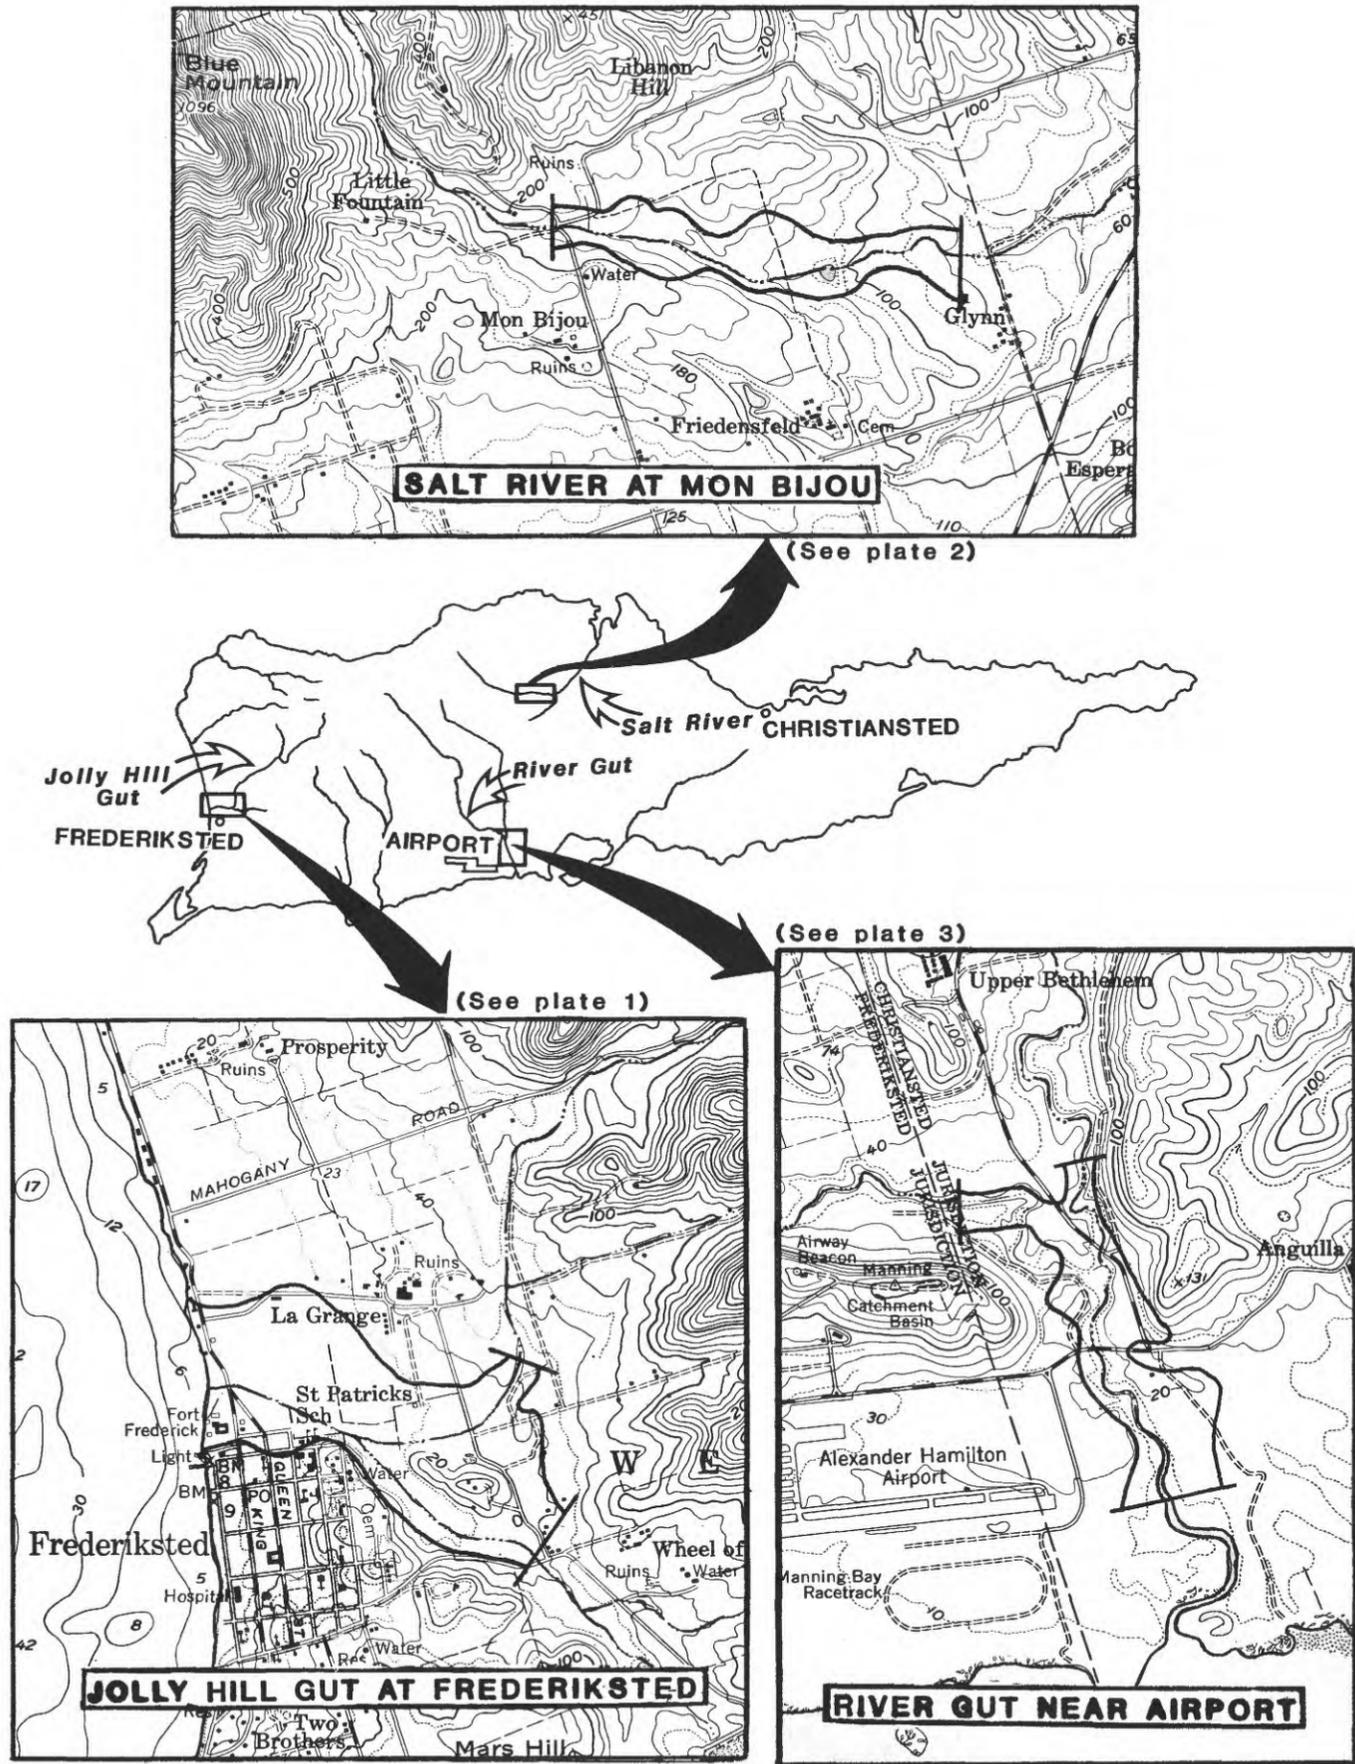
Figure 3.2-1. Flooded areas during the October 8, 1977 storm.

The flooded areas described in this report include Frederiksted, Mon Bijou, and the vicinity of the Airport (fig. 3.2-1 and plates 1, 2, and 3). The magnitude of the flooding in the other affected areas was similar to or less than that of the floods of November 11-13, 1974, as reported by Haire and Johnson (1974). Therefore, flooded areas defined by Haire and Johnson are not delineated in this report.

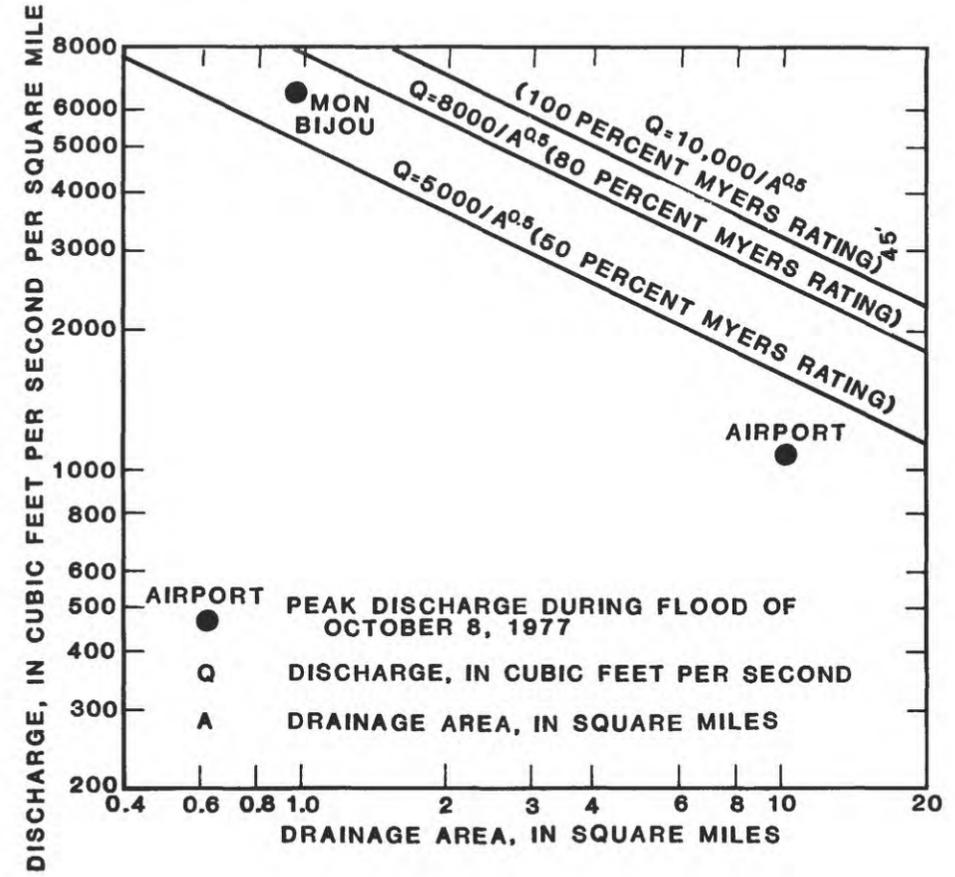
Figure 3.2-2. Peak discharges at Mon Bijou and near airport compared to Myer's historical floods.

Peak discharges can be compared on the basis of drainage area to maximum discharges at other basins throughout the world (Lindsey and others, 1949). The discharge data for Mon Bijou and River Gut, as well as Myers comparison curves, are plotted in figure 3.2-2. The comparison shows that the Airport flood was less than 50-percent Myers rating. The Mon Bijou flood on the other hand, was greater than the 50-percent Myers rating and approaches the 80-percent yield curve, indicating a flood of greater relative magnitude. As a comparison, 9 sites of 24 affected by the floods of 1960 in eastern Puerto Rico exceeded the 80-percent Myers rating (Barnes and Bogart, 1961). These floods were the greatest known in Puerto Rico.

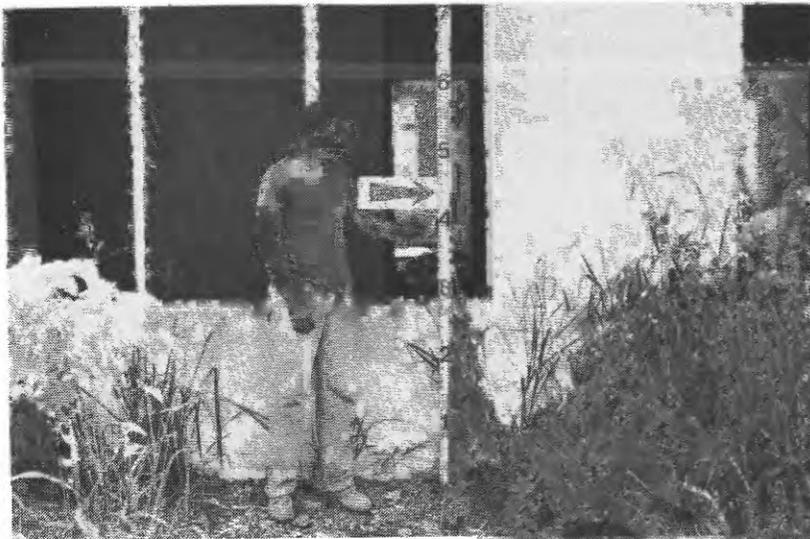
Figure 3.4-1. Depth of water at abandoned house at entrance to Mon Bijou housing area, lot 471. (photo A)

The depth of the the water in some of the flooded urban areas exceeded four feet. The housing project in Mon Bijou (plate 2), was the most affected area. The water depth in some of the houses was about 4.5 feet (fig. 3.4-1 and 3.4-2). Water depths of about 4 feet were also recorded in some areas near the Airport (fig. 3.4-3 and 3.4-4). In Frederiksted (plate 1), water depths did not exceed 2.5 feet (fig. 3.4-5 and 3.4-6). Most of the flooding occurred west and north of town.

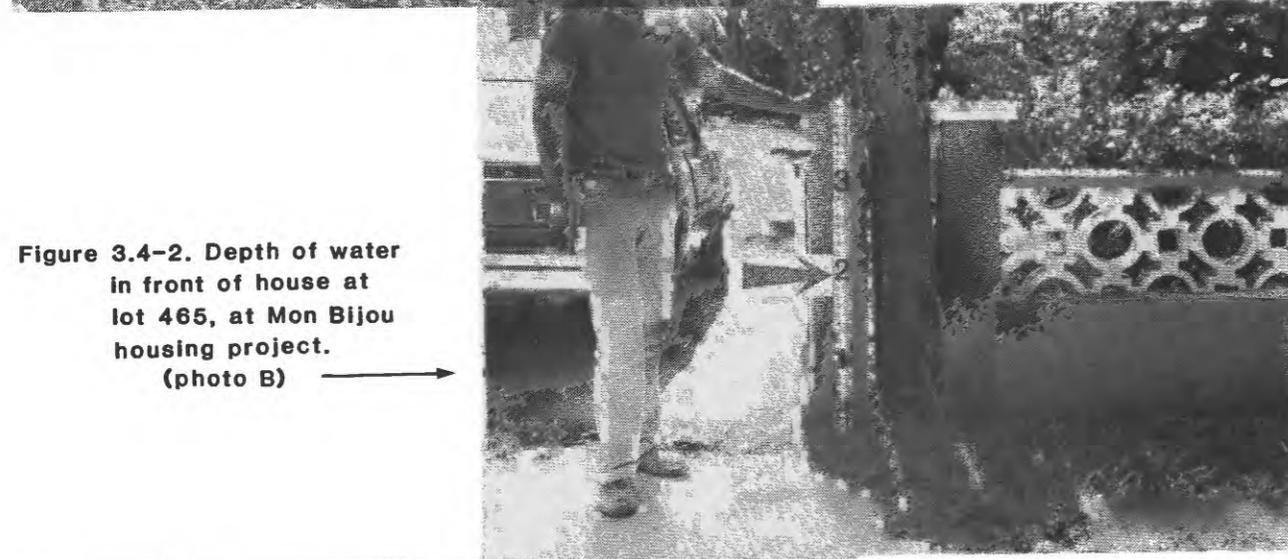
Figure 3.4-2. Depth of water in front of house at lot 465, at Mon Bijou housing project. (photo B)

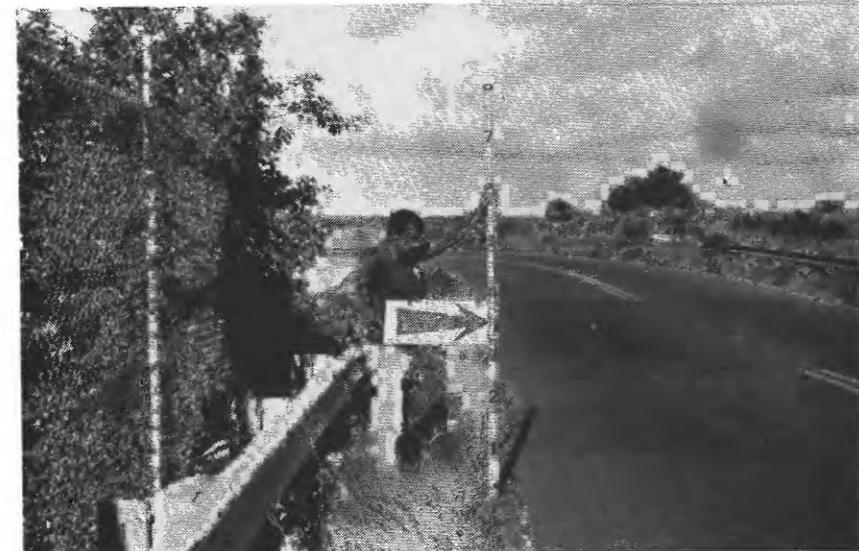
Figure 3.4-3. Depth of water at farthest downstream bridge over River Gut on airport road. (photo C)

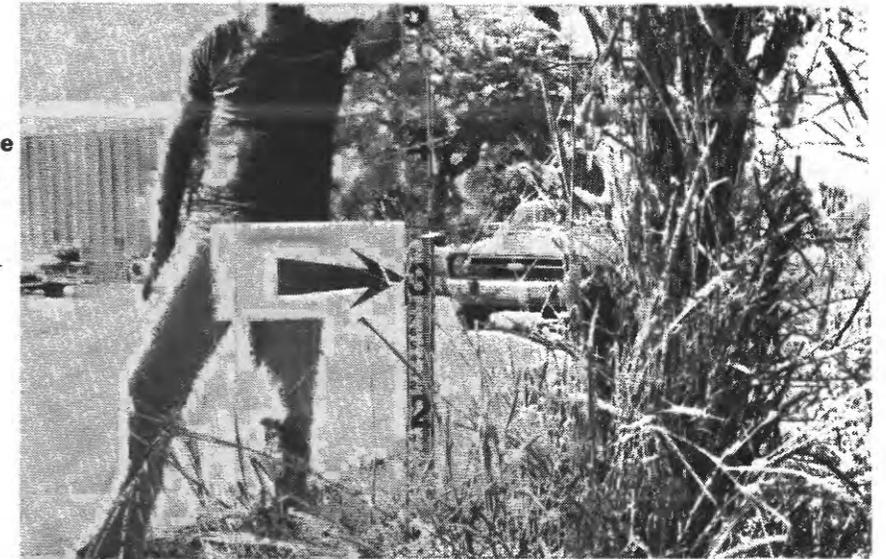
Figure 3.4-4. Depth to water in the vicinity of service station, about 200 feet north of fourth bridge on airport road. (photo D)

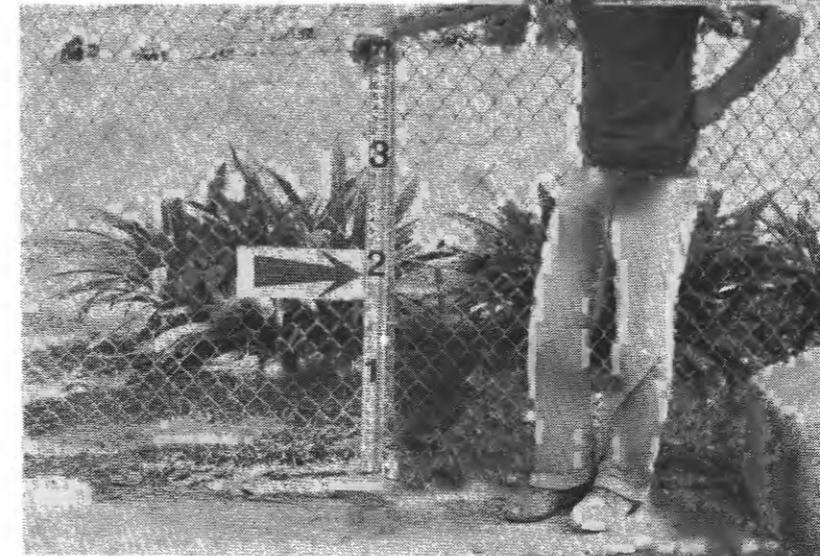
Figure 3.4-5. Depth of water in front of ballpark about 200 feet south of most downstream culvert at Frederiksted. (photo E)

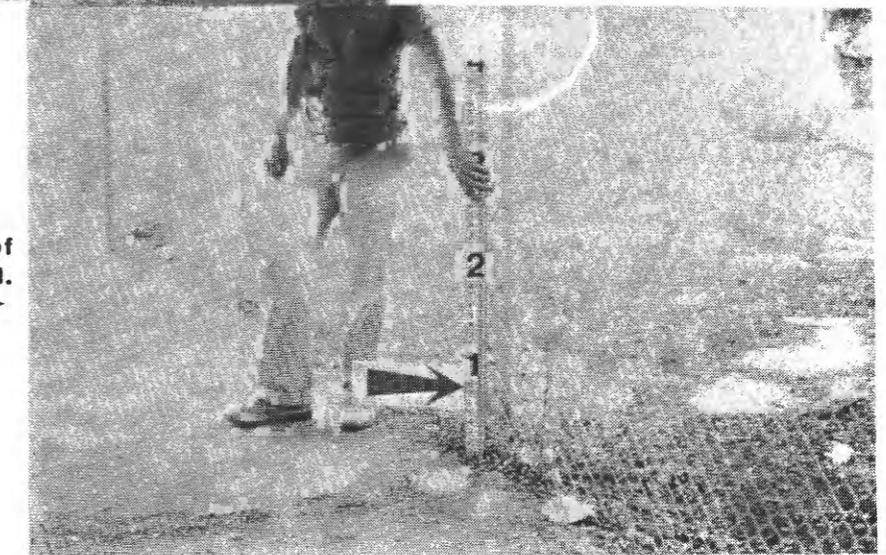
Figure 3.4-6. Depth of water on fence at east side of ballpark at Frederiksted. (photo F)

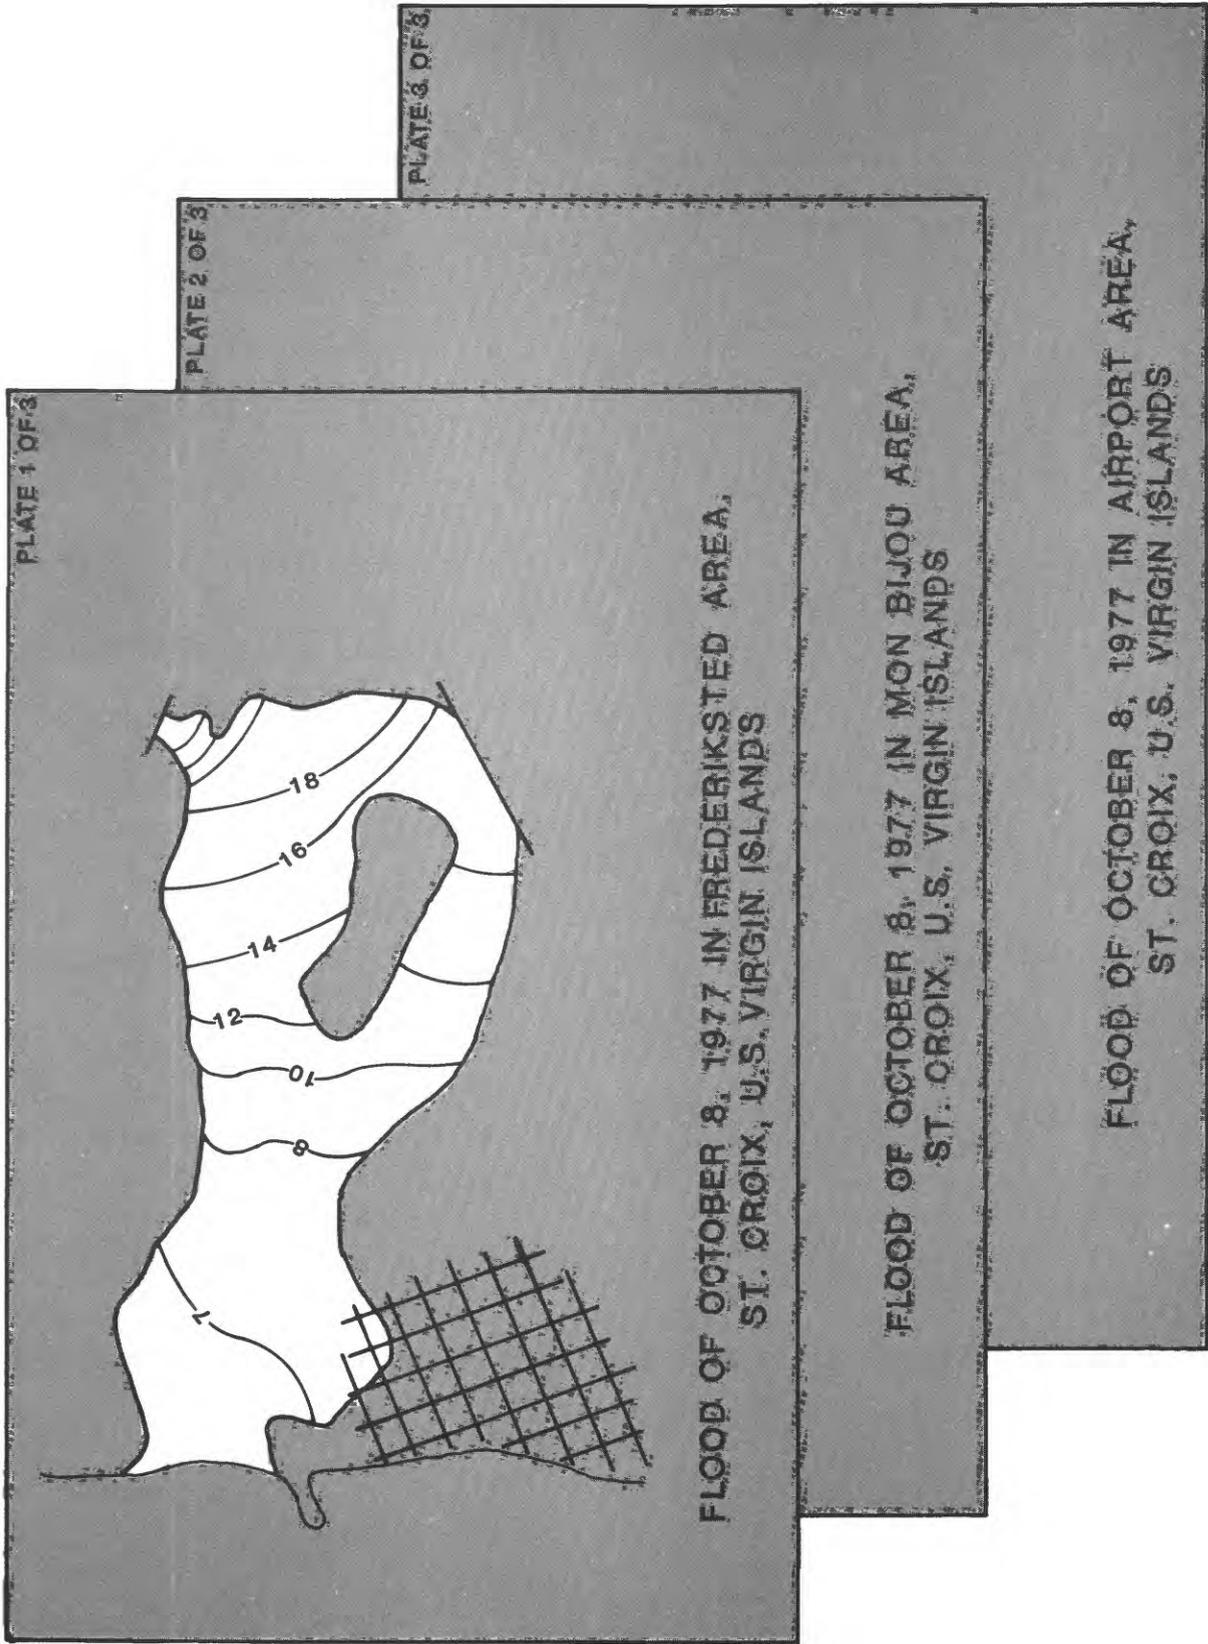
Figure 3.5-1.-Flood maps presented in this report. (in pocket)

The areas inundated by the October 8, 1977 flood are delineated on variable contour-interval topographic maps (fig. 3.5-1 and plates 1-3). The base maps for the Frederiksted and Airport areas (plates 1 and 3), were provided by the U.S. Virgin Islands Department of Public Works. The Mon Bijou area Map was delineated from a field survey by U.S. Geological Survey employees.

Water-surface contours on the flood maps (plates 1-3) are based on the elevations of the floodmarks and the flood profiles. The contours represent lines of equal elevation of the water surface at about a normal angle to the direction of flow. Obstructions to the flow, such as man-made structure and vegetation, can cause irregularities in the contours. In the Mon Bijou area, the flow of the floodwaters was obstructed by the buildings in a housing project. A similar condition was observed in the Frederiksted area, where fences and buildings also obstructed some of the flow. The approximate depth of flooding at any point in the inundated areas can be estimated by subtracting the ground elevation from the water-surface contour. Interpolation can be used to estimate points between contours.
